National Transportation Safety Board

CEN22FA331

VIDEO STUDY

Location: North Fork, Idaho
Date: July 21, 2022
Time: 1642 MDT
Aircraft: CH-47D Chinook helicopter

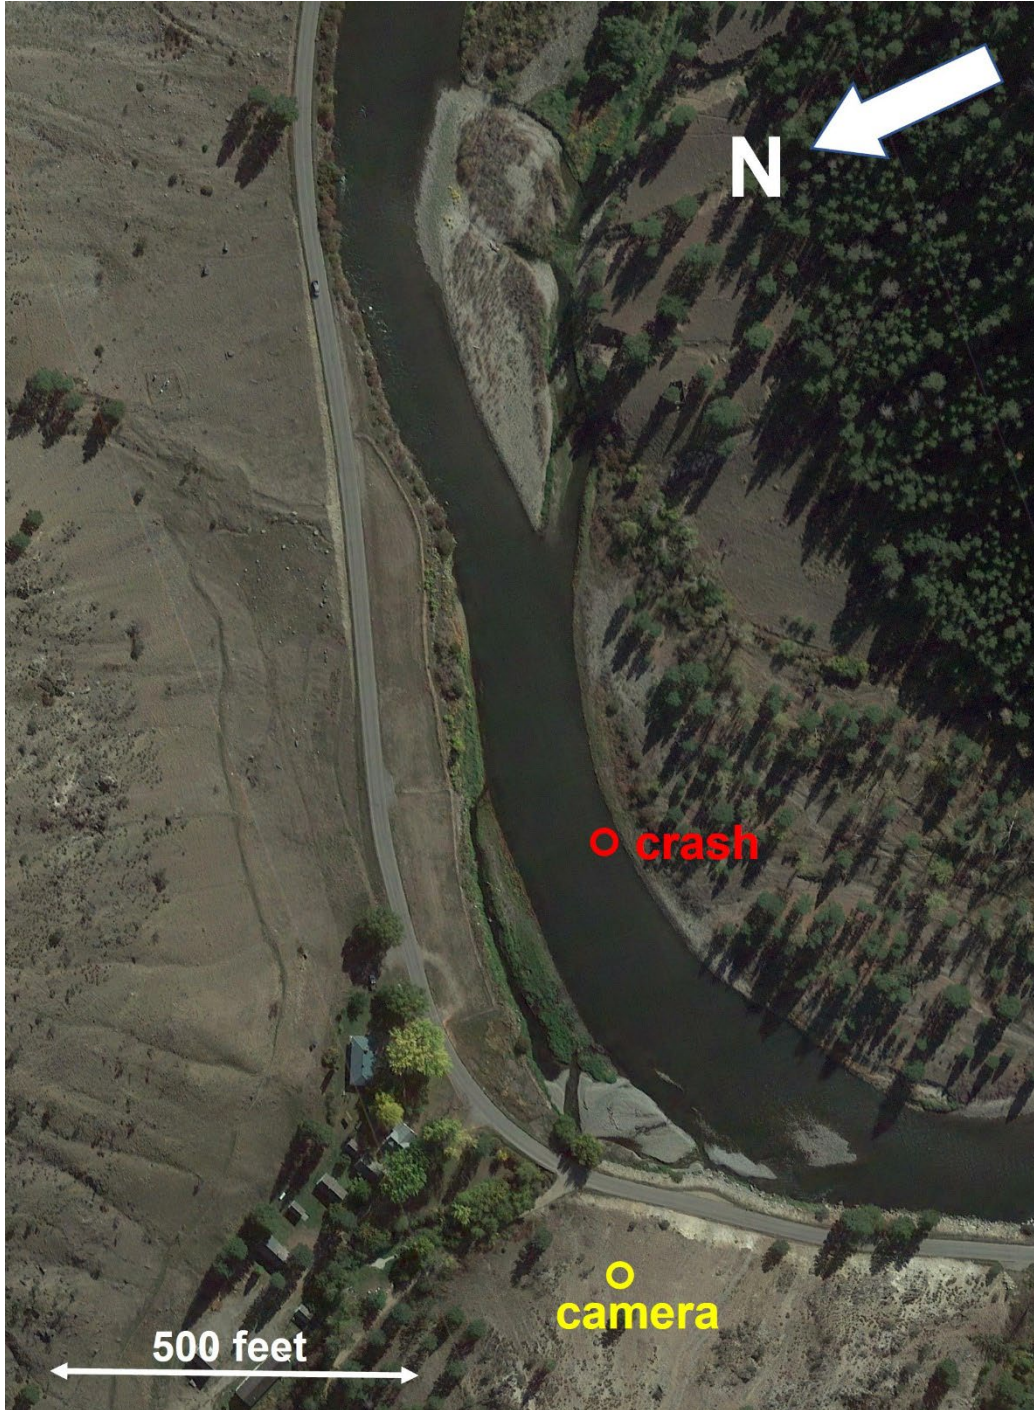
Figure 1. Aerial View of the Accident Area

The estimation of camera model parameters is based on references that are visible both in aerial images and in video frames. The references must be objects and features that can be identified in aerial images. In this case, the available calibration references were the Salmon River shorelines and trees on both sides of the river. Figure 1 is an aerial view of the accident area. It shows the location of the camera and the location where the helicopter impacted water. The aerial view is shown rotated to approximately correspond to the images of the area as seen in video frames.

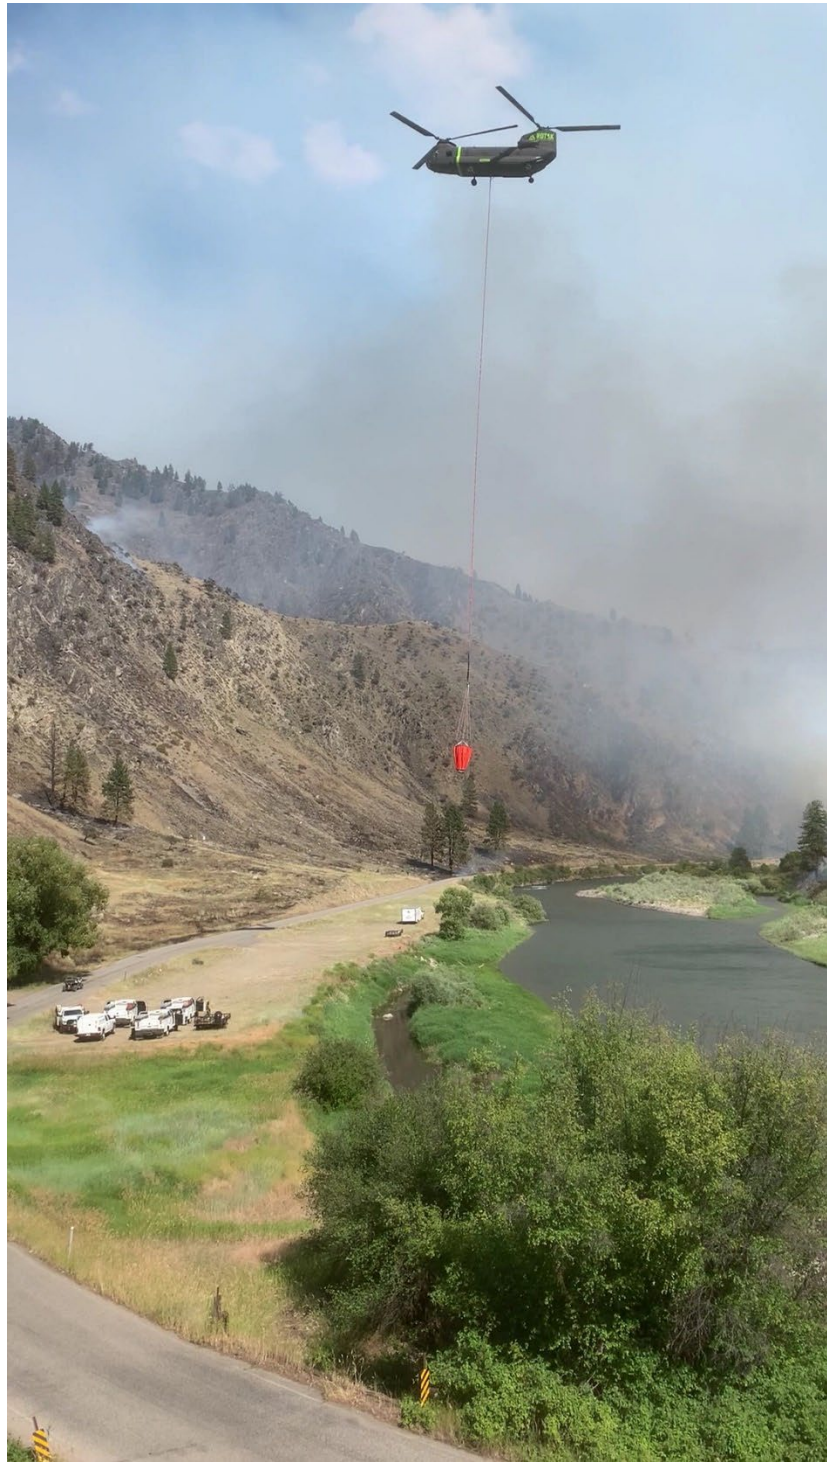
Figure 2. Video Frame Recorded at Time 15.7 seconds

Figure 2 is a frame from the analyzed video. The frame was recorded at video time 15.7 seconds. The helicopter was already rotating at that time at a relatively low counterclockwise yaw rate of about 38 degrees/second. Its pitch angle was about 2° nose up (positive pitch) and its roll angle was about 2° left side down (negative roll).

A computer program that simulates camera optics was used to project the calibration references onto a frame from the video in an iterative process in which the seven parameters were varied so as to align the projected references with their images. When the projected references were aligned optimally with their images in the frame, values of the seven parameters were their optimal estimates. At that point, the estimated camera X, Y and Z coordinates and the HFOV angle were optimal for all the video frames that were to be analyzed.

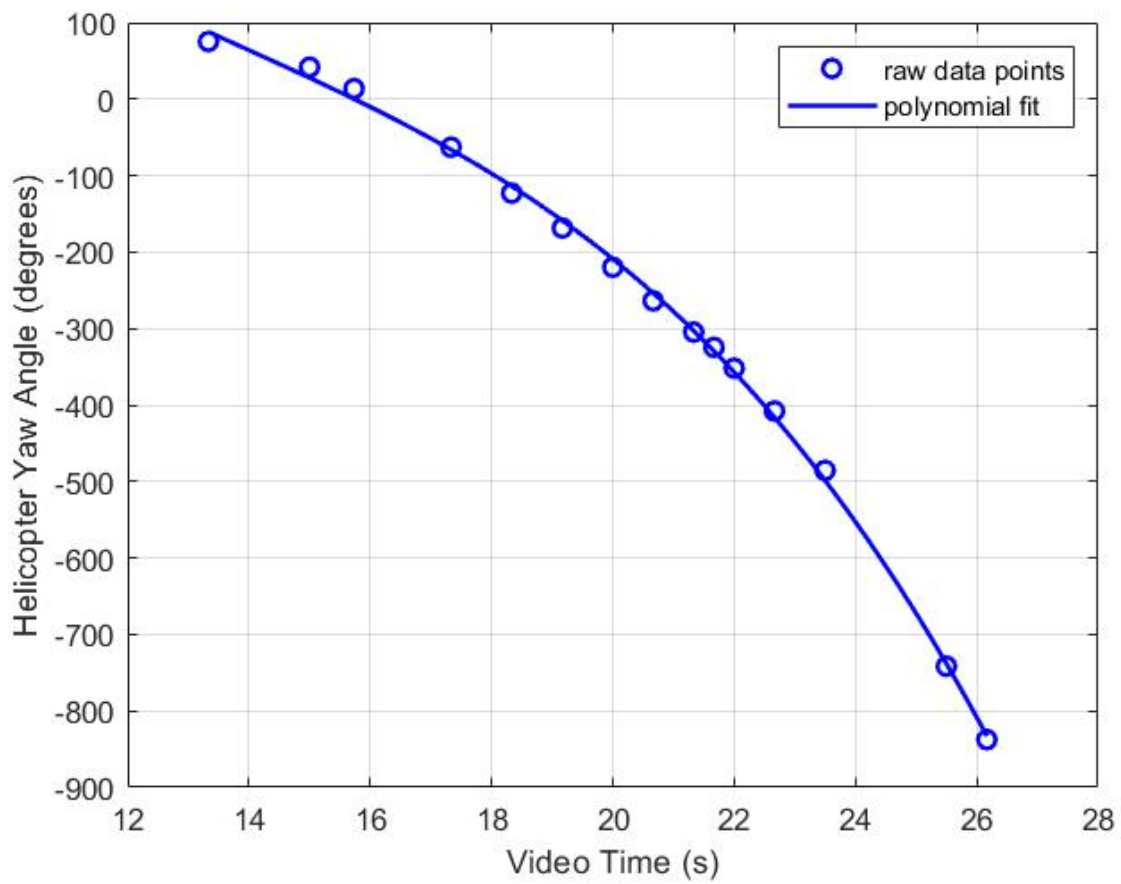
Figure 3. Estimated Helicopter Yaw Angle

Figure 3 shows the estimated yaw angle of the helicopter. The markers are the raw data points and the curve is a second-order polynomial fit to the raw data. The angle is zero when the helicopter nose points to the north. The negative yaw angles in the figure mean that the helicopter was yawing counterclockwise in top view. The yaw angle starts at about $+90^\circ$ and ends at about -840° at time 26.2 seconds when the helicopter contacted the water. This yaw angle range corresponds to about $2 \frac{1}{2}$ counterclockwise rotations.

Figure 4 shows the estimated helicopter yaw rate. It was derived by differentiating the second-order polynomial fit from Figure 3. Figure 4 shows that the magnitude of the negative (i.e., counterclockwise) yaw rate is increasing. At the time of water contact, the estimated yaw rate was about -148 degrees/second.
