DCA22PM034

ONBOARD IMAGE RECORDER

Specialist's Factual Report

Location: Vega Baja, PR
Date: August 8, 2022
Time: 1345 eastern daylight time (EDT)
Vessel Name: *Winslow Griesser* (IMO: 4686175)

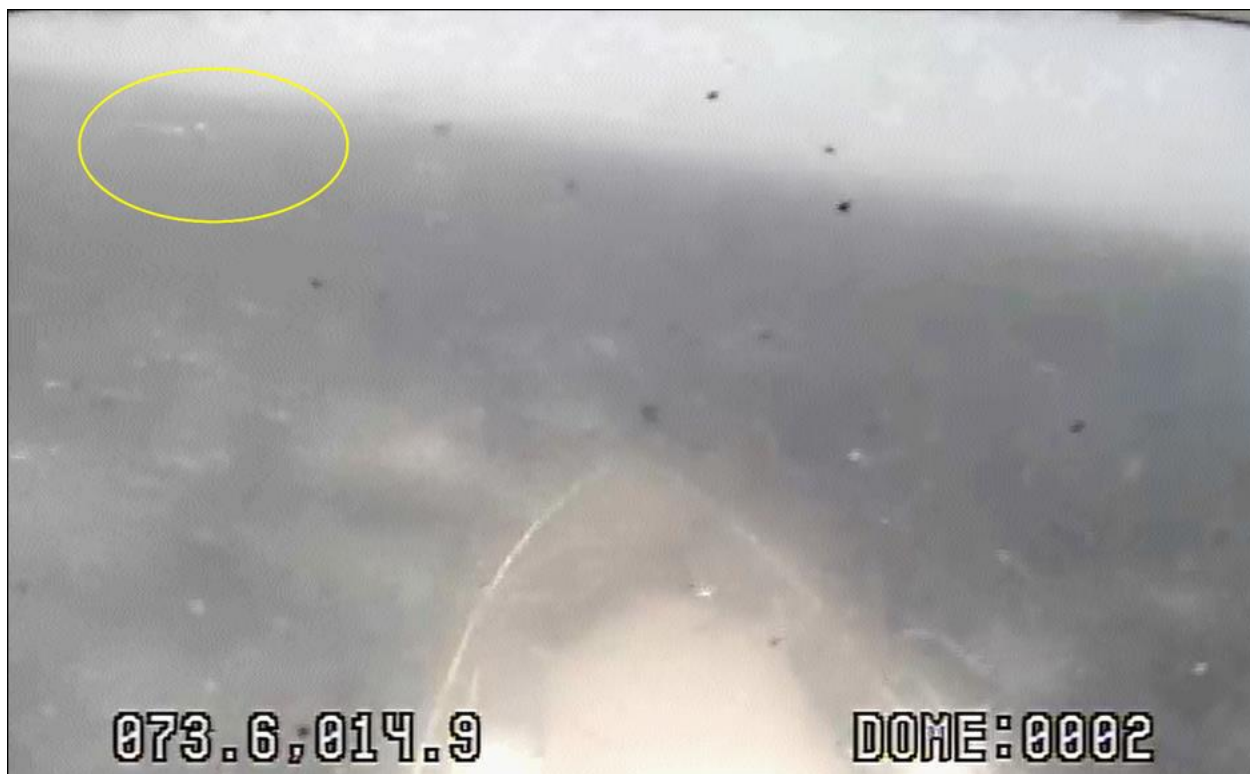
Around 12:50 into the recording, some white colored features of the Fishing Vessel *Desakata* came into the left FOV of the recording. Figure 1 is a screen capture of the recording at this time. The *Desakata* is circled in yellow.

Figure 1. A screen capture at approximately 12:50.

The *Desakata* was crossing from the *Winslow Griesser's* port side to its starboard side. The recording show the *Desakata's* heading and speed appeared to be unchanged. The *Desakata* continued to move across the *Winslow Griesser's* bow from port to starboard.

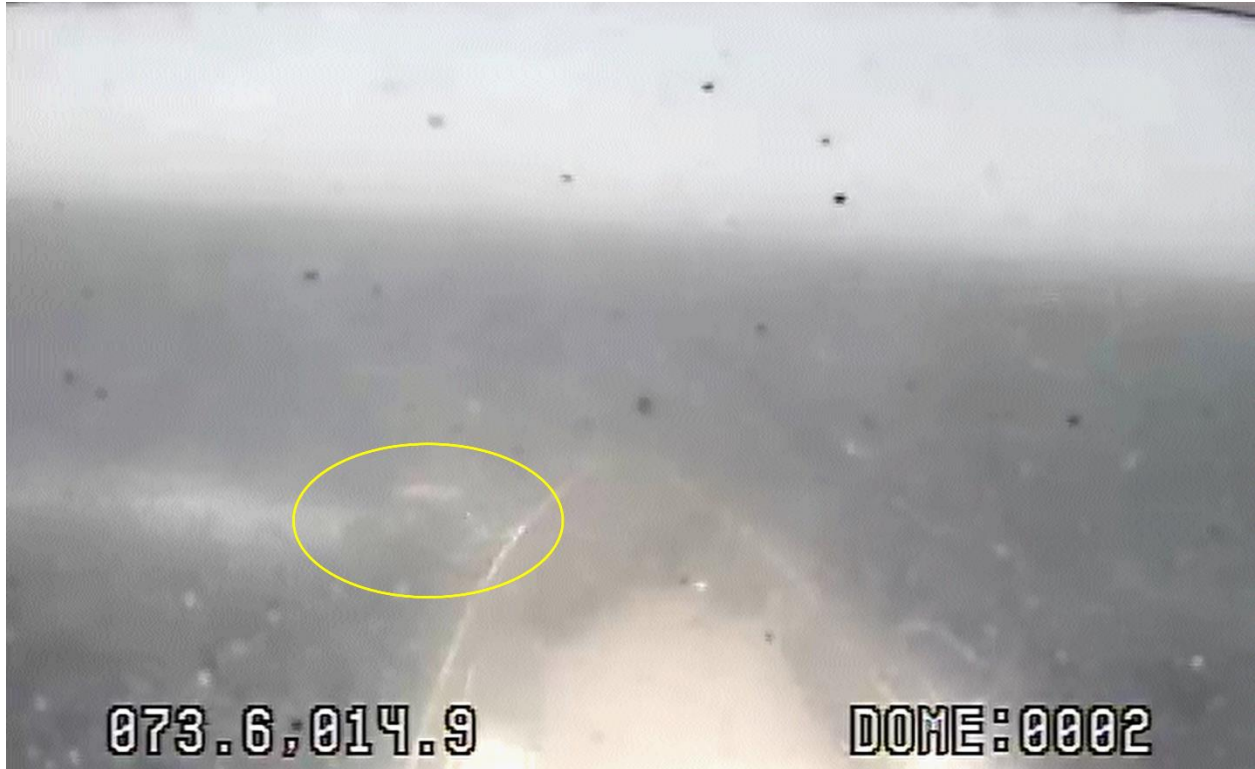
Figure 2 is a screen capture at 13:07. The *Desakata* is circled in yellow.

Figure 2. A screen capture at approximately 13:07.

At 13:08, the camera FOV shook slightly. *Winslow Griesser* was still traveling forward. The recording later showed the *Winslow Griesser* slow. No other details were documented from this camera position. The recording ended about 1:00:23 elapsed.
