**NATIONAL TRANSPORTATION SAFETY BOARD
OFFICE OF HIGHWAY SAFETY
WASHINGTON, D.C.**

**MOTOR CARRIER FACTORS GROUP CHAIRMAN'S
FACTUAL REPORT**

PHOENIX, ARIZONA – HWY21MH008

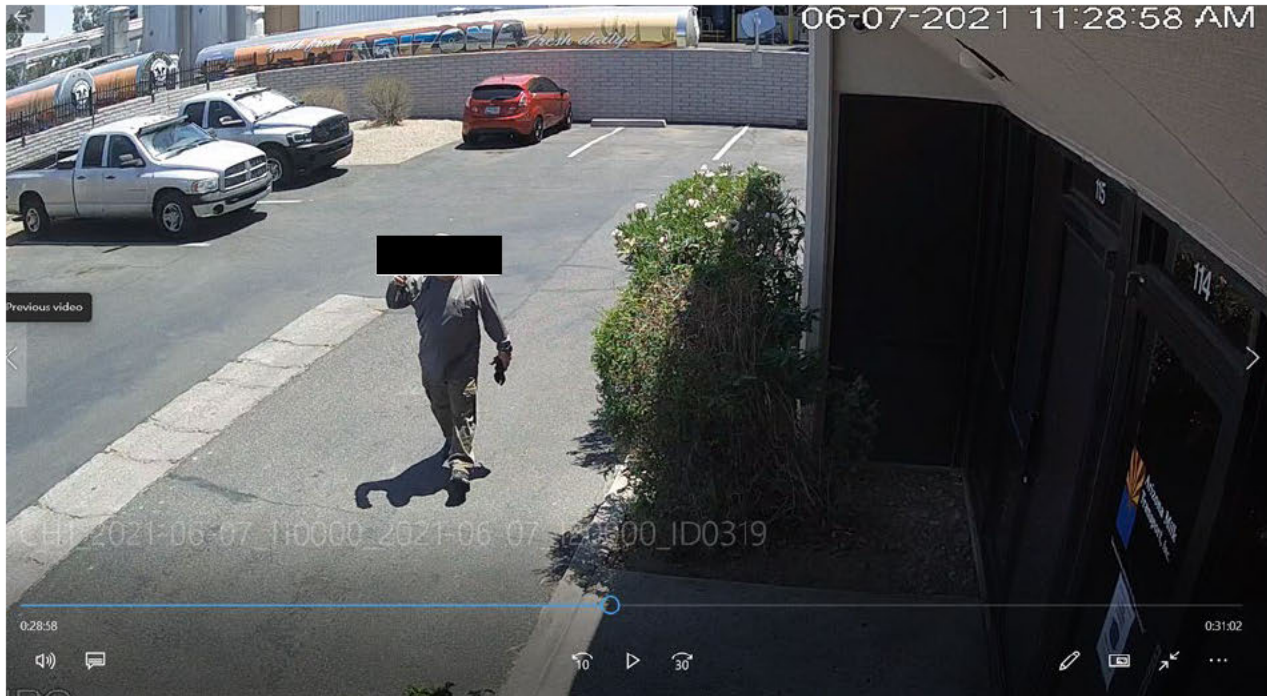
Figure 2. Screen shot of AMT Security video camera footage showing crash-involved driver walking towards the dispatch office on 6/07/2021.

The video was analyzed by the NTSB Vehicle Recorders Division and determined the videos time stamps did not reflect accurate local time. The NTSB Vehicle Recorders Division used a video forensic software to determine the actual timestamps for the video footage to document the crash-involved driver’s activities.²⁷ For additional information concerning the video analysis see the *NTSB Security Video-Time Correlation Factual Report* in the docket.

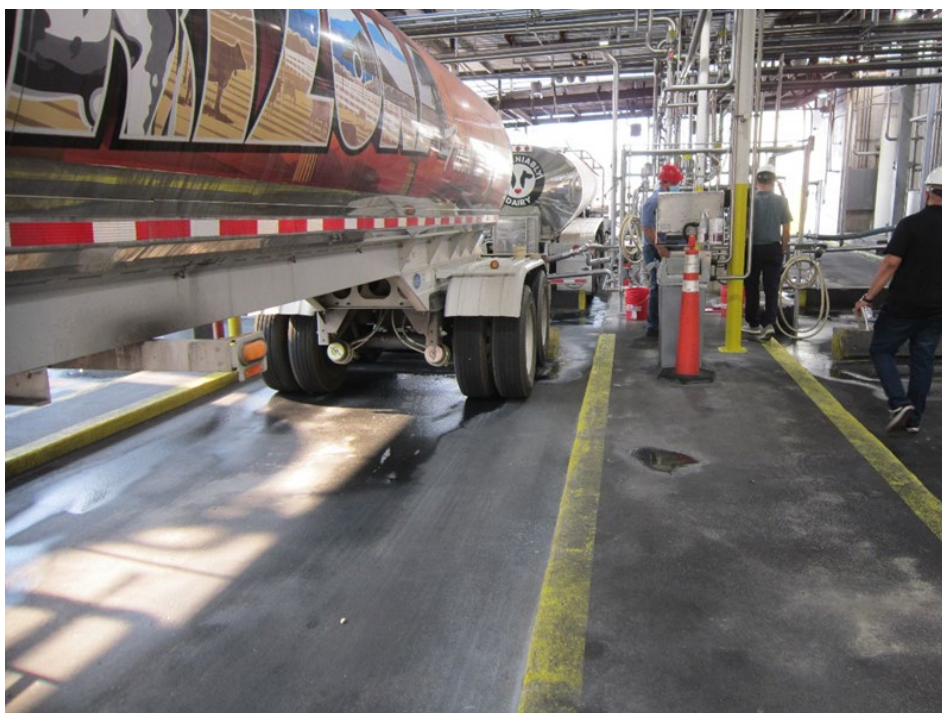
Photo 1. Milk tanker-trailers being off loaded at United Dairymen of Arizona.

UDA officials provided NTSB investigators with a tour of the operations. UDA officials explained that loads are dispatched to the contractors in advance for pickup at local dairies. Milk tank-trailers were staged at the UDA facility, picked up by the driver, driven to the dairy, filled with raw milk and returned to UDA. Drivers would be prompted for various entries on the UDA company iPad with a dropdown menu. Drivers were required to take samples of loads at each dairy farm that must be taken to the UDA lab upon arrival of each load. Raw milk loads can follow two paths: either loads are taken to customers (for example grocery stores like Kroger) who will pasteurize, bottle, and distribute; or loads that are not needed by customers are turned into powdered milk or other products. The UDA facility processes over 4 billion pounds of milk each year.⁵⁸ A photograph of a milk truck arrival at UDA and offloaded is documented in **Photo 1**.
