**NTSB ERA22LA011**

N121YT, Flight Design GMBH CTLS

Photo Array

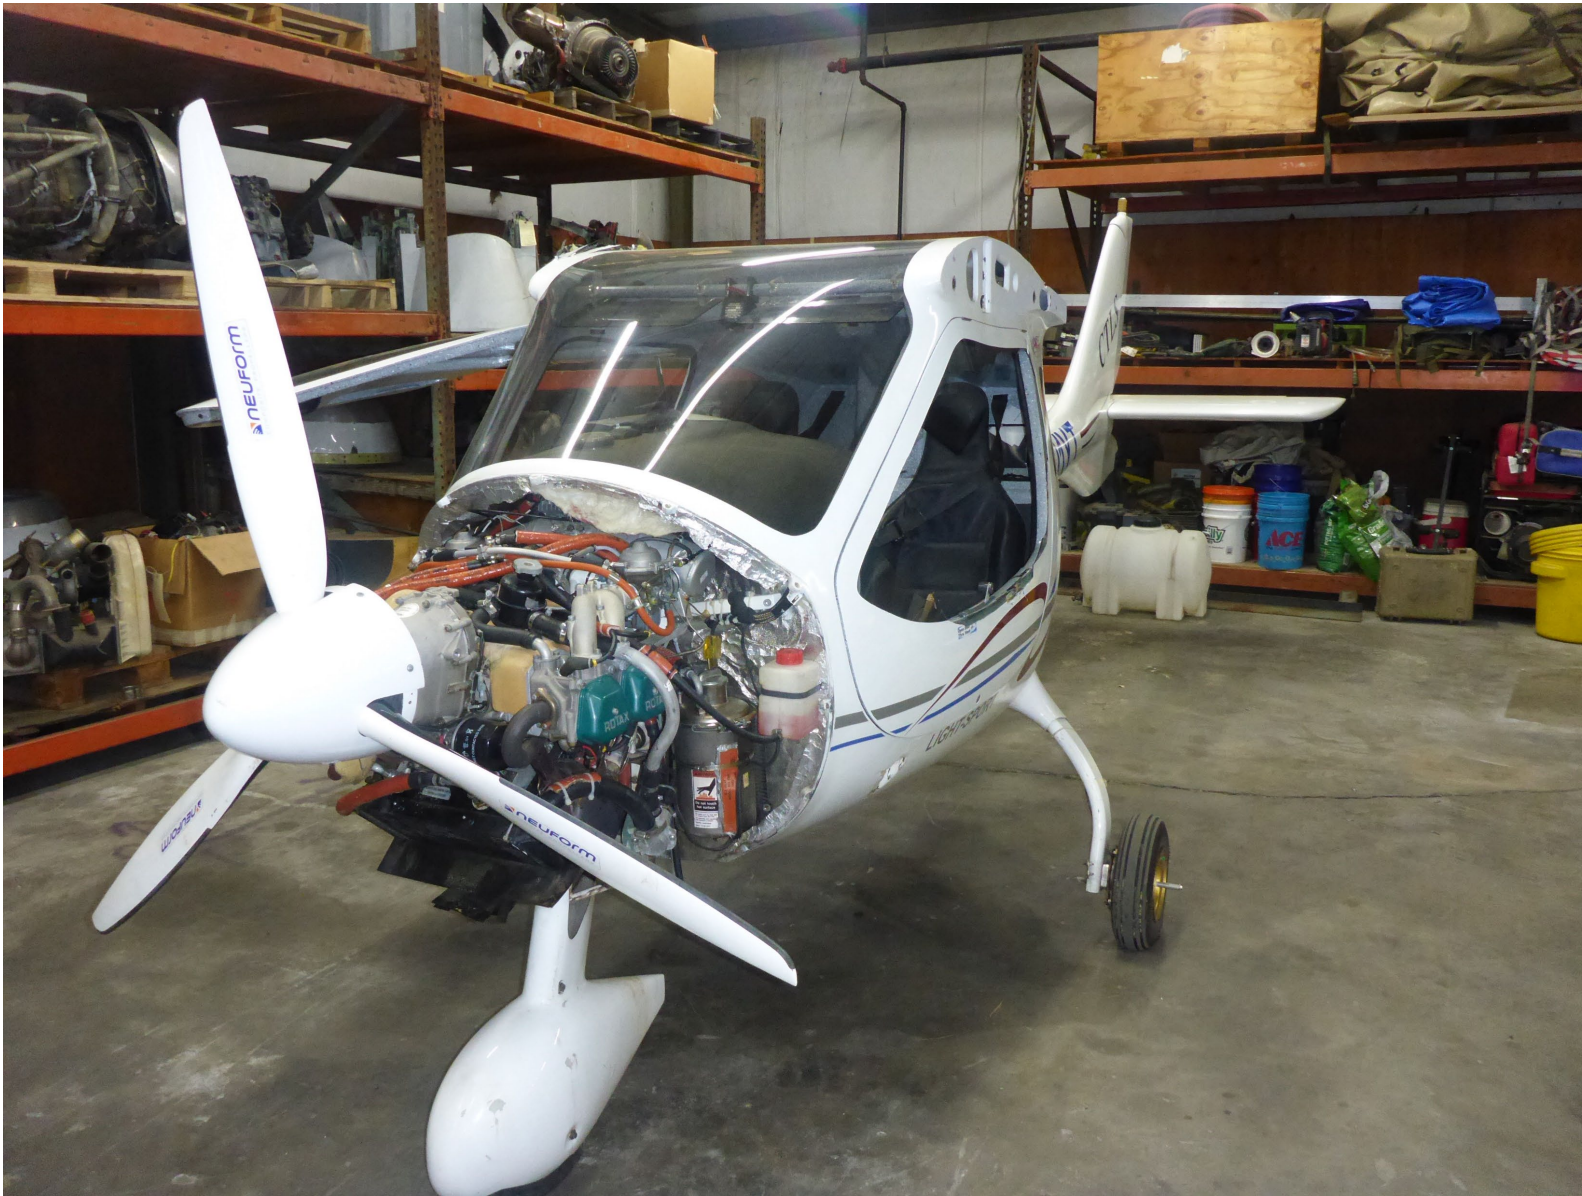
Photo 1: View of the airplane as found at Atlanta Air Salvage (Photo Courtesy of Rotax)

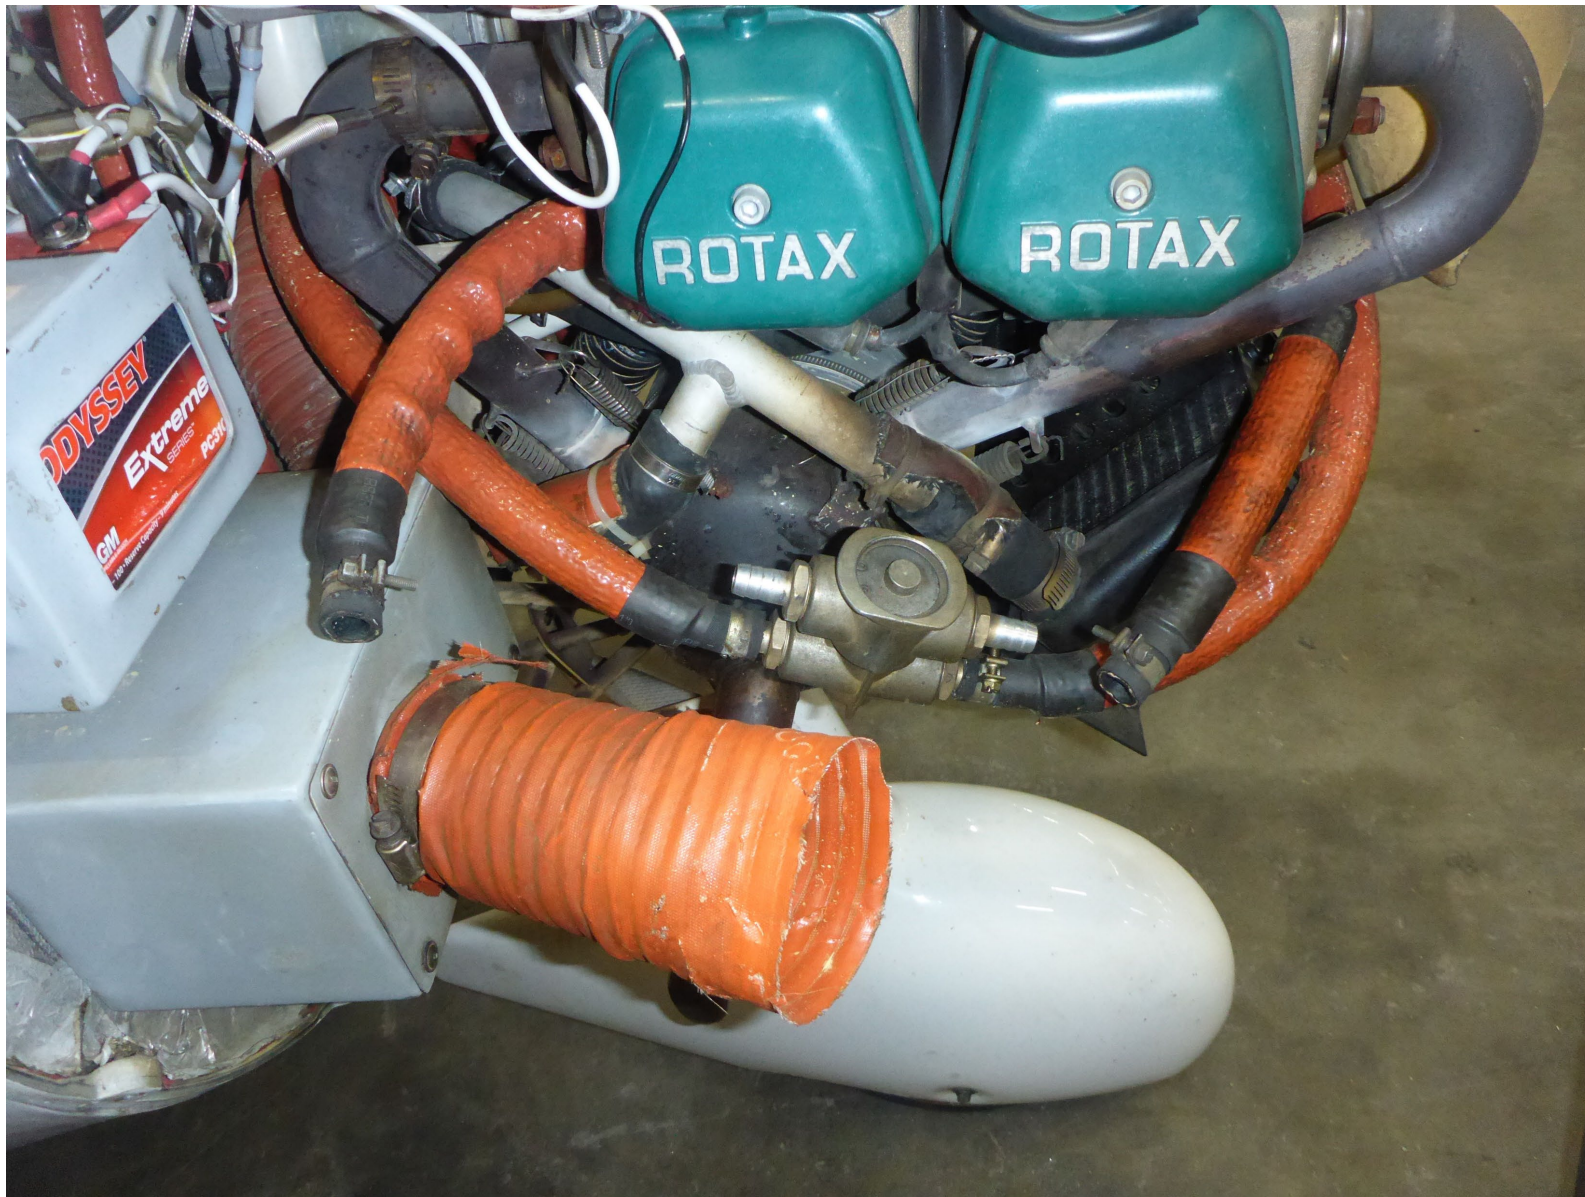
Photo 2: View of the oil thermostat and oil hoses. (Photo Courtesy of Rotax)

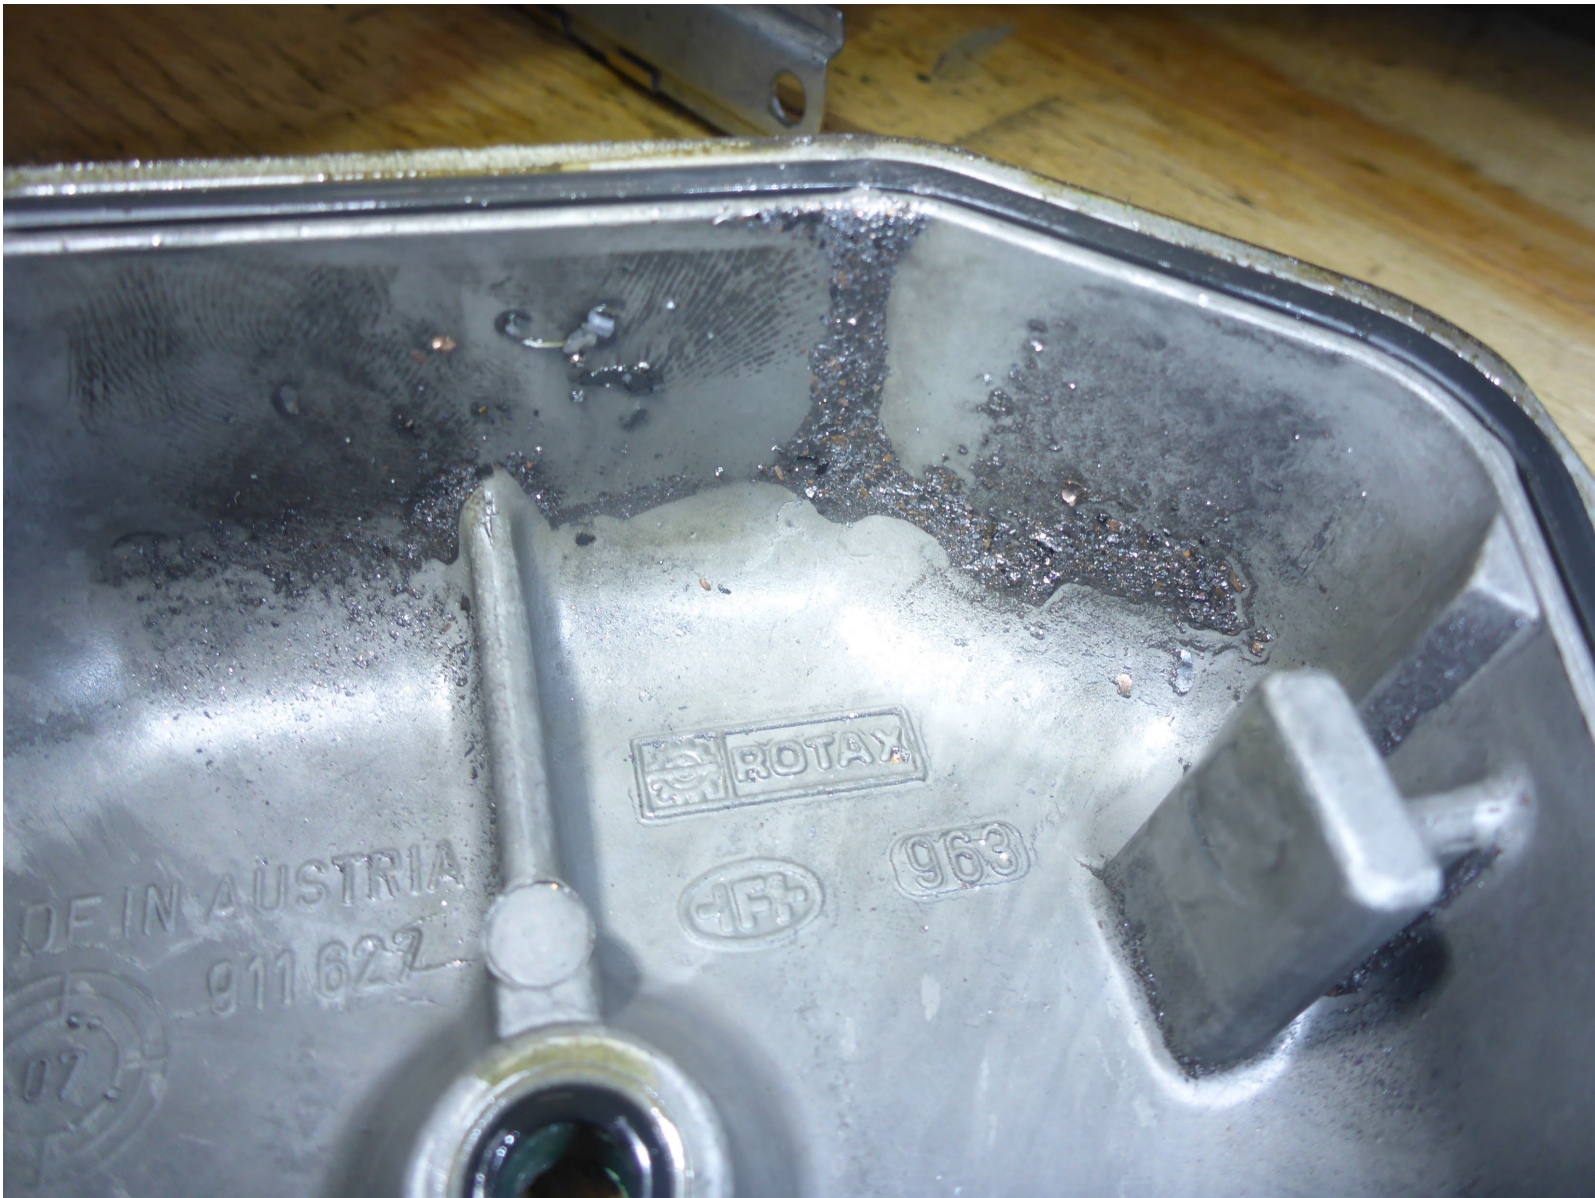
Photo 3: Number 1 rocker cover with metallic debris inside. (Photo Courtesy of Rotax)

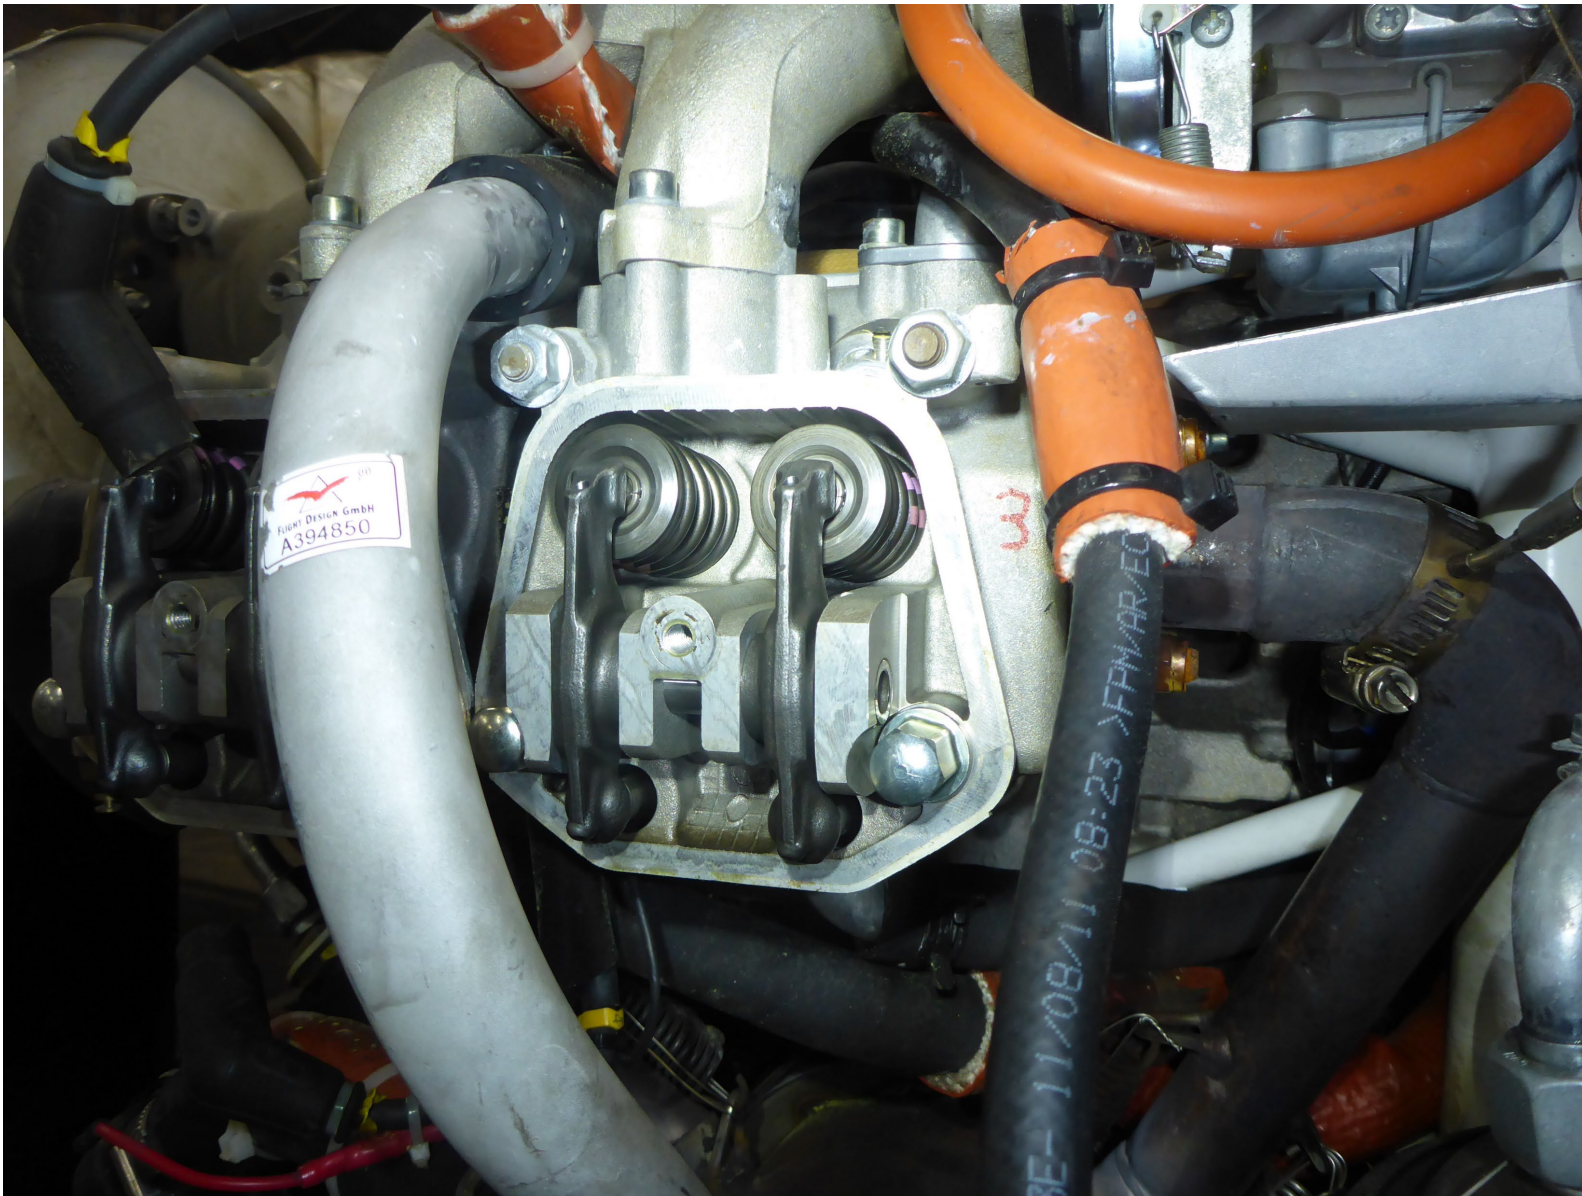
Photo 4: View of the number 3 cylinder head. (Photo Courtesy of Rotax)

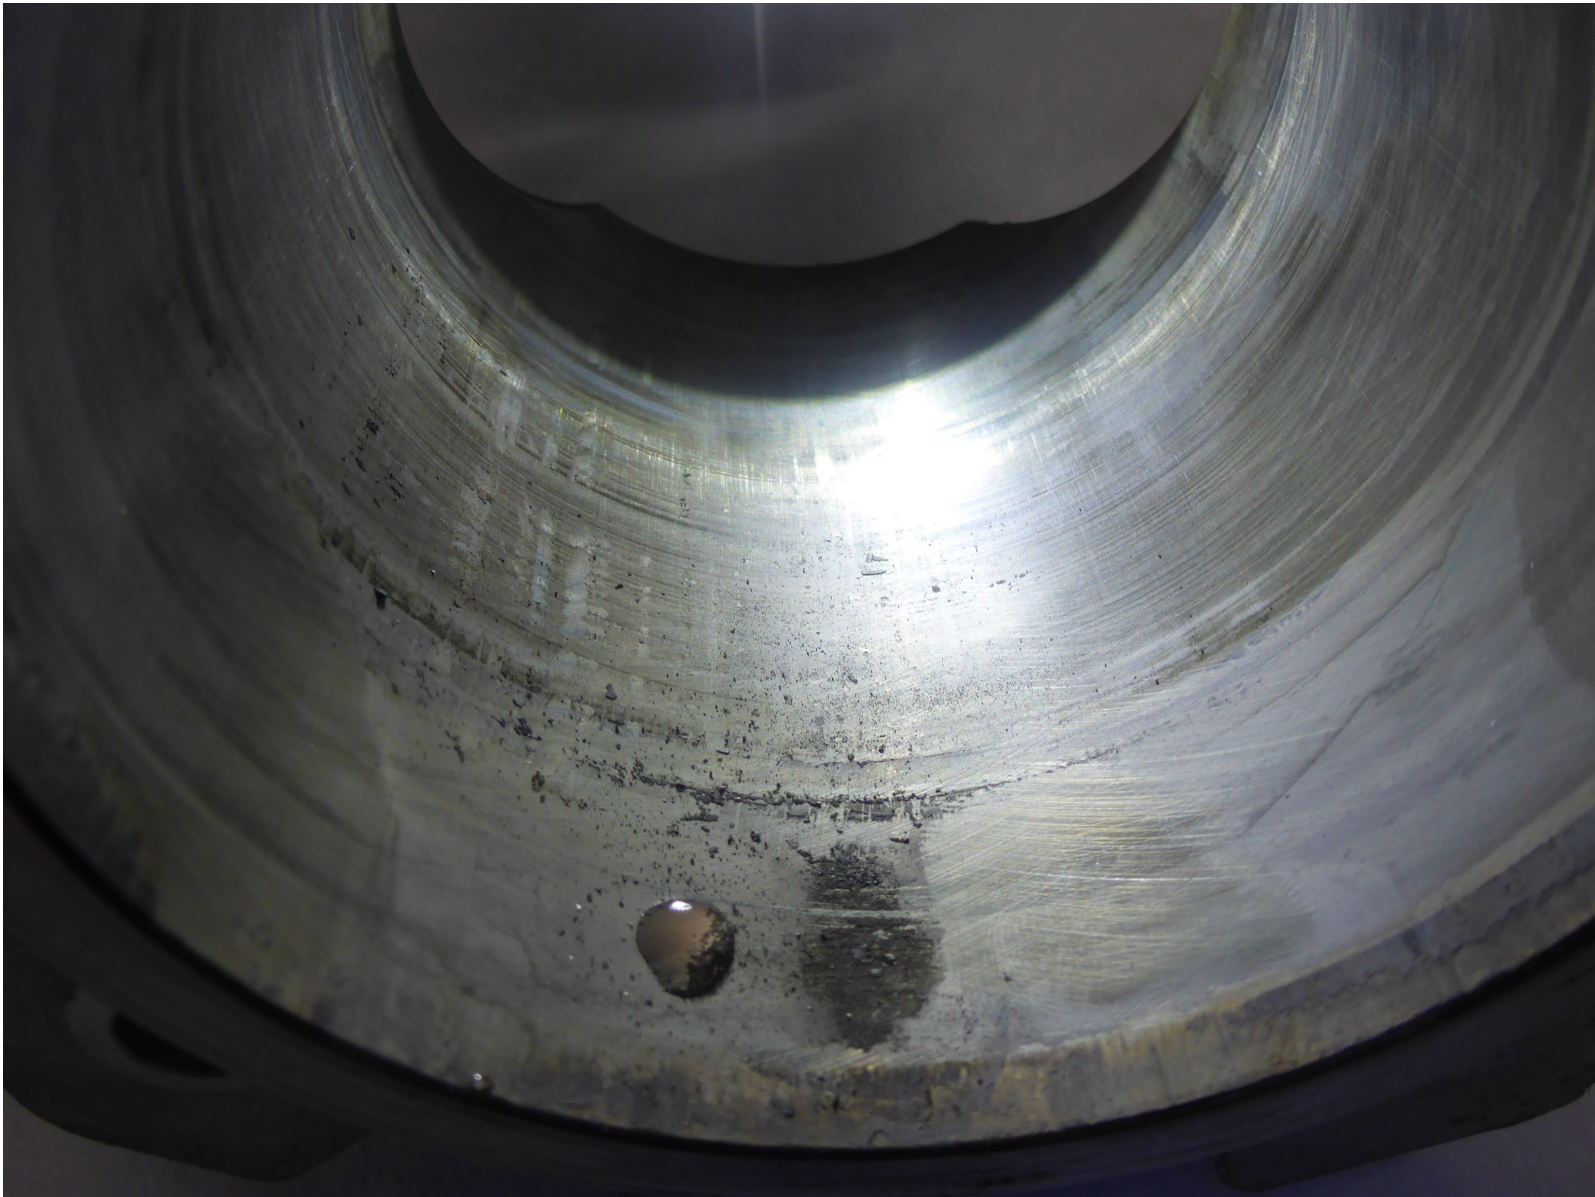
Photo 5: Number 3 cylinder with metallic debris and no oil. (Photo Courtesy of Rotax)

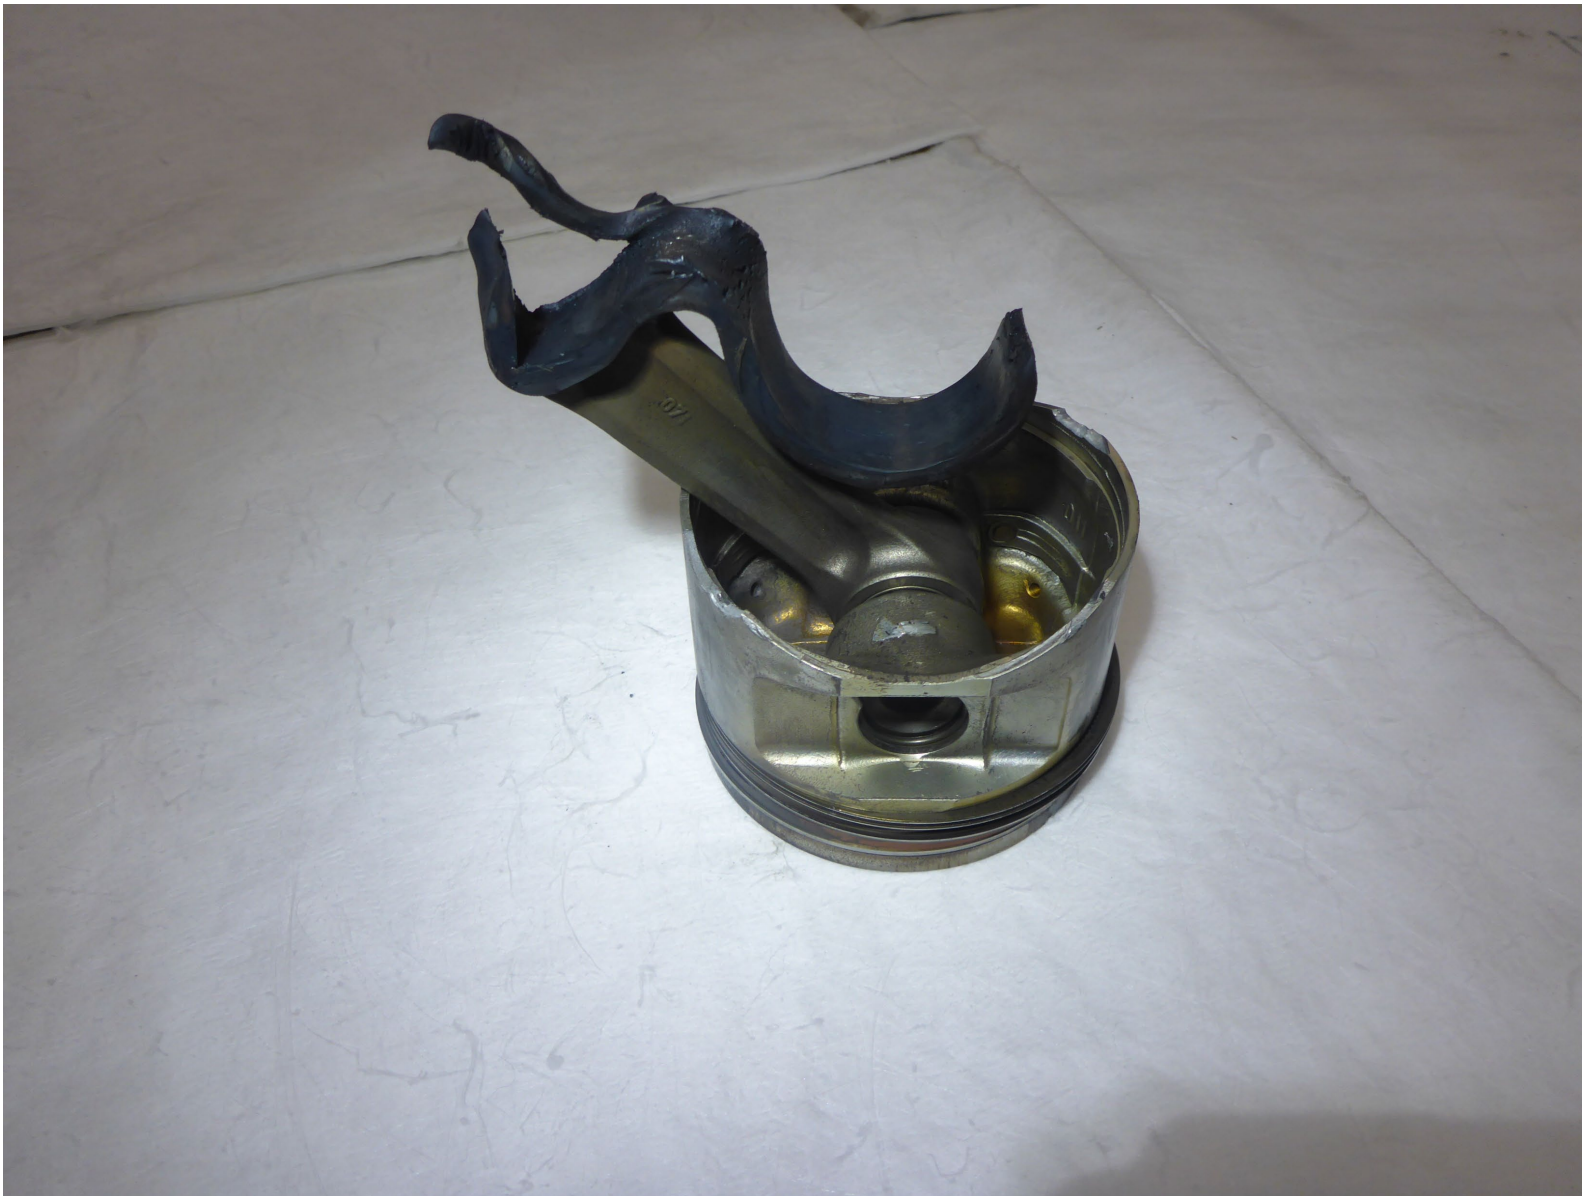
Photo 6: Number 3 connecting rod bearing, connecting rod, and piston (Photo Courtesy of Rotax)
