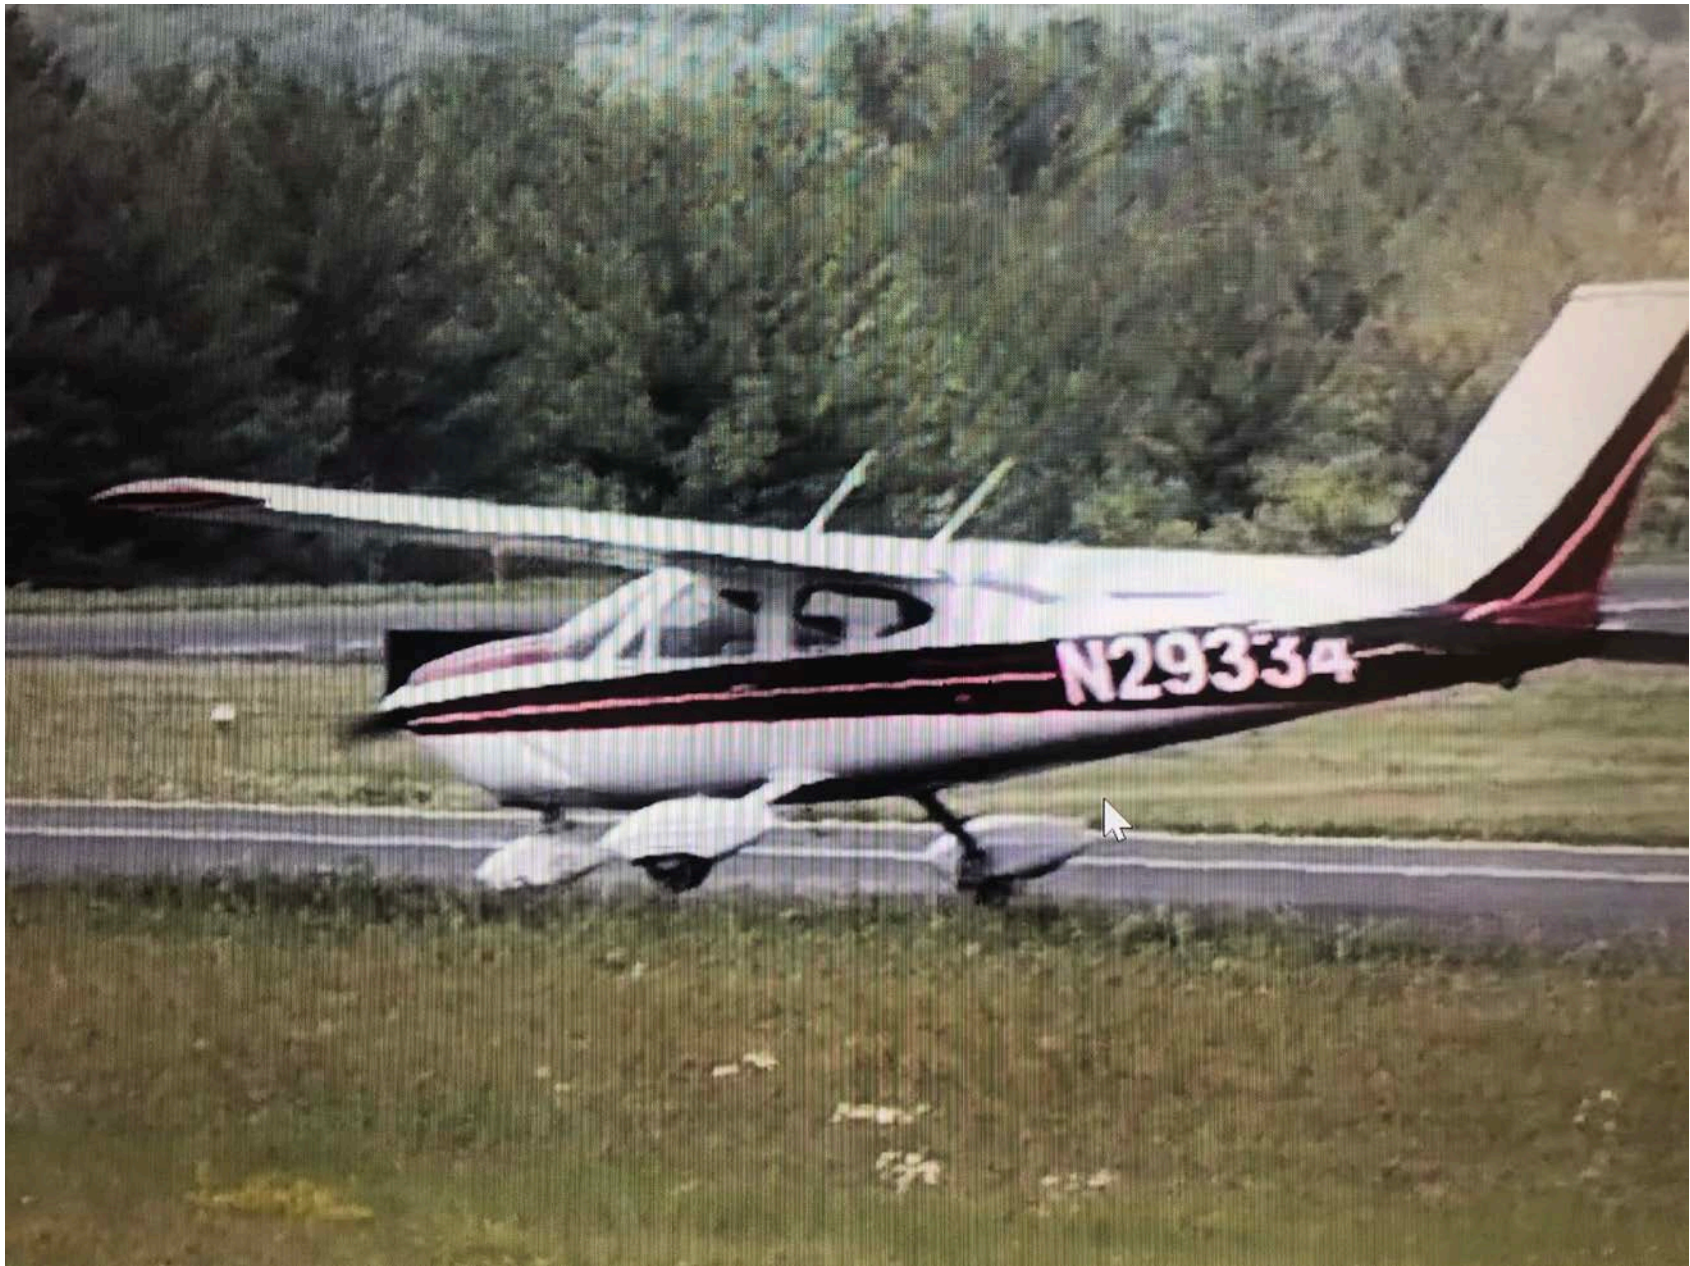
Photo 1 – Screen Shot from Security Camera Video 1 Showing Nose Landing Gear Off Runway and Wrinkle on Left Side of Forward Fuselage – Courtesy of Pittsfield Municipal Airport

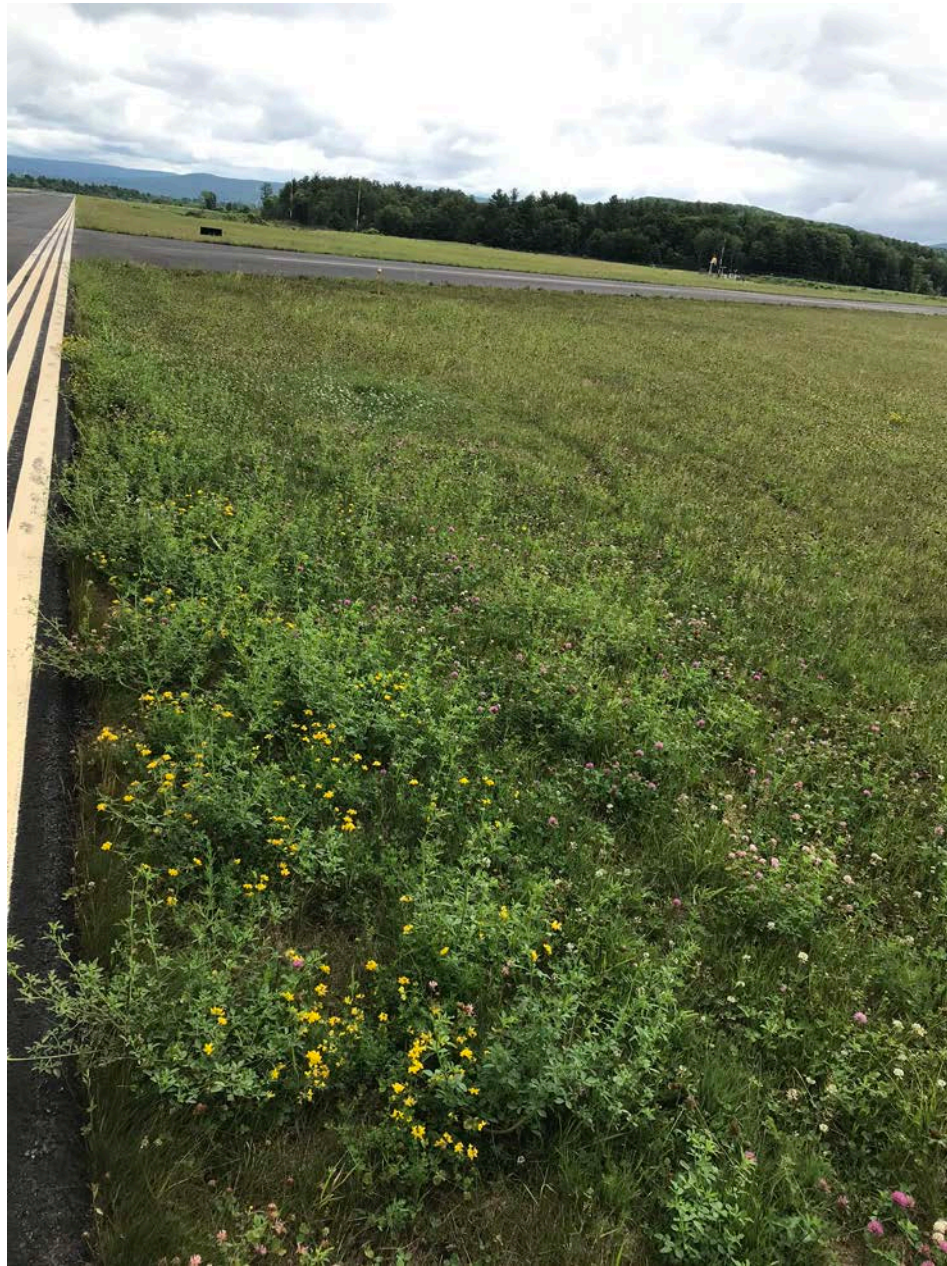
Photo 2 – Tracks in Grass Off Left Side of Runway - Courtesy of Pittsfield Municipal Airport

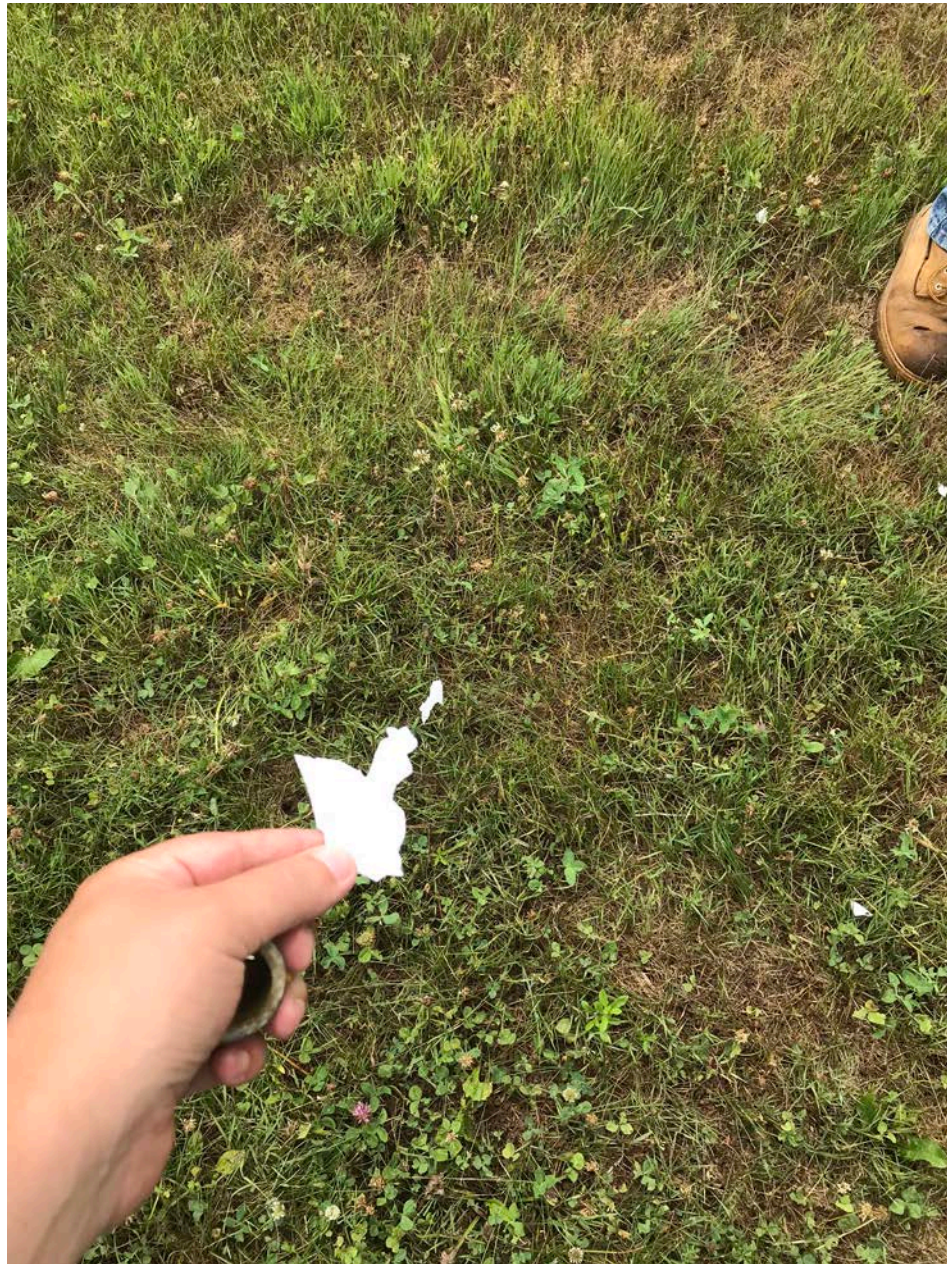
Photo 3 – Paint Chips from Nose Wheel Landing Gear Pant – Courtesy of Pittsfield Municipal Airport

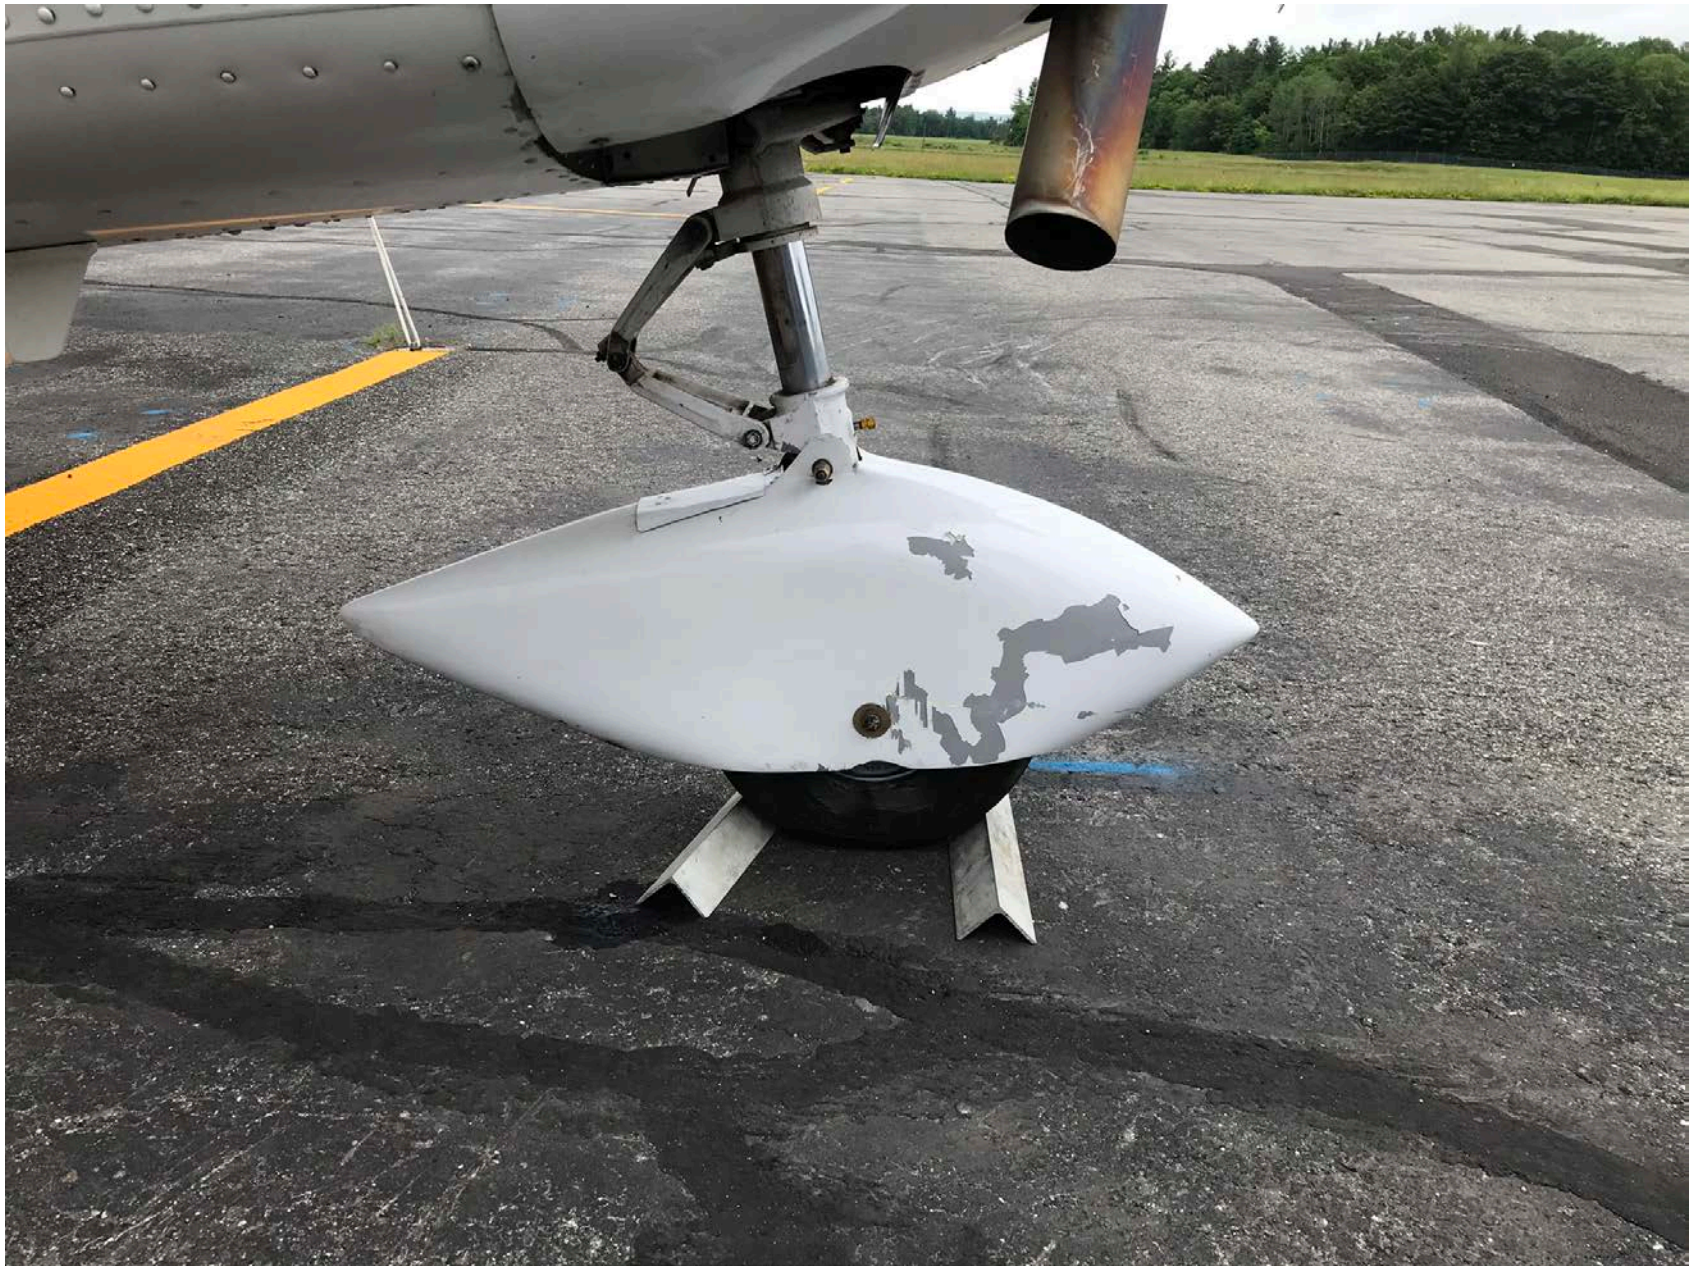
Photo 4 – Nose Wheel Landing Gear Pant Showing Missing Paint - Courtesy of Pittsfield Municipal Airport

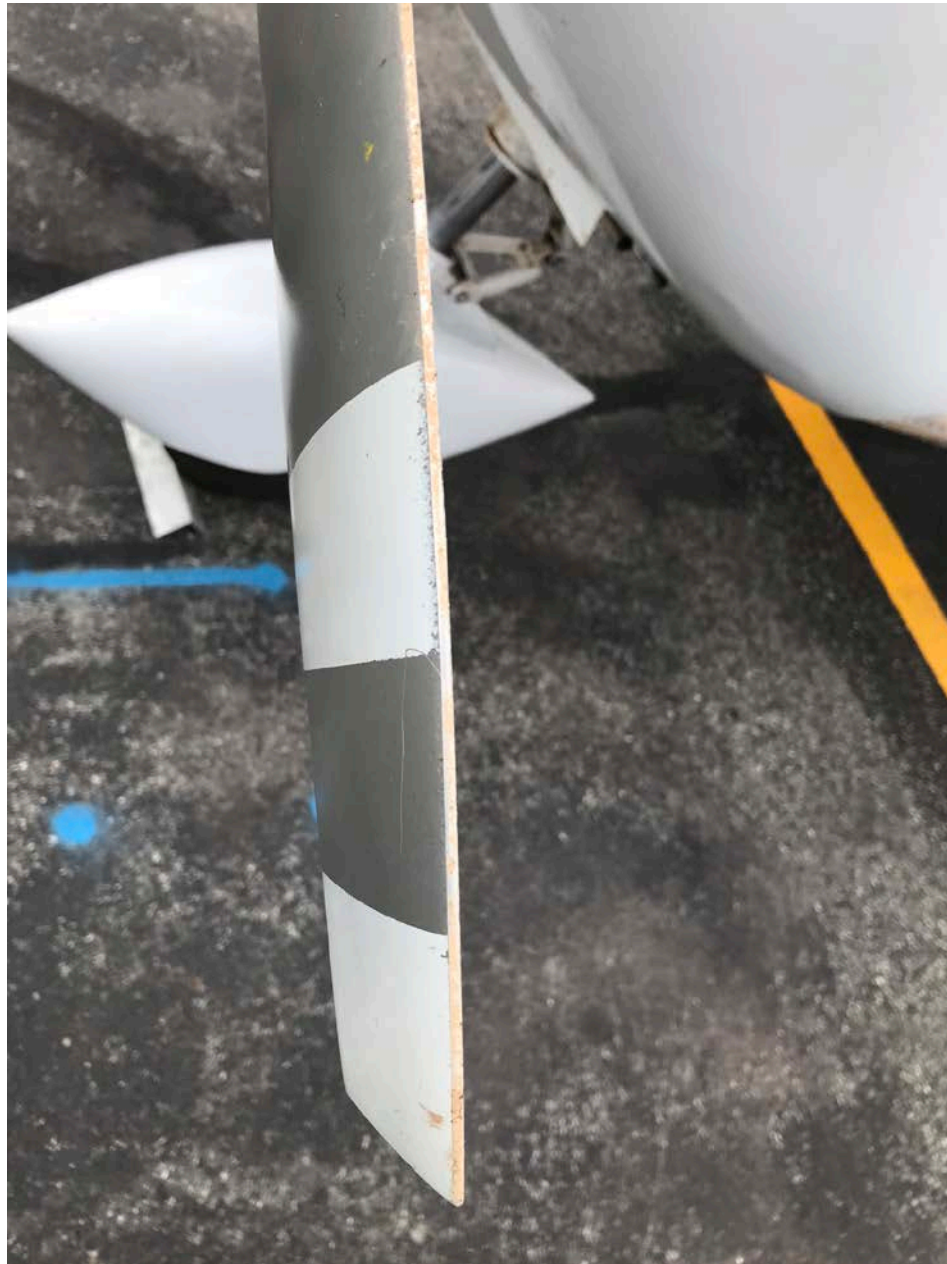
Photo 5 – Propeller Blade Showing Dirt from Ground Contact and Yellow Paint Transfer - Courtesy of Pittsfield Municipal Airport

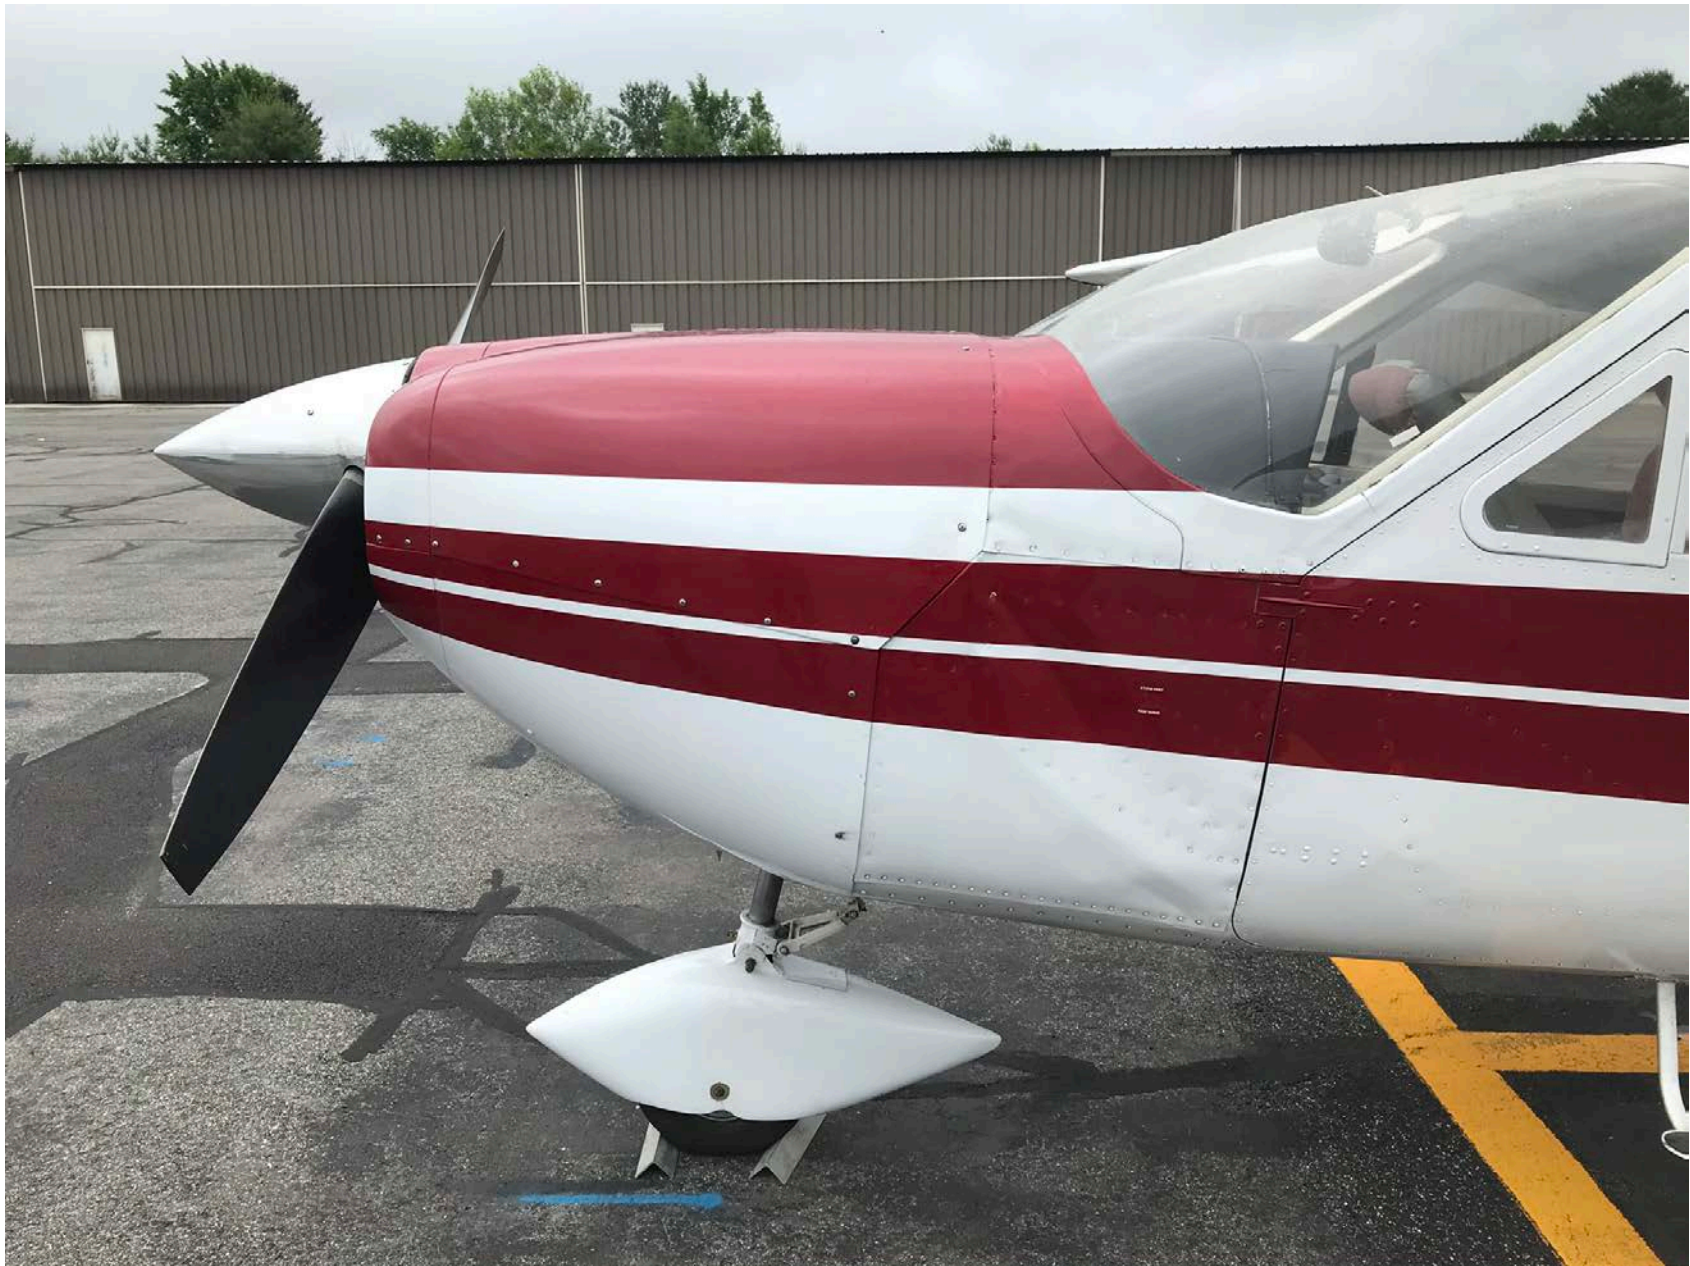
Photo 6 – Left Side Forward Fuselage Wrinkle - Courtesy of Pittsfield Municipal Airport

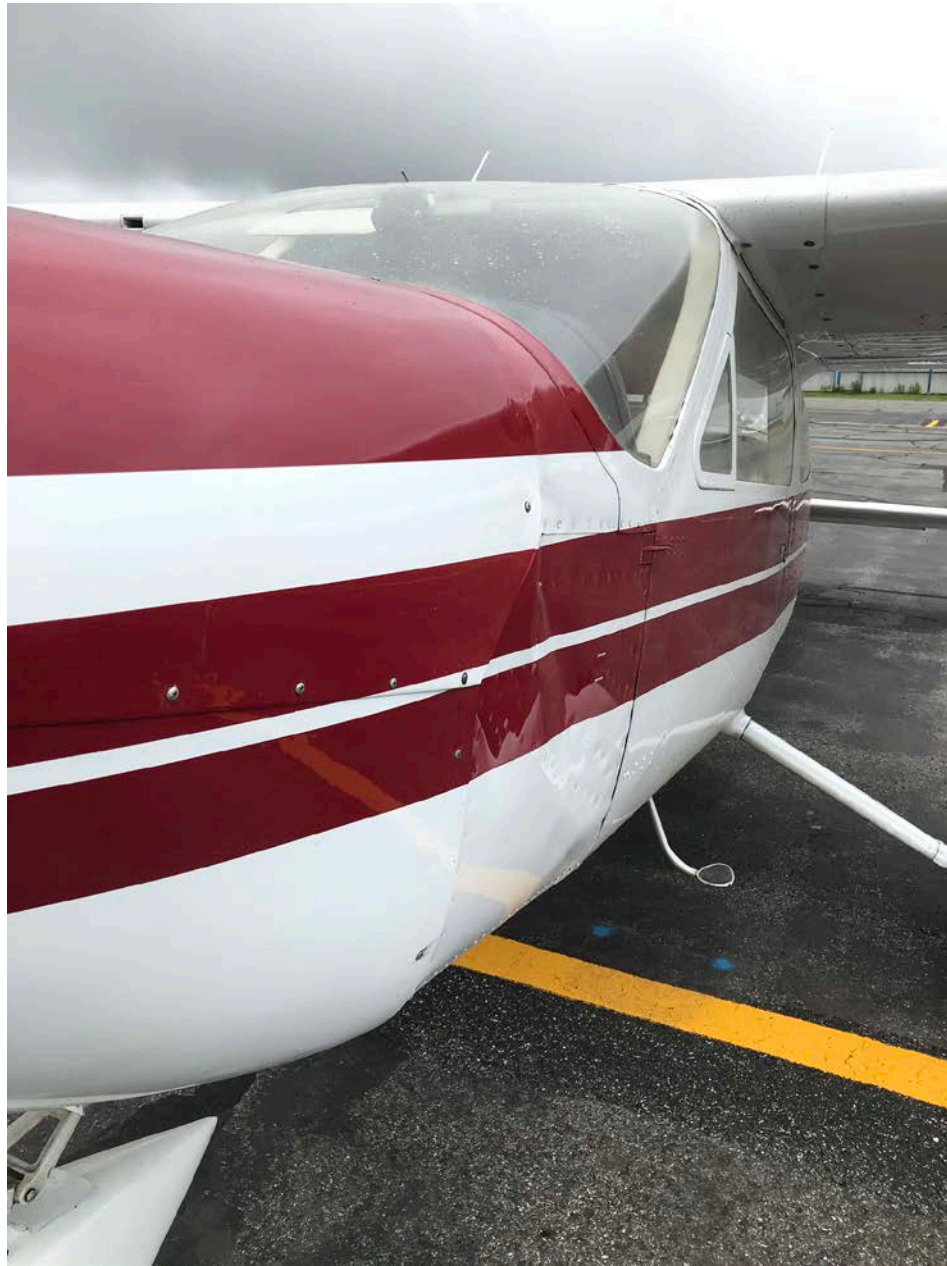
Photo 7 – Close Up of Left Side Forward Fuselage Wrinkle - Courtesy of Pittsfield Municipal Airport

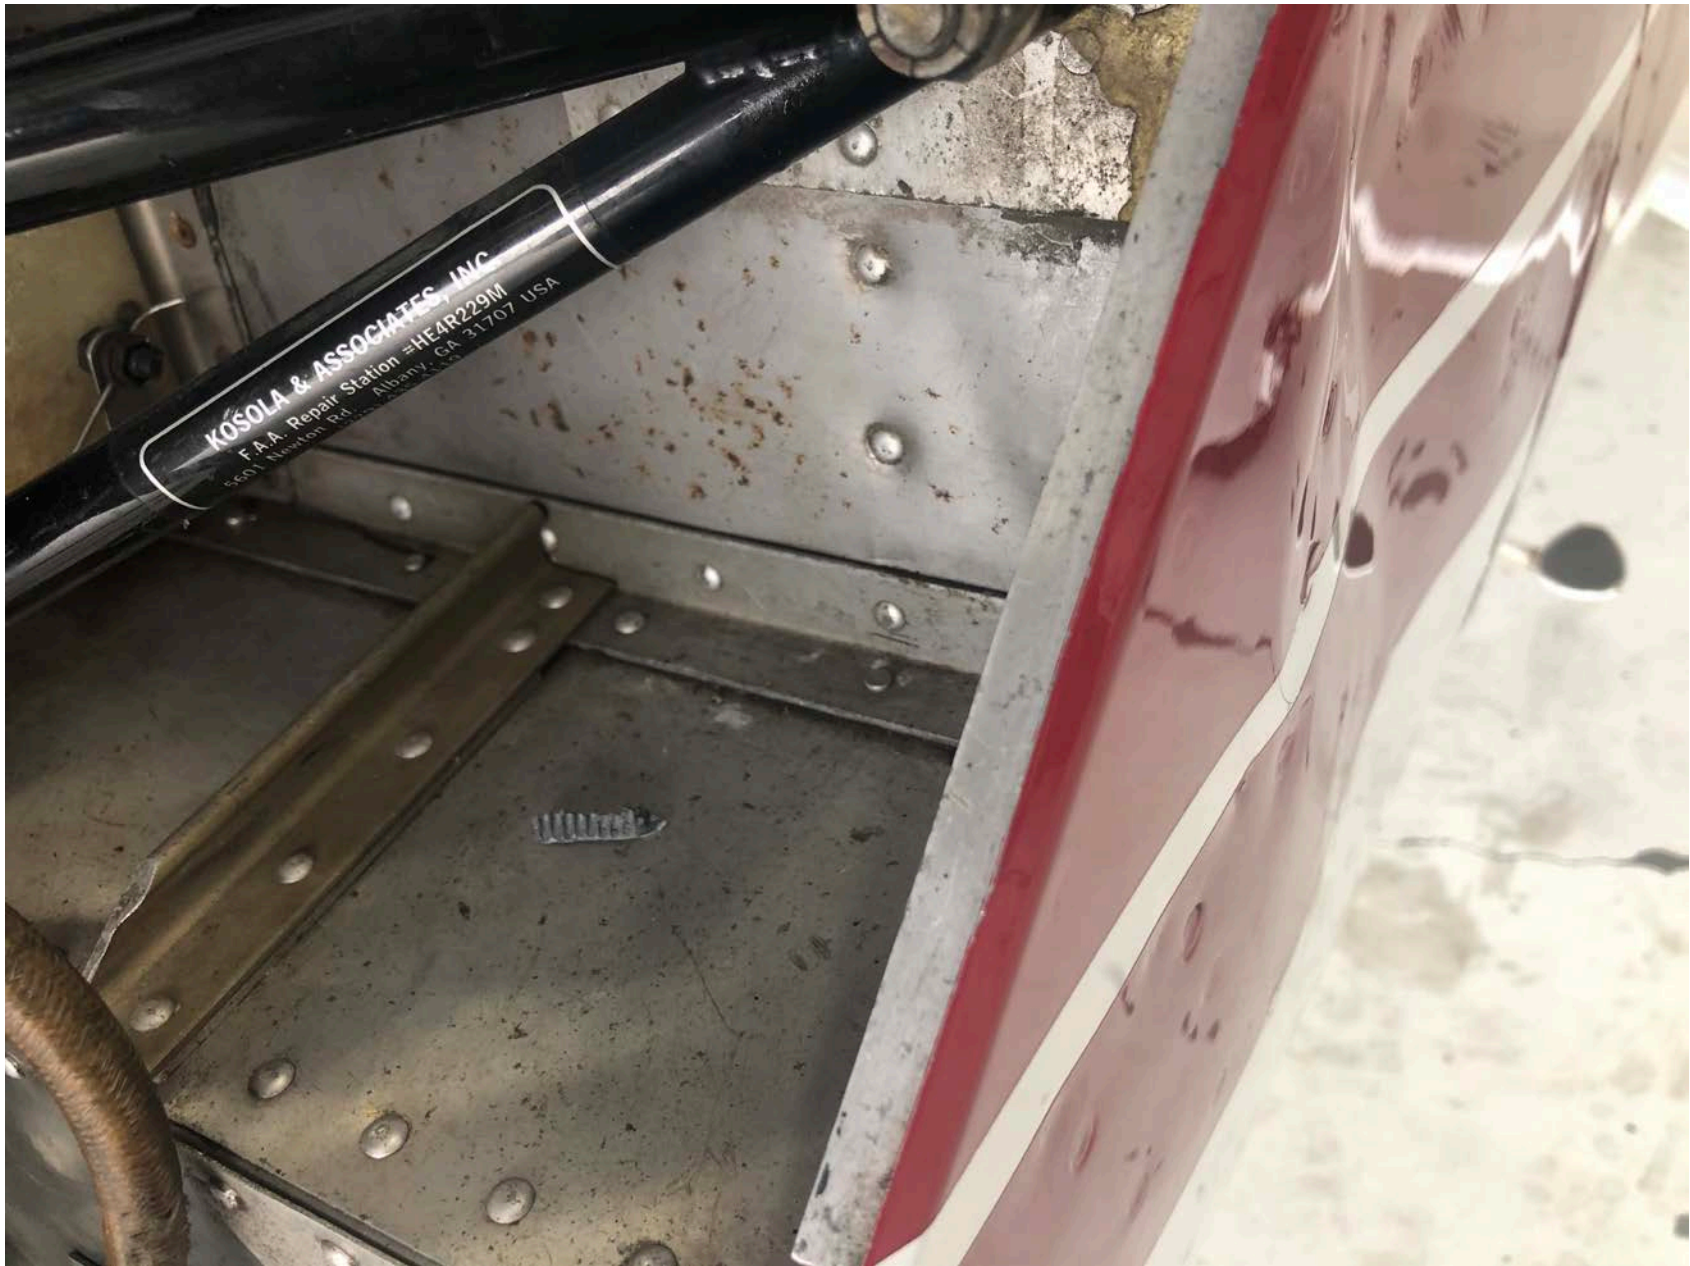
Photo 8 – Left Side Firewall and Fuselage Wrinkles - Courtesy of Pittsfield Municipal Airport

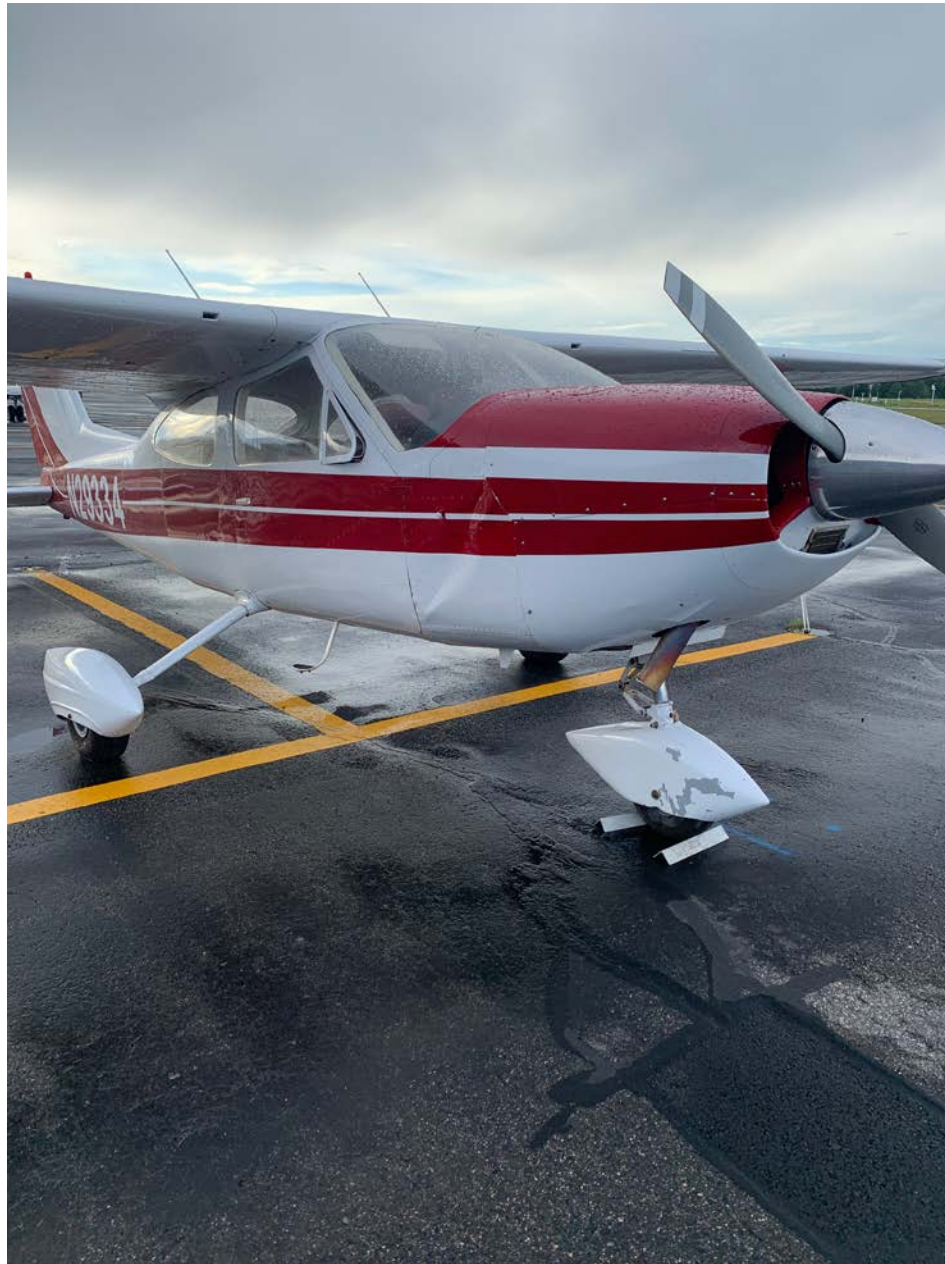
**Photo 9 – Right Side of Airplane Showing Fuselage Wrinkle and Missing Paint on Nose Wheel Landing Gear Paint -
Courtesy of Pittsfield Municipal Airport**

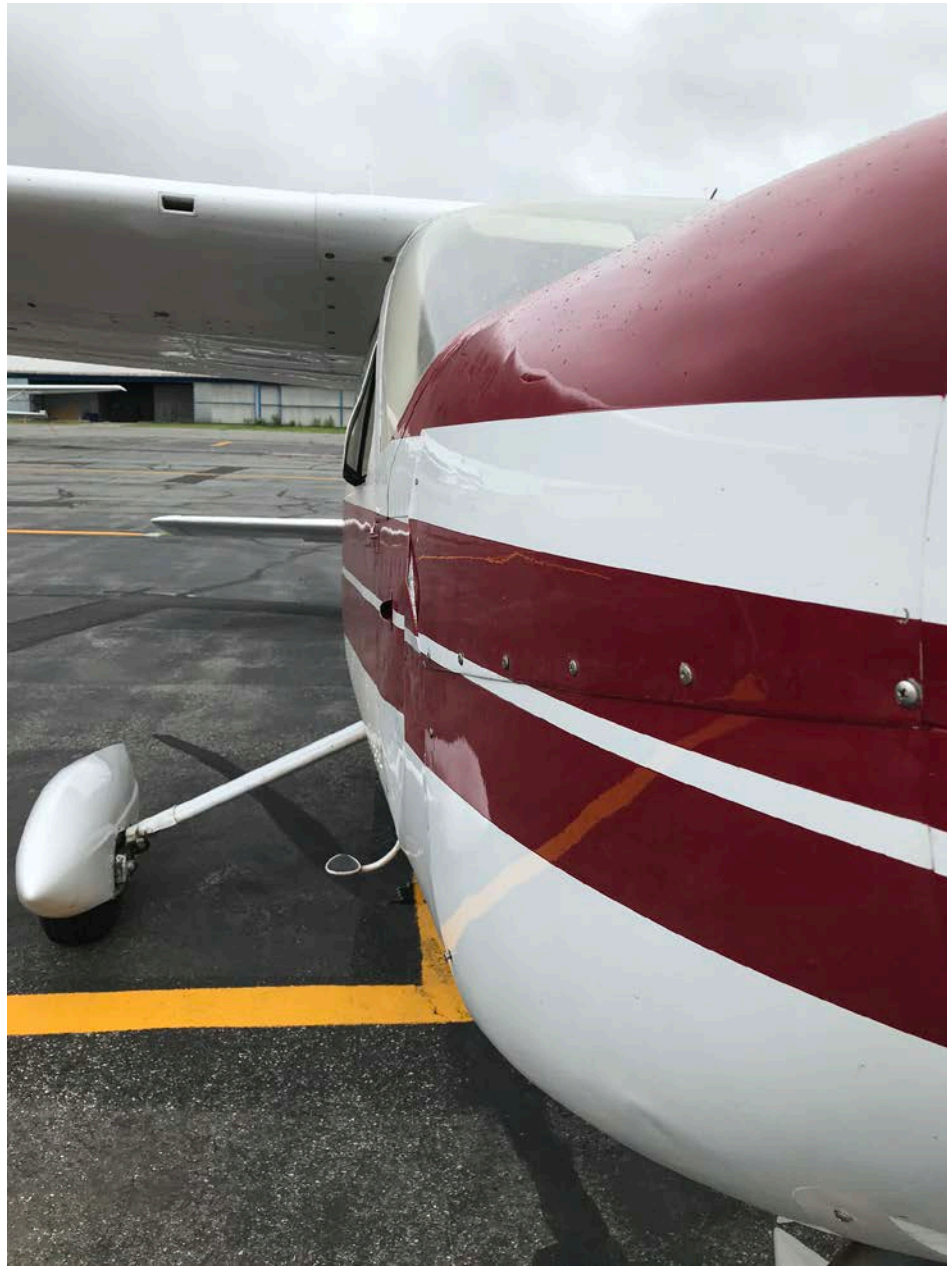
Photo 10 – Right Side Forward Fuselage Wrinkle - Courtesy of Pittsfield Municipal Airport

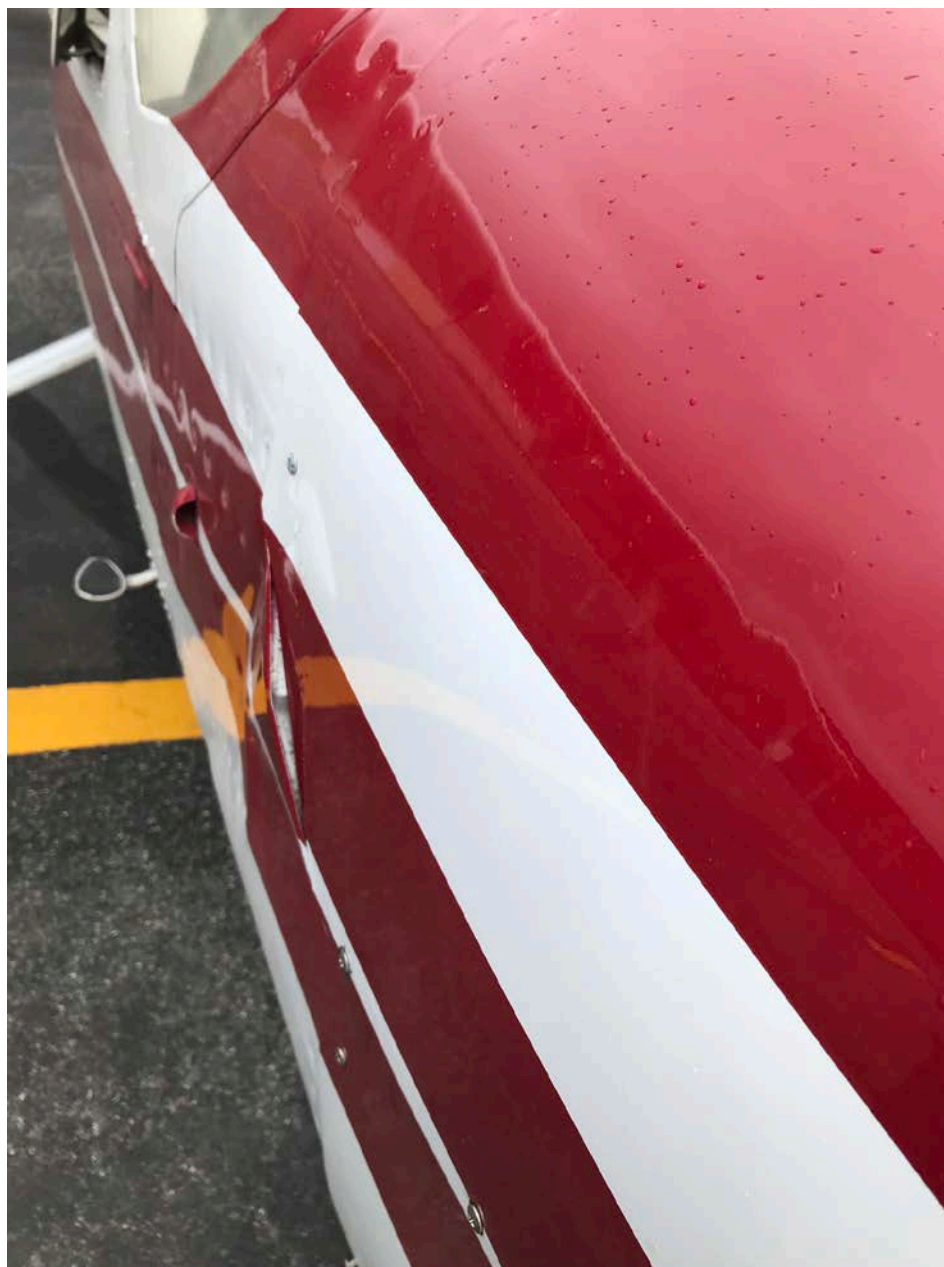
Photo 11 – Close Up of Right Side Forward Fuselage Wrinkle - Courtesy of Pittsfield Municipal Airport
