**Photo 1 – View of the airplane in the house from the front of the house. (Photo courtesy of the FAA)**

**Photo 2 – View of the airplane in the house from the back of the house. (Photo courtesy of the Polk County Sheriff's)**

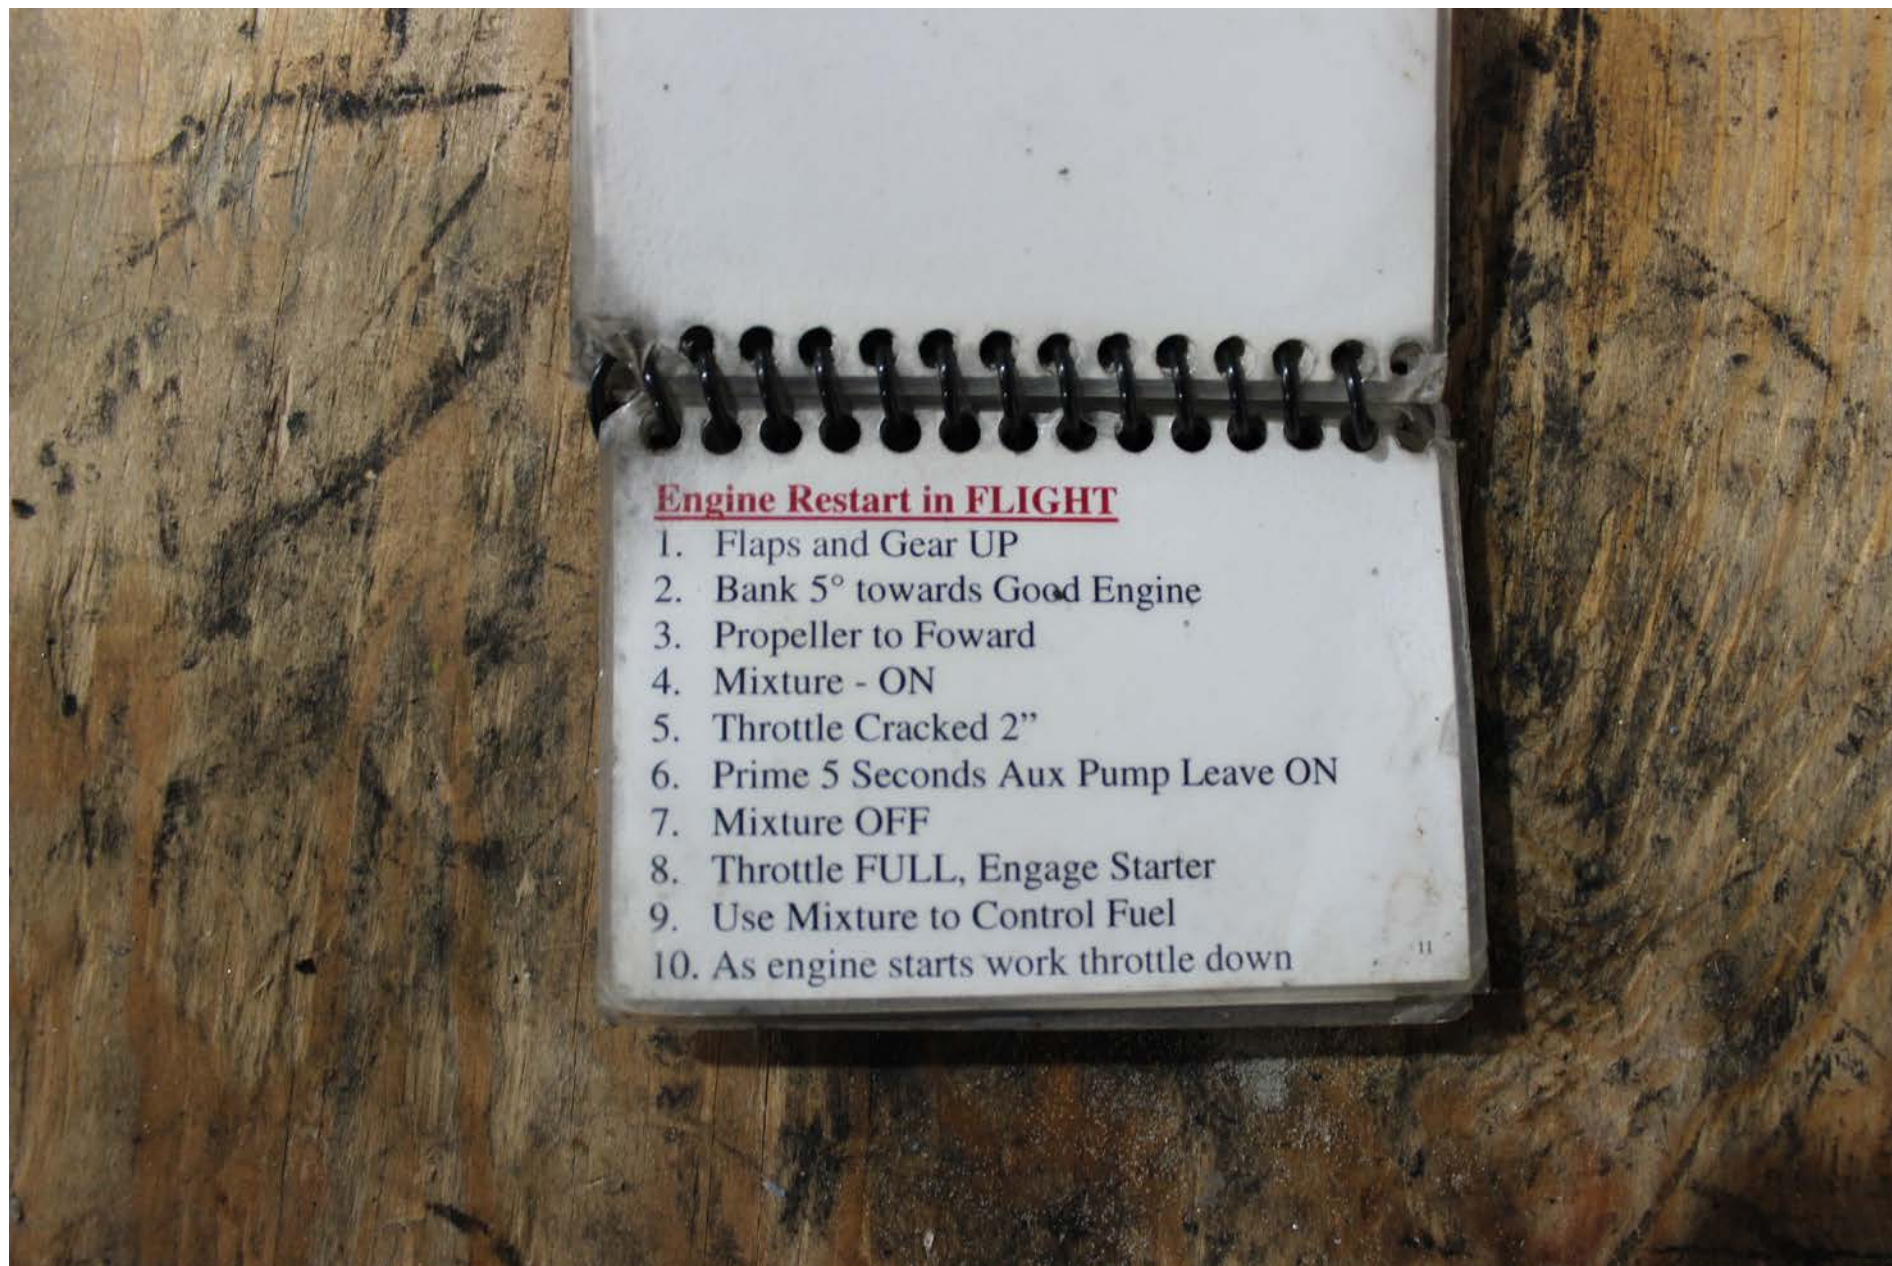
**Photo 8 – Twin Seabee engine restart in flight checklist found in the wreckage.**

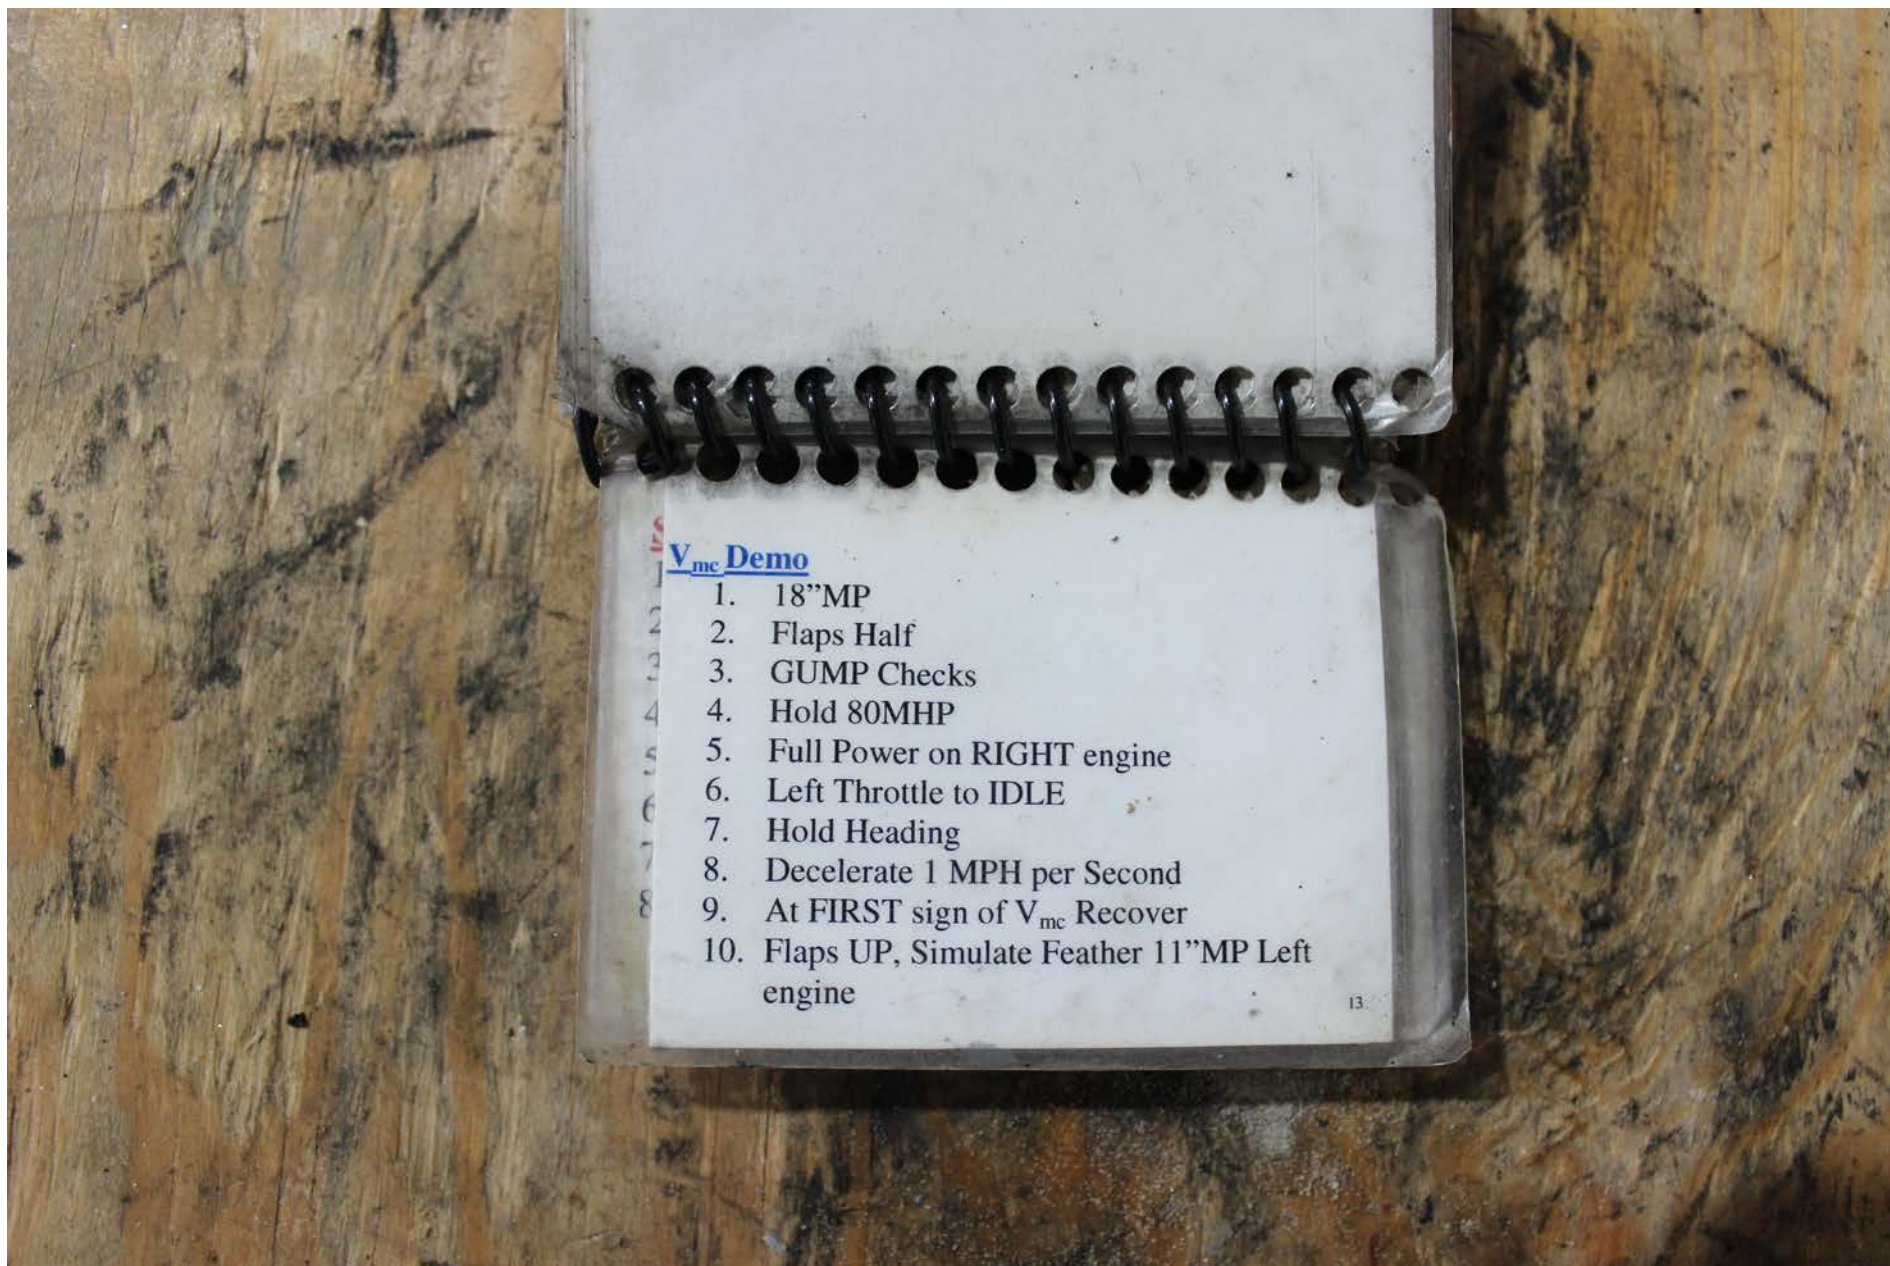
**Photo 9 – Twin Seabee Vmc demo checklist found in wreckage.**
