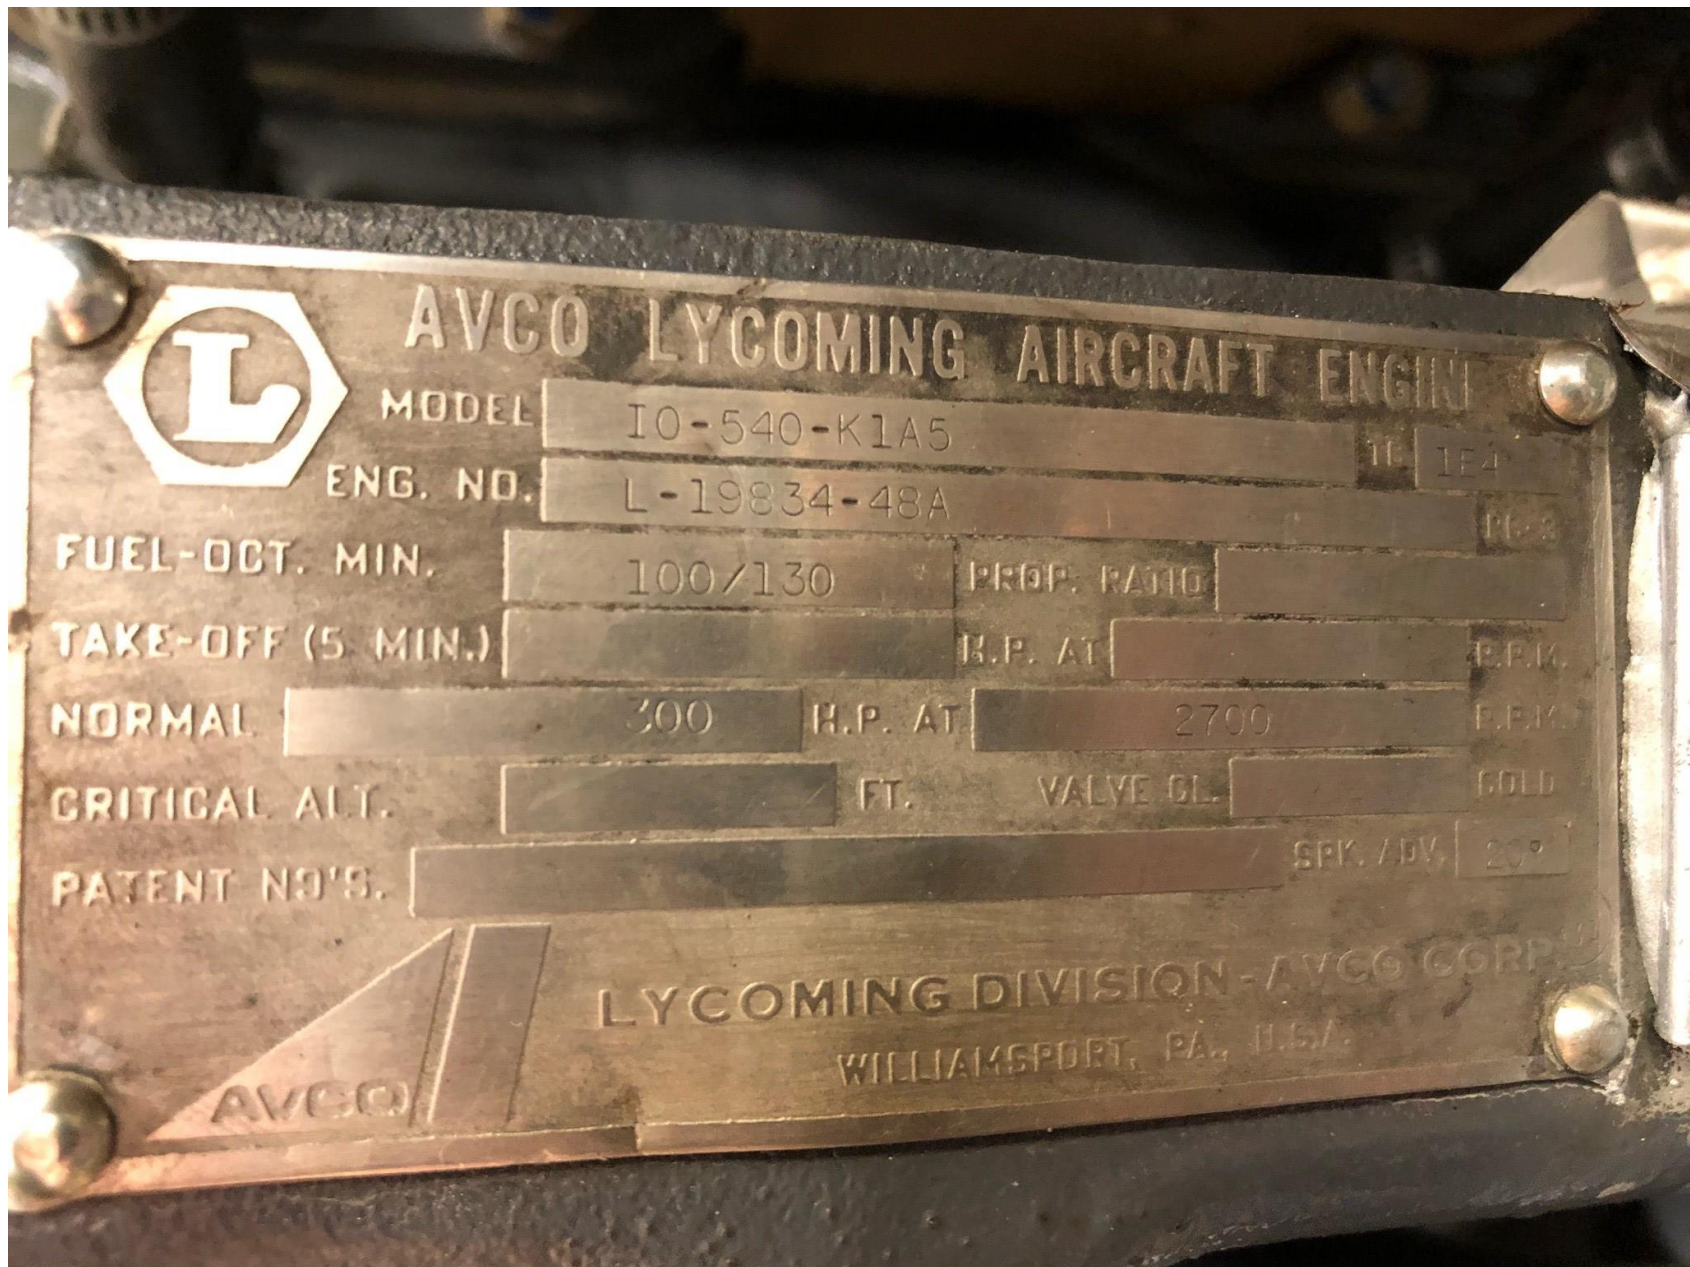
Photo 1 – Engine data tag (Photo courtesy of the NTSB)

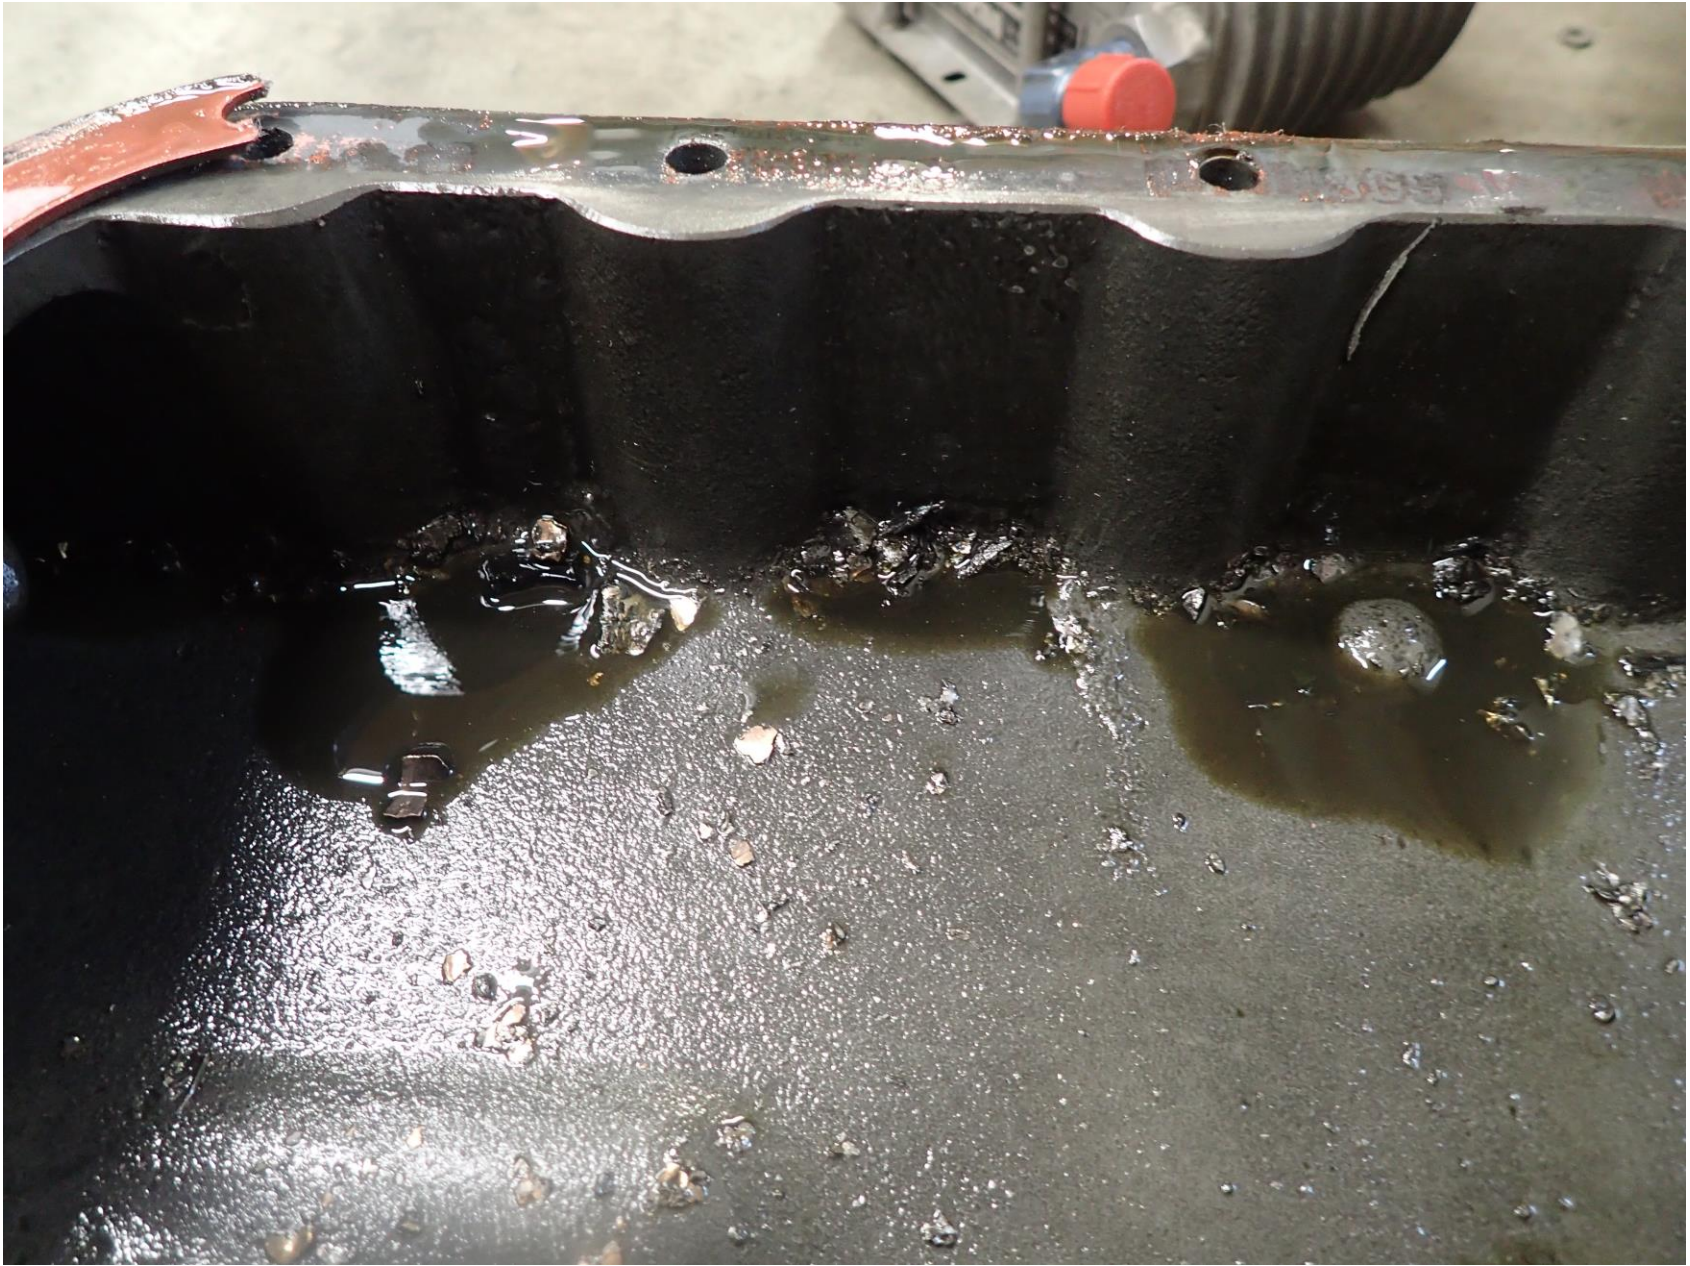
Photo 2 – Metal shavings in oil pan (Photo courtesy of the NTSB)

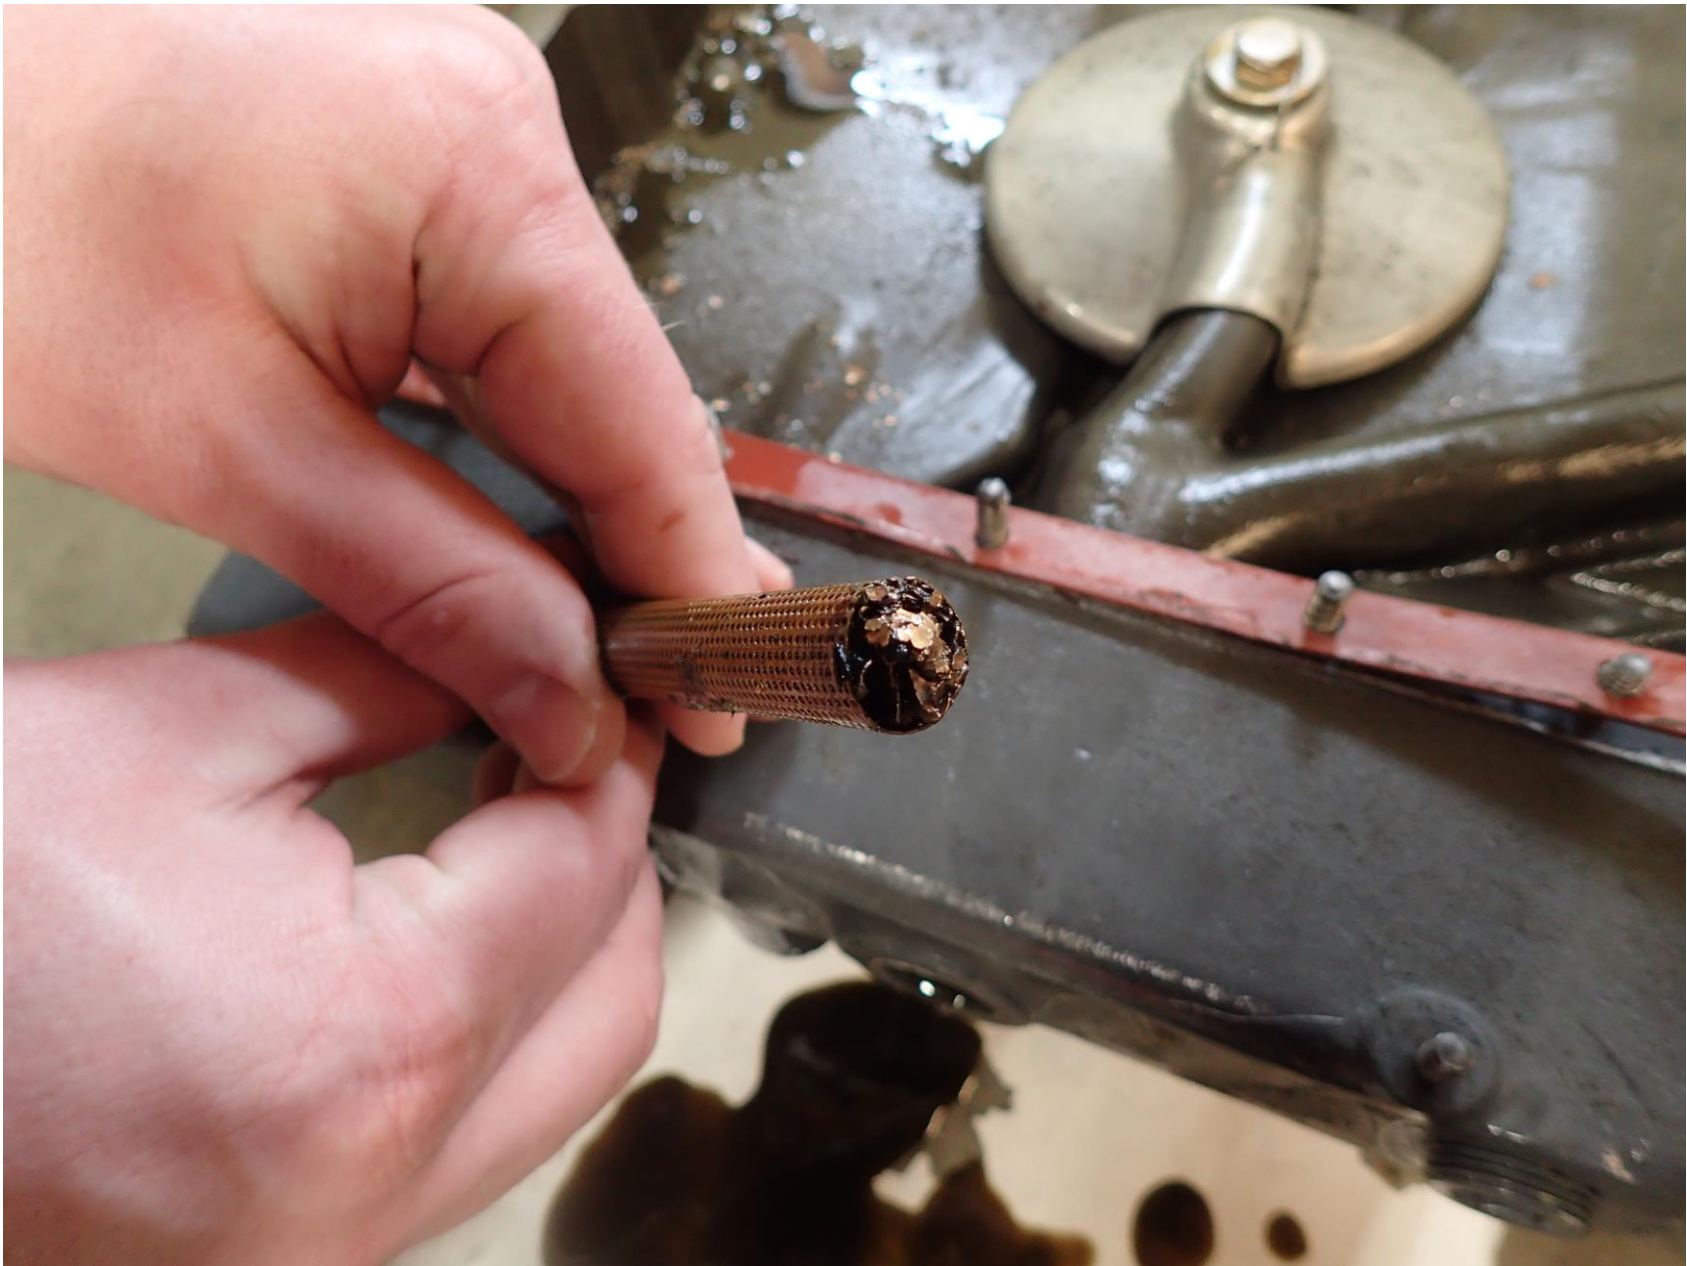
Photo 3 – Metal shavings in oil filter (Photo courtesy of the NTSB)

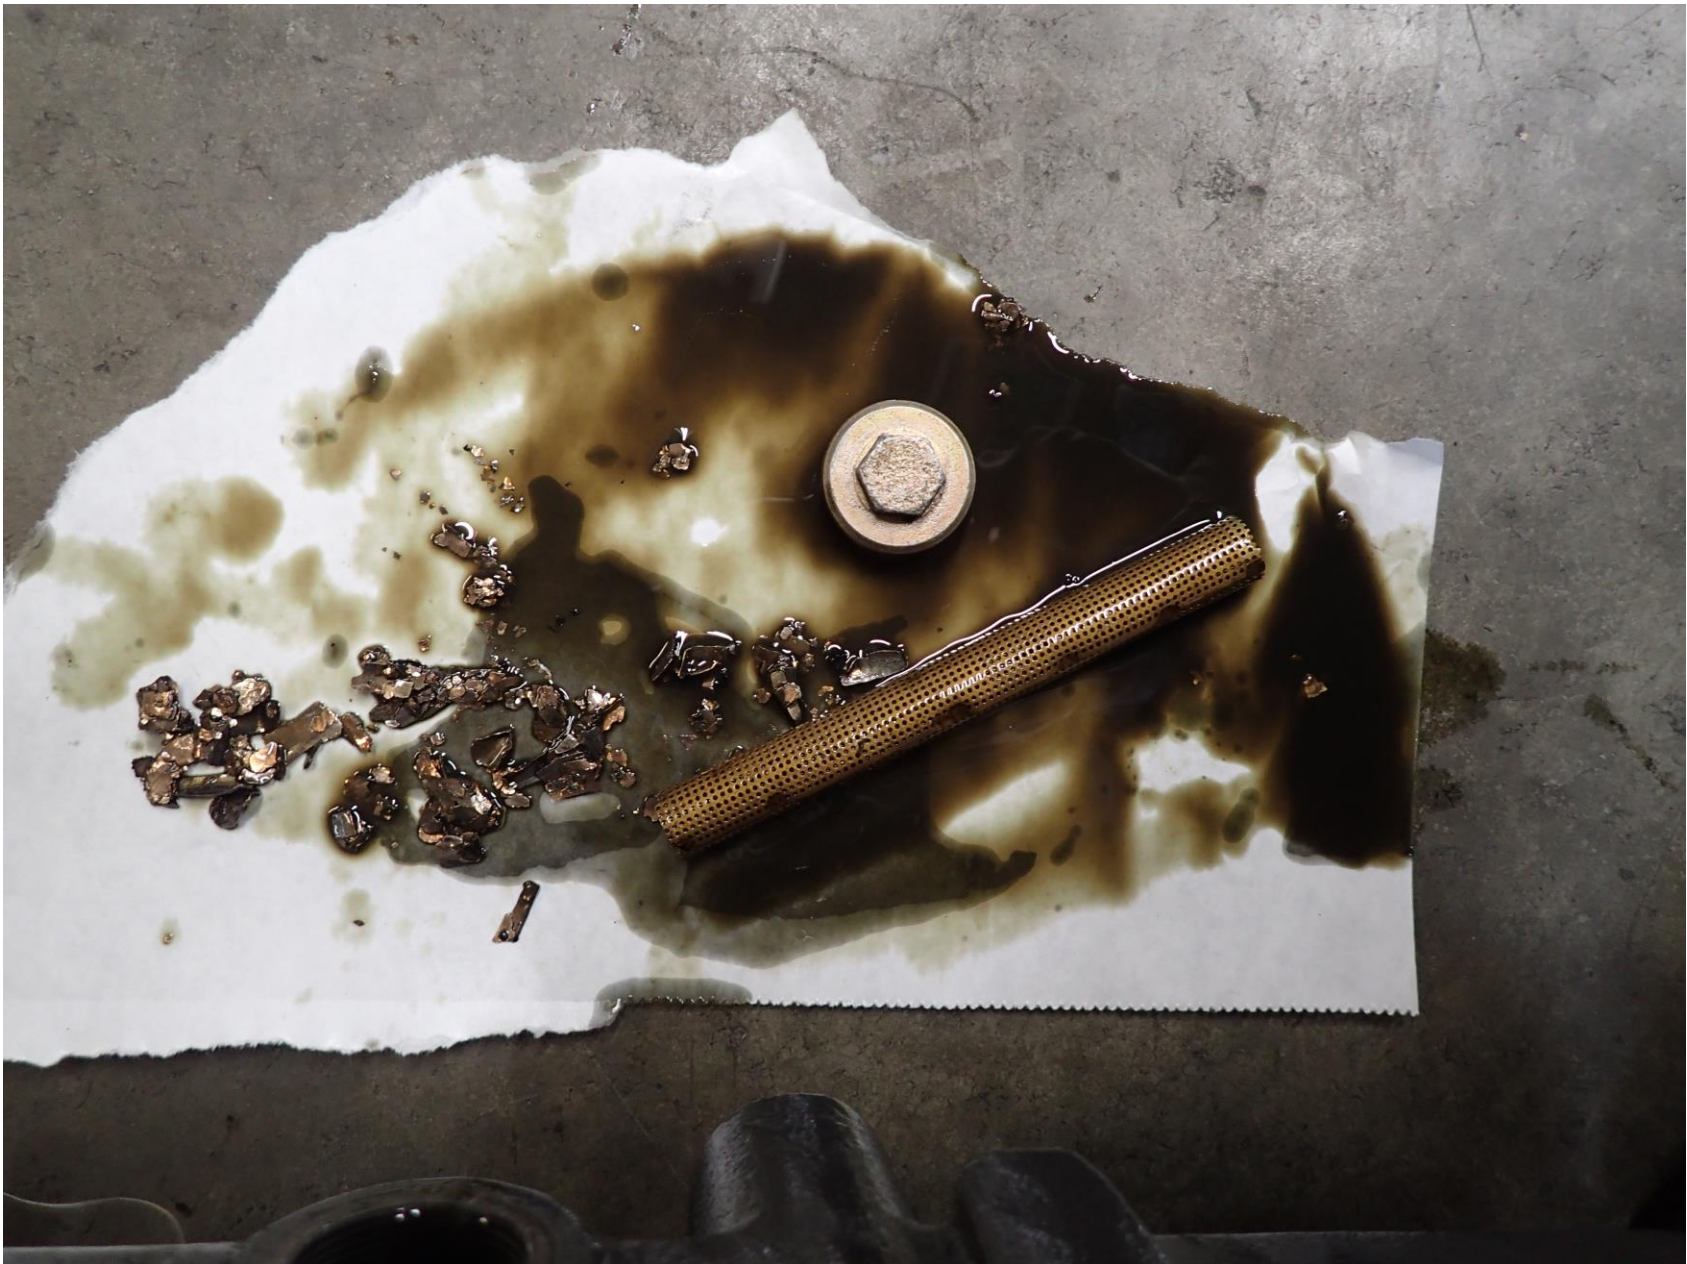
Photo 4 – Oil filter debris (Photo courtesy of the NTSB)

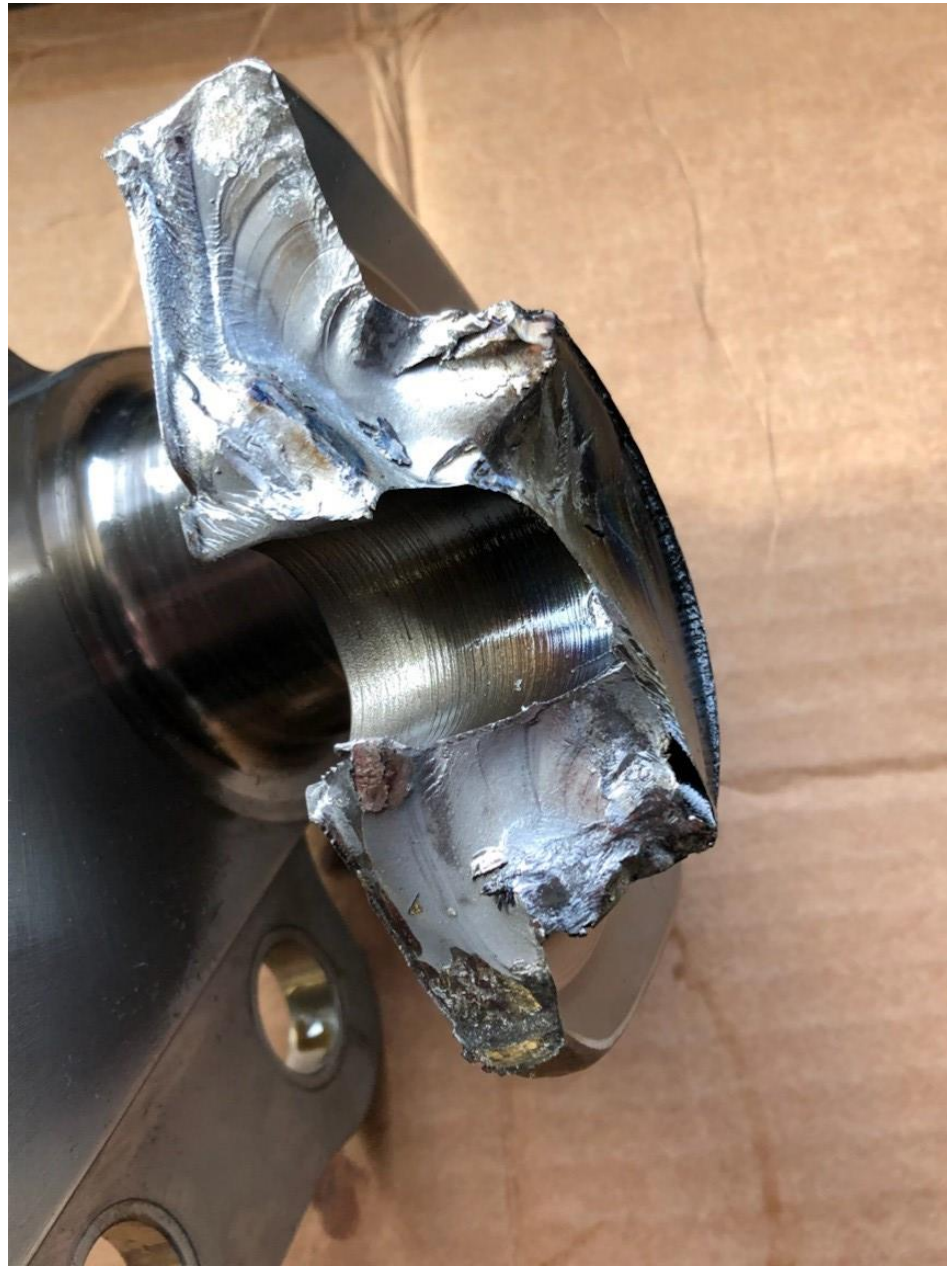
Photo 6 – Damaged crankshaft piece #1 (Photo courtesy of the NTSB)

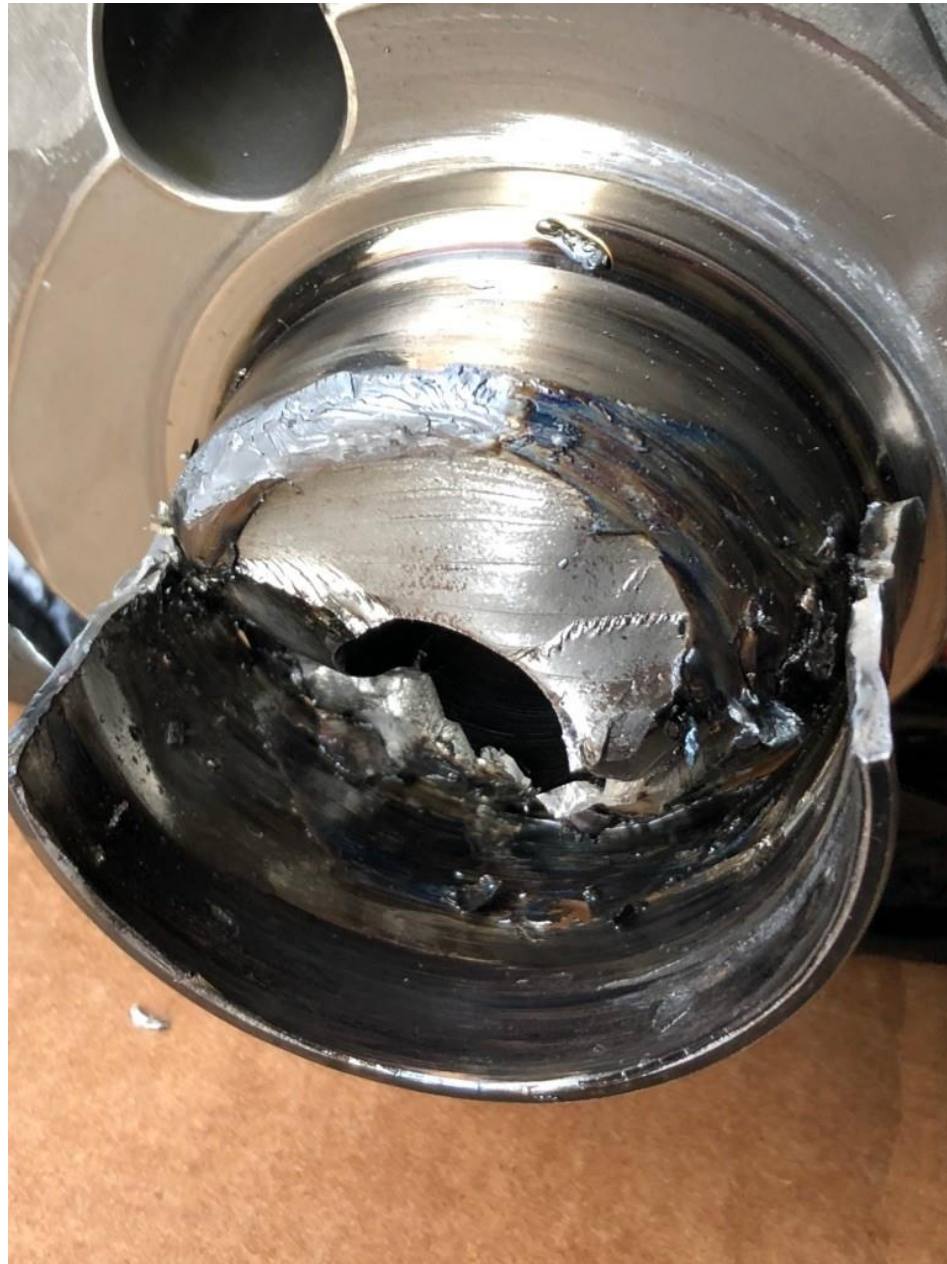
Photo 7 – Damaged crankshaft piece #2 (Photo courtesy of the NTSB)

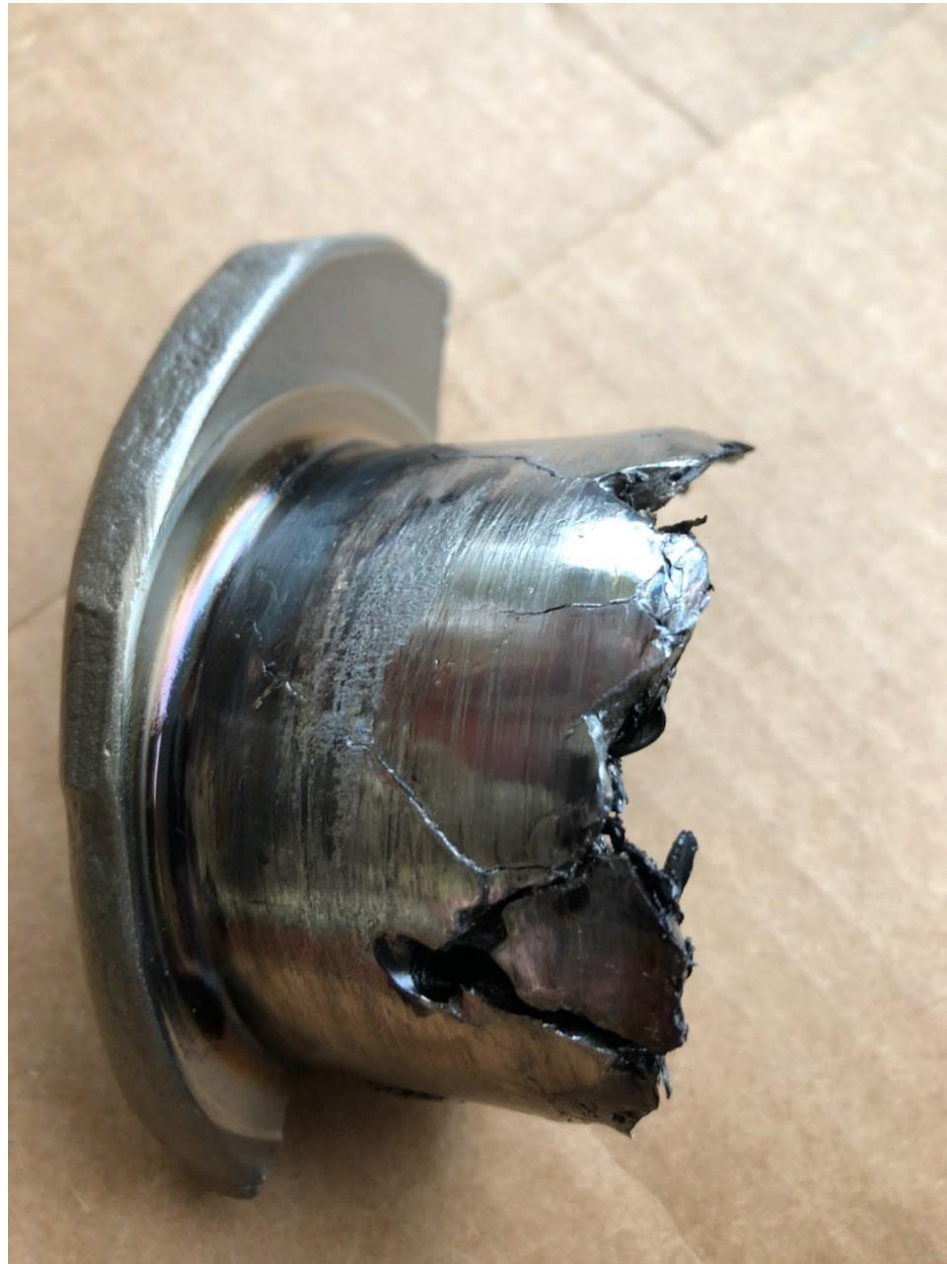
Photo 8 – Damaged crankshaft piece #3 (Photo courtesy of the NTSB)
