**Survival Factors Attachment -Pinal
County Fire Investigation Team
(PCFIT)
Final Investigation Report**

Coolidge, Arizona

PLD21FR003

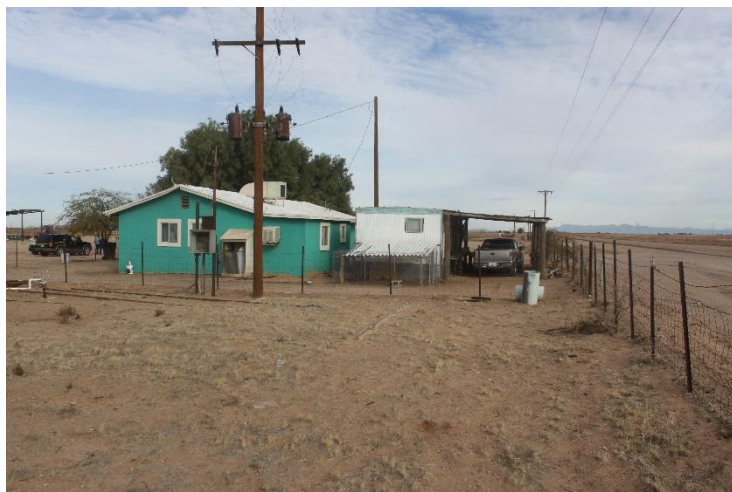
The residence's front door (main entrance) was located on the structure's west side (Figure 1). The residence was located on the Kelly Freeman Farm. The fire originated from the Kinder Morgan El Paso Pipeline, located approximately 200 yards southeast (Figure 2). The pipeline was a 30-inch line with a burry depth of approximately 10 feet below grade. The images of responding fire crews showed flame jets extending from both sides of the ruptured pipe (Figure 3). The pipeline was used to transport Natural Gas from Texas to California, according to representatives from Kinder Morgan.

Figure 1: Residence from south (pre-fire)

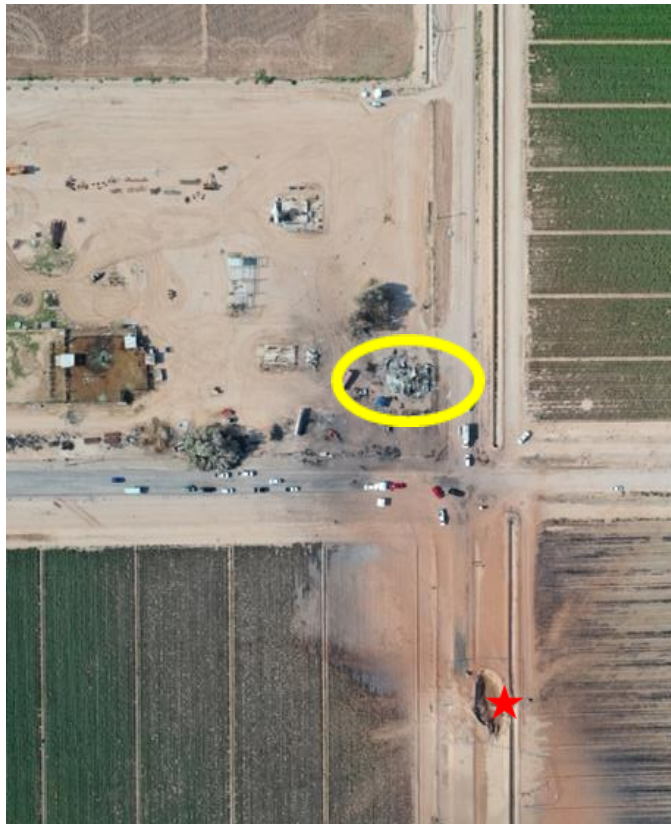
Figure 2: Flame Jet from pipe site.

Following the blast, the flame front caused measurable damage up to 400 - 600 feet away. After the explosion, a flame jet was sustained by natural gas from the severed pipe. Radiant heat damage was observed up to 800 feet away from the flame. The size of the flame jet produced could be seen from several miles away. Based on the photos and Unmanned Aerial Vehicle (UAV = Drone) video, the height of the flame jets reached over 150 feet above ground level. A deputy with the Pinal County Sheriff's Department assigned to assist with traffic control $\frac{3}{4}$ of a mile away compared looking at the scene to looking at the sun. The deputy also stated he was able to feel the radiant heat from the fire at this location.

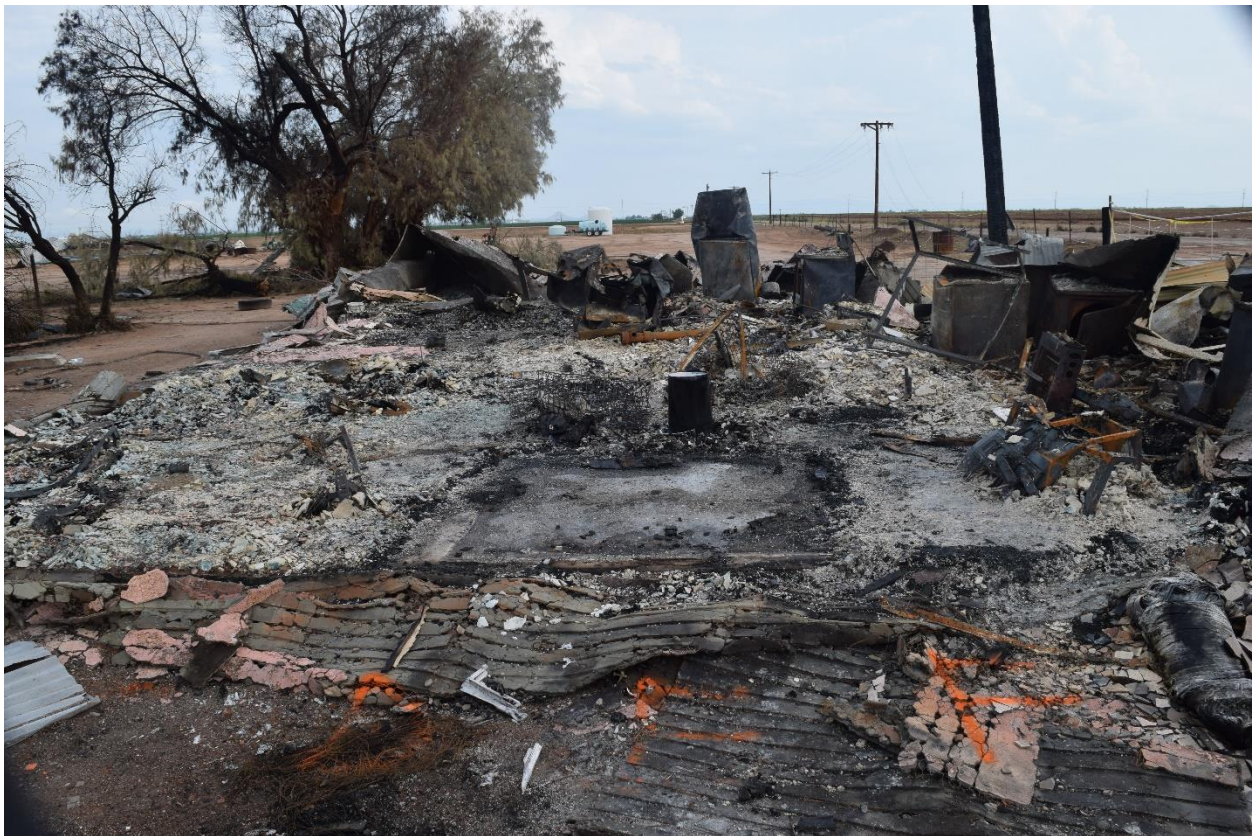
Once members of NTSB arrived on site, it was determined that they would investigate the pipeline site. PCFIT focused on the residence. Examination continued from the exterior of the residence. The south and east walls were pushed into the structure before the roof collapsed (figure 4). The west wall had fallen outward. The north wall also fell outward from the structure. The trailer and covered carport protected the northeast side of the residence. (See figure 1 with the white trailer on the left of the photo.)

Figure 4: South wall looking north.

The only livable structure within this area was 4490 N Vail Rd. The blast first caused structural damage to the south wall of the residence. The subsequent fire ignited the wood frame and contents within. The fire continued to burn till members of Kinder Morgan were able to locate shutoff valves approximately a half-mile away.
