NATIONAL TRANSPORTATION SAFETY BOARD

July 29, 2022
Factual Report

ENVIRONMENTAL RESPONSE GROUP

PLD22FR002

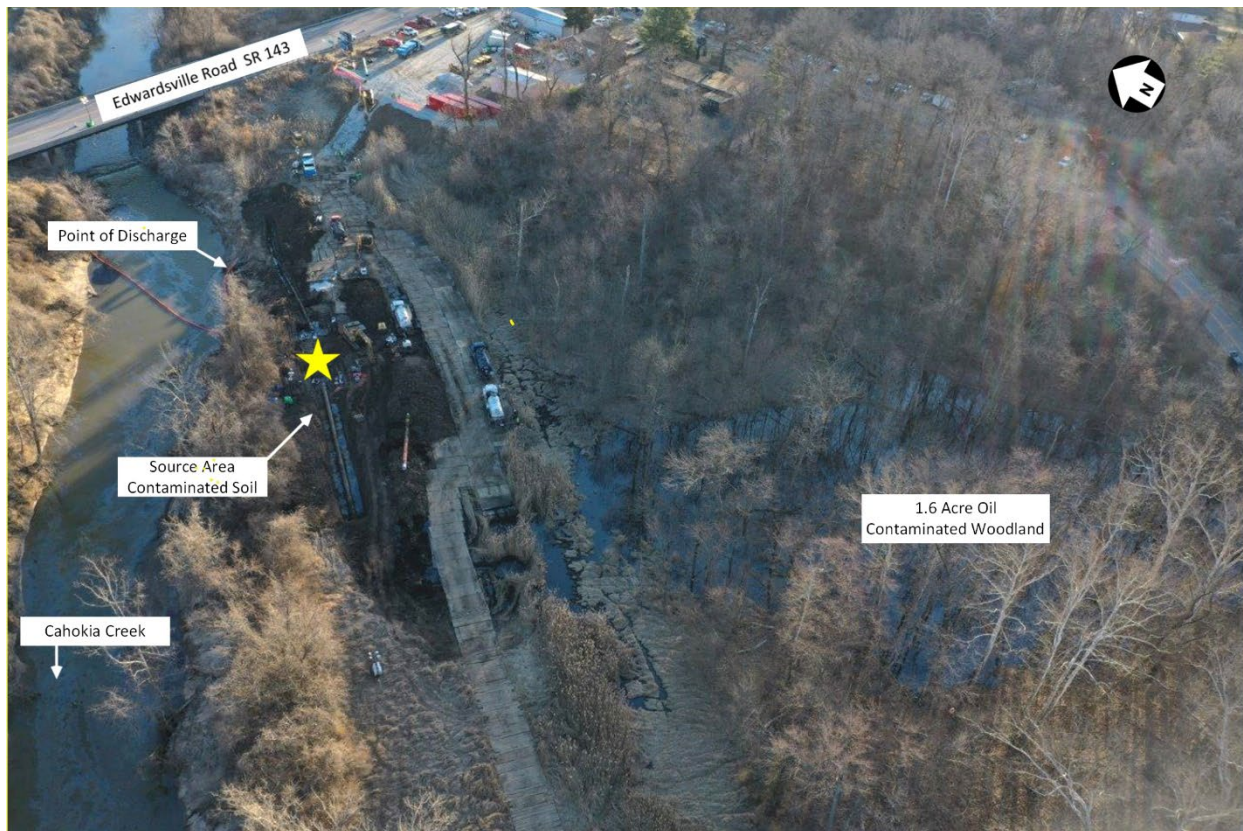
Figure 1. Incident location, Edwardsville, Illinois. Yellow star indicates approximate pipeline breach location. March 13, 2022, 08:09. Courtesy, Marathon Pipe Line LLC with NTSB annotations.

The site was bordered on the north by IL State Route 143 near its intersection with Old Alton-Edwardsville Road, with the Cahokia Creek and agricultural properties beyond; to the east and south by Old Alton-Edwardsville Road, with a Norfolk Southern railroad track and residential and commercial properties beyond; and to the west by forested land, with residential properties beyond (Figures 1 and 2).

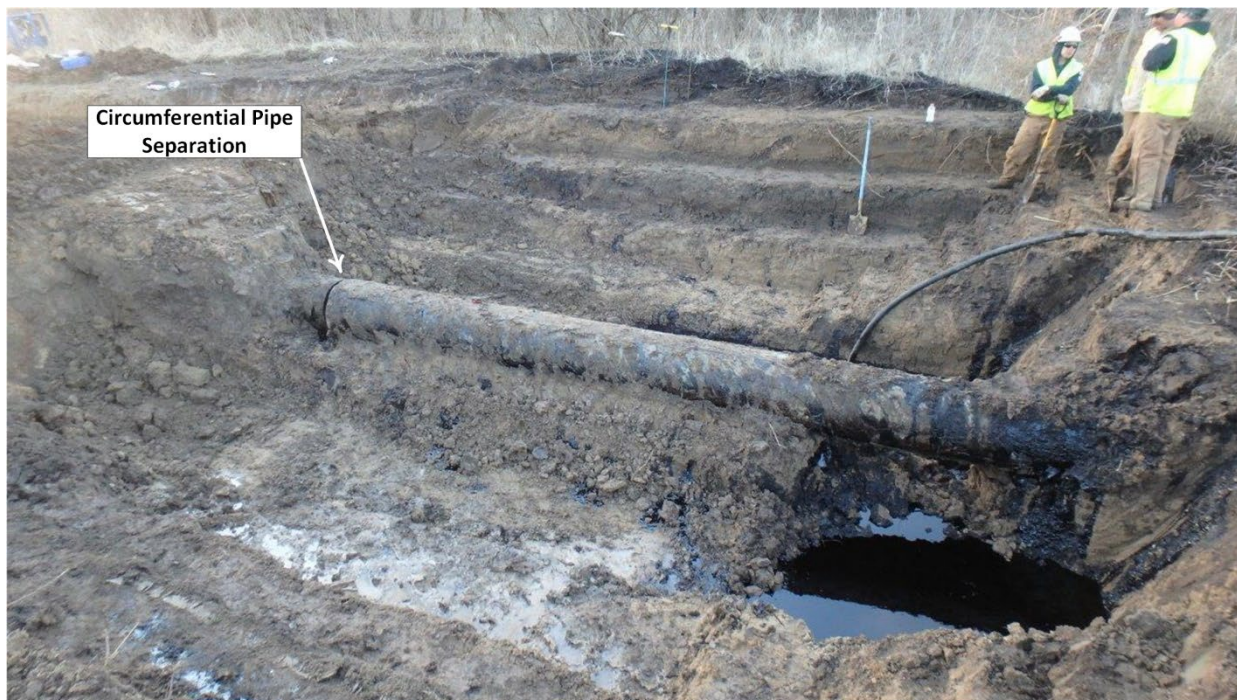
Figure 3. Excavated pipeline at the breach location and circumferential pipe separation, March 12, 2022, 17:27.

On March 12, 2022, NTSB investigators monitored excavations at the breach location, where Marathon crews uncovered a circumferential pipe separation on the Woodpat pipeline at joint number MAPLID # 29782. The gap between the two separated pipeline segments measured between 6 ¾-inches to 8-inches (Figure 3). The release location was within the pipeline right-of-way.

As crews uncovered the breached pipe, investigators observed released oil from underneath the pipe accumulate in the excavation.

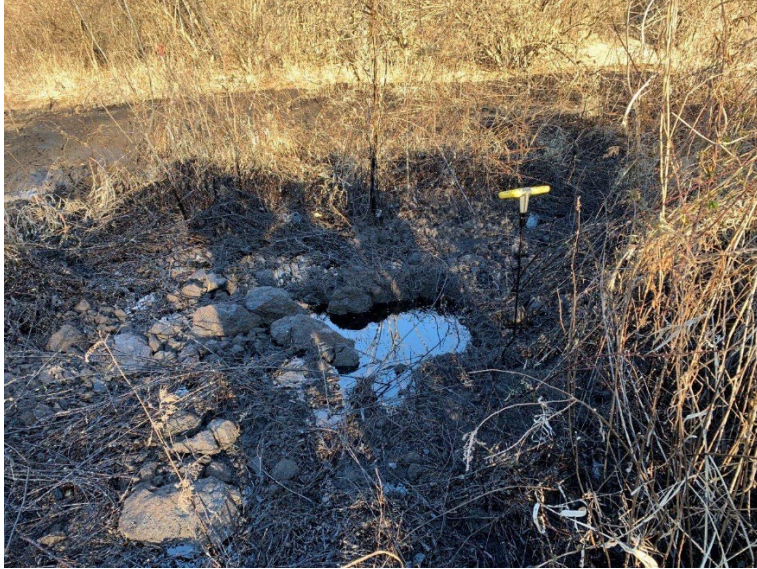
Figure 6. Point of pipeline failure, March 12, 2022, 07:43.

Within the pipeline breach source area, the surface oil-saturated soil footprint was about ½ acre. The pipeline breach location was identified by a pool of oil in the center of this saturated zone (Figures 6 and 7).

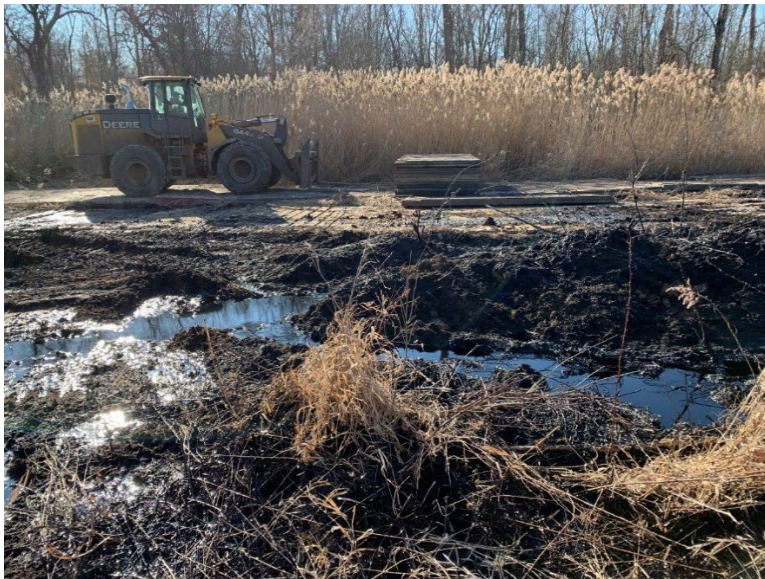
Figure 7. Puddled oil, saturated soil and vegetation near source area, March 12, 2022, 08:20.

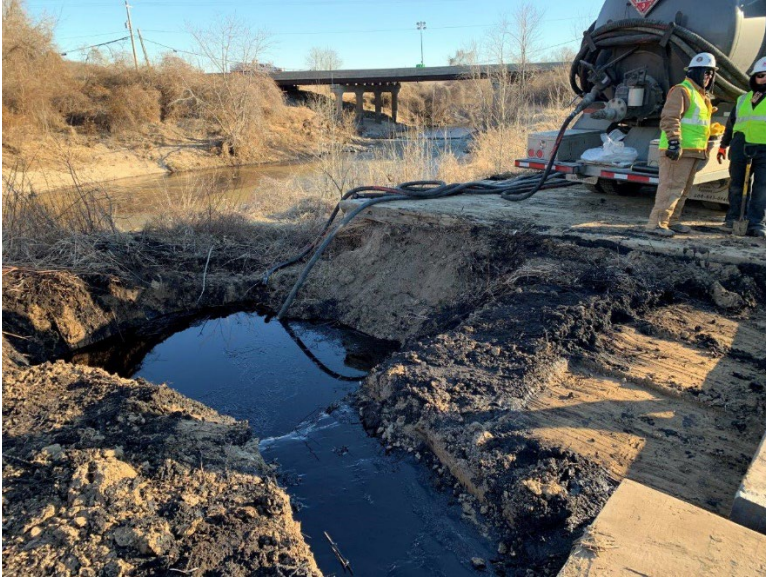
Figure 8. Diversion ditch and pothole at source area, March 12, 2022, 11:36.

Oil containment in the source area was accomplished with a diversion ditch and interceptor sump/pothole installed about 20 feet of the pipeline breach. OSRO crews tended the sump with two vacuum trucks (Figure 8).

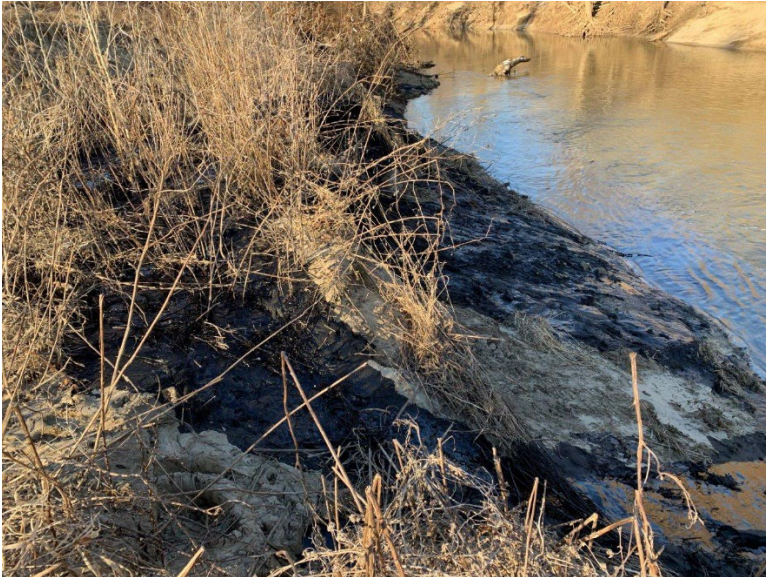
Figure 9. Point of discharge to Cahokia Creek adjacent to pipeline breach, March 12, 2022, 07:48.

Although on the morning of March 12, 2022, no active point-source discharges of oil to Cahokia Creek were found on the ground surface, investigators observed some oil emerging from the bank downgradient of the interceptor sump that led to sheen in the creek (Figure 9).²⁶ A roughly 75-foot long circular patch of black oil was stationary, held in place by swirling current on the opposite side of the creek from the point of discharge.

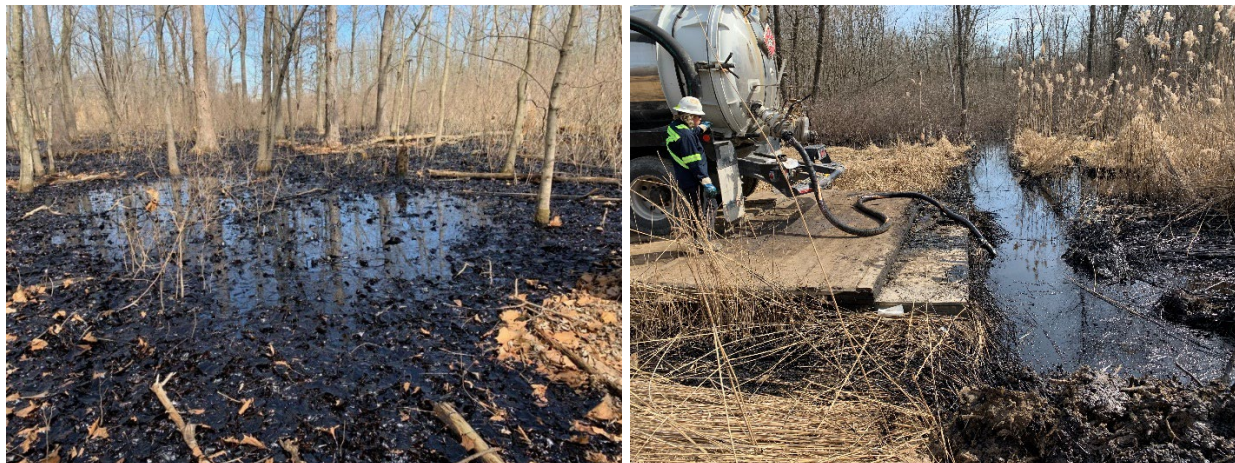
Figure 10. Oil saturated soil, wooded area Old Alton Edwardsville Road, March 14, 2022, 13:05.

On March 14, 2022, 13:05, investigators observed approximately 1.6 acres of oil contaminated soil and vegetation in a wooded/wetland area south of the release location (Figures 10 and 11). A

large fraction of the released crude oil had accumulated in this area. Investigators observed Marathon crews working to vacuum the oil puddles in advance of expected precipitation, March 17-18, 2022. Crews were also engaged in constructing berms and a timber mat access road into the area, which added to physical oil containment, along with the existing topography. There were no storm drain outlets, ditches, or other release pathways found from this impounded wetland area.

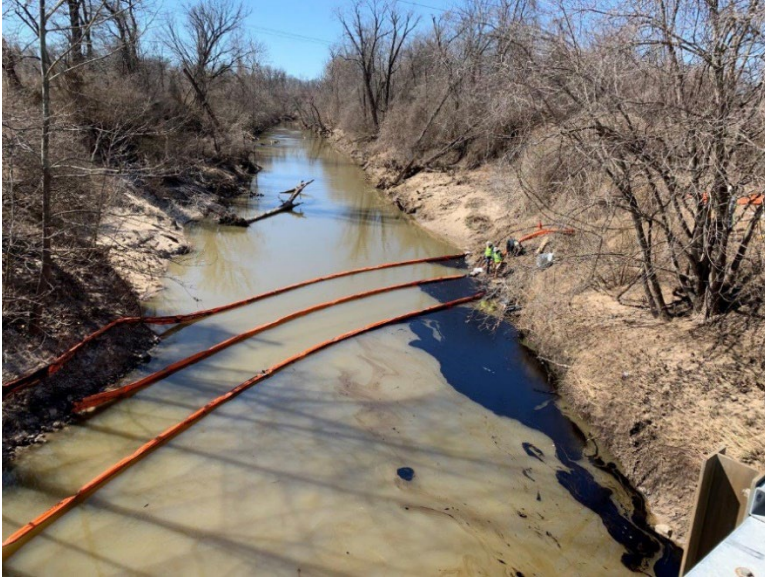
Figure 12. First containment boom in Cahokia Creek downstream of source area, March 12, 2022, 11:52.

On March 12, 2022, 11:52, investigators observed 2 vacuum trucks and 1 oil boom trailer staged next to a spill containment site, adjacent to the Old Alton Edwardsville Road bridge over Cahokia Creek, which was about 400 yards downstream of the breached pipeline source area. This location

had visibly less water flow velocity than the upstream shallower portion of the creek, adjacent to the release site. Three strands of floating skirted hard oil boom were in place downstream of the bridge.²⁷ At this time, oil sheen with intermittent globules of floating oil was flowing from upstream into this containment location. The boom had been deployed at an angle across the creek channel to deflect the oil to collection points on the bank where OSRO contractors skimmed and removed the oil with vacuum trucks (Figures 12 and 13).

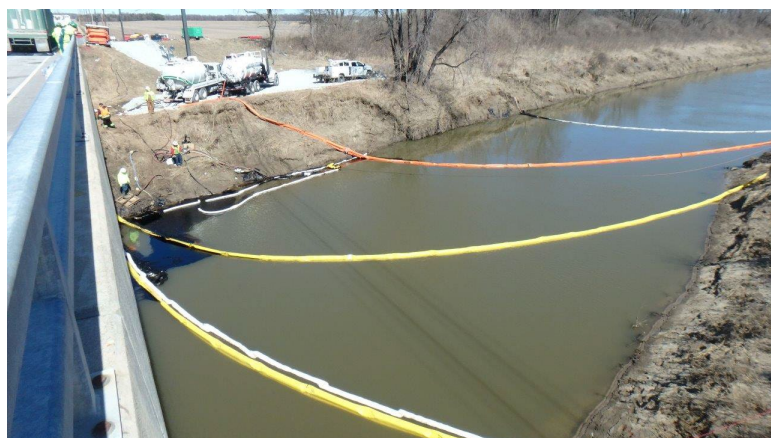
Figure 14. Oil recovery operations in Cahokia Creek upstream side of Wanda Road bridge, March 12, 2022, 12:12.

On March 12, 2022, 12:12, investigators visited the Wanda Road oil containment site in Division 2, about 5.0 miles downstream of the release site. At that time, equipment onsite included 6 vacuum trucks, a single staged boom trailer, and 5 frac tanks. Crews were actively vacuuming a relatively small area of pooled black oil, which had been diverted to the shoreline with oil boom (Figure 14). Three strands of oil boom and sections of sorbent boom were installed on the upstream side of the Wanda Road bridge.²⁸ A light oil sheen was seen flowing into the containment area from upstream.

²⁸ Sorbent boom has the appearance of a long sausage made from material that absorbs oil. Unlike hard boom, sorbent boom does not have a skirt that extends below water and is intended for use in slow moving current. Hard boom can be used in combination with sorbent boom, such as seen in Figure 14.

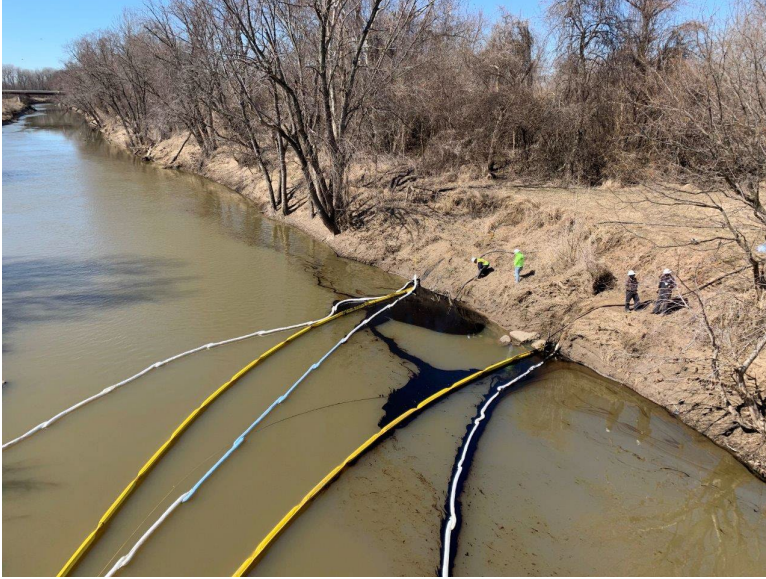
Figure 15. Oil recovery operations downstream of Wanda Road bridge, March 12, 2022, 12:12.

The oil containment measures included two additional oil boom strands on downstream side of the Wanda Road bridge (Figure 15 and 16). Contractor crews were tending and repositioning the downstream oil boom to address a streamer of entrained oil that was escaping the final boom section. Other crews employed a vacuum truck and skimmer to remove the pocket of oil. The alternate EPA OSC advised that at the direction of the unified command, Marathon crews were working to add additional containment measures at this location.

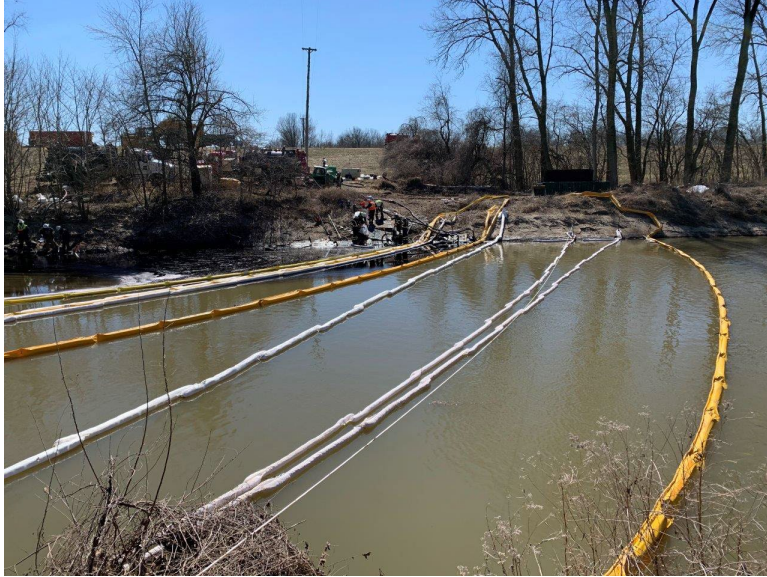
Figure 17. Oil recovery operations in Cahokia Creek at Oldenburg Road in Division 3, 7.3 miles downstream of the release site, March 12, 2022, 12:30.

On March 12, 2022, 12:30, investigators observed oil containment measures in Cahokia Creek between Oldenburg Road and Canal Road. This location was the leading edge of recoverable quantities of the oil spill, which was about 7.3 miles downstream of the pipeline breach and 2.5 miles upstream of the Mississippi River.

Resources engaged at the time of this inspection included 4 vacuum trucks, 2 frac tanks, 4 strands of hard boom, and 5 strands of sorbent boom. There was no visible amount of oil downstream of these containment structures (Figures 17 and 18).

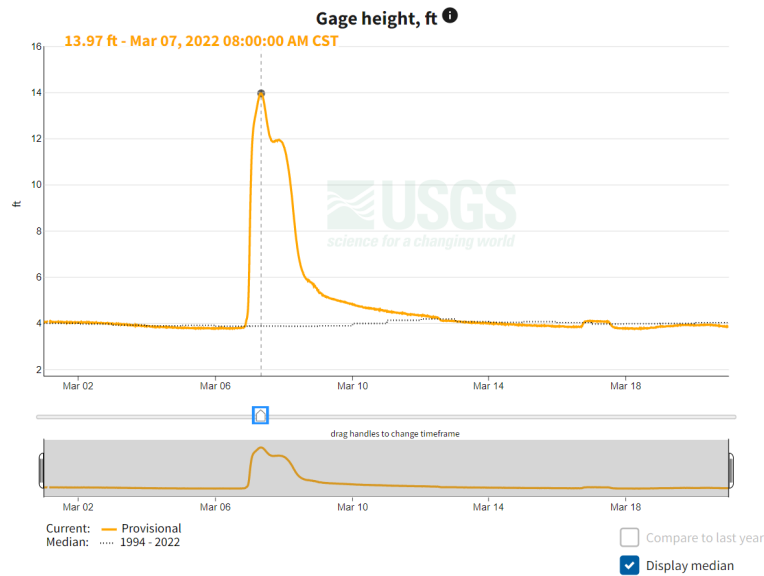
Figure 19. Cahokia Creek at Edwardsville, IL gage height data, March 1 – 20, 2022, near incident location. Source: USGS station 05587900.

Near the time of the pipeline breach incident on March 11, 2022, 08:15, the creek stage was 4.46 ft. and trending downward, reaching mean water level on March 12, 12:30. The stream flow at the time of the incident was 242 ft³/s and trending downward.

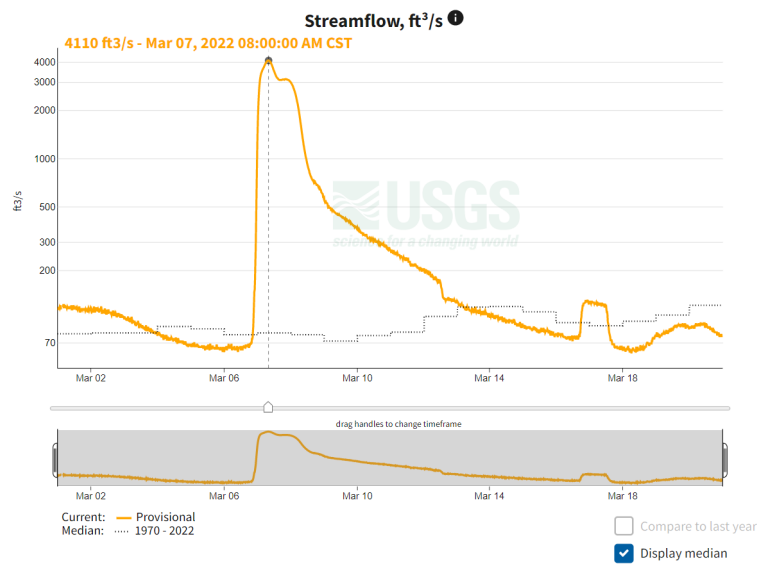
Figure 20. Cahokia Creek at Edwardsville, IL streamflow data, March 1-20, 2022, near incident location. Source: USGS station 05587900.
