NATIONAL TRANSPORTATION SAFETY BOARD

Attachment 2 –Airbus Hydraulic Check Valves Test Report

DCA18LA163

Hydraulic Test_A330 MSN 578 ATA29 Check Valves

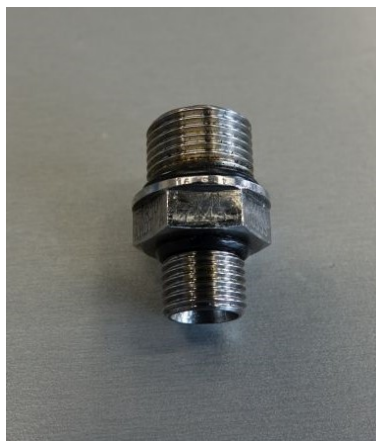
Figure 1: CAR101

Every object was subjected to a visual inspection. There were no visible damages or anomalies. The following pictures show the tested specimens.
