Issued: June 15, 2022

Preliminary Report HWY22MH009

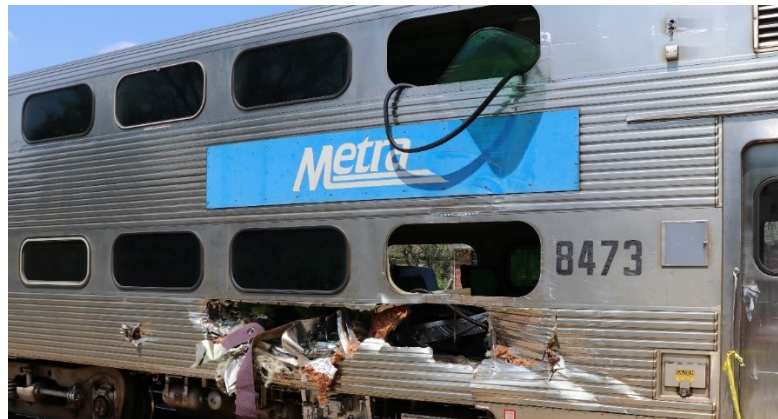
Figure 2. Truck impact damage to side of train cab car.
