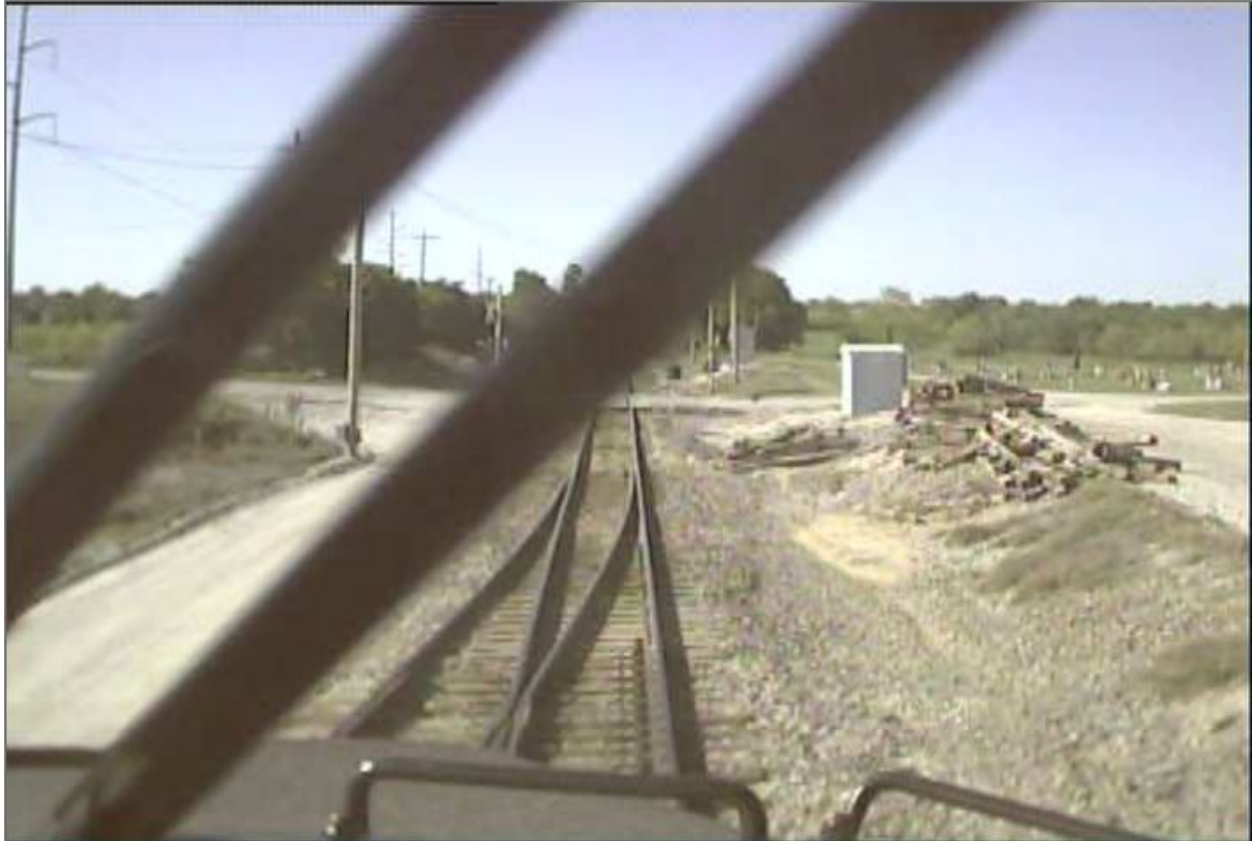
Image from the NS 4055, lead unit on the RHKPHQ15, as it traversed the C yard switch on arrival at Chico. This confirms that the crew that moved the RDACO14 in the C yard lined the C yard switch back for main track movement when they were complete.
