# **NATIONAL TRANSPORTATION SAFETY BOARD**

## **RRD18FR009 Operations Factual Report**

Description: BNSF Train vs BNSF Train Collision

Location: Kingman, Arizona

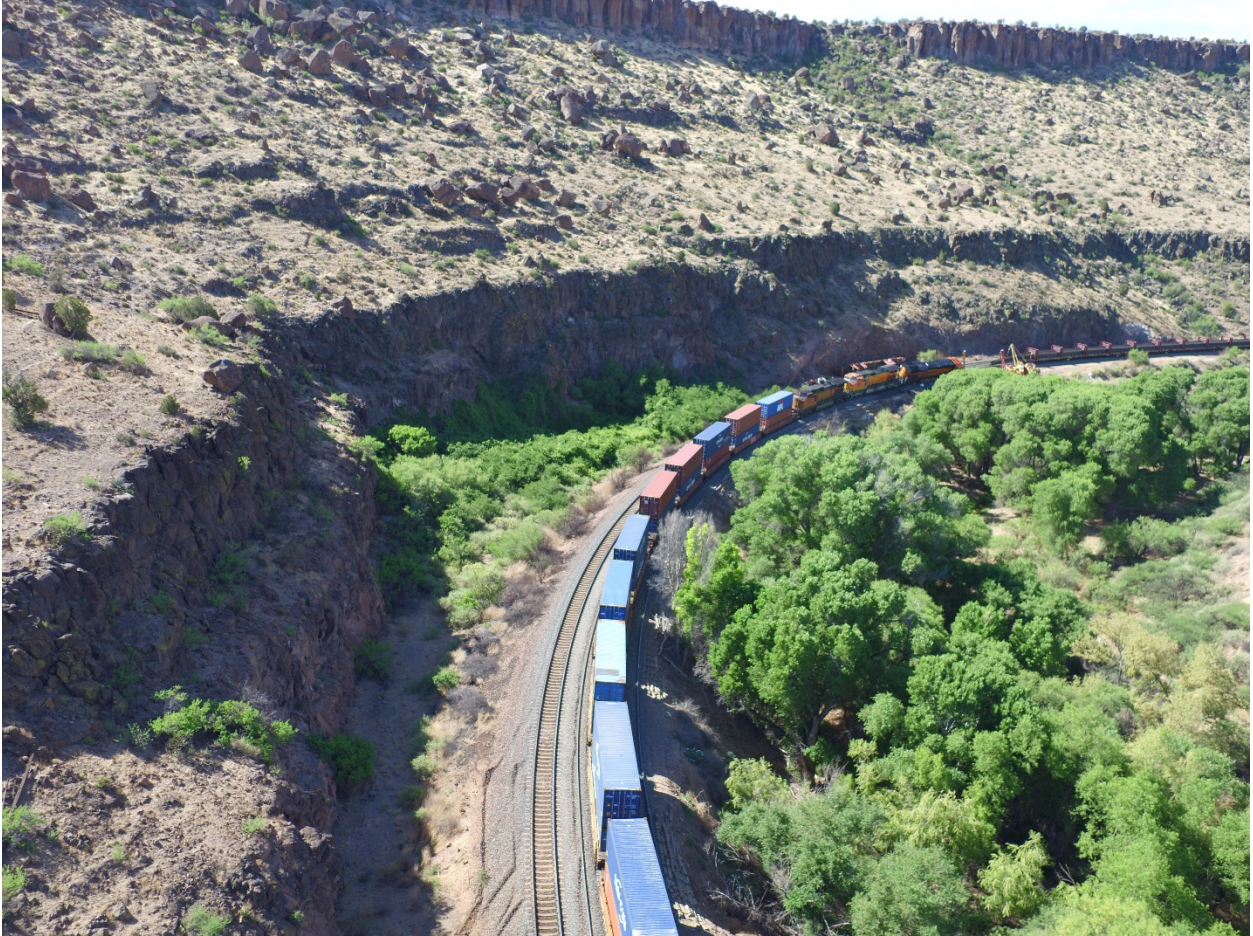
Figure 1 Photo courtesy of BNSF

The S-MEMSCO1-02 train traversed on a right hand 8-degree curve and the view was obstructed by trees and vegetation. As the train negotiated around the curve, they came upon the W NEESGM1-05R work train. When the train crew of the S-MEMSCO1-02 initially saw the approaching work train, they assumed that it was traveling east on Main Track 2. Moments later, both crew members realized it was on Main Track 1 and called out emergency, the Engineer and Conductor simultaneously placed the train into emergency.

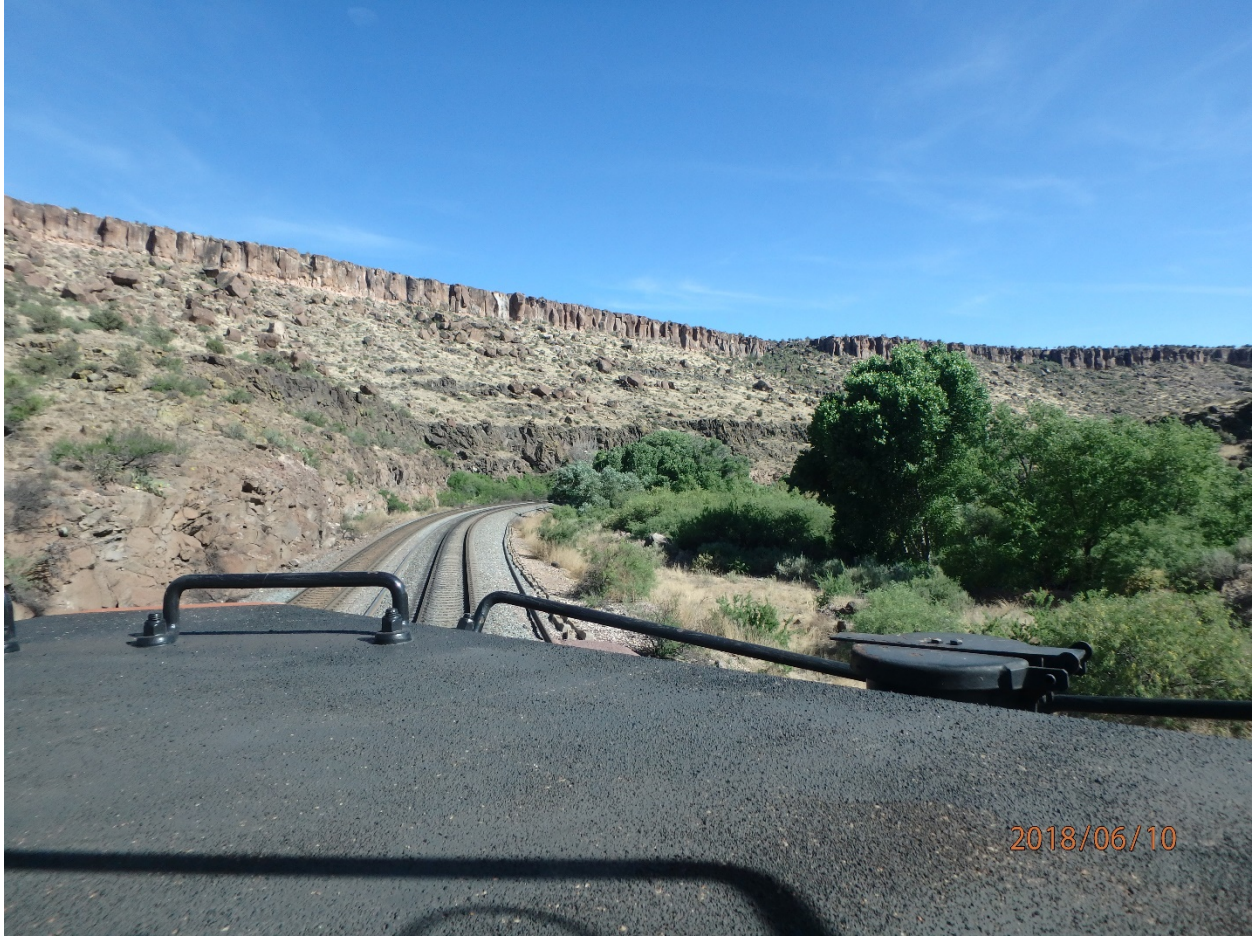
*Figure 2 Photo is of an exemplar train approaching in a westward direction the curve where the accident occurred. View of the curve is obstructed by vegetation.*

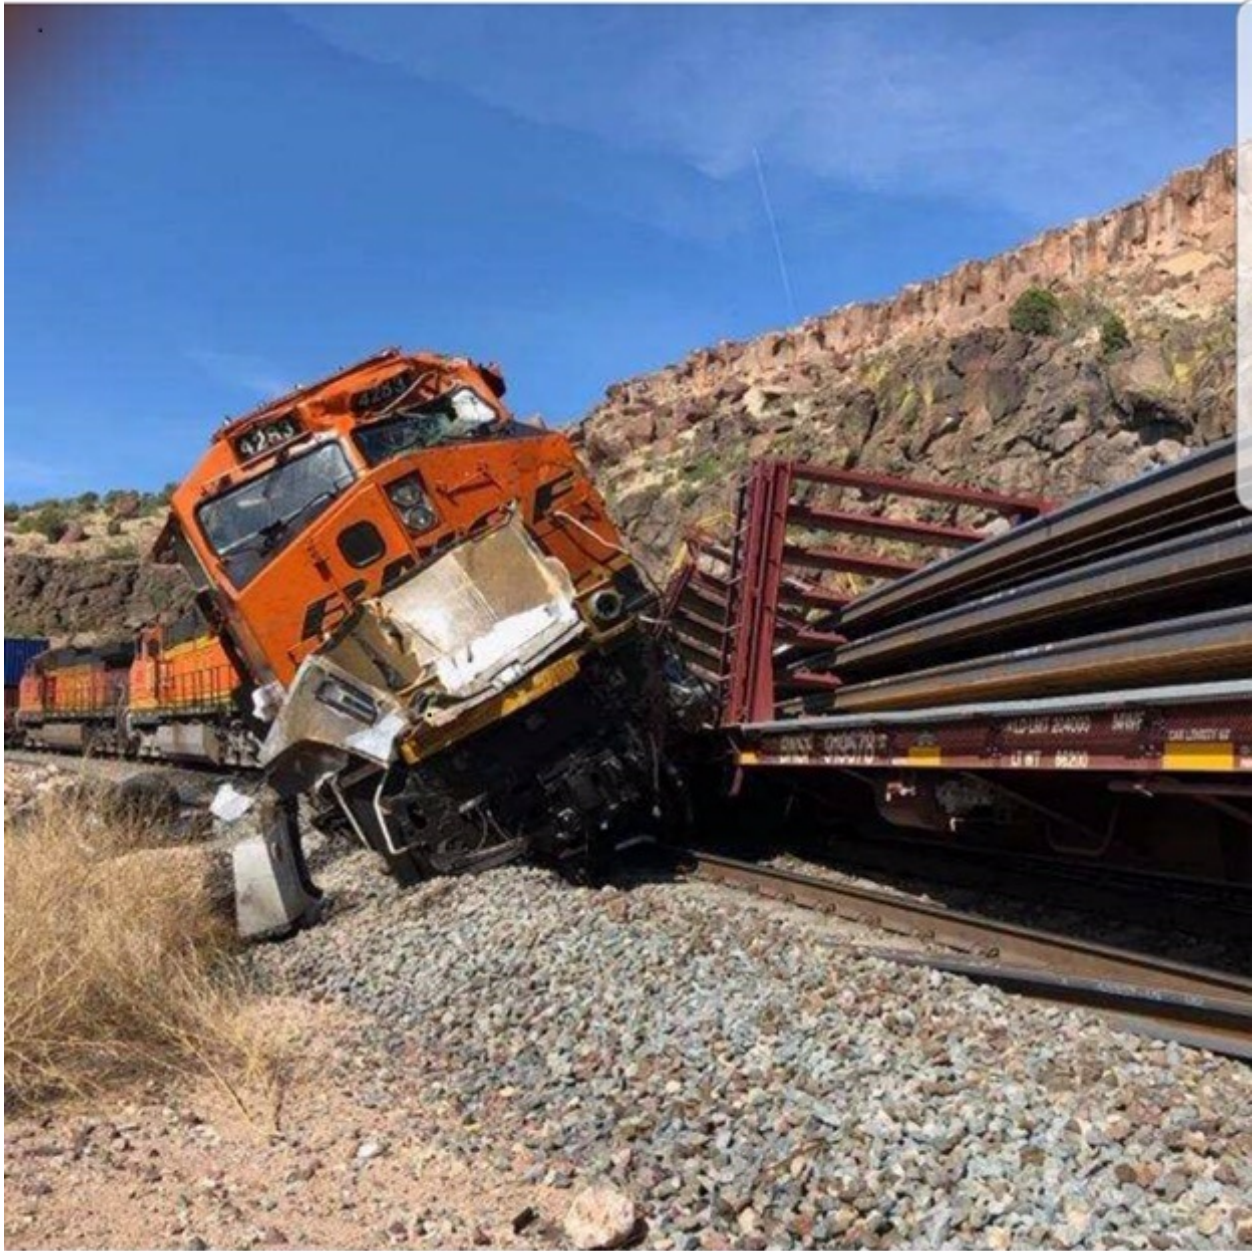
When the trains collided, the Conductor landed on top of the Engineer, the locomotive came to rest leaning to the right, diesel fuel started to leak into the locomotive cab. Both crew members got out of the locomotive and started looking for the crew members of the work train. They immediately found the Brakeman of the W NEESGM1-05R work train. A Herzog employee that was part of the work train notified the Engineer and Conductor that there were two other Herzog employees trapped in the RUM truck on the south side of the tracks. The Conductor said he managed to pull one of the Herzog employees out of the cab of the Rail Unloading Machine (RUM) truck.

*Figure 3 Photo courtesy of SMART, photo is looking east at the westbound S-MEMSCO1-02 lead locomotive came to rest leaning to the right in direction of travel.*

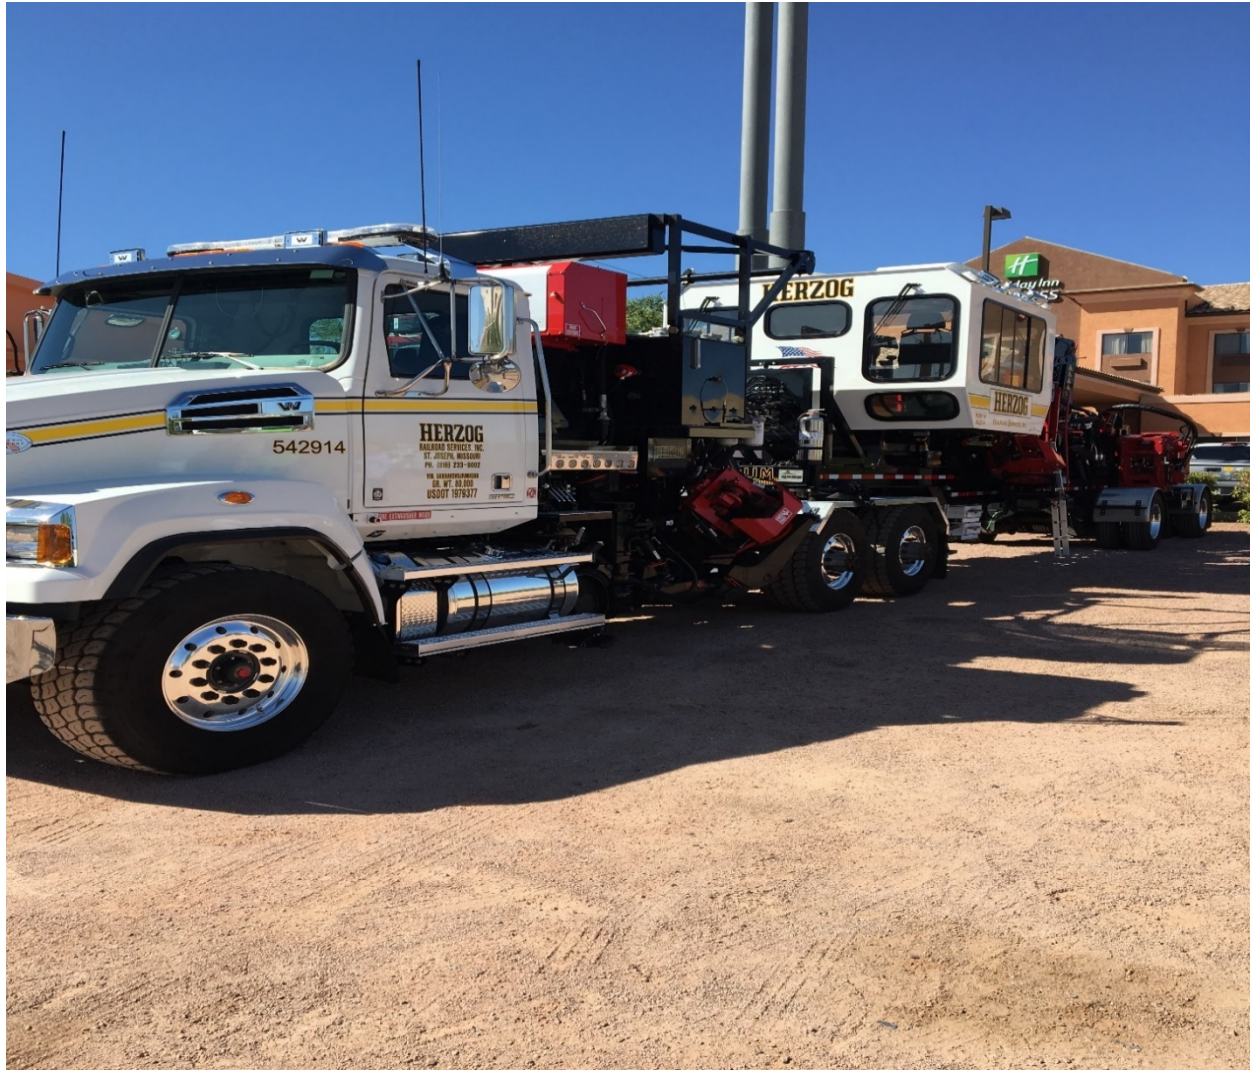
Figure 4 NTSB photo of exemplar Rail Unloading Machine ( RUM) truck.

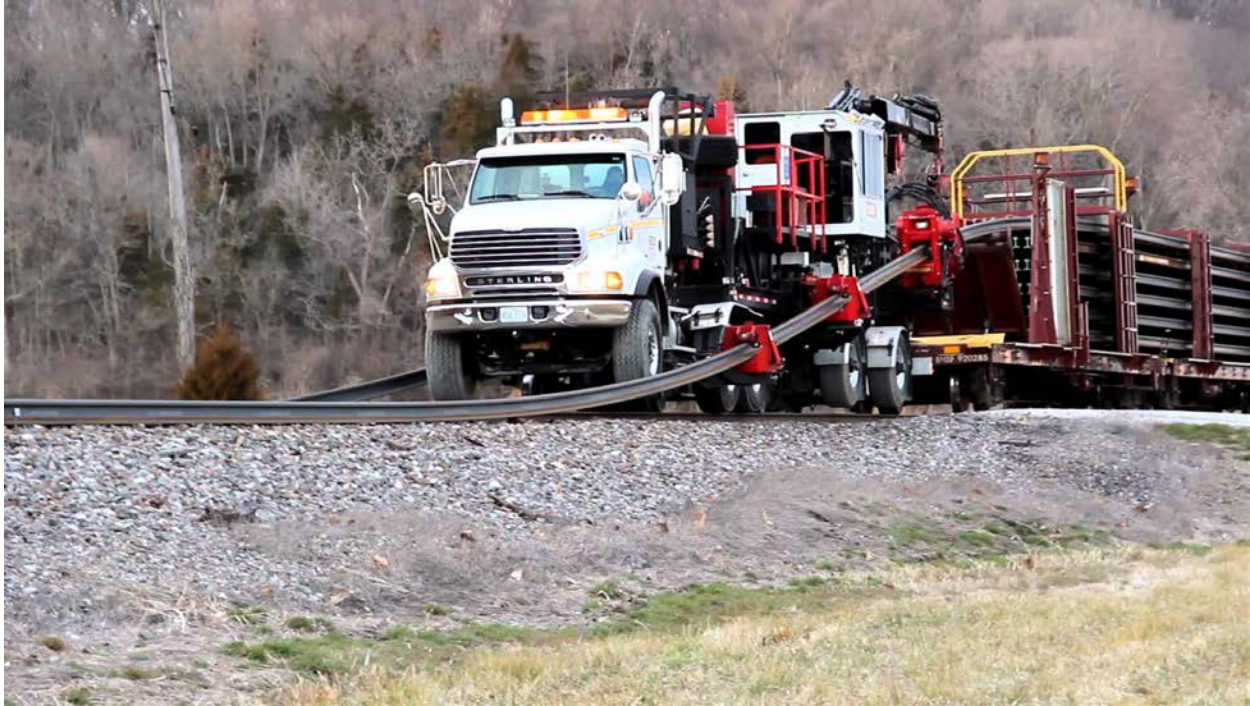
*Figure 5 Photo courtesy of BNSF, this is a photo of the work train a day prior to the accident. The Rail Unloading Machine (RUM) truck is attached to the rear of the work train.*

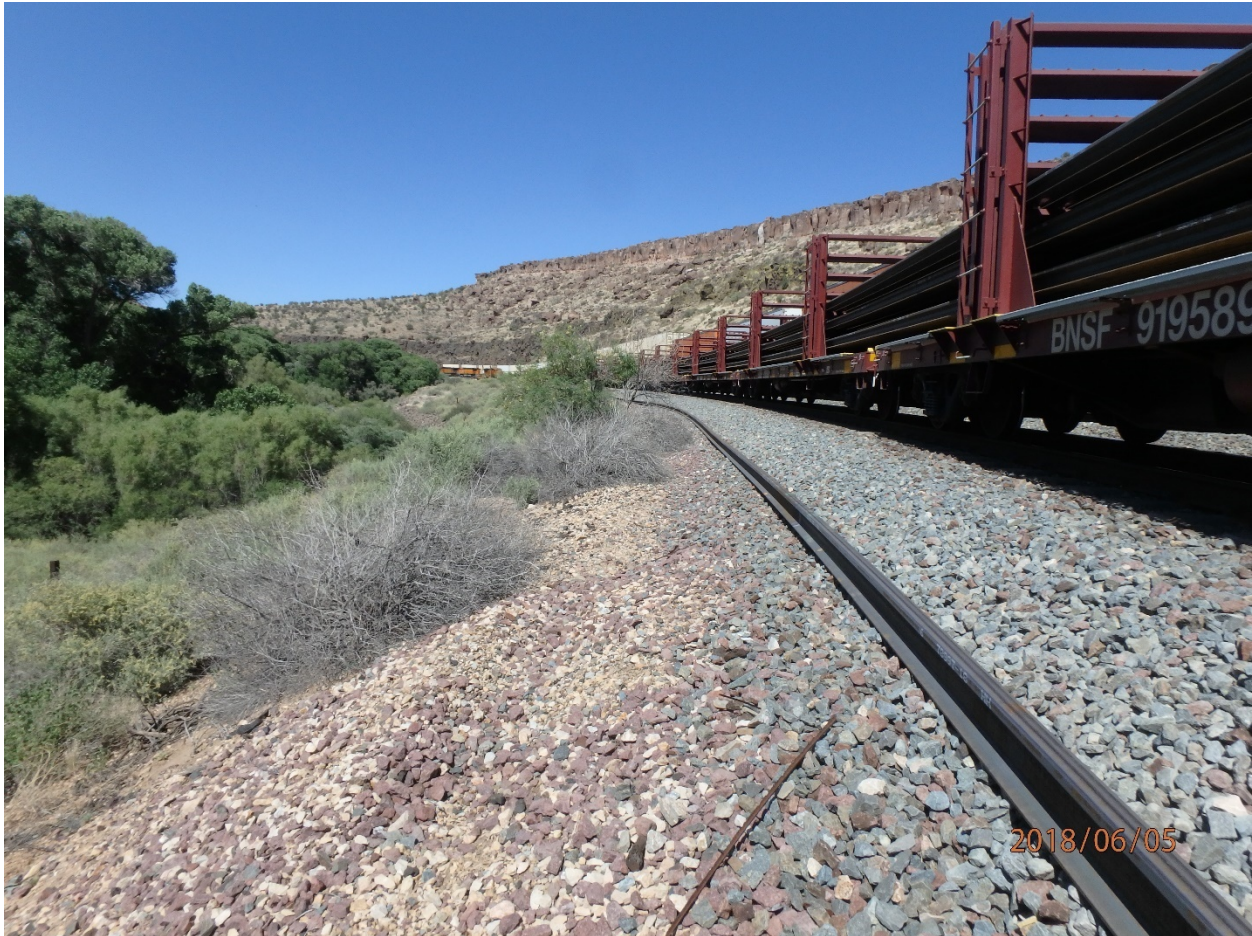
*Figure 6 NTSB Photo*

The Track Supervisor said that prior to impact, he saw the door of the operator station of RUM opened and close by one of the Herzog employees. The track supervisor said he jumped off on the south side of Main Track 1 and landed on the southside of the tracks. The track foreman and track laborer held on and rode out the collision.
