National Transportation Safety Board

RRD23MR005

METEOROLOGY

Specialist's Factual Report

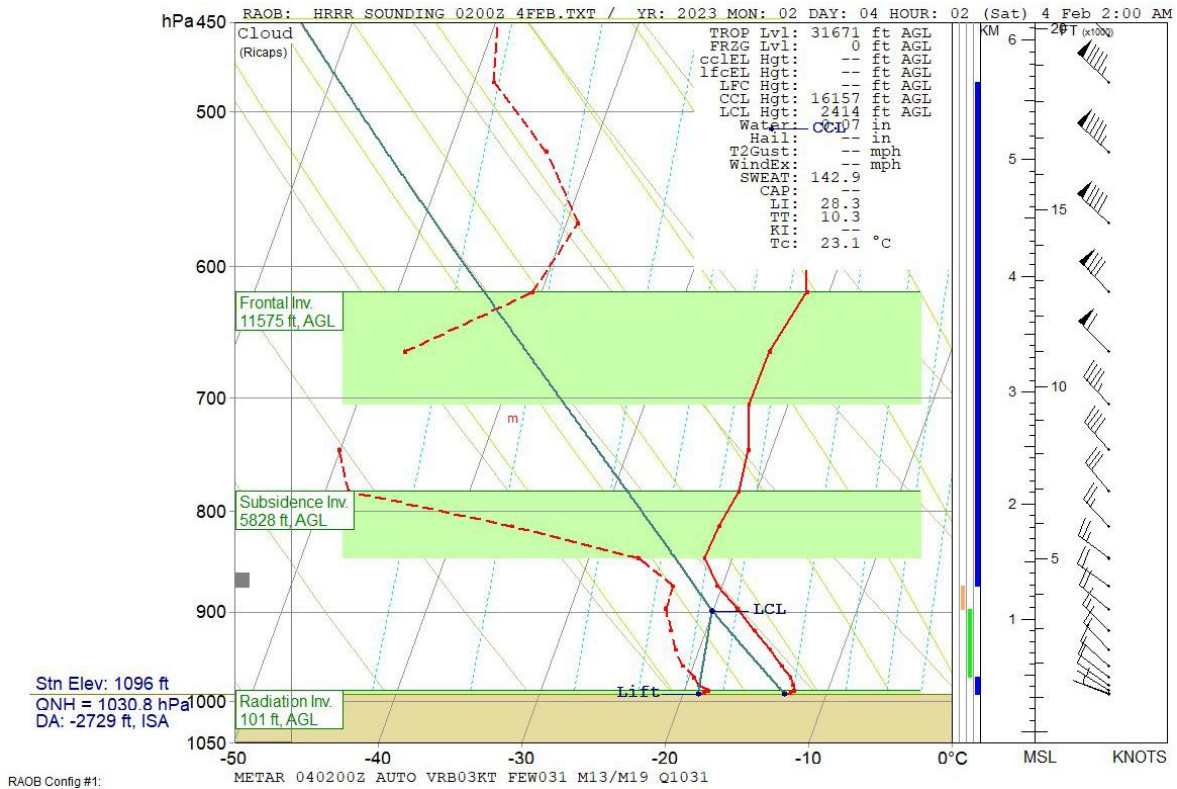
The HRRR sounding for 2100 EST on February 3, 2023, is included as figure 3. The sounding indicated a defined temperature inversion (green shaded area) between 5,000 ft with a top near 11,575 ft, where the temperature increased with height and resulted in a stable atmosphere with a Lifted Index (LI)⁸ of 28.0. An inversion can restrict the vertical transport of the hazardous material being burned from being dispersed to great heights in the atmosphere. The wind profile indicated a surface wind from about 300° at 3 knots with winds slowly veering⁹ to the northwest with height, and increasing wind speeds of 25 knots or more above 5,000 ft.

Figure 3 - High-Resolution Rapid Refresh (HRRR) numerical model sounding for 2100 EST over the derailment site depicting the vertical structure of the atmosphere.

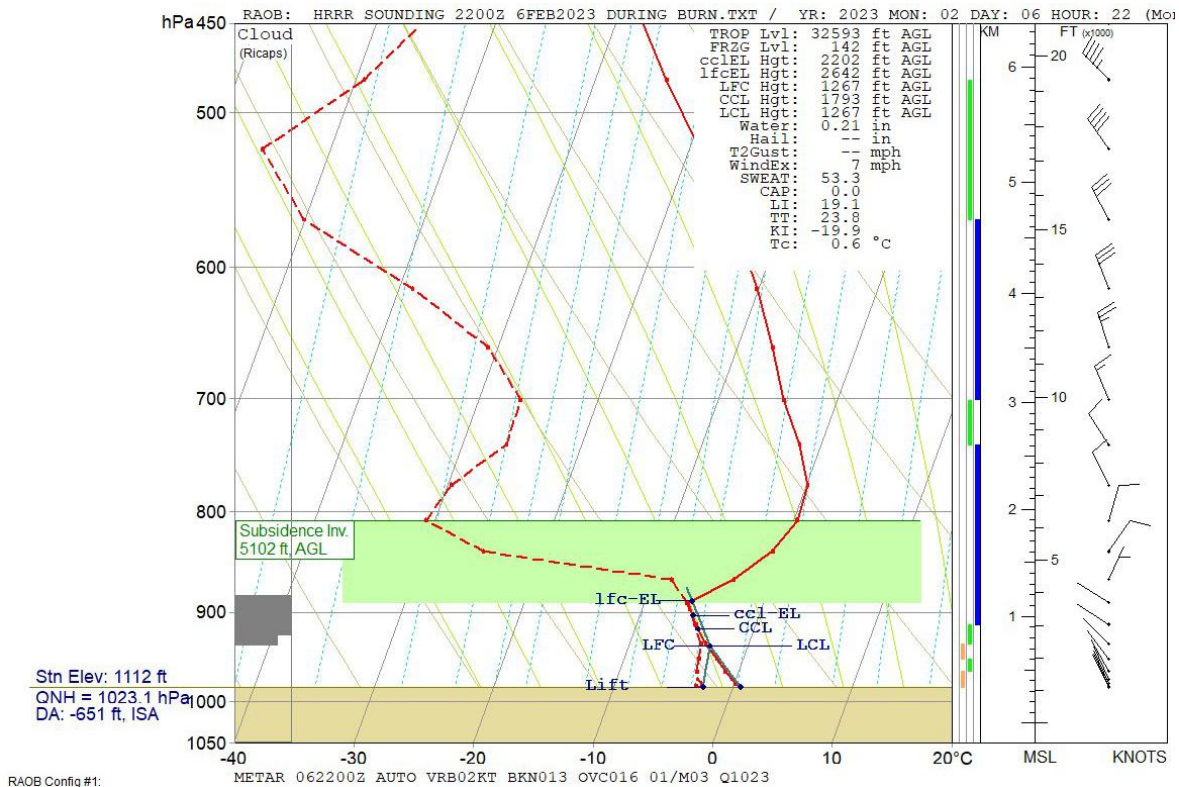
A HRRR sounding for 1700 EST on February 6, 2023, at the time of the controlled burning of the hazardous chemicals is included as Figure 4. The sounding again depicted a defined temperature inversion between 3,600 and 5,100 ft, with a LI of 19.1 and indicated a stable atmosphere. The sounding indicated a lifted condensation level (LCL)¹⁰ and a level of free convection (LFC)¹¹ at 1,267 ft agl, and a convective condensation level (CCL)¹² at 1,793 ft agl and RAOB supported a broken to overcast layer of stratiform clouds from the LCL with tops near 4,000 ft. The precipitable water content was 0.21 inches. The wind profile indicated a near surface wind from 340° at 2 knots with winds less than 10 knots through 5,000 ft.

Figure 4 - HRRR sounding for 1700 EST on February 6, 2023, at the time of the controlled burn.

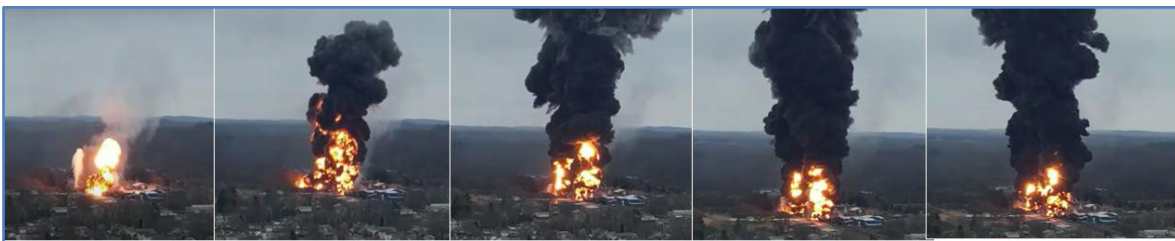
The controlled burn of the hazardous chemicals, specifically the vinyl chloride¹³ occurred on Monday afternoon at 1737 EST on February 6, 2023. Figure 5 are images of the plume from the fire during the first minute after ignition. The image depicts two defined burn areas initiated with a near vertical column of dark smoke rising, that merges with little drift. The fire and smoke plume lasted for an estimated 3 hours.

Figure 5 - Drone photography of the control burn of chemicals at 1637 EST on February 6, 2023.

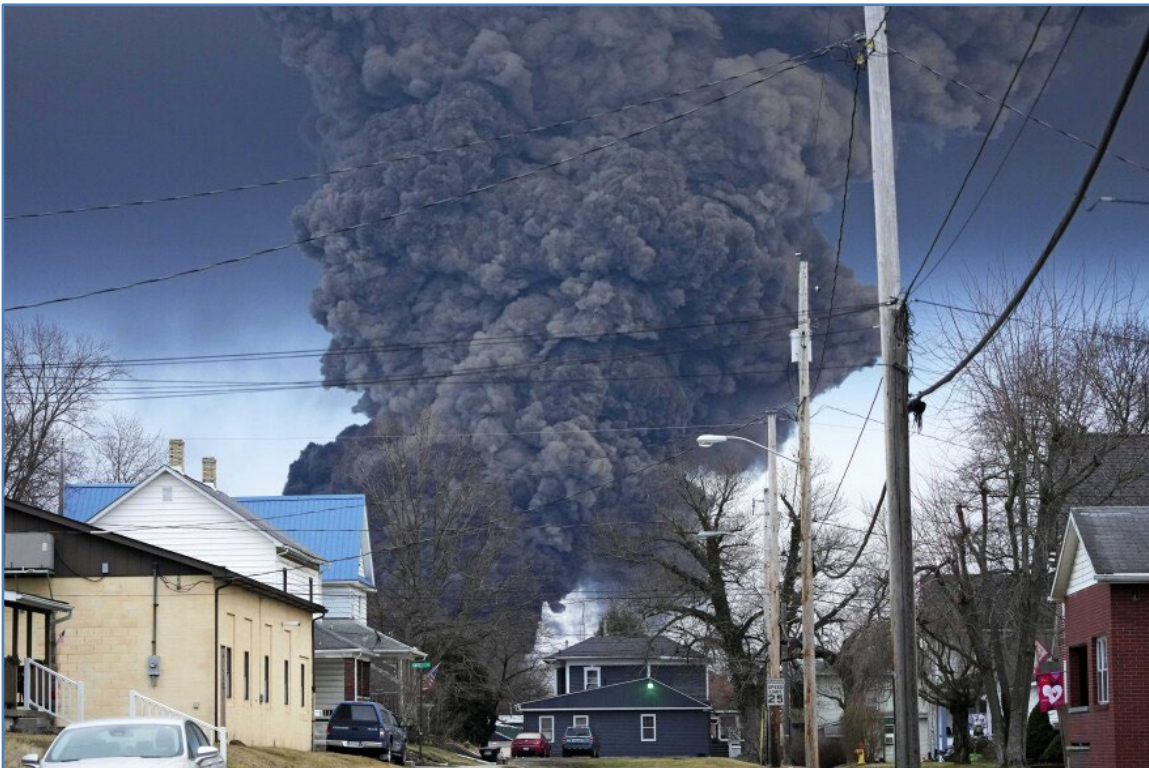
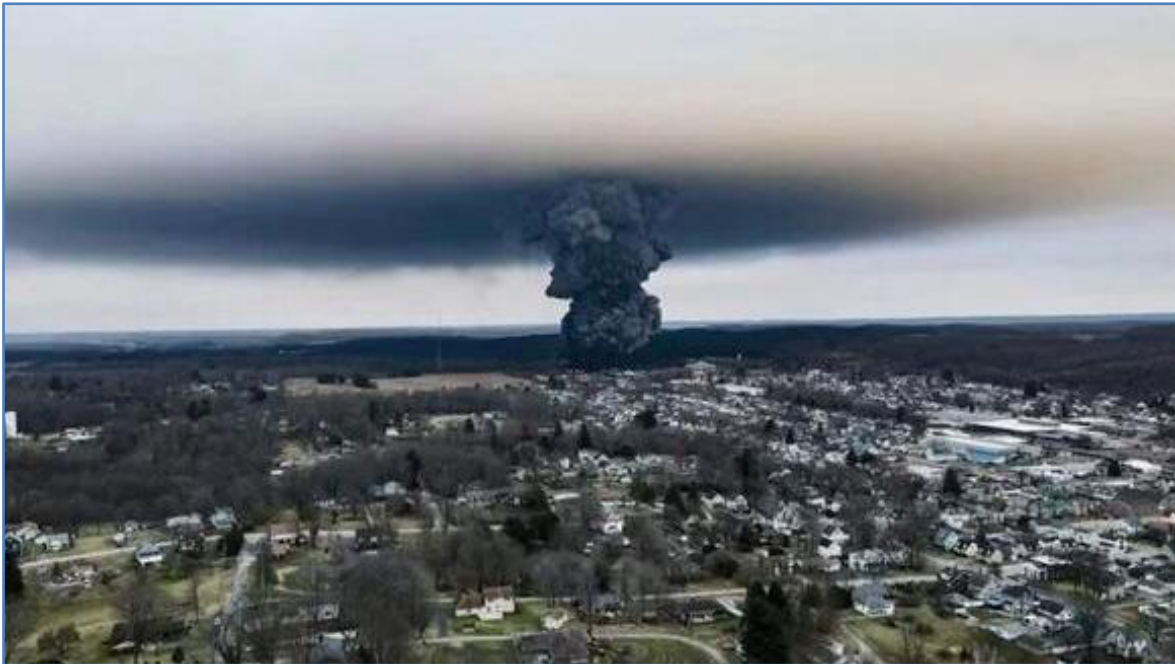
Other images of the controlled burn smoke plume also showed the plume rising vertically and spread out under the overcast cloud layer, as shown in figures 6 and 7.

Figure 6 - East Palestine, Ohio, smoke plume from controlled burn on February 6, 2023.

Figure 7 - Drone image of controlled burn on February 6, 2023.

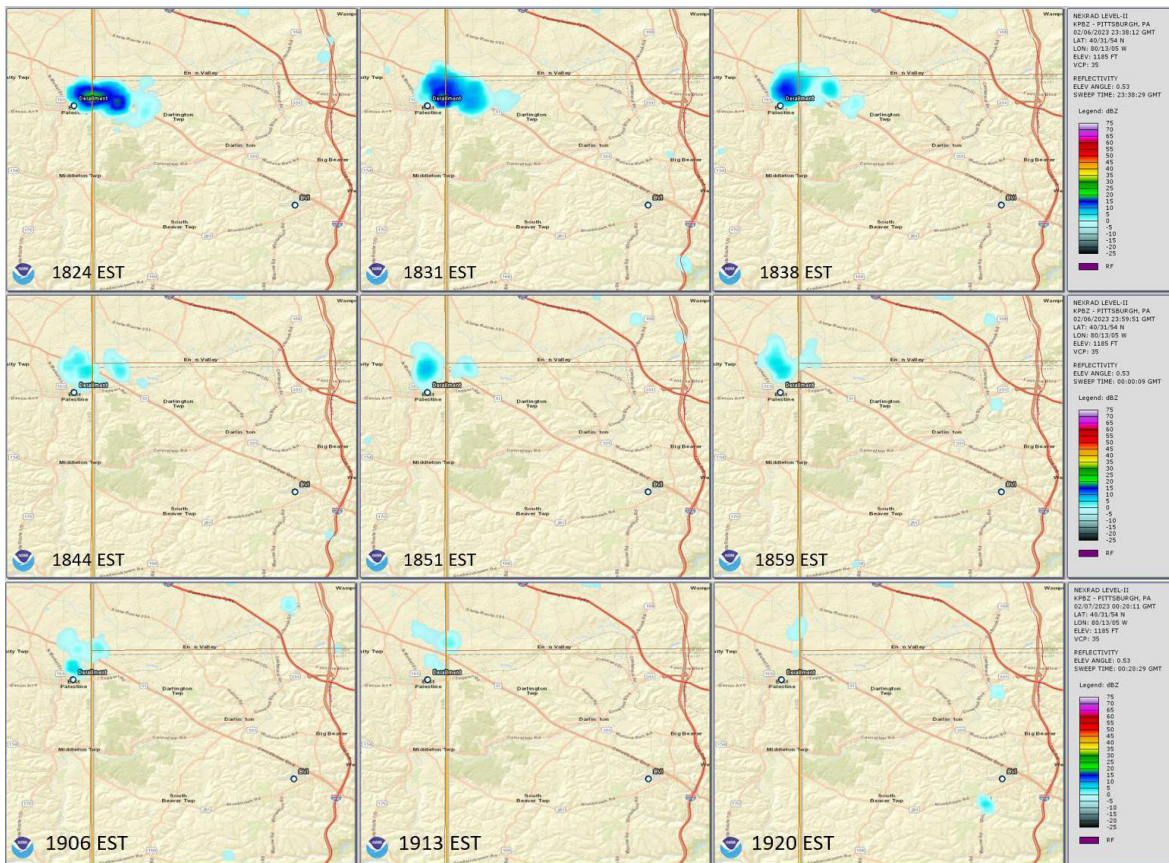
Figures 8-10 are the KPBZ WSR-88D 0.53° base reflectivity images of the plume detected at 1639 through 1920 EST, the train derailment location is noted in the upper left corner of the image with the observation site BVI also located in the right lower corner. Assuming a standard refraction of the radar beam, the 0.53° beam was scanning the atmosphere between approximately 1,750 through 4,070 ft over the area. The smoke plume is observed to about 3 miles east of the derailment location during the period before dissipating.

Figure 8 - NWS KPBZ WSR-88D 0.53° base reflectivity images from 1639 through 1717 EST.

Figure 9 - KP82 WSR-88D 0.53° base reflectivity images from 1721 through 1817 EST.

Figure 10 - KPZB WSR-88D 0.53° base reflectivity images from 1824 through 1920 EST.

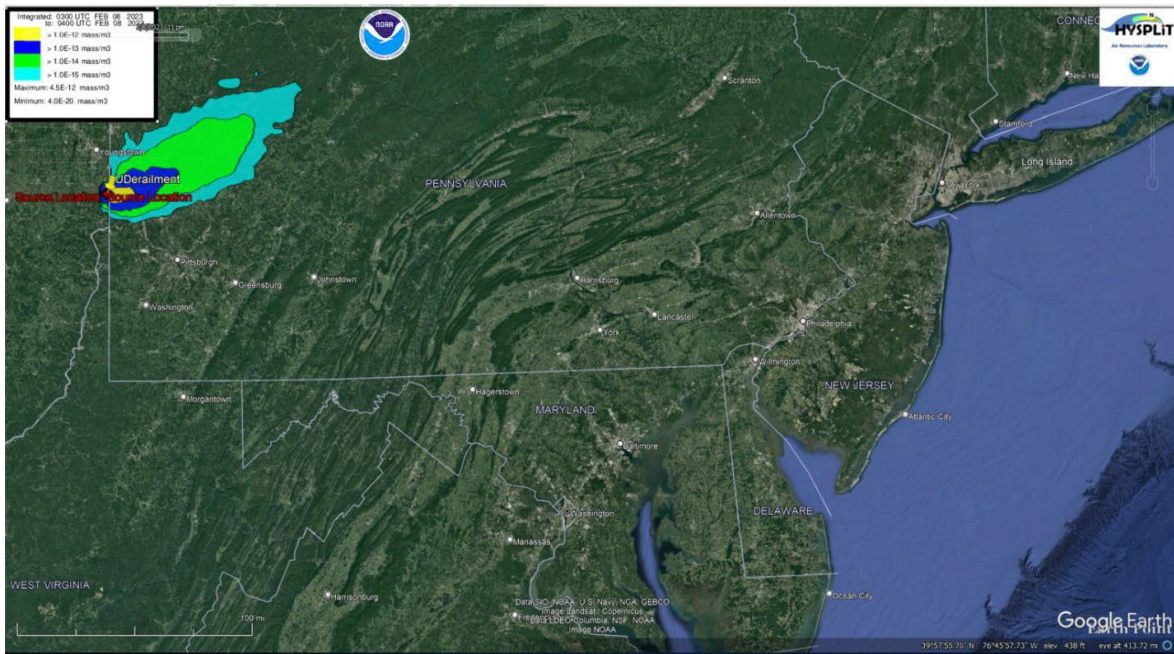
Figures 12-15 are the HYSPLIT run at 1733 EST for the time of arrival of the plume cloud every 5-hours beginning at 2300 on February 7th through 0400, 0900, and 1400 EST on February 8th of the burn plume. The range scale is set at 100 nm.

Figure 12 - HYSPLIT concentration at 2300 EST on February 7, 2023.

Figure 13 - HYSPLIT concentration 0400 EST on February 8, 2023.

Figure 14 - HYSPLIT concentration 0900 EST on February 8, 2023.

Figure 15 - HYSPLIT concentration 1400 EST on February 8, 2023.
