# National Transportation Safety Board

RRD24MR002

## **OPERATIONS**

Group Chair's Factual Report

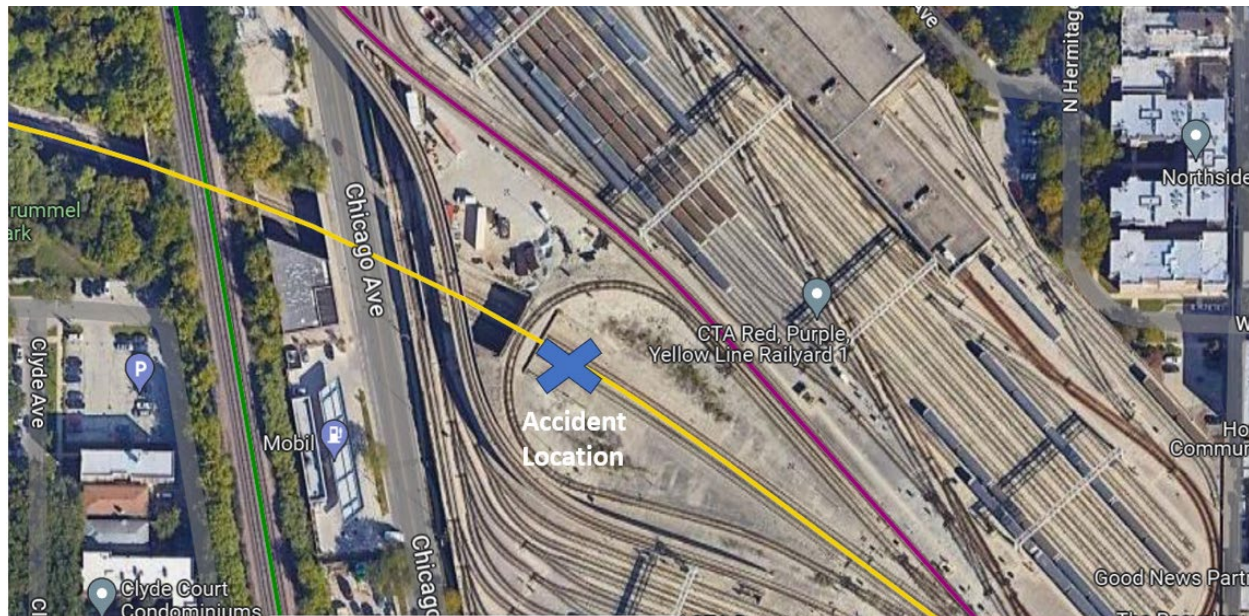
**Figure 1:** Overhead view of Howard Yard (courtesy of Google Earth)

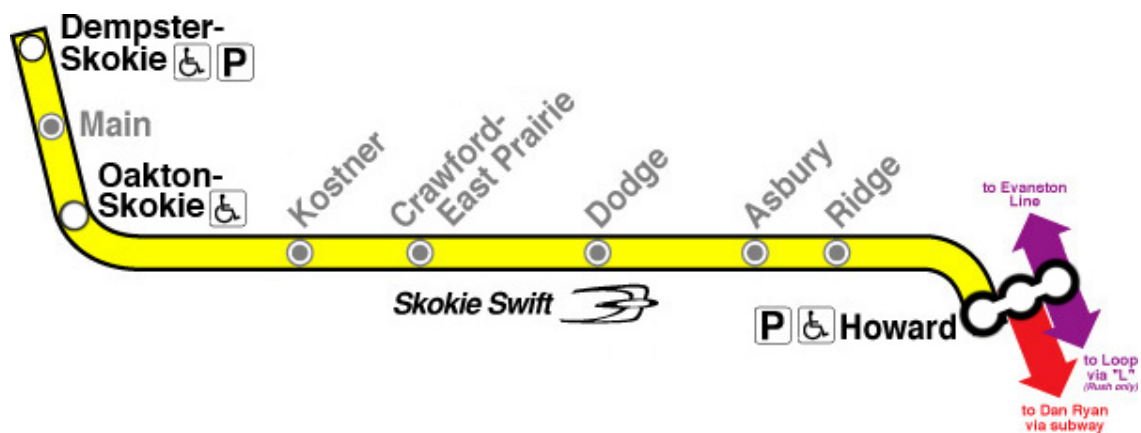
**Figure 2:** Overview of the Yellow Line (courtesy of CTA)

The Yellow Line route provides rapid transit train service between Dempster-Skokie (in Skokie, IL) and Howard (in Chicago) on multiple main tracks, with connecting service to downtown Chicago via Purple Line Express or Red Line.

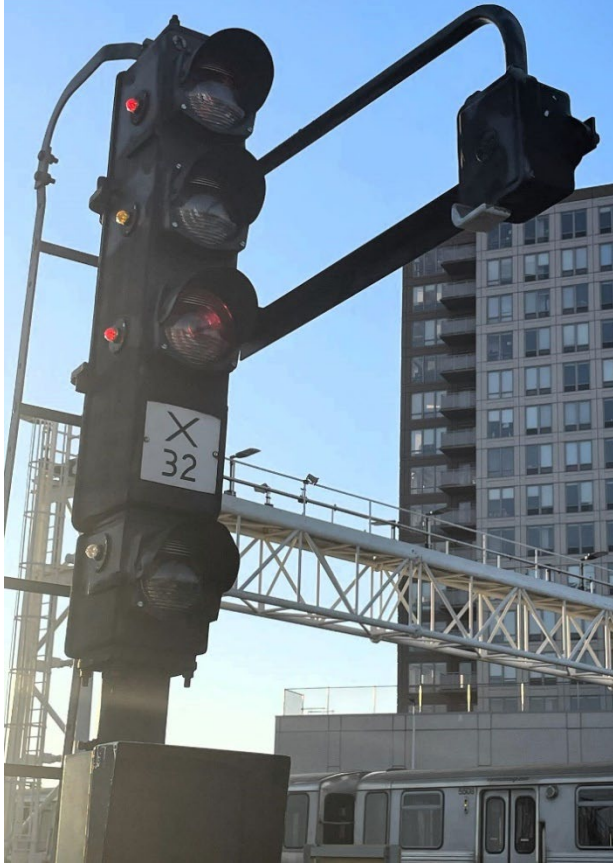
**Figure 3:** Signal the S-500 Snow fighter was stopped at.

On November 16, 2023, Train CTA 593 was moving south on main track SK-1 on the yellow line towards Howard station and collided with a stationary S-500 snow fighter that was stopped behind the signal (X32) at Howard at approximately 10:30 am.

Train movements are authorized by wayside and in-cab signal indications with an overlaid automatic train control system. The CTA 593 while moving south, was traveling at 54 mph when it received a stop command from the signal system because of the snow removal machine stopped on the track approximately 2,150 feet ahead. The operator of the CTA 593 train immediately initiated a full-service braking application to stop the train. Once the S-500 snow fighter was in view of the train operator, the operator initiated an emergency brake application. The train decelerated to about 22.7 mph before striking the S-500 snow fighter machine.

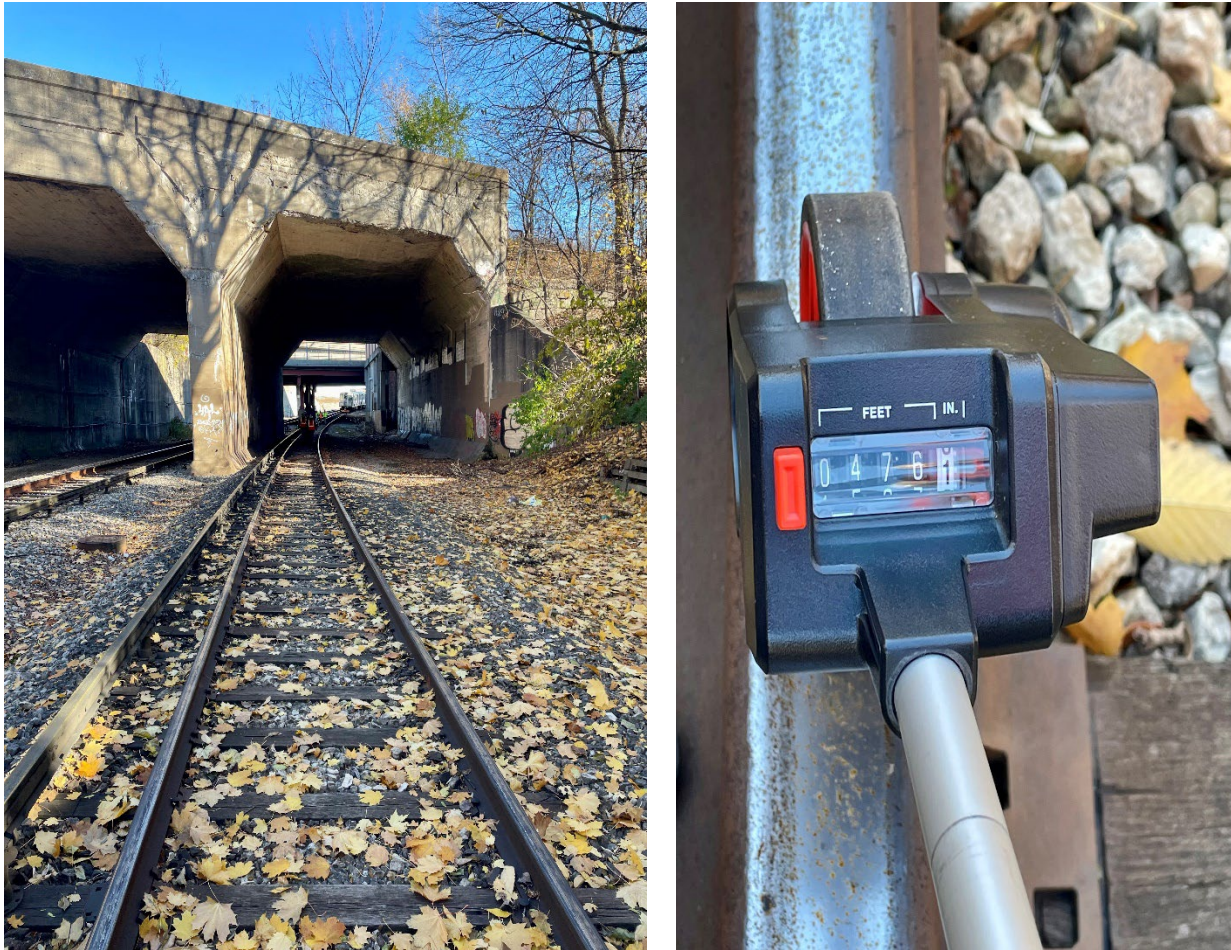
**Figure 4:** Site distance from Train Operator to Maintenance Equipment

On Friday, November 17, 2023, the Operations group conducted an on-scene inspection of the accident site. The purpose of the site walk was to collect and document information related to the accident. While on scene it was determined that the incident location was on an uphill grade, in an area with leaf's covering the area, beneath the viaduct. Train 593 consisted of one married pair/ two car consist, cars 5599 (lead) and 5600 (trailing). The operators cab, lead car 5599, was caved in, with front truck derailed. The S-500 snow fighter was not derailed and had damage to the brush and rear cab, along with windshield ejected from frame.

NTSB also conducted site distance observations while on scene to determine when the operator of the revenue train could see the snow fighter machine and determined that the train operator had approximately 476 feet of site distance.

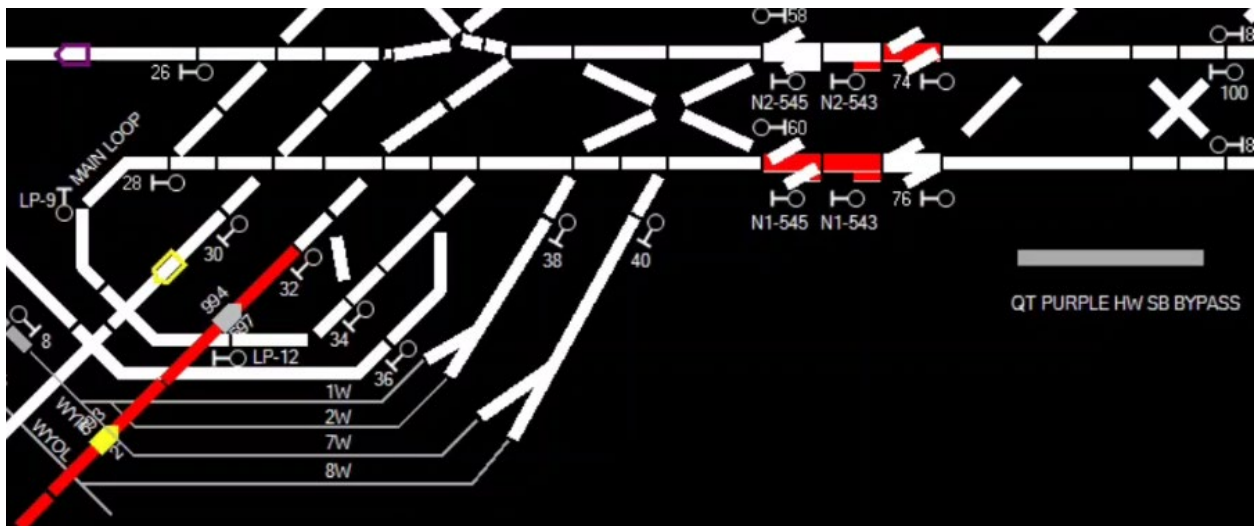
**Figure 6:** Screen shot of QuikTrak showing train 593 approaching the 994.

- QuikTrak is used by the Control Center, Tower Workers, and Supervisors to monitor the location of trains (and equipment) on the rail system.
- The playback starts around 10:14 AM
- In the top left, the recording shows Dempster/Skokie to Chicago to Howard.
- S-500 is on Yellow Line, going southbound to Howard, labeled 994
- Train 593 has just turned around from northbound back to southbound.
- 994 stops at X32 signal.

- 593 approaches the stopped 994 and playback ends when the collision occurs, with 593 and 994 in sequential track sections.

QuikTrak is another verification that 994 consistently shunted from time it entered the line of road to the time of collision.
