# National Transportation Safety Board

RRD24MR004

## COMMUNICATIONS

Group Chair's Factual Report

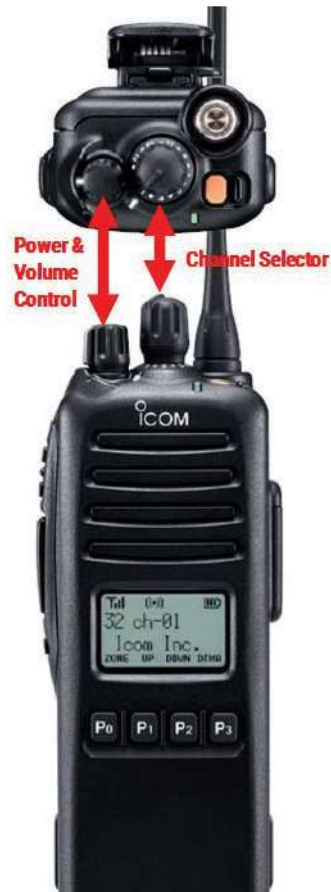
Picture 1.1

Frequencies are assigned to named channels, within the programming of NYCT radios per table 1.2. This enables a user to not have to remember the precise details of each frequency, but to instead having to know what channel name or number that he/she may need to use. To access the desired radio channel, the user will turn one of the two control knobs on the top of the radio, which will cycle through the programmed bank of channels, per picture 1.1.

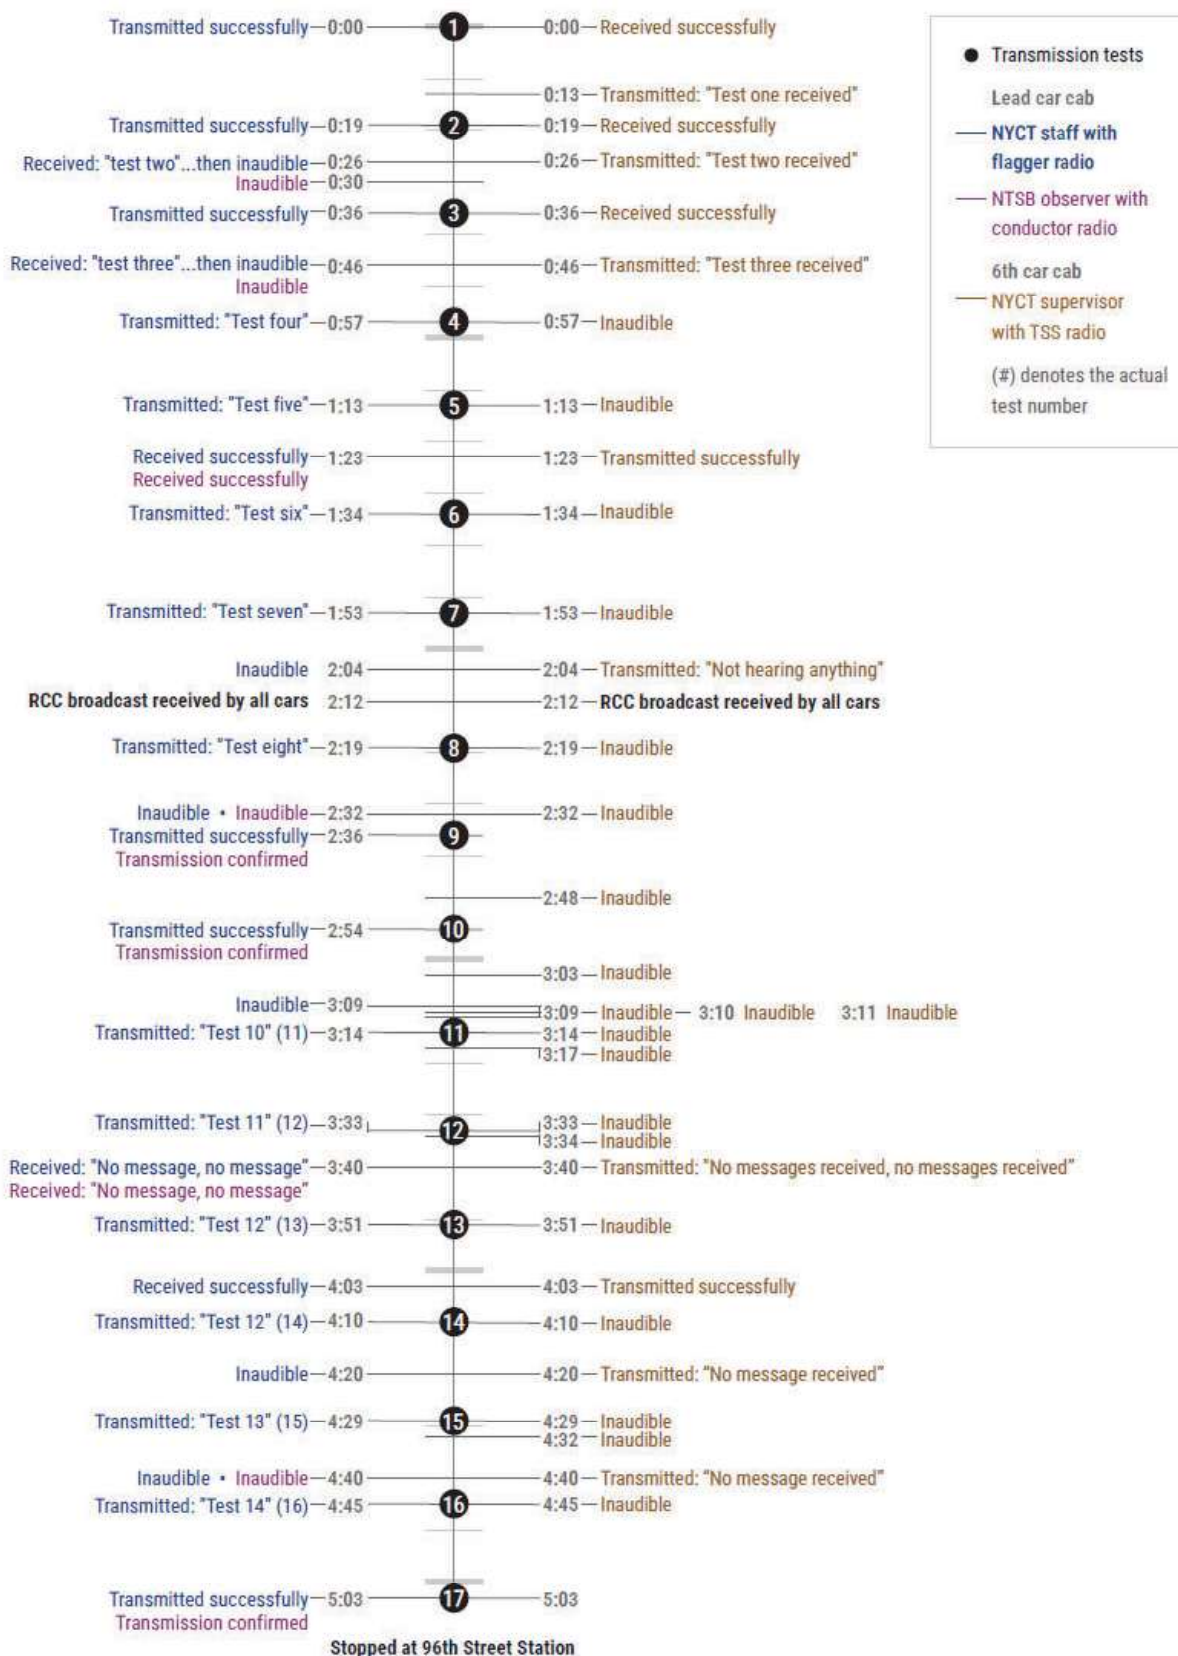
Illustration 1.2 - Timeline summary of radio message communication performance.

Permission to proceed northbound by signal indication was received by the test train at approximately 2:50PM, which commenced the departure and subsequent northbound movement. At approximately 2:55PM, the test train arrived at 79th Street Station, where the radio testing began, and continued to 96th Street Station. The test train arrived at 96<sup>th</sup> Street Station at 3:00PM, concluding the radio testing. The radio test performance data and other important notes were transcribed by NTSB investigators (docket file *Consolidated Radio Testing Data.pdf*), from the recorded iPhone video footage. A summary of the test train procedure with radio test performance as illustrated in *Illustration 1.2*.

- Sixteen verbal test messages were transmitted using the Flaggers radio from the operating cab of the first car, three messages were received in the sixth car operating cab, with the message complete and being able to be fully understood.
- Nine transmissions were made from the operating cab of the sixth car using the TSS radio, with only two messages being received by the Flagger radio, with the message complete. There were two additional transmissions received by the Flagger radio with the message partially intact.
- One message was received by the conductor radio from the TSS radio. There was one transmission received that was mostly intact, but not completely.
