**NATIONAL TRANSPORTATION SAFETY BOARD  
OFFICE OF HIGHWAY SAFETY  
WASHINGTON, D.C.**

**SURVIVAL FACTORS GROUP CHAIRMAN'S  
FACTUAL REPORT**

Location: State Highway 2 (SH-2), Randolph, in Coos County, New Hampshire

Operator #9: 45-year-old male (deceased)  
Passenger #9: 42-year-old female (deceased)  
Vehicle #10: 2015 Harley Davidson FLST  
Operator #10: 52-year-old female (injured)  
Vehicle #11: 2007 Harley Davidson FLHRSE3  
Operator #11: 51-year-old male (injured)  
Vehicle #12: 2019 Harley Davidson FLXH  
Operator #12: 53-year-old male (not injured)  
Vehicle #13: 2006 Harley Davidson FLTRI  
Operator #13: 70-year-old male (injured)  
Operator #13: 69-year-old female (injured)  
Vehicle #14: 2015 Harley Davidson FLHTKS  
Operator #14: 46-year-old male (not injured)  
Passenger #14: 48-year-old female (injured)  
Date: Friday June 21, 2019  
Time: 6:26 p.m. Eastern Daylight Time  
NTSB #: **HWY19MH010**

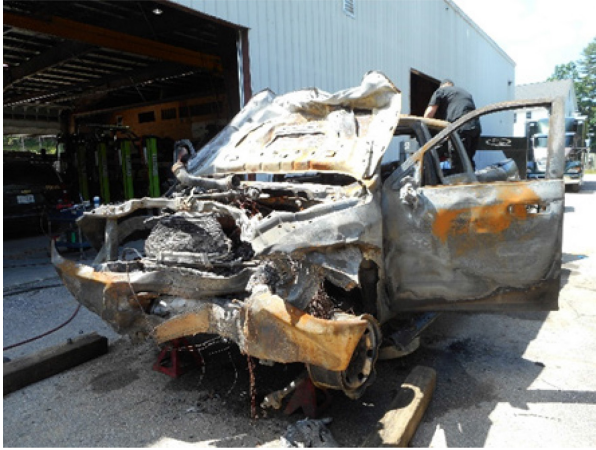
The Ram 2500 sustained deformation to the front end and right side as well as being mostly consumed in the post-crash fire. The initial impact was to the front end of the pickup truck and there were several areas of deformation on the front end, but the damage sequence could not be determined. There was significant deformation to the front bumper and engine compartment as shown in **Figure 1**. At the time of examination, the hood of the pickup truck was found open and flipped back against the windshield frame.<sup>1</sup> As shown in **Figure 2**, the right-side deformation was moderate and appeared to have been the result of several impacts, the sources of which could not be determined. The driver's door was open at the time of the inspection. The front passenger door had been jammed shut and was pried open by the New Hampshire State Police during their post-crash inspection.

Deformation to the front end resulted in a maximum of approximately 20 inches of crush in the aft direction, across the front end. The frontal impacts resulted in a 10-inch difference between the left side (144 inches) and right side (154 inches) wheelbase with the manufacturer's original wheelbase listed at 149 inches. Deformation to the right side extended from the right front tire to just forward of the right rear wheel. Maximum crush to the right side was estimated at 18 inches.

**Figure 1.** Frontal view of deformation to Ram 2500. **Figure 2.** Right side view of deformation to Ram 2500.

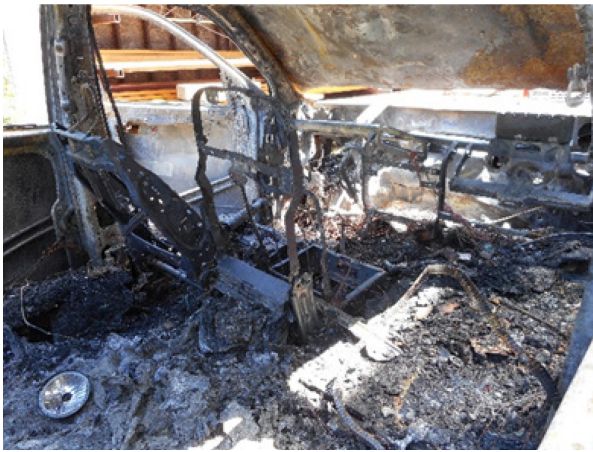
The non-metallic parts of the interior of the Ram pickup were totally consumed in the post-crash fire. As shown in **Figures 3 and 4**, the only remaining interior components were the driver seat frame and fold down center armrest. The driver's seatbelt latch plate and buckle were not found in the debris.

**Figure 3.** Interior view of fire damage to Ram looking rear to front. **Figure 4.** Ram interior looking front to rear.

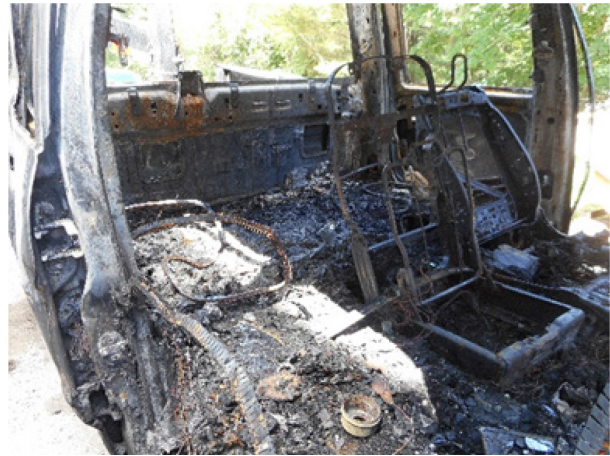
The interior inspection of the Ram revealed that the front right passenger seat and the rear bench seat had been removed to accommodate an improvised sleeping area in what was once the back seat.

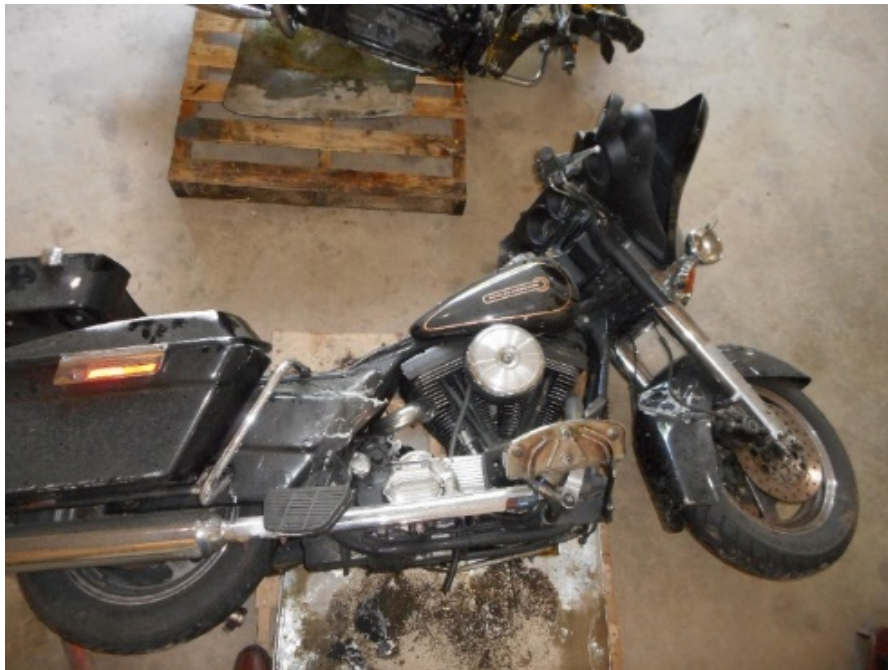
The small headlight on the right side was missing its lens and was twisted in its mount. The windshield was missing, as was the right rearview mirror lens. The right floorboard was displaced upward. The front fender had contact damage to the right side and to the rear. The motorcycle was missing its seat as shown in **Figure 5**. The left handlebar was folded in half. The right rear floorboard was displaced downward. The fiberglass on the right side was damaged and torn. The top saddlebag was missing its lid and there was damage to the lid of the right-side saddlebag. The left side saddle bag was missing. The left floorboard and crash bar were displaced, and the left side tailpipe was detached. There was damage to the left side of the fuel tank. The transmission cover on the left side was fractured.

**Figure 5.** Right side overhead view of 1998 Harley Davidson Electric Glide FLHT.

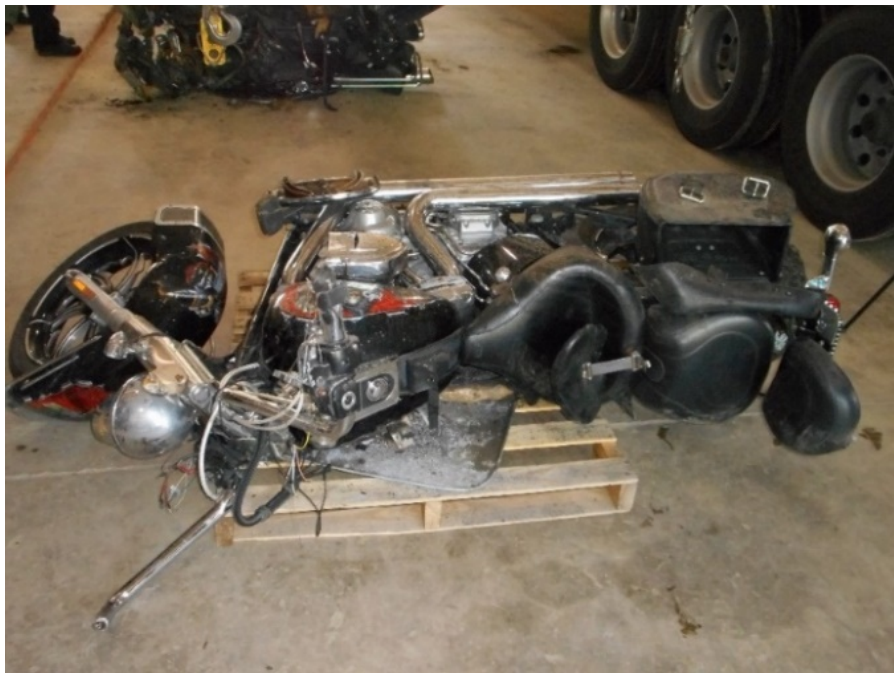
The left handlebar was sheared off as shown in **Figure 6**. The headlight assembly was broken, and the right mirror was torn from its mount. The throttle control on the right handlebar was broken. The right front turn signal was sheared off its mount. The right floorboard was displaced upward. The front fender was torn and deformed. The rear fender was also damaged and dented. The left rear turn signal was sheared off. The back of the passenger seat was displaced aft. The kickstand and gearshift were both sheared away from the frame. The left side of the transmission housing was fractured. The left rear saddle bag was torn and damaged.

**Figure 6.** Right side overhead view of 2006 Harley Davidson FLSTI.

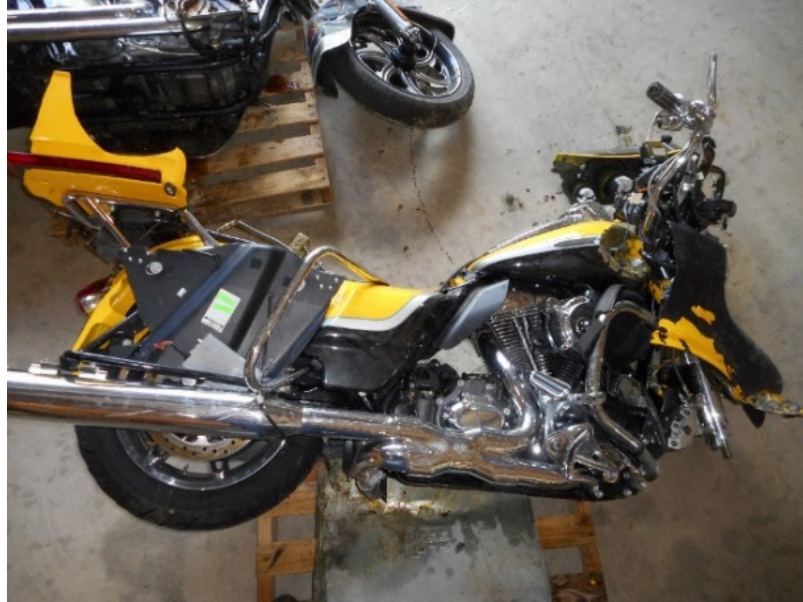
The front tire was missing from the motorcycle and the forks were fractured at the shock absorbers as shown in **Figure 7**. The instrument cluster was displaced from its mount. The handlebars were twisted and deformed. The right crash bar was displaced rearward and the right floorboard was displaced upward. All saddle bags were broken or displaced. The left front brake handle was twisted. The windshield was missing from the bike.

**Figure 7.** Right side overhead view of 2012 Harley Davidson FLHTKCUSE7.

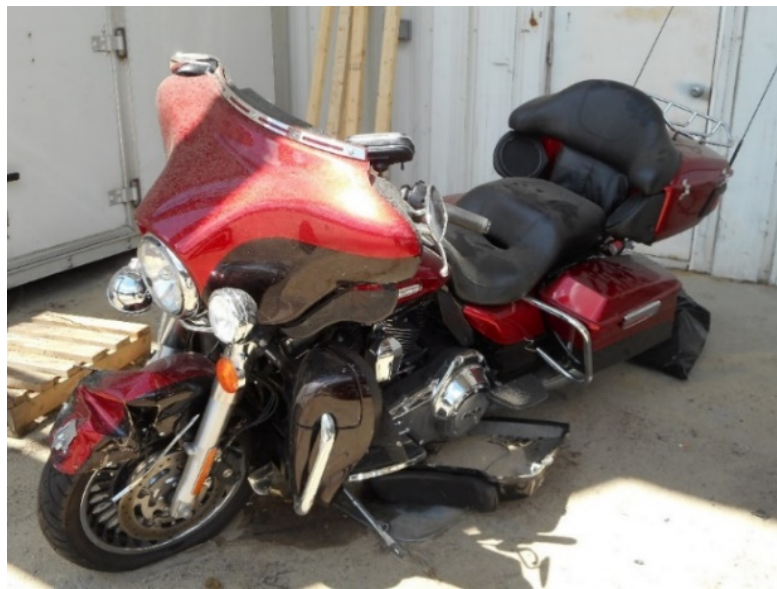
The motorcycle was missing its windshield as shown in **Figure 8**. The right front turn signal and light were broken away from their mounts. There was contact damage to the front fender and the front tire pressure was low.

**Figure 8.** Front left angle view of 2012 Harley Davidson FLSTI

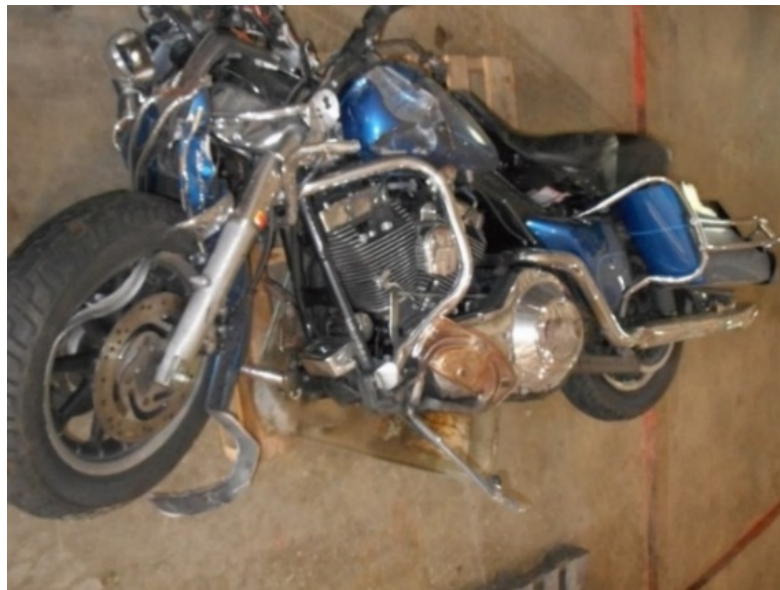
The front fender was torn and severely damaged. The left handlebar was sheared off and missing. The left floorboard was displaced upward and there was contact damage to the left and right sides of the fuel tank from the left floorboard. The left tail pipe was damaged. The seat was torn from its mount and the left saddlebag was fractured and missing the lid. The instrument cluster was torn away from the handlebars and missing. The headlight was missing, and both turn signals were torn from their mounts. The front rim was deformed, and the tire was flat as shown in **Figure 9**. The right floorboard was displaced upward. The clutch lever was missing, and the left crash bar was displaced rearward. The left side transmission case, muffler, and highway peg were scratched. The left rear turn signal was missing. The right-side saddle bag was damaged. The right rear passenger floorboard was deformed.

**Figure 9.** Overhead side view of 2005 Harley Davidson FLHTCU

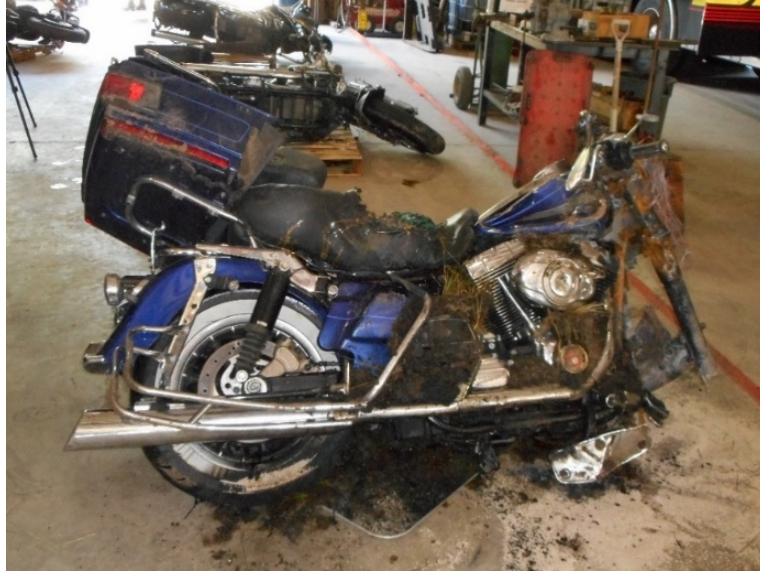
As shown in **Figure 10**, the front of this motorcycle sustained burn damage from the post-crash fire. The front tire and wheel assembly were fractured at the shock absorbers and were missing. The seat was partially melted. The rear tire sustained fire damage. The left crash bar was displaced inward to the frame. The left floorboard was displaced upward. The instrument cluster was burned to the point that only wiring was left. The motorcycle was missing its windshield. The rear passenger back rest was torn from the bike. All saddle bags were broken. The fuel tank was damaged. Both handlebars were sheared from the frame.

**Figure 10.** Right side view of 2007 Harley Davidson FLHTCU.

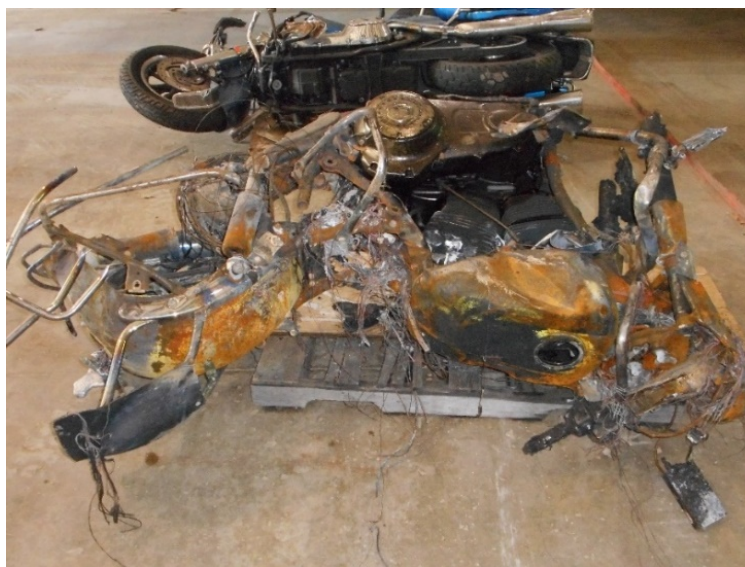
This motorcycle was severely damaged in the crash and the post-crash fire as shown in **Figure 11**. It was missing its front tire and wheel assemble entirely. The forks were sheared off at the shock absorbers. The instrument cluster was burned to the wires. There was damage to all sides of the fuel tank. The seat was consumed in the fire. Both side crash bars were displaced and deformed. The rear tire was consumed in the fire.

**Figure 11.** Overhead view of left side of 2012 Harley Davidson FLHTK EL.

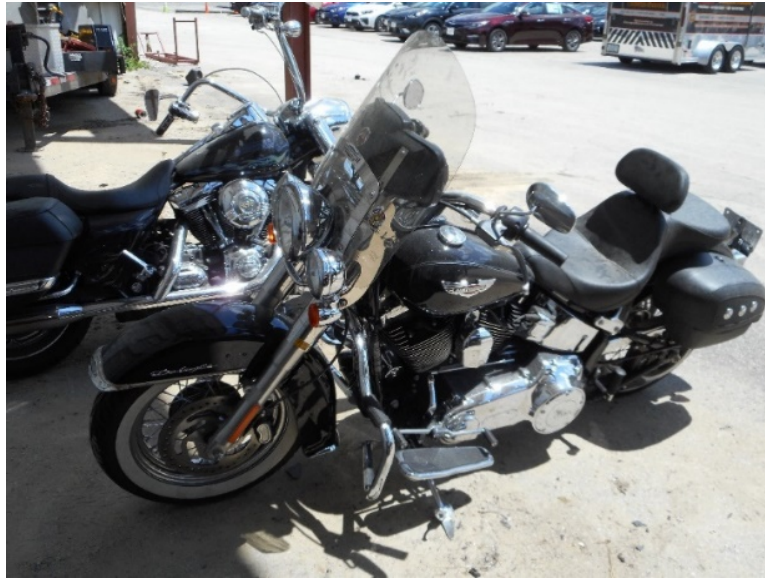
There were minor scrapes to the right brake handle and right crash bar. As shown in **Figure 12**, the headlight lens, windshield, right saddle bag, and right mirror also sustained minor scrapes. There was a minor dent in the front fender.

**Figure 11.** Left side view of 2015 Harley Davidson FLST.

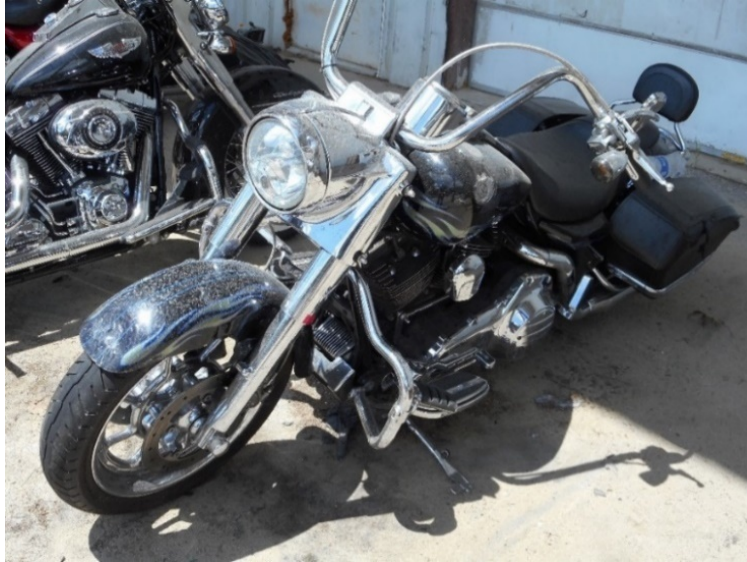
The left clutch handle sustained bent. The left side of the fuel tank had a dent and scratches. There was damage to the front fender and a dent in the headlight area. The handlebars were twisted out of position and had several scrapes on the right handlebar. The clutch cable was torn. The left foot peg was displaced inward. The left rear saddle bag was damaged. **Figure 13** shows the damaged 2007 Harley Davidson FLHRSE3 at the tow facility.

**Figure 13.** Front left angle view of 2007 Harley Davidson FLHRSE3.
