**Reconstruction Group Attachment
Mecanica Scientific Services Report**

Avenal, CA

HWY21FH003
(9 Pages)

RE: Avenal, CA (HWY21IH003) 9-Fatal, 2013 Dodge Journey EDR Imaging

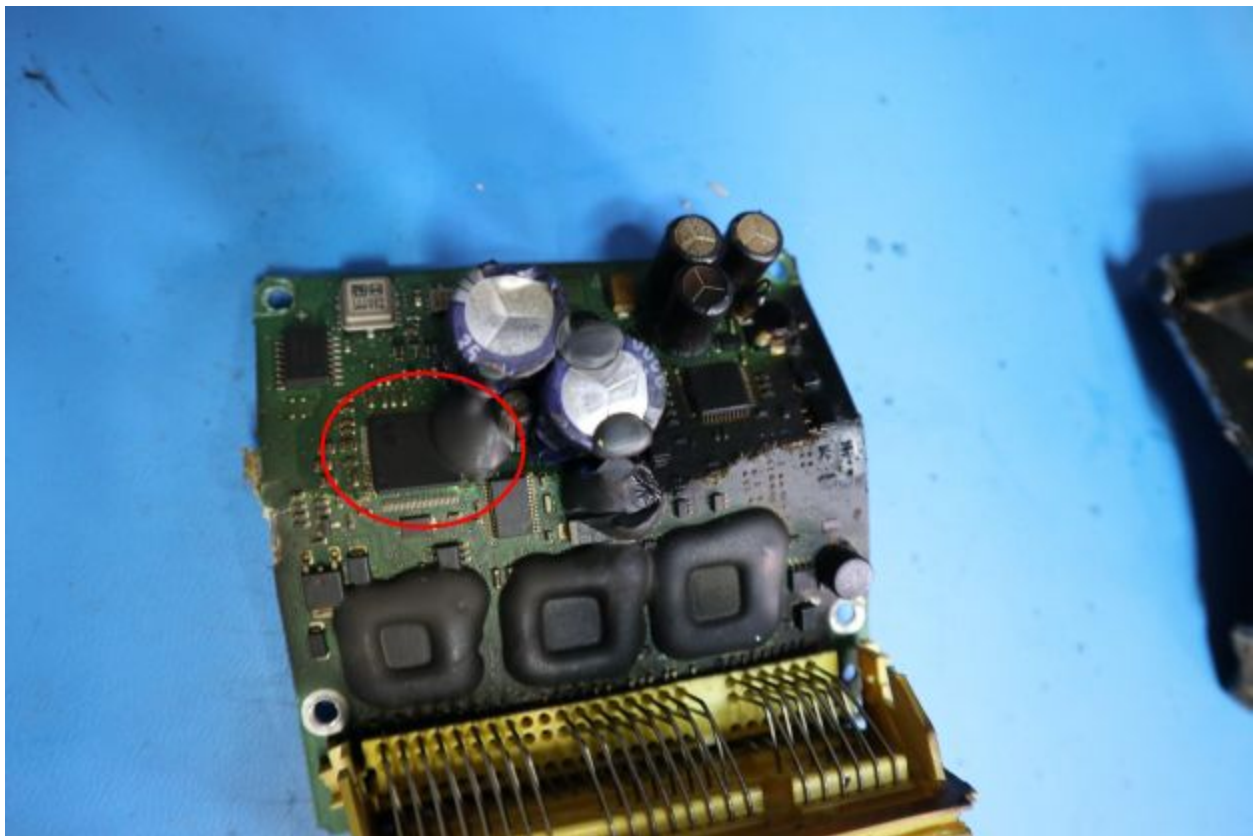
Figure 1

A Zoom video teleconference was initiated between Mecanica and the NTSB to allow viewing of the process. Sgt. Kolter removed the involved ACM from the evidence bag. The ACM, which has been previously documented, was examined by Mecanica staff. The outer casing was opened to expose the printed circuit board (PCB) within. There was a crack across the entire circuit board, which disconnected one chip from its input legs (circled in Figure 1). The probable chip that was suspected to carry the EDR data (circled in Figure 2) was then removed from the PCB and inserted into the location on the exemplar PCB (Figure 3, 4)

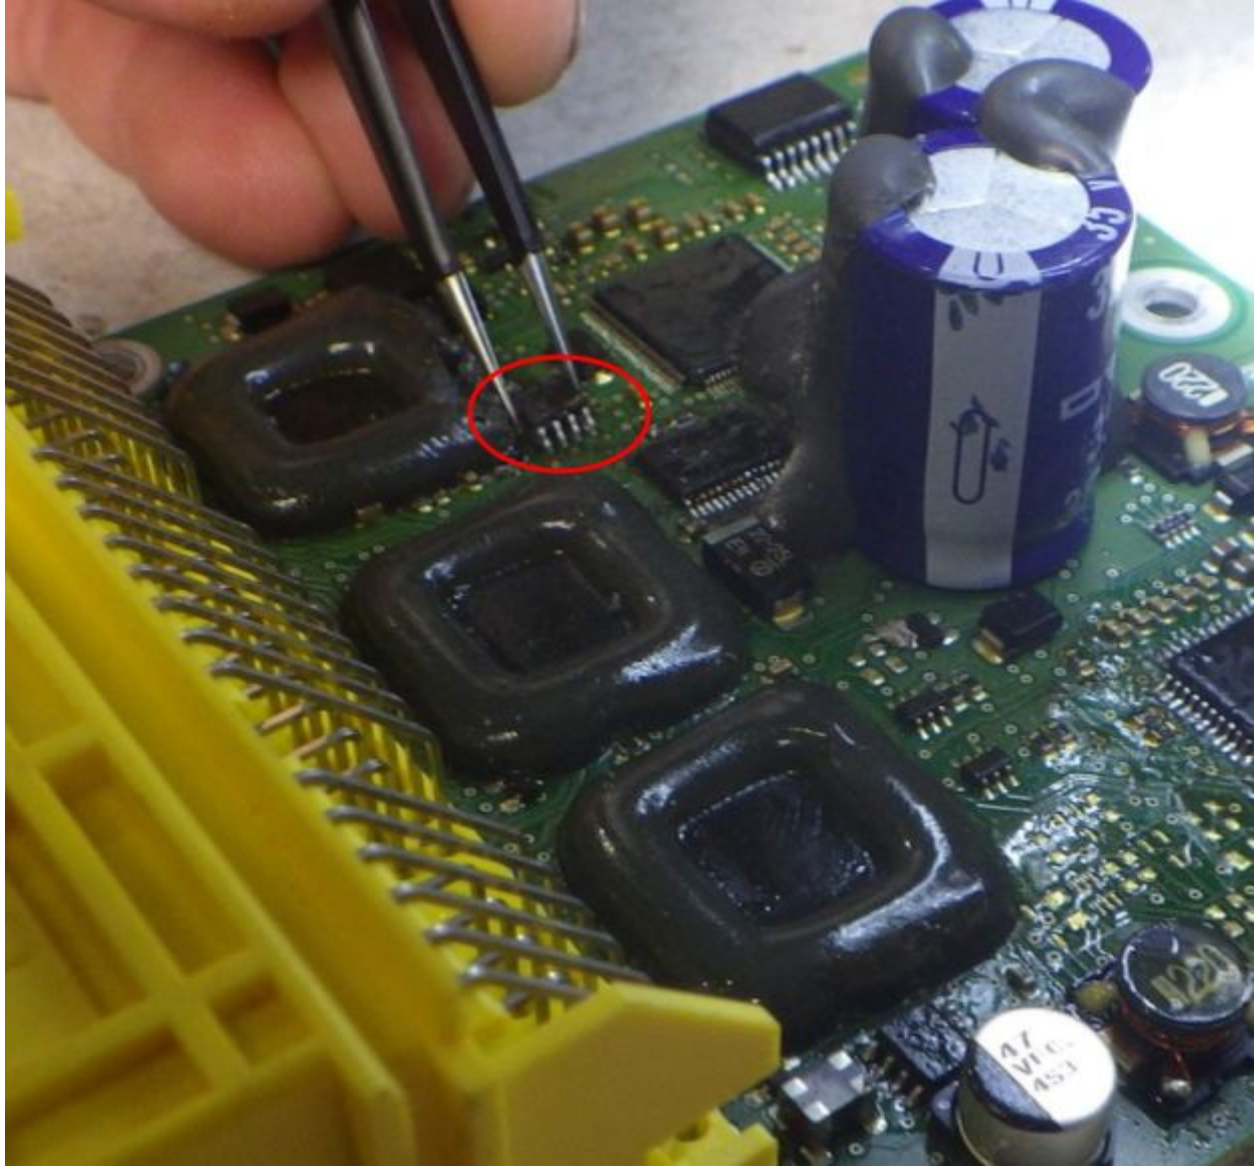
Figure 5

It was necessary to pull various suspected chips to determine which chip contained the EDR data. After removal of the chips, it was determined that the 8-pin chip (Figure 5) for this module was the EDR EEPROM that contained the EDR data. This was accomplished by removing the 8-pin chip from one exemplar and installing it to the second exemplar, then imaging the data to confirm that data was in fact consistent with the swapped chip. The 8-pin chip was then removed from the incident module PCB (Figure 6) and was placed onto the exemplar PCB (Figure 7).
