NATIONAL TRANSPORTATION SAFETY BOARD OFFICE OF HIGHWAY SAFETY WASHINGTON, D.C.

SURVIVAL FACTORS GROUP CHAIRMAN'S FACTUAL REPORT

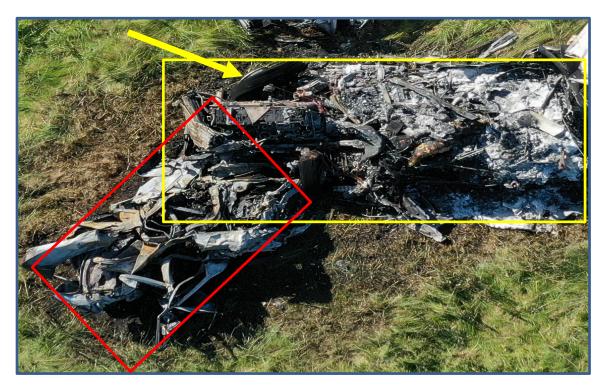
The 2013 Freightliner truck-tractor was destroyed by the collision and post-crash fire. The 2017 Utility semitrailer also sustained severe collision damage and damage from post-crash fire. **Figure 1** shows an overhead view of the remains of the Freightliner truck-tractor and the Chevrolet Malibu at the scene. The yellow box provides an approximate outline of the truck-tractor, and the yellow arrow indicates the right-front wheel. The red box provides an approximate outline of the Chevrolet. The occupant compartment of the Freightliner was destroyed, and an inspection of the debris was not conducted.

Figure 1. Overhead view of the Freightliner truck tractor, outlined in the yellow box, with the left-front portion in contact with the Chevrolet Malibu, outlined in red box. [source: WSP]

The 1999 Chevrolet Malibu sedan was destroyed by the collision and post-crash fire. It remained engaged with the 2013 Freightliner post-crash, as shown in figure 1. The entire vehicle was completely destroyed. The WSP Limited Reconstruction Analysis provided a photograph of the Malibu from an alternate angle that is shown in figure 1, see **Figure 4**.

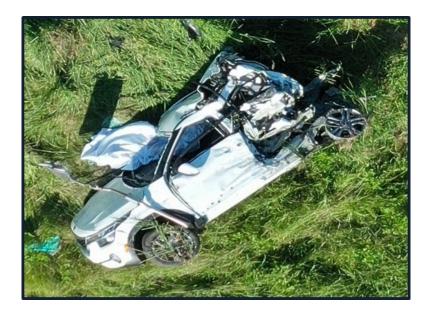
The 2021 Kia Seltos SUV sustained severe damage from a rear impact which crushed the aft half of the vehicle, as shown in **Figure 2**. The vehicle came to rest after rolling onto its right side.

Figure 2. Overhead view of the left side of the Kia, which is rolled onto its right side. [source: WSP]

Photographs reveal that while the front seating area appears generally intact, extensive damage is evident from broken windows and the deformed roof, extending throughout the occupant compartment.

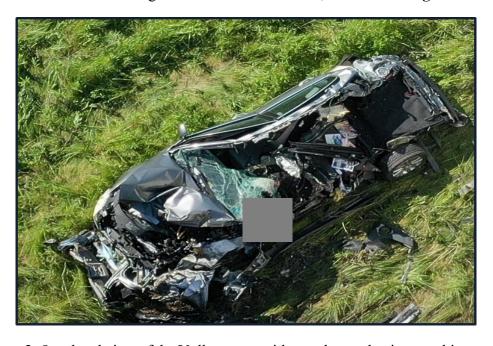
The 2006 Volkswagen Passat sedan was destroyed by the collision with the roof torn off of the vehicle and severe damage to the left side and front, as shown in **Figure 3**.

Figure 3. Overhead view of the Volkswagen with grey box redacting graphic content. [source: WSP]

Survivable space throughout the occupant compartment appears to have been compromised due to intrusion.

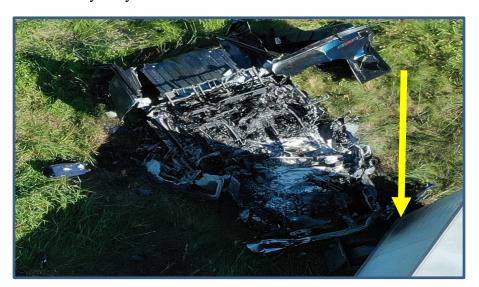
The 2018 Ford F150 pickup was destroyed by the collision and post-crash fire as shown in **Figure 5**. The left front corner of the pickup was in contact with the left-rear drive axle of the 2013 Freightliner, as indicated by the yellow arrow.

Figure 5. Overhead view of the Ford pickup at its final rest position, with the left-front corner in contact with the left-rear drive axle of the Freightliner. [source: WSP]

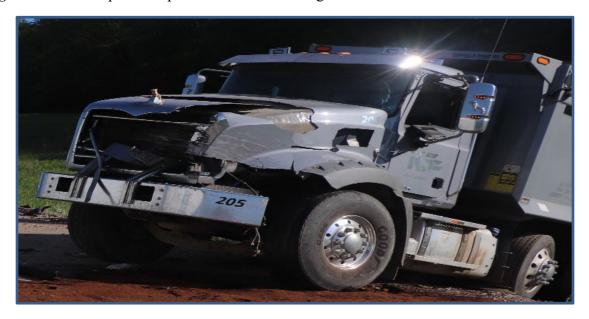
The 2018 Mack dump truck sustained damage to the front hood and grill as shown in **Figure 6**. The occupant compartment was not damaged.

Figure 6. Left-front view of the Mack dump truck. [source: WSP]

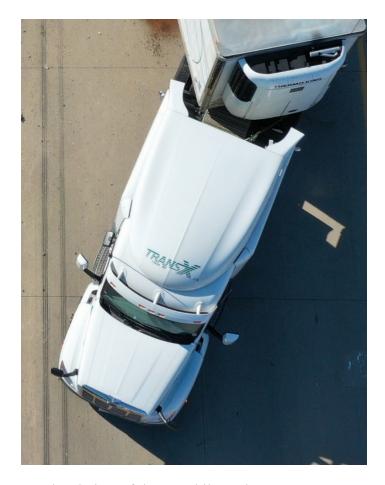
The 2020 Peterbilt 579 truck-tractor did not appear damaged, and the 2014 Utility semitrailer were damaged in the collision. **Figure 7** shows an overhead view of the truck-tractor. The vehicle was inspected by police. The WSP Driver Vehicle Examination Report No. WI2674000874 was conducted on June 12, 2020. The report indicated that the truck-tractor and trailer had a mechanical inspection and the trailer was placed out of service due to "disabling damage to sidewalls, lower railing, landing gear, and windguard." The truck-tractor did not appear damaged.

Figure 7. Overhead view of the Peterbilt truck-tractor. [source: WSP]
