# National Transportation Safety Board

RRD22LR012

## **SYSTEM SAFETY**

Group Chair's Factual Report

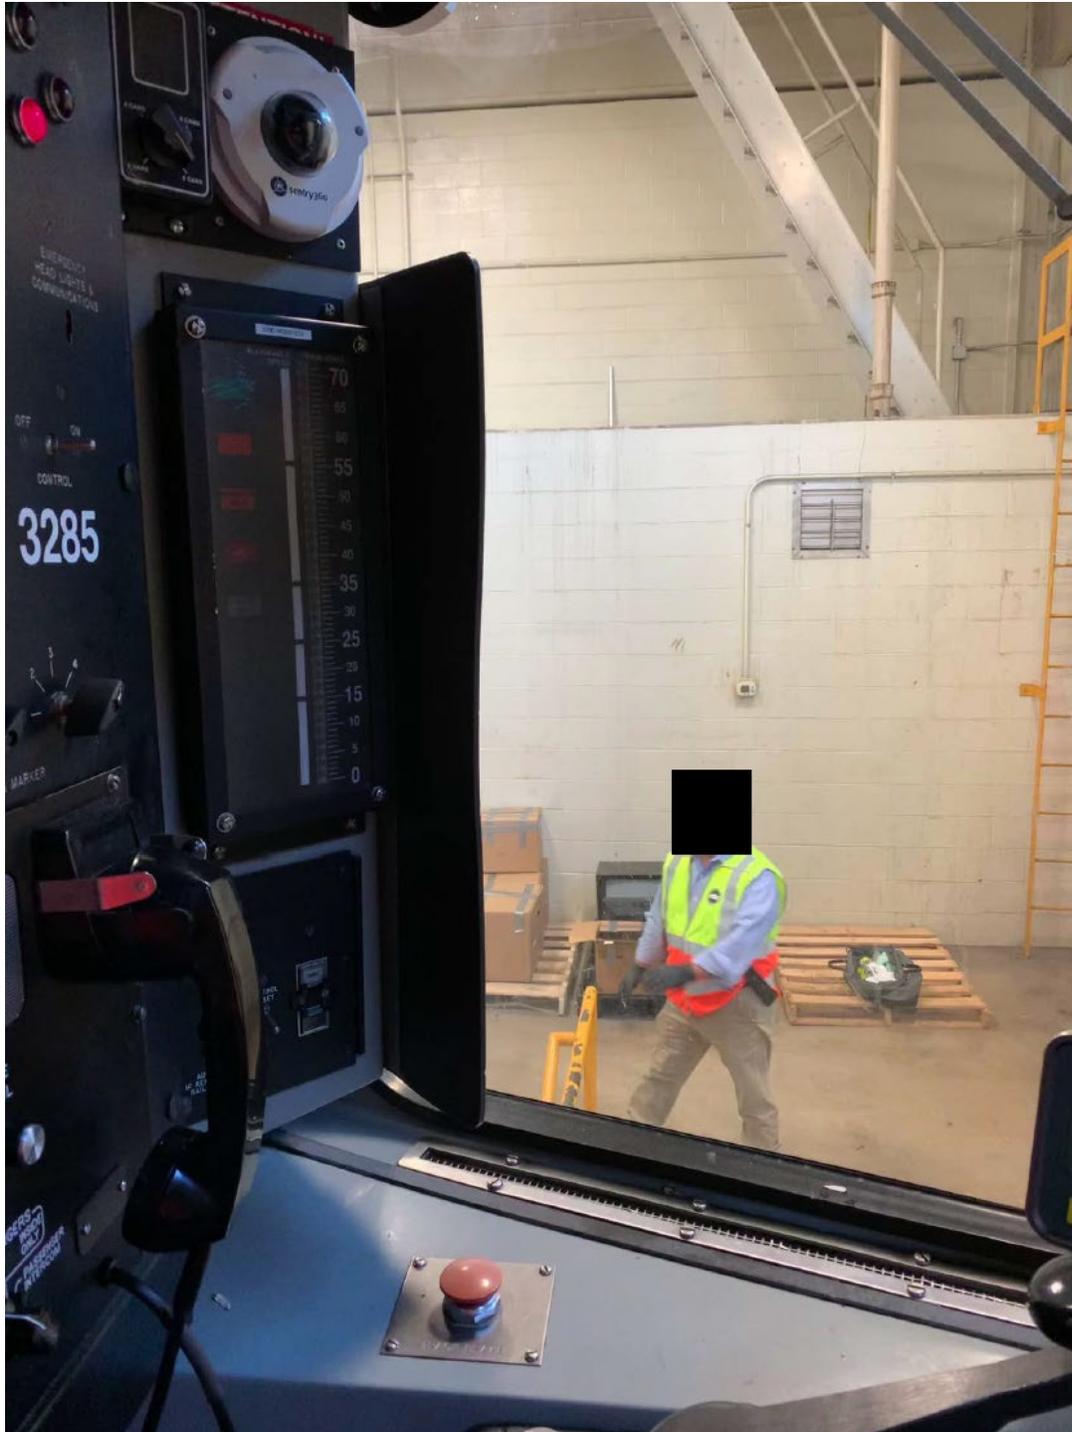
*Figure 3. Photograph of view looking out of accident train operator's cab. There is an instrument panel on the left side of the image, which contains a phone, several dials, lights, and an inward facing camera. The view out of the window on the right side of the image shows an employee and white brick wall. Photograph taken by NTSB.*

On the day of the accident, the train operator said that it was raining, and the wheels of the train were slipping and sliding. He indicated that he was cycling between coasting and using power, “concentrating” on controlling the train. He said that there was “a little bit of streaking” from the windshield wipers. He indicated that visibility could be improved with new wipers. He also indicated that brighter train headlights would improve visibility. Finally, he indicated that visibility “to the sides” of the train could be enhanced if the left side instrument control panel (“the partition”) was less obstructive and if the operator’s cab was “more open.”<sup>15</sup>

<sup>15</sup> Investigators examined the view out of the cab while the train was out of service. A photograph of this is shown on the next page.
