NTSB Investigation – Cal Train collision/ derailment Mach 10th, 2022, San Mateo, Ca

Data retrieved on March 11th, 2022

Main Track 2 – Mile Post 11.5

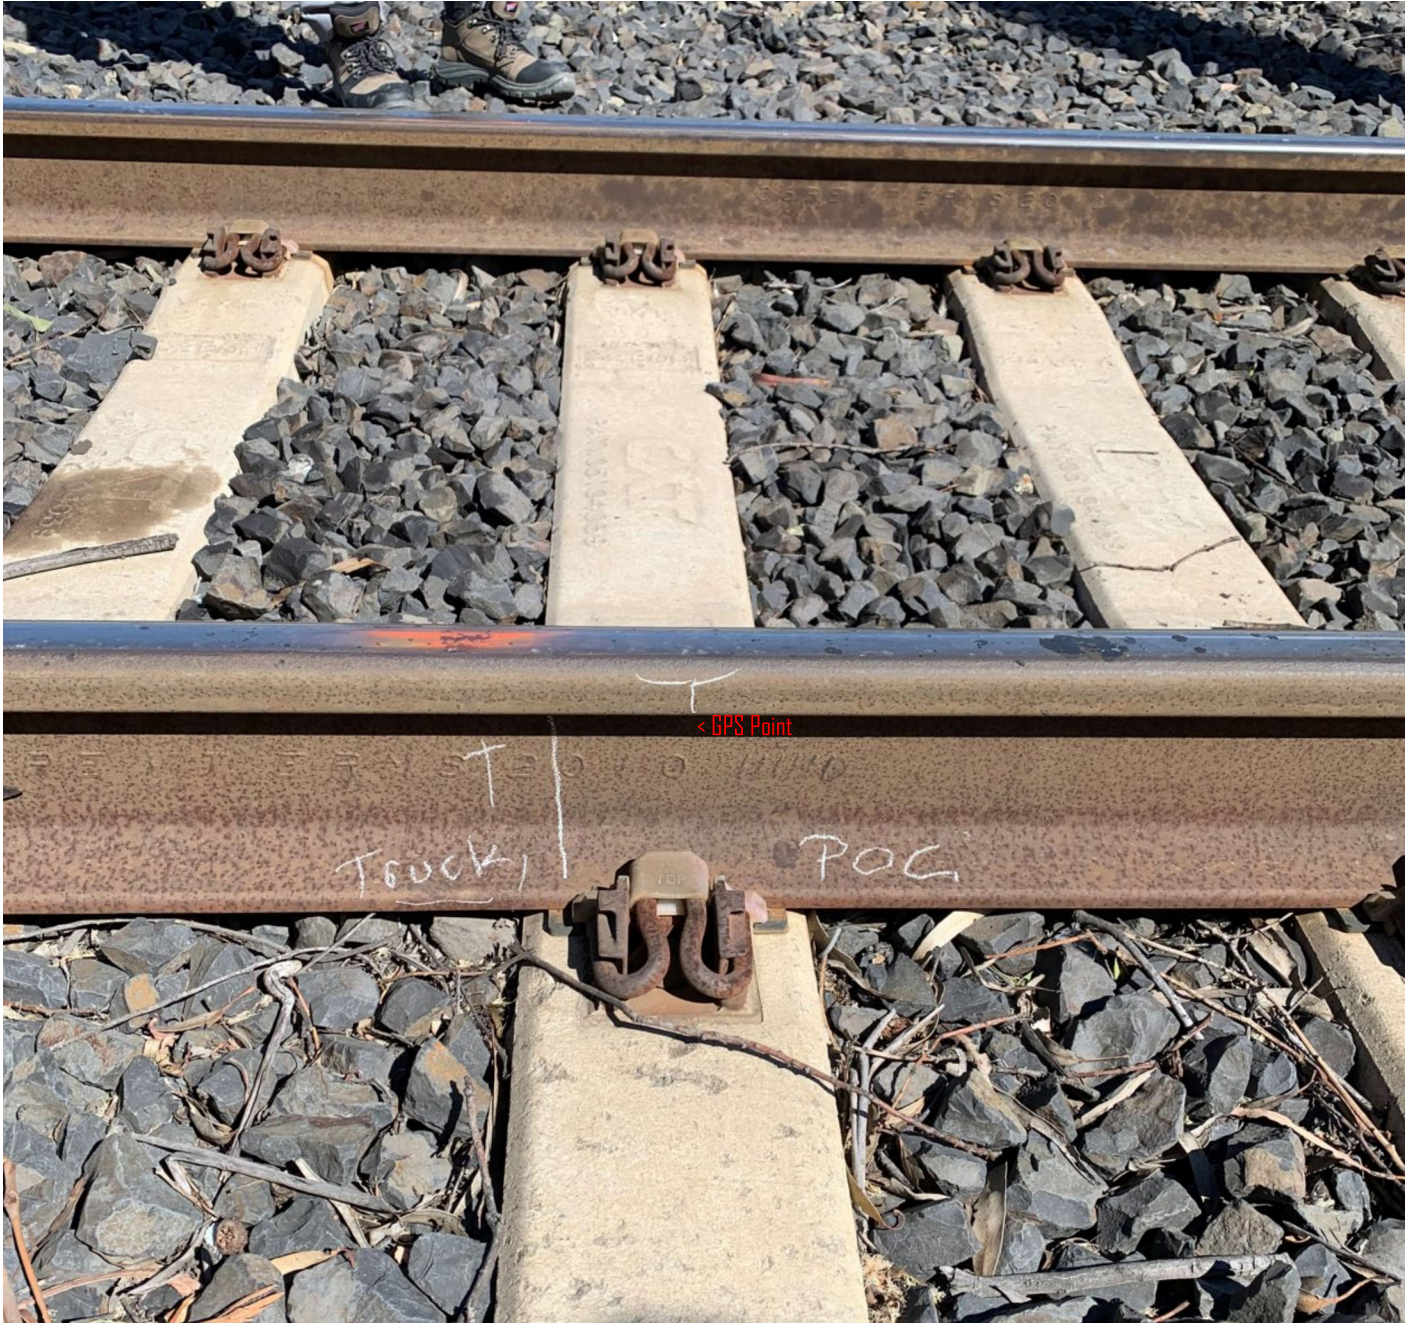
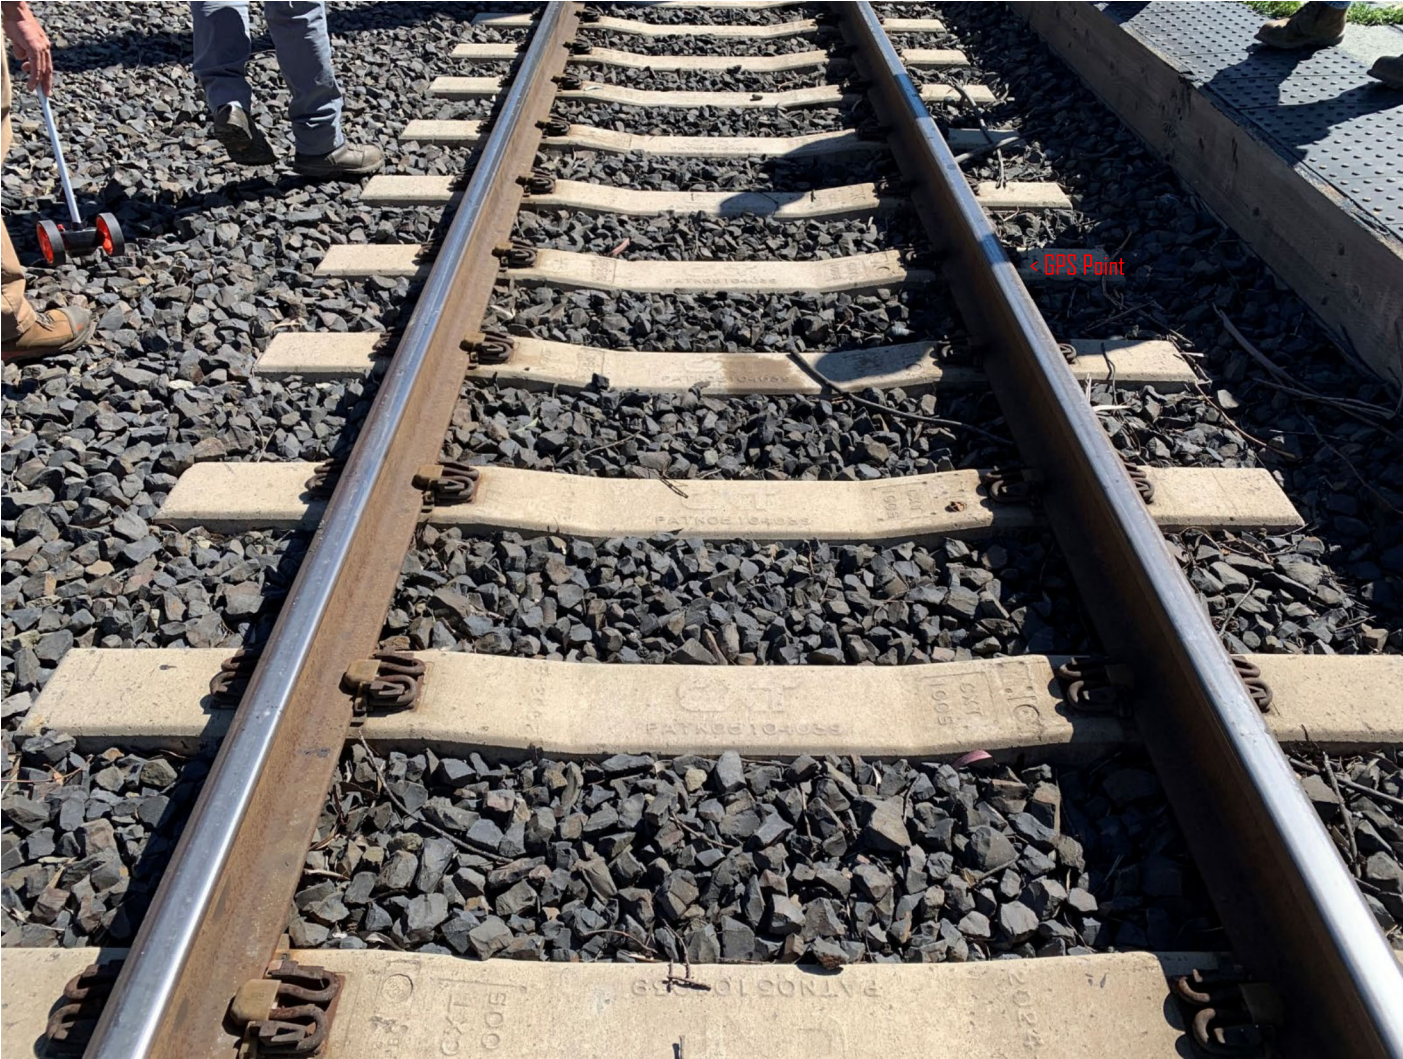
Point of collision

- Mile Post 11.69 / Main Track 2
- 37.62121*N / 122.40608*W

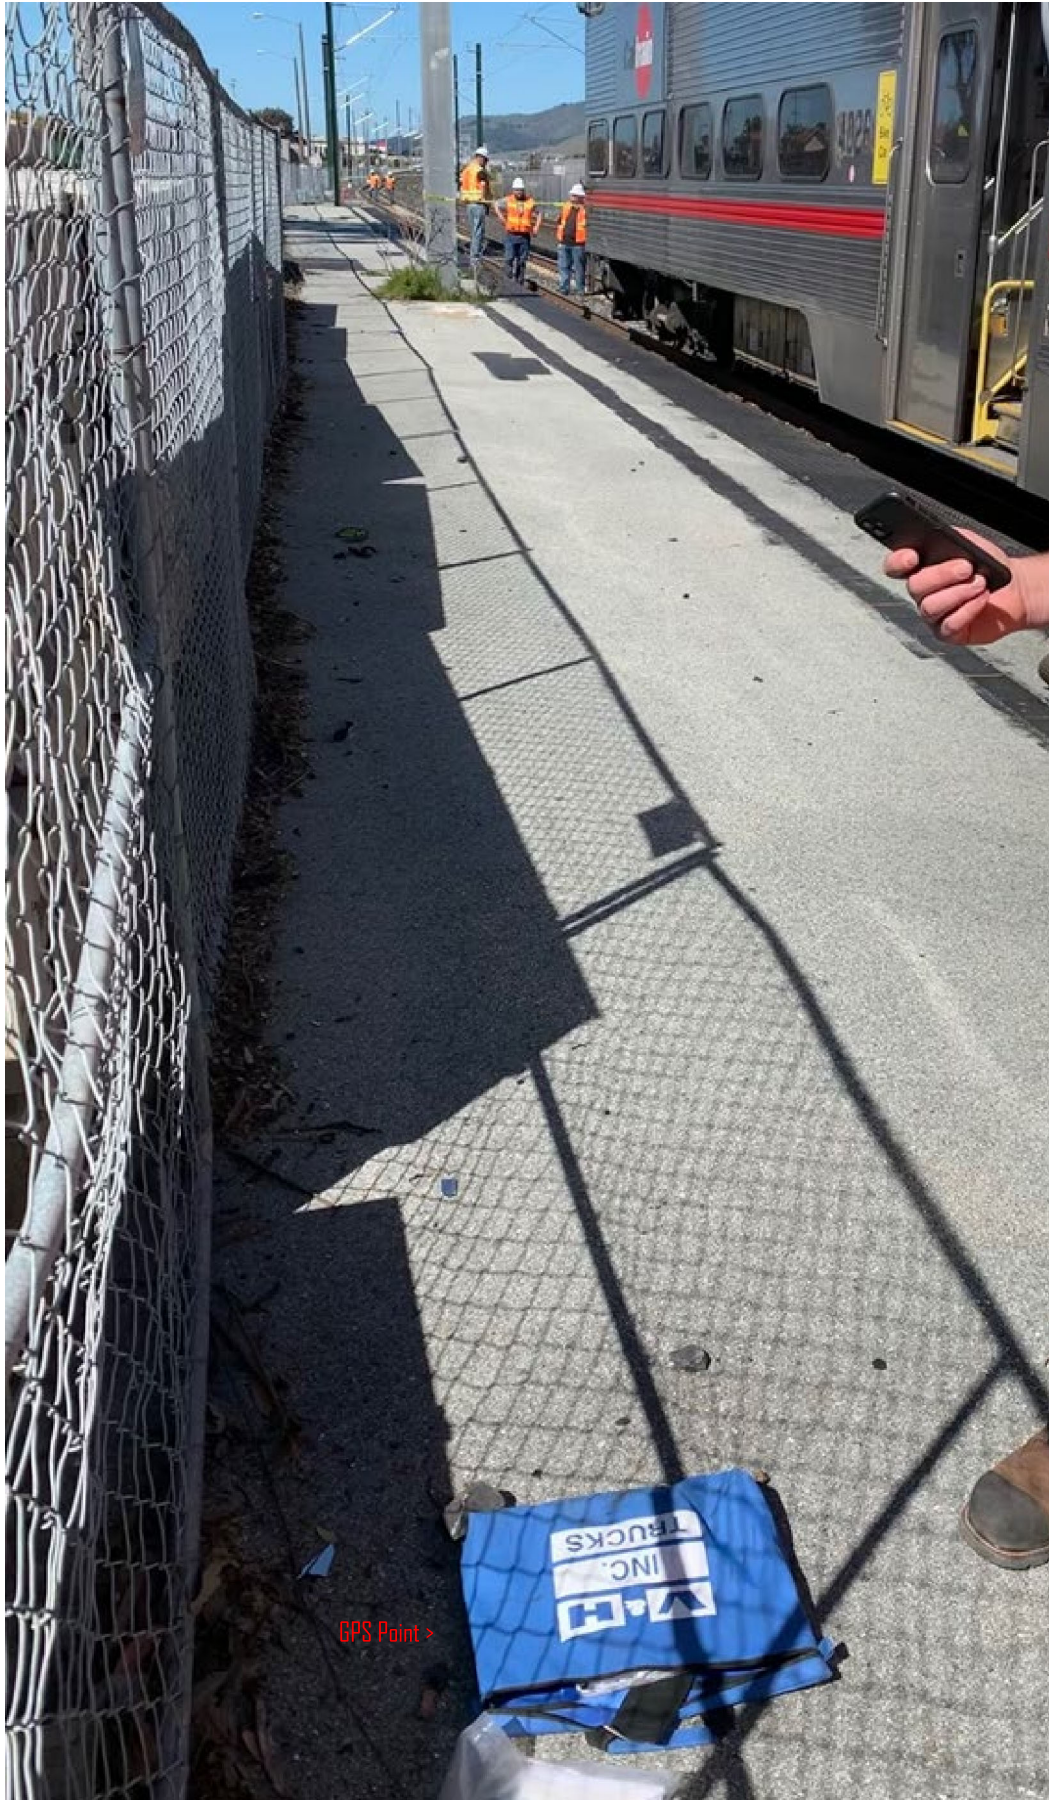
Harsco Blue bag from pickup truck

- 37.62101*N / 122.40598*W

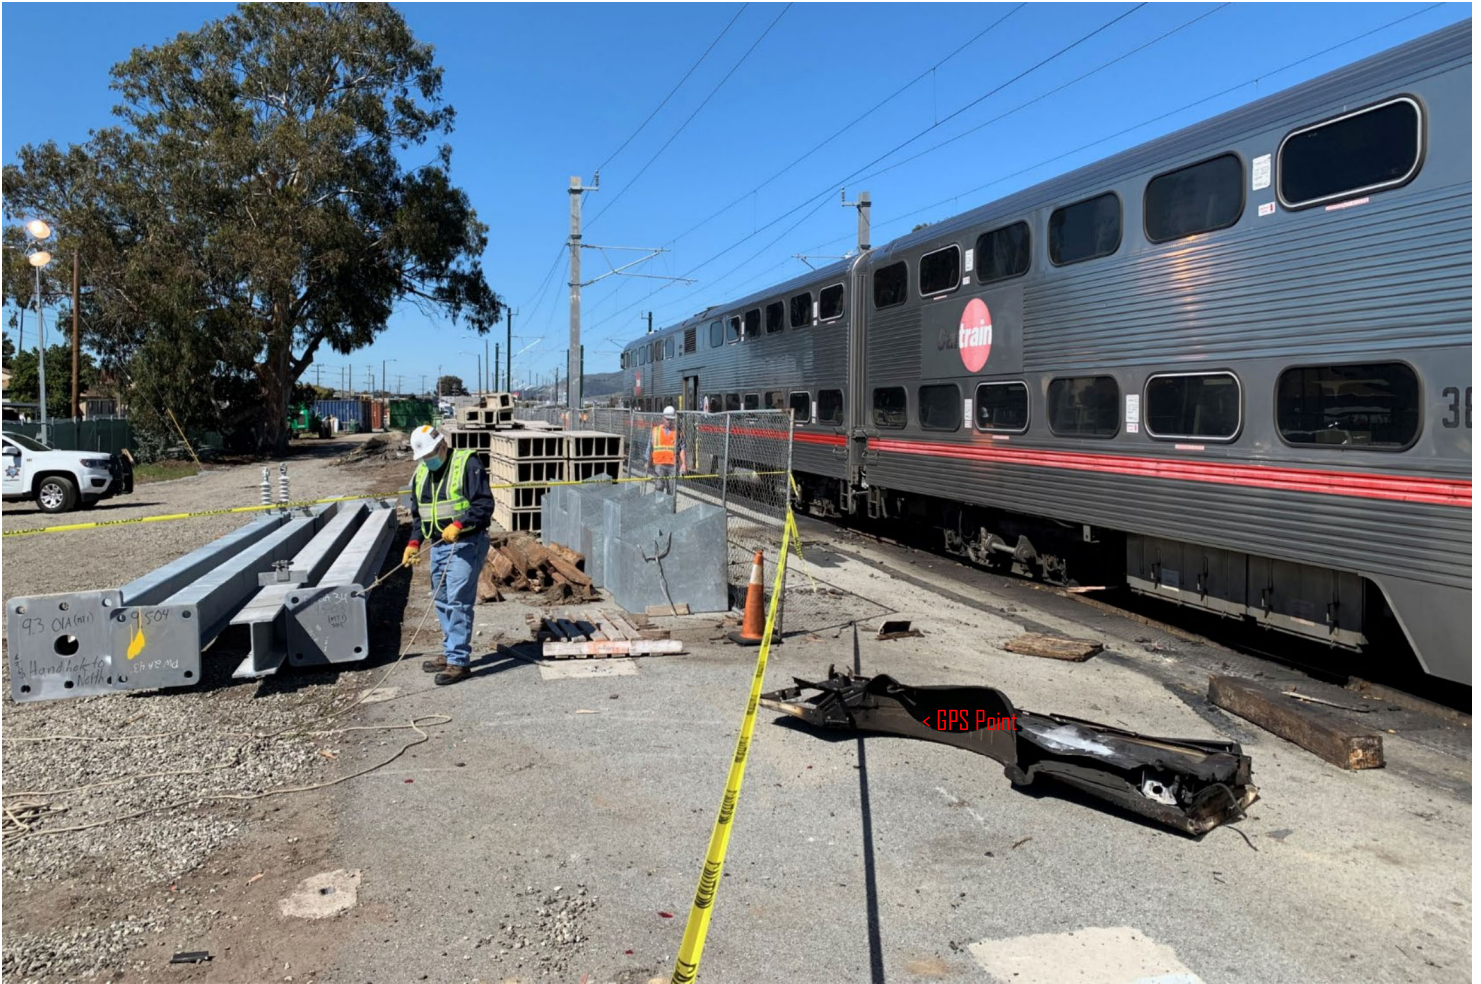
Driver's side Truck Bed panel

- 37.62086*N / 122.40591*W

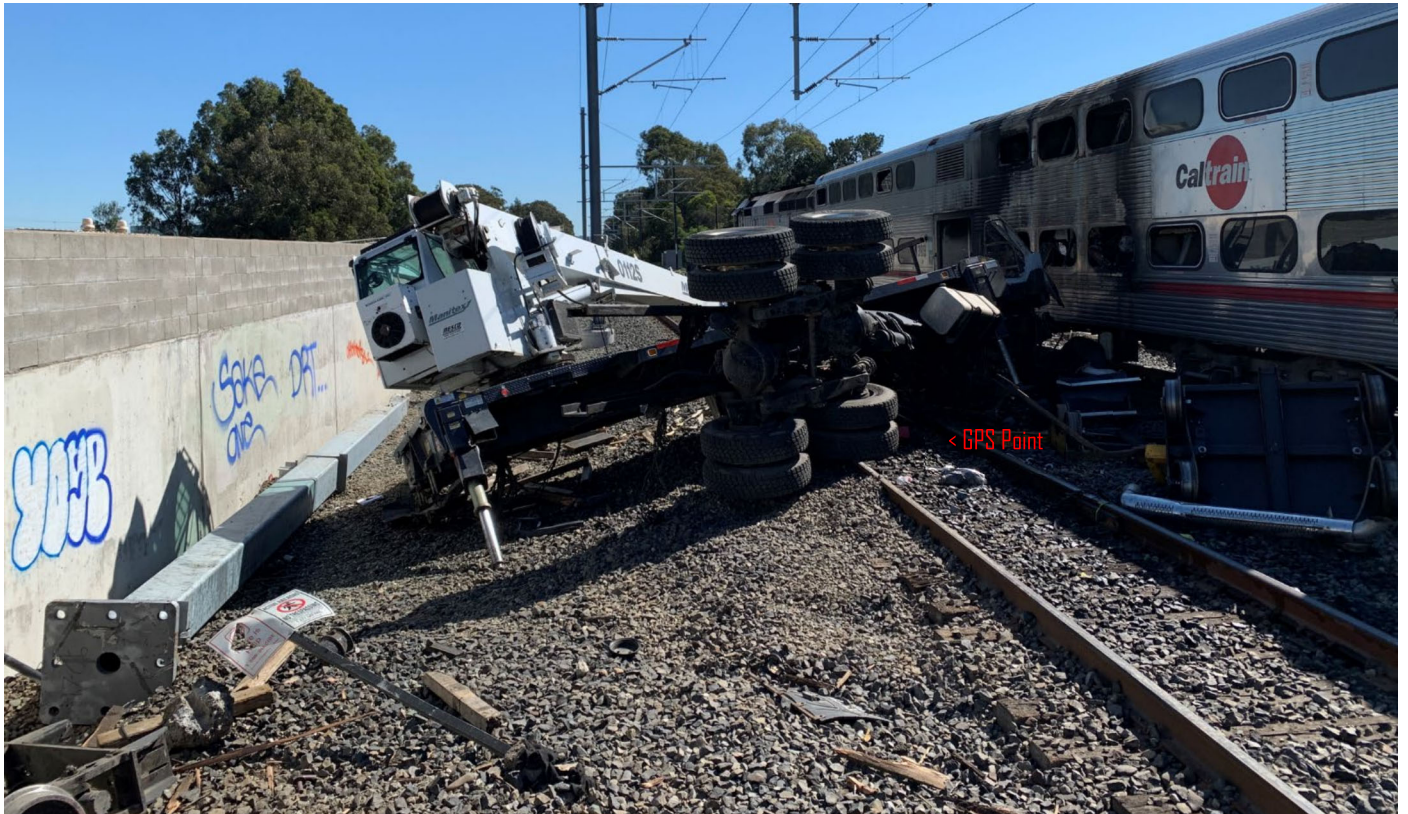
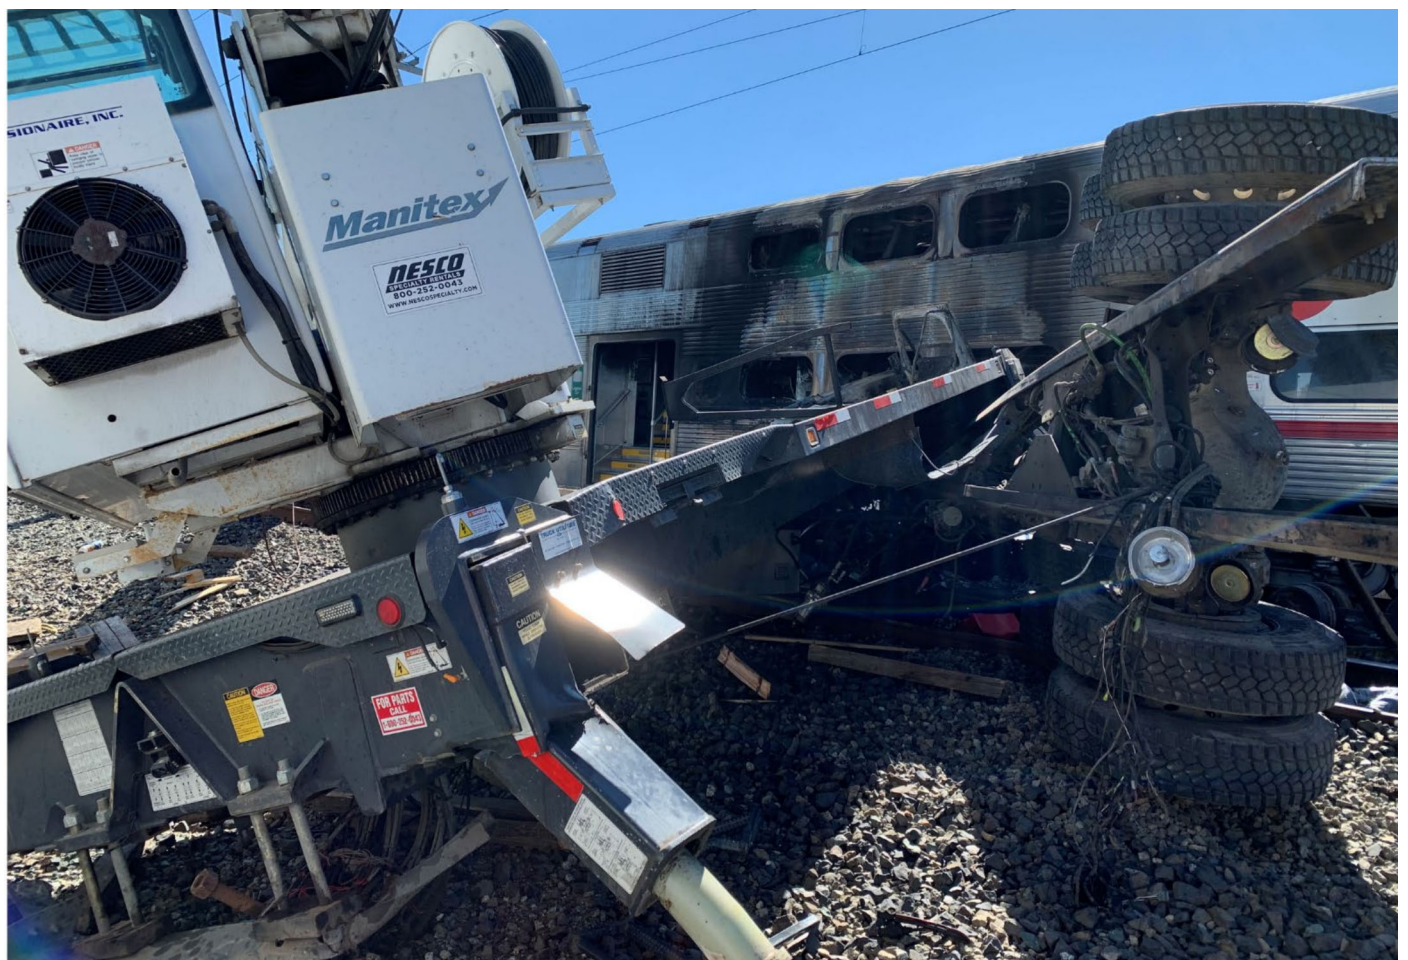
Northbound Facing Boom Truck

- 37.62034*N / 122.40516*W
- Main Track 1

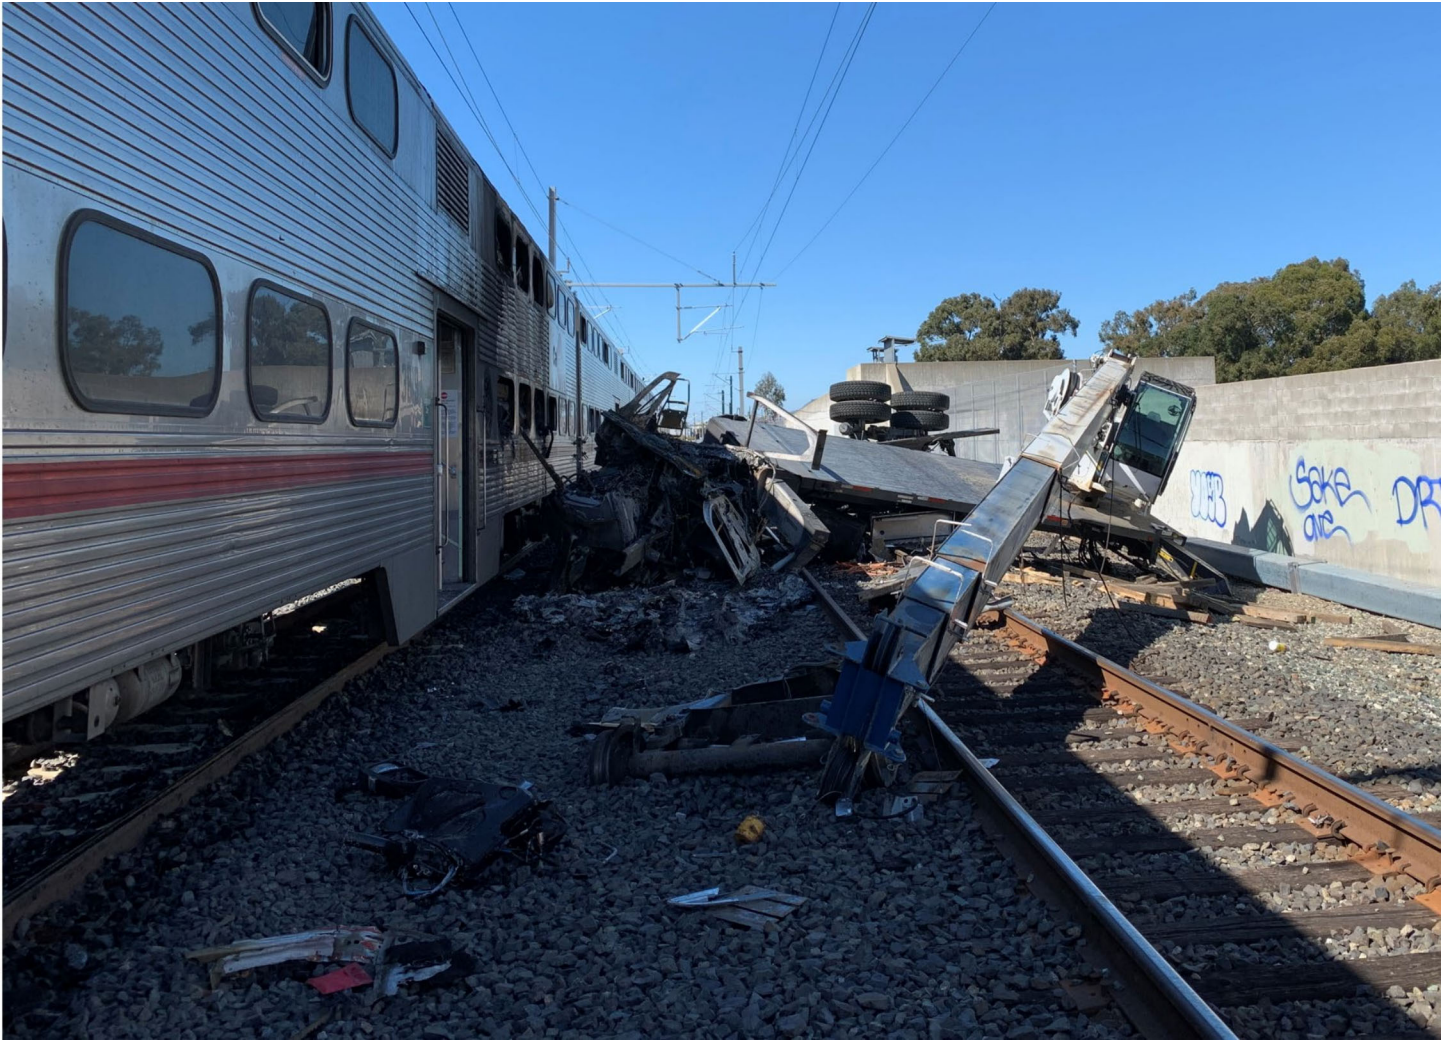
End of wreckage, facing Northbound

- 37.61996*N / 122.40516*W

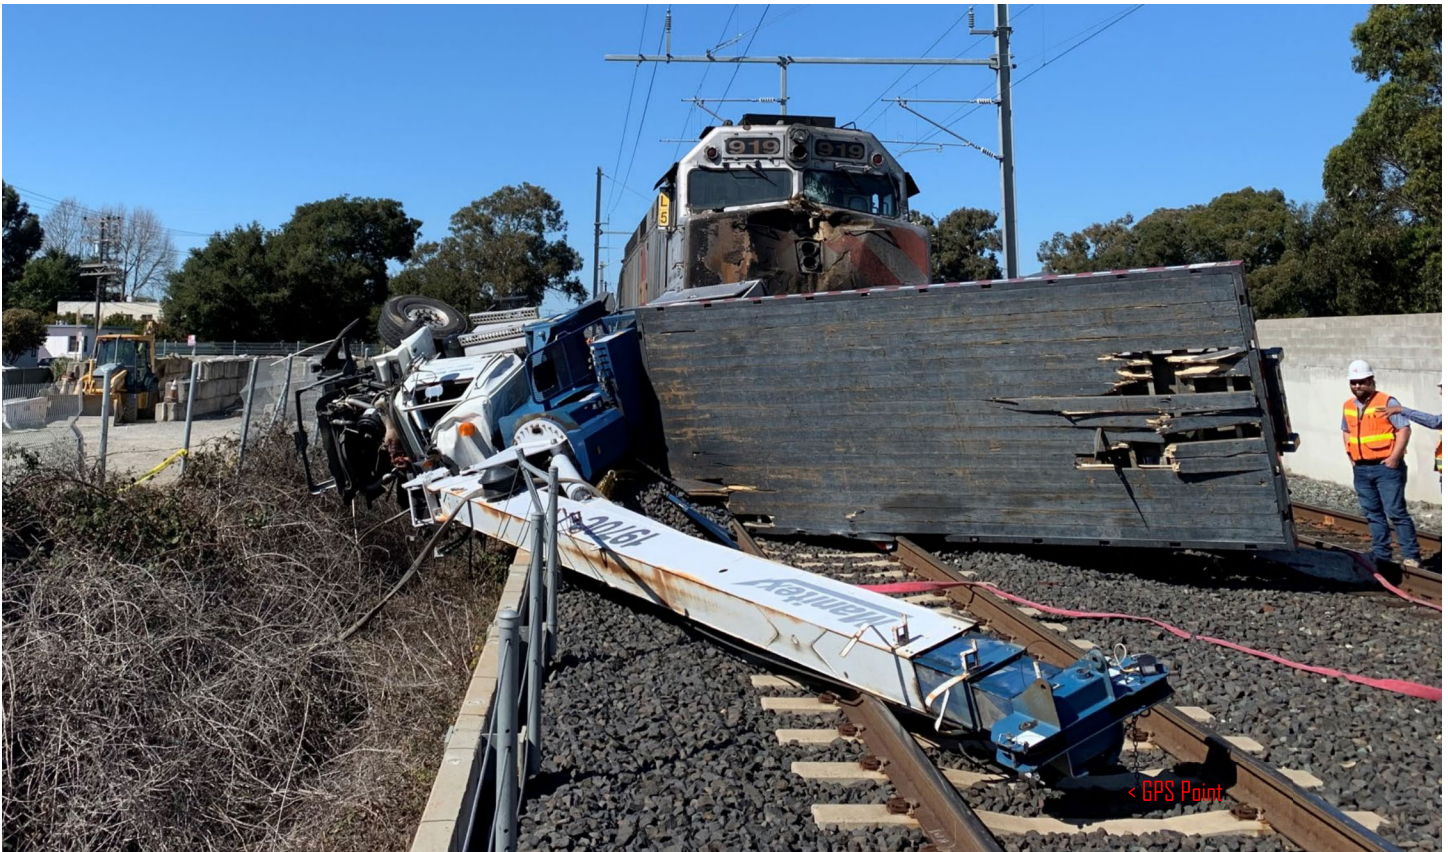
End of wreckage, Facing south

- 37.61996*N / 122.40516*W

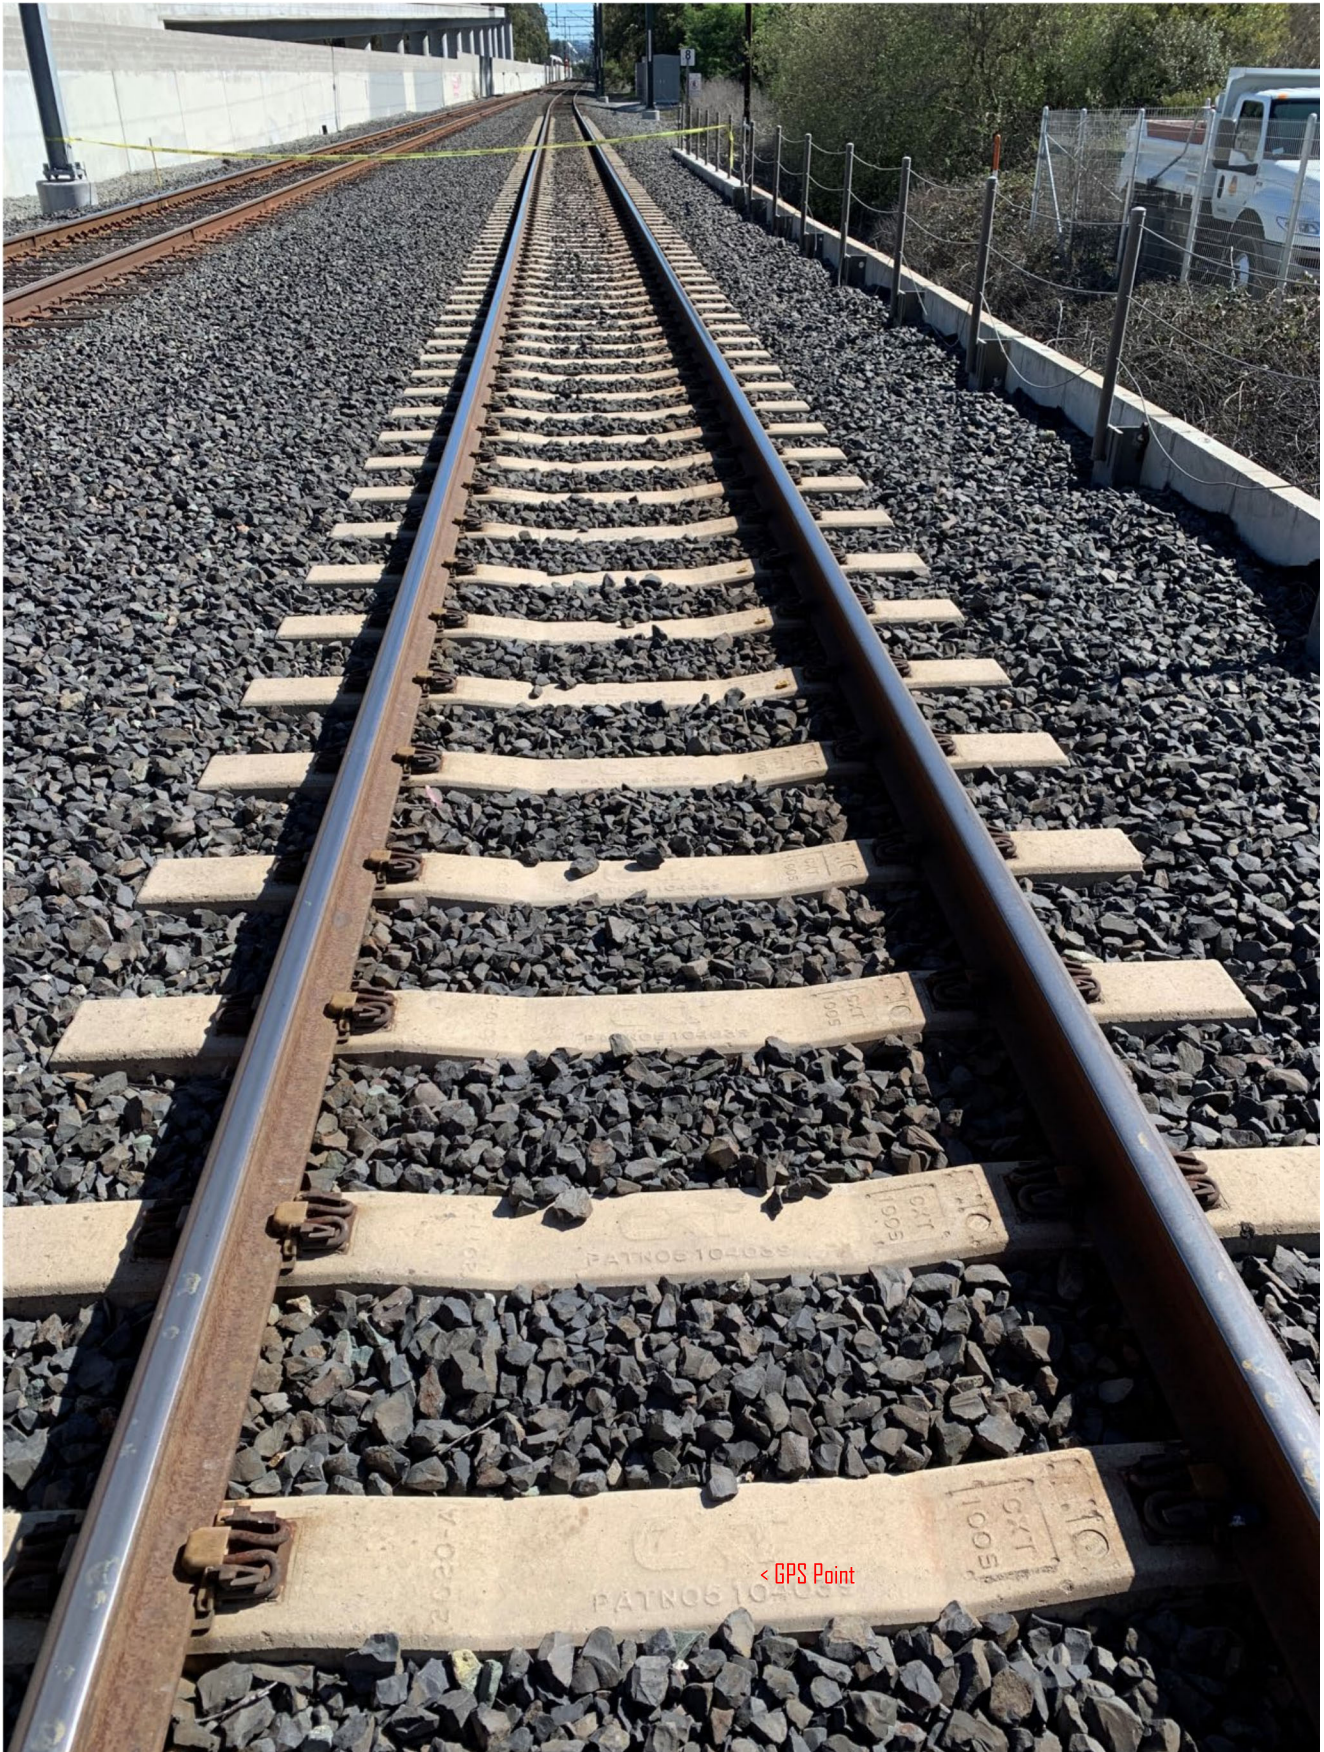
Southbound facing Boom Truck

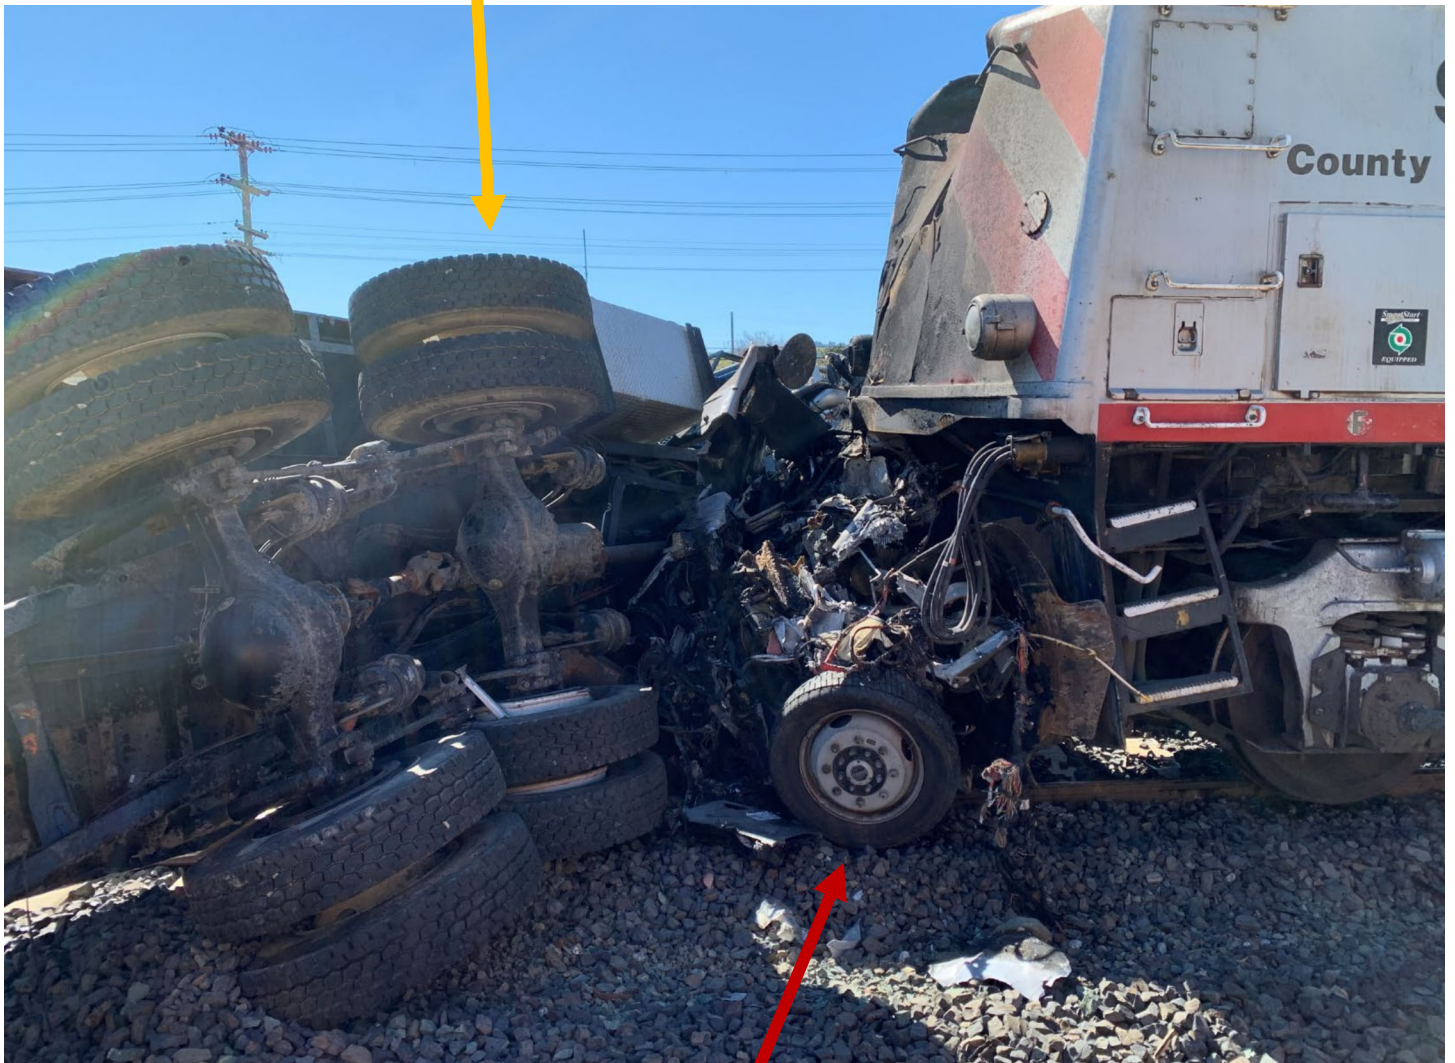
Northbound facing Pickup Truck
