TESLA INSPECTION FACTUAL ATTACHMENT 1 – FIRE RESPOSE AT TOW YARD, MARCH 28, 2018

Mountain View, CA

HWY18FH011

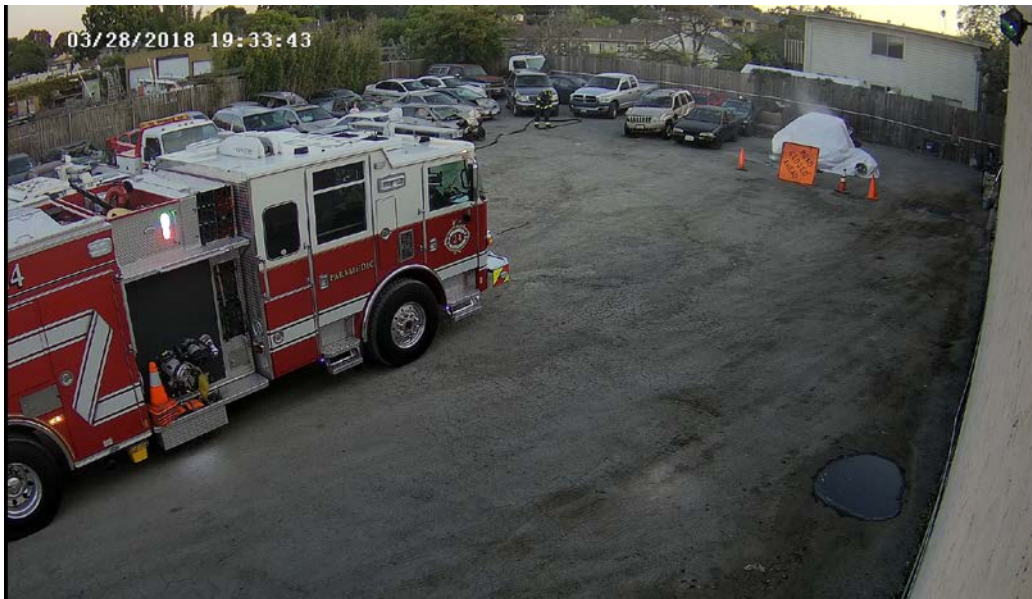
Figure 1. San Mateo Fire Department 24 at Atlas Towing lot. The Tesla Model X is beneath the white tarp at the upper right, partially concealed by a road sign. Prior to this, the Atlas Towing employees removed three vehicles from the lot.

- 19:00:42 Video shows first light traces of smoke from vehicle covered by a white tarp.
- 19:00:46 Atlas Towing employees work in lot without noticing the smoke.
- 19:02:06 Employees notice the smoke and clear the area of other vehicles.
- 19:14:01 San Mateo truck 24 arrives, as shown in Figure 1.

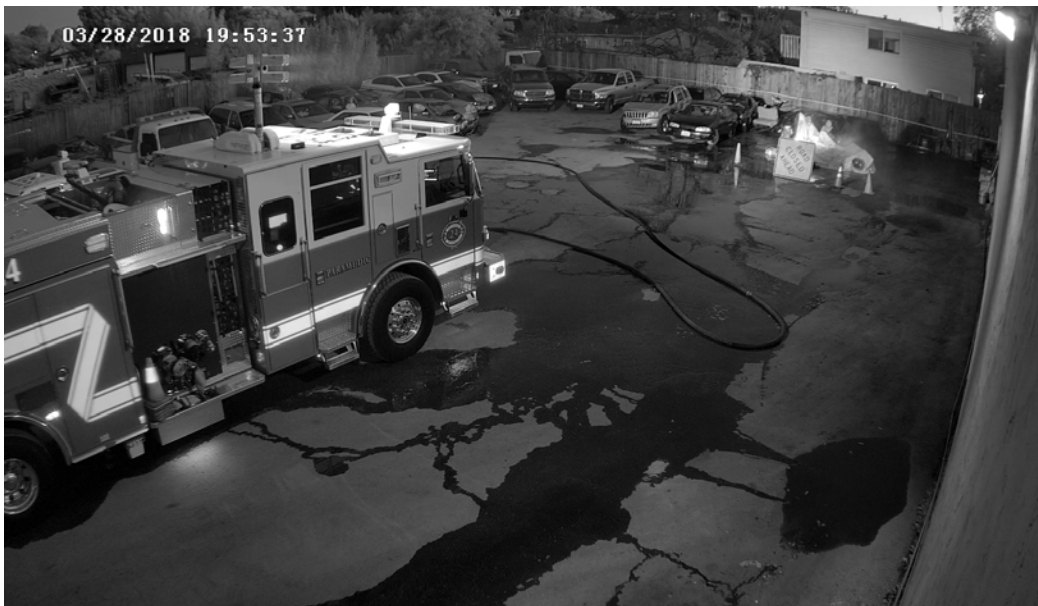
Figure 2. Security video recording of a San Mateo fire truck and Tesla Model X, the front of which is located in the upper right, behind a road sign. The vehicle is partially covered by a white tarp.

Note: With diminishing daylight, the video changed from color to black and white as shown in Figure 2.

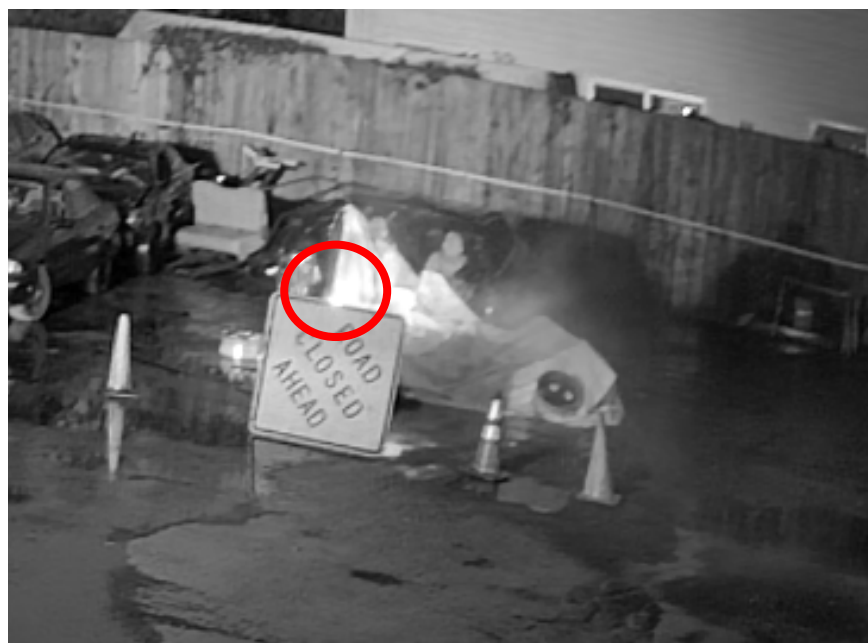
Figure 3. Cropped close-up of partially covered Tesla Model X with circle added around open flame.

Flame was visible at the front of the vehicle, as shown in Figure 3, and fire fighters applied water to suppress the fire as shown in Figure 4.

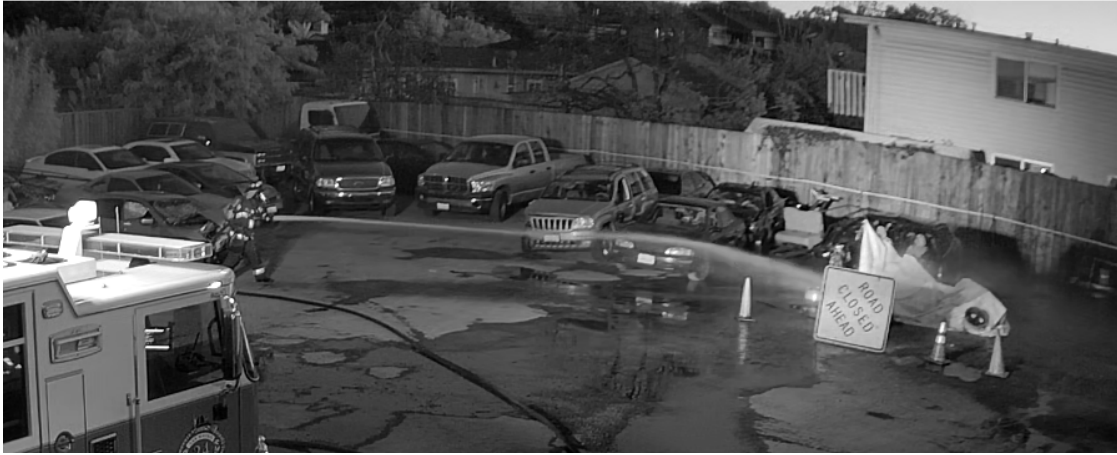
Figure 4. Fire fighter putting water on source of flame shows location at front right of vehicle.
