WPR22FA331

VIDEO SUMMARY

Location: Shafter, California
Date: September 2, 2022
Time: 1100 Pacific daylight time
Airplane: N5943, Yakovlev Yak-11

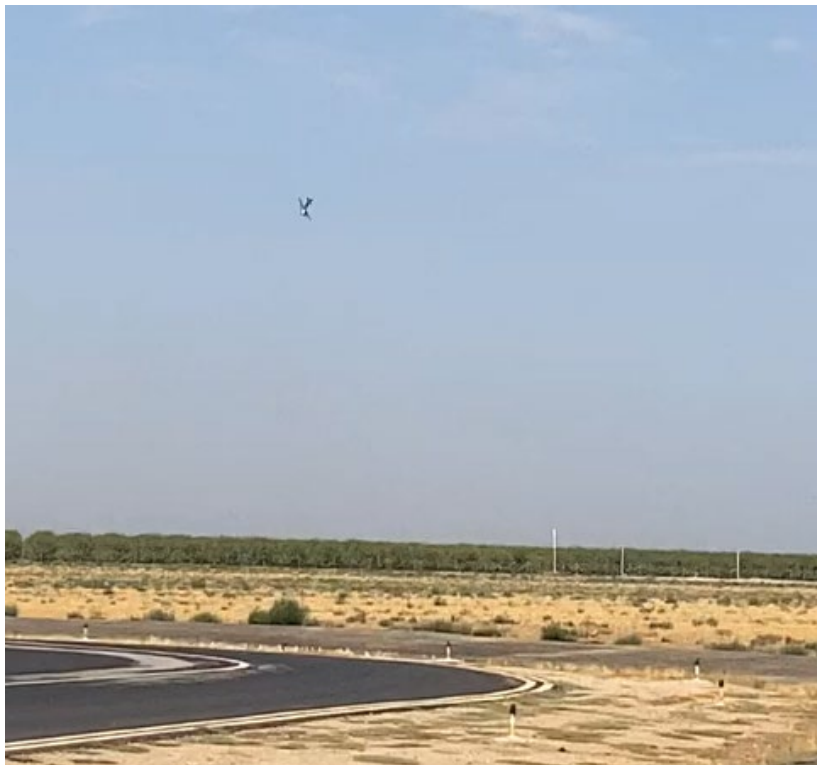
One witness captured a video of the final moments of the accident sequence located near the approach end of runway 12. Review of video showed that at the start of the recording, the airplane was descending rapidly while in steep nose low, left bank attitude (figure 1). The airplane began to roll to the right and pitch upward, until just prior to impact, when a slight left roll was observed. Throughout the video, the propeller was observed rotating.

Figure 1: A capture of the initial start of the witness provided video.
