NATIONAL TRANSPORTATION SAFETY BOARD

UAS Aerial Imagery Report

A. ACCIDENT WPR18MA087

Location: Peach Springs, Arizona
Date: February 10, 2018
Time: 1719 Local Time (MST)

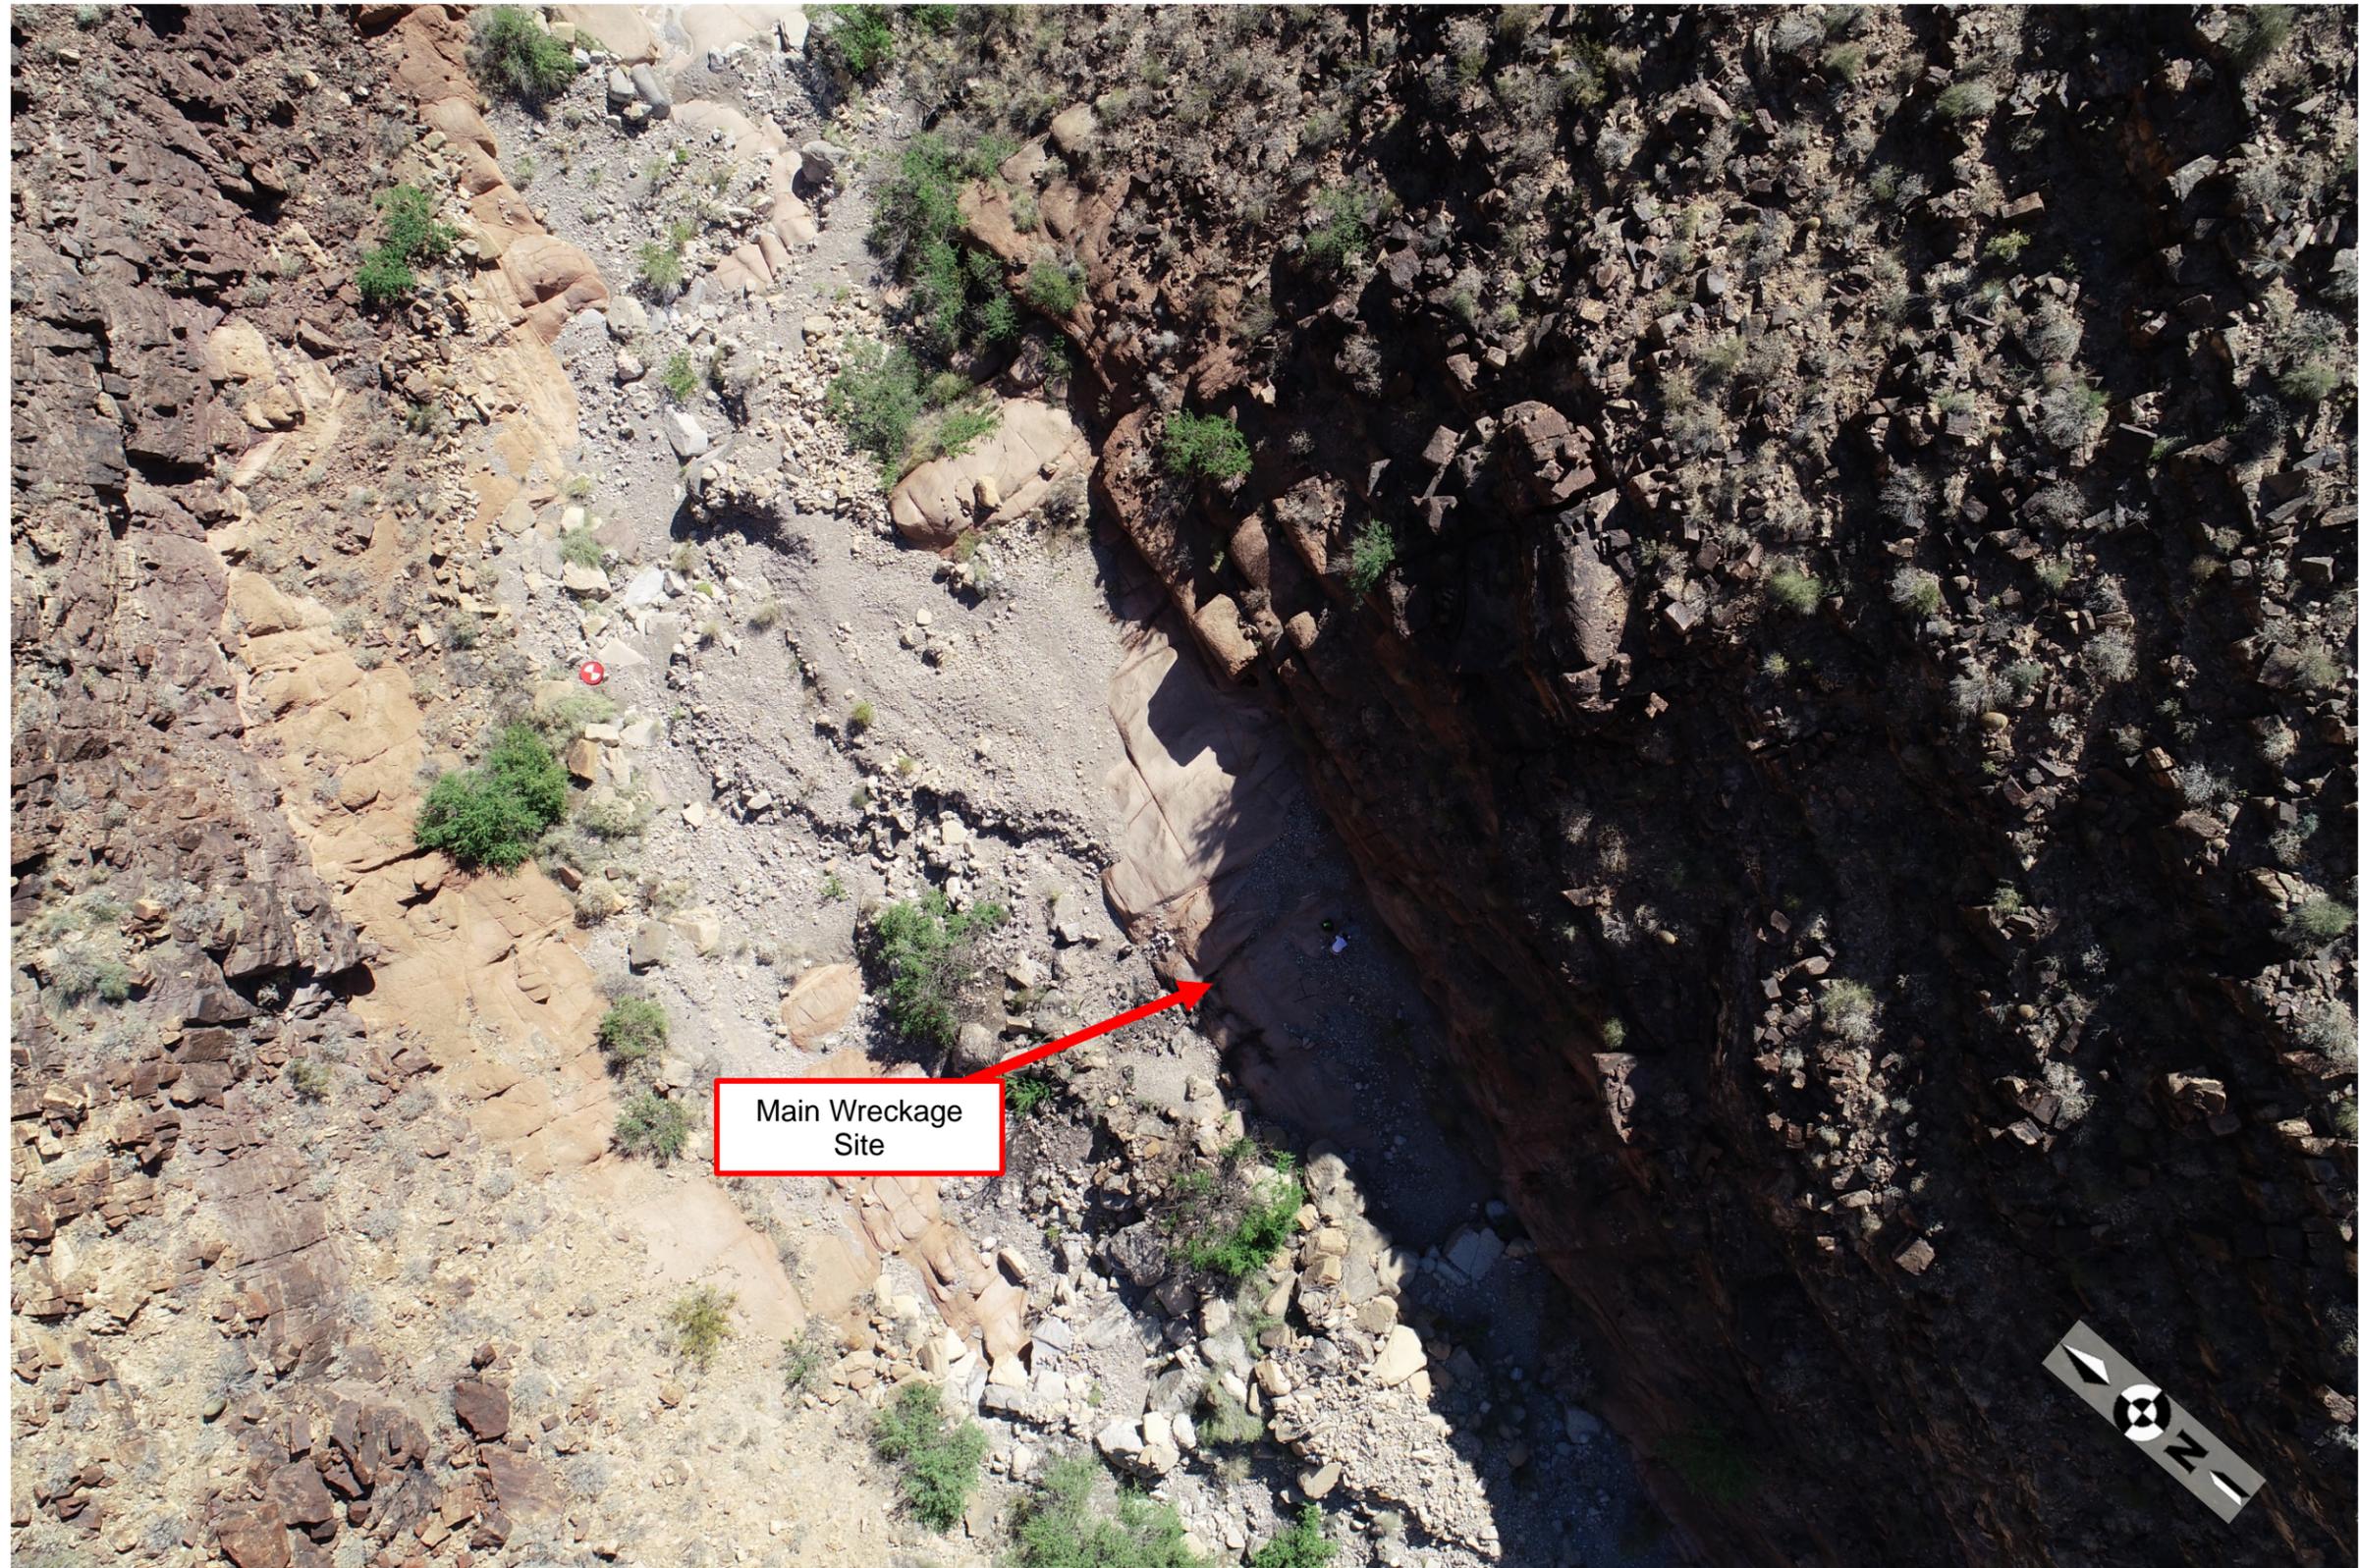
Figure 9 – Photo - Aerial overhead view of accident site (directional arrow approximated)

Figure 9 is an overhead image of the accident site.

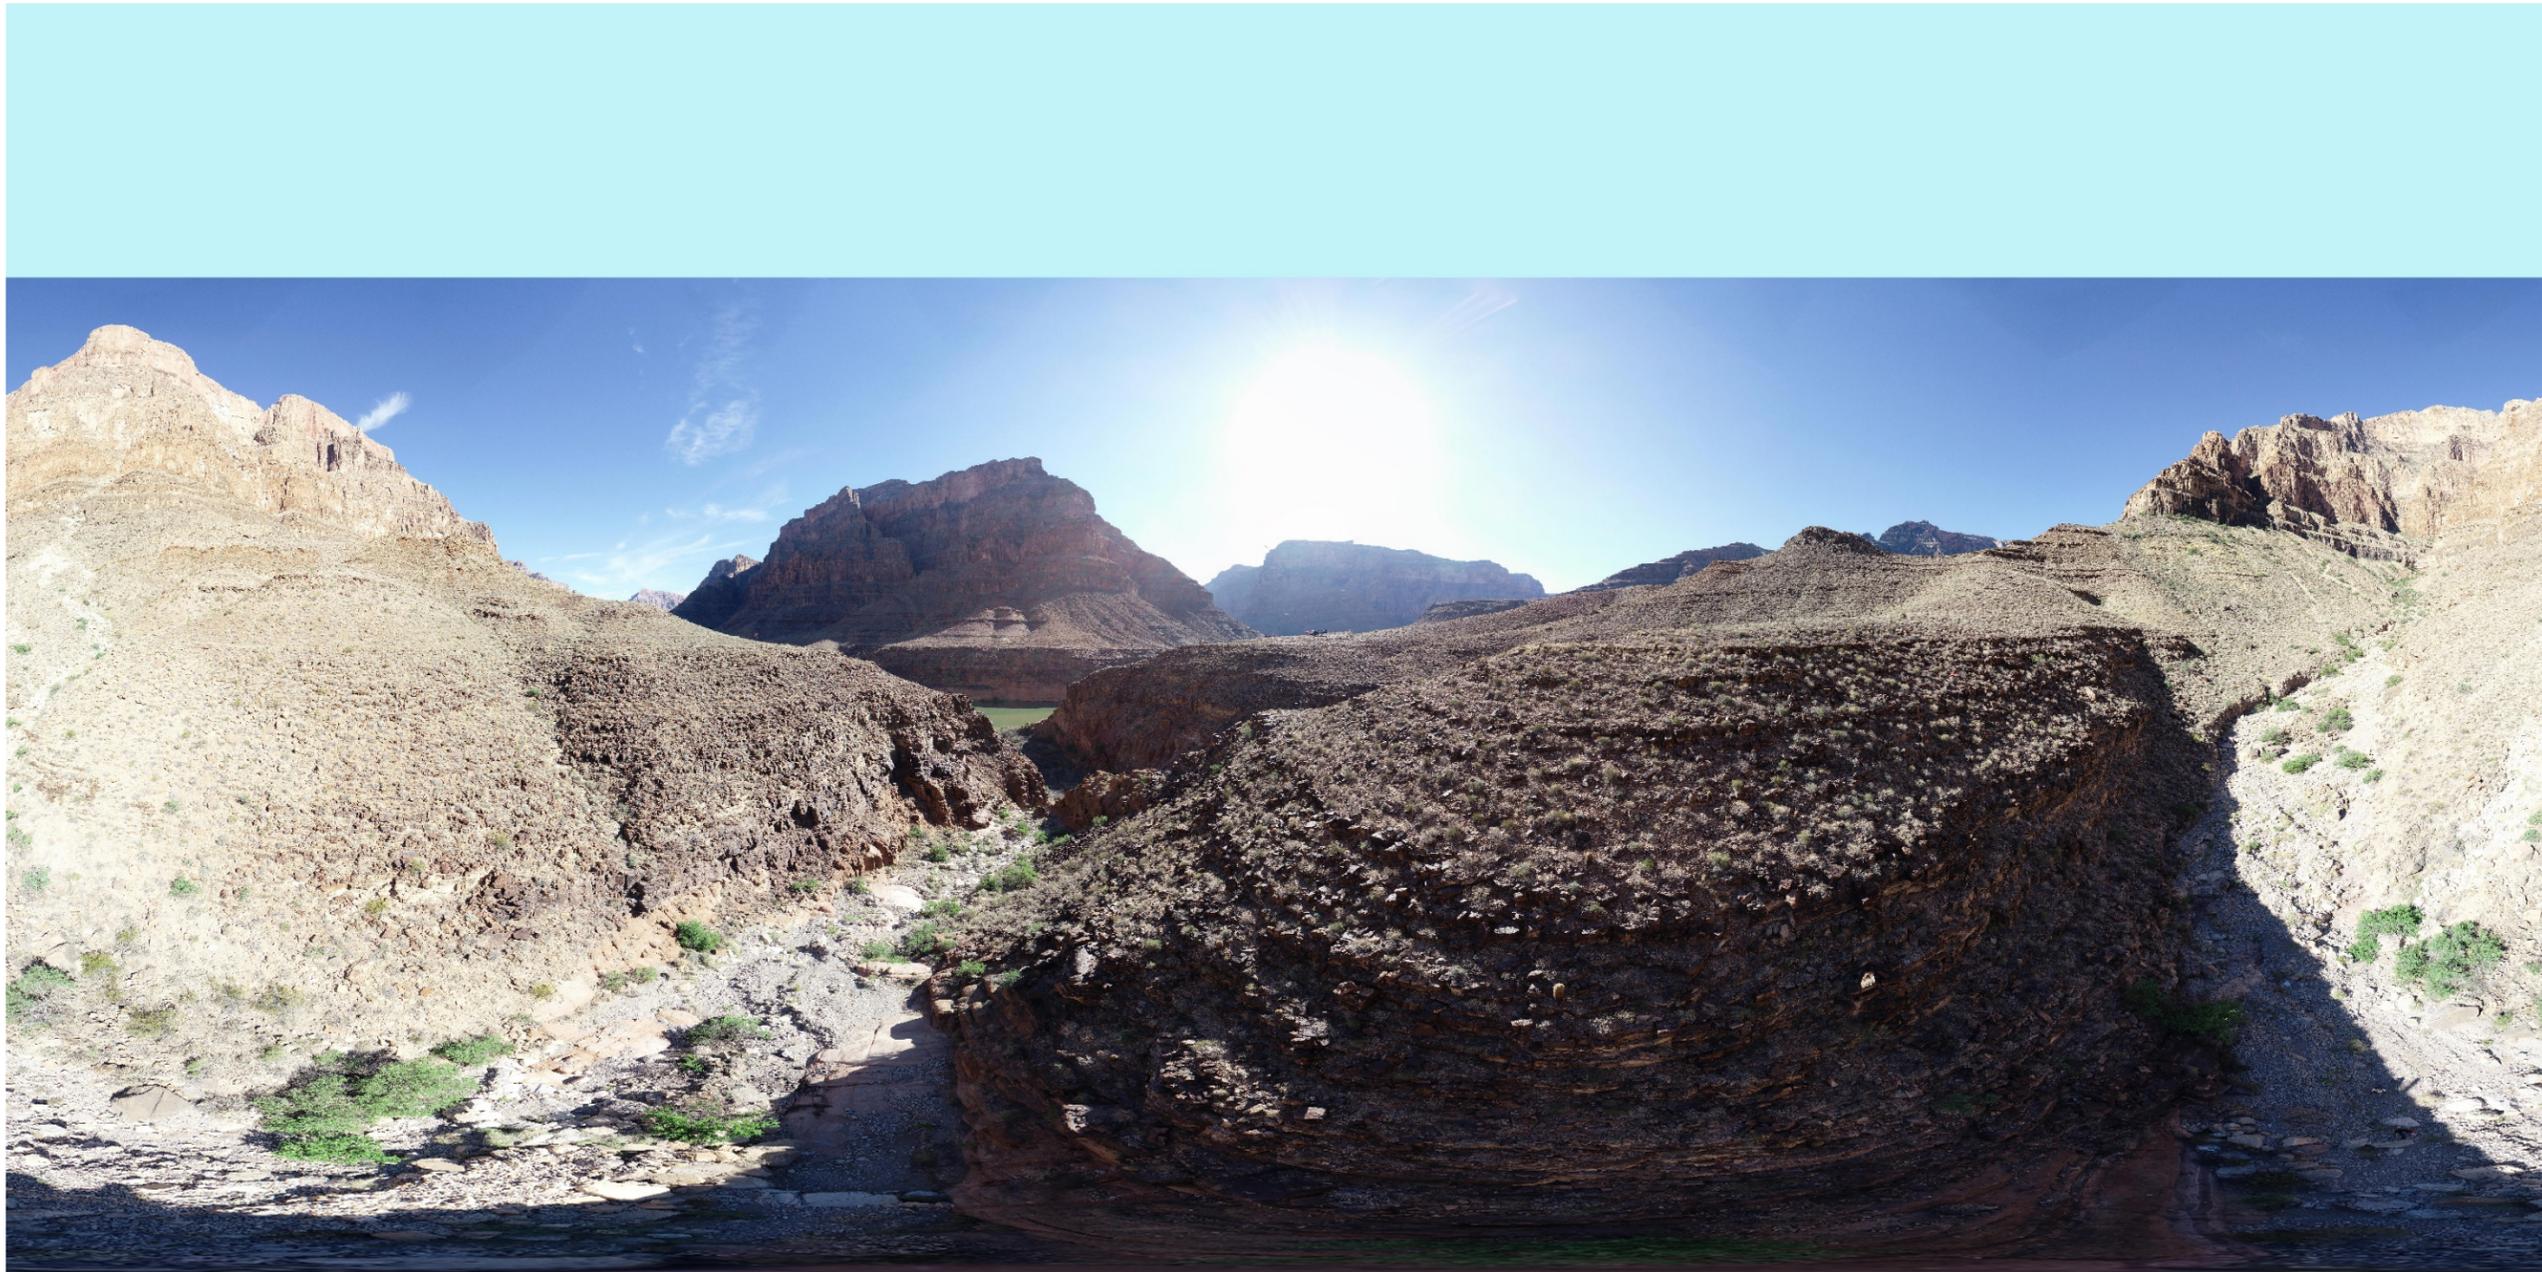
Figure 12 - Panoramic image of scene taken from above the accident site (light blue strip at top of image added during panoramic creation, and the 2D image contains distortions)⁵

Figure 12 and Figure 13 present panoramic views of the overall accident scene. The images were created using commercially available software which stitched together 34 individual images taken using a programmed sequence from the drone control software. The product is intended to be used with a 360 Panoramic viewer software and it is projected onto 2D for this report, creating various distortions. The original panoramic image is an attachment to this report and located in the accident docket.
