NATIONAL TRANSPORTATION SAFETY BOARD

Factual Report

METEOROLOGY

WPR19FA123

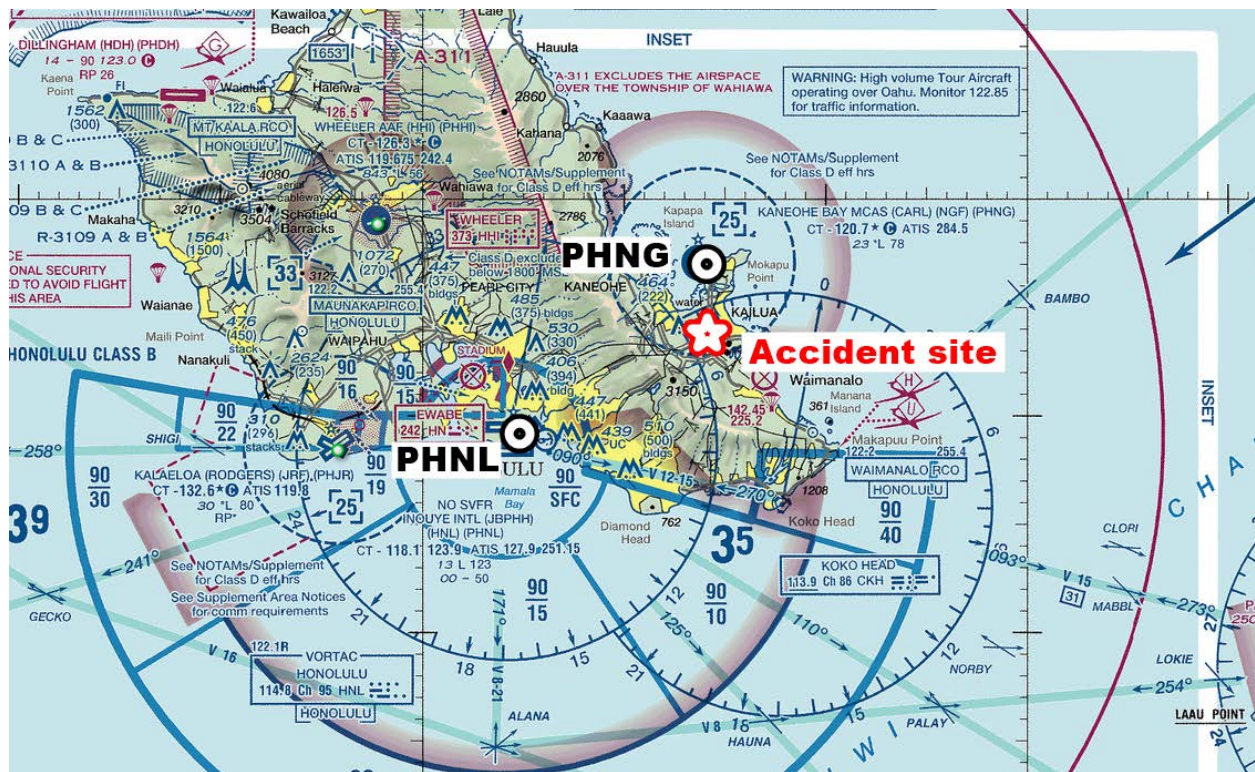
Figure 2 – Sectional map of the accident area with the location of the accident site and surface observation sites

The area surrounding the accident site was documented using official Meteorological Aerodrome Reports (METARs) and Specials (SPECIs). The following observations were taken from standard code and are provided in plain language. Figure 2 is a local sectional chart with the accident site and the closest weather reporting locations marked.
