## **NATIONAL TRANSPORTATION SAFETY BOARD**

# **METEOROLOGY**

WPR19FA154

Location: Grover, Utah  
Date: May 24, 2019  
Time: about 1116 mountain daylight time  
1716 Universal Coordinated Time (UTC)  
Airplane: Cirrus SR22; Registration: N809SR

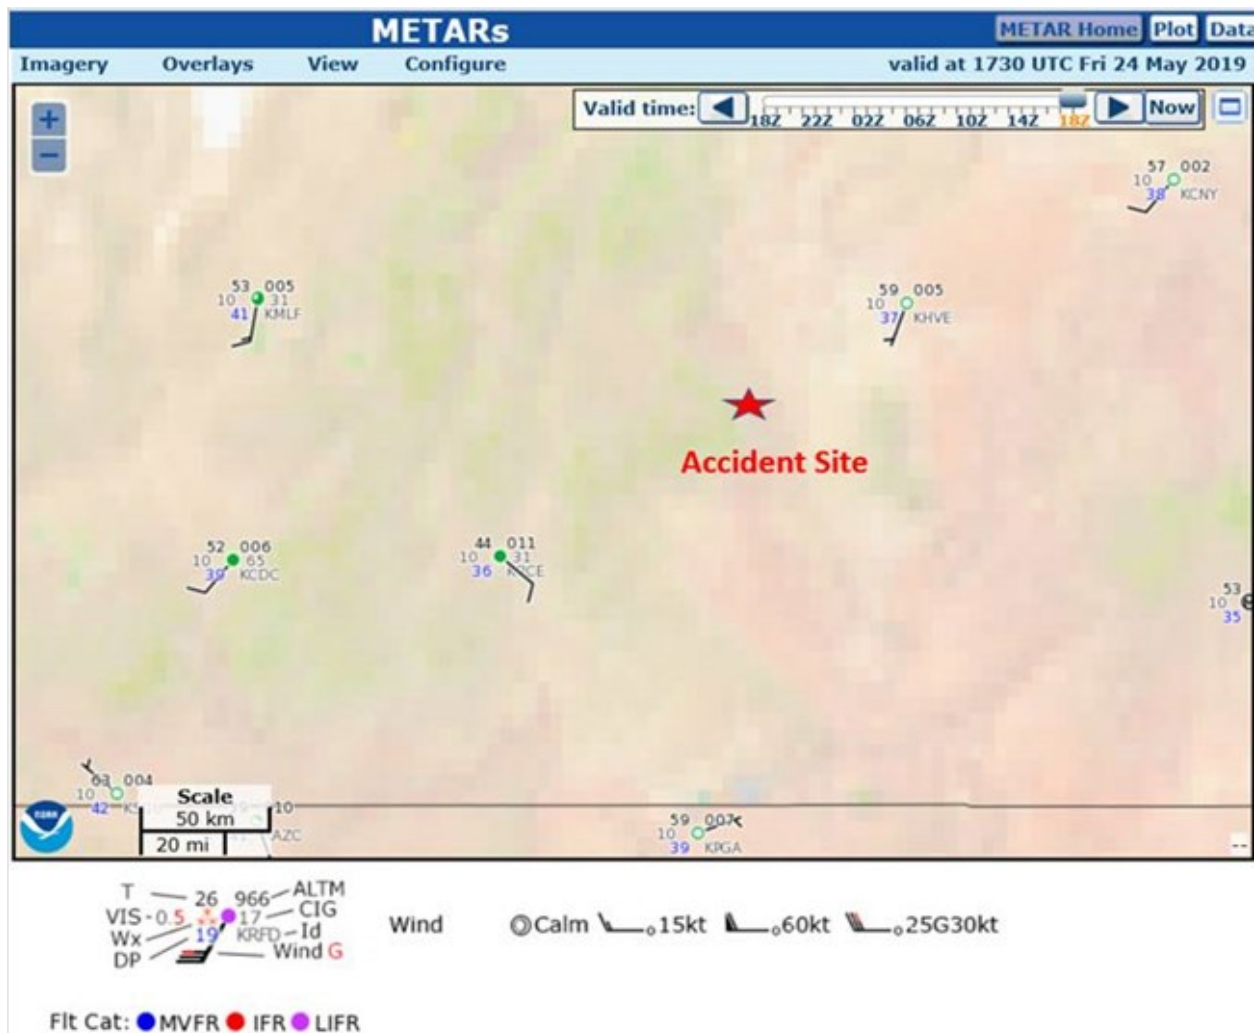
The NWS Aviation Weather Center (AWC) METAR display showing the general flight categories, with the radar composite for 1130 MDT is included as figure 6 with the approximate accident site marked by the red star. The display shows generally VFR conditions<sup>2</sup> being reported over the region with clear skies over the eastern portion of Utah with broken to overcast cloud cover over the western portion of the station.

Figure 6 - METAR display at 1130 MDT
