NATIONAL TRANSPORTATION SAFETY BOARD

Aircraft Performance Study

Aircraft: Bombardier CL-600-2B16, registration N605TR

NTSB#: WPR21FA286

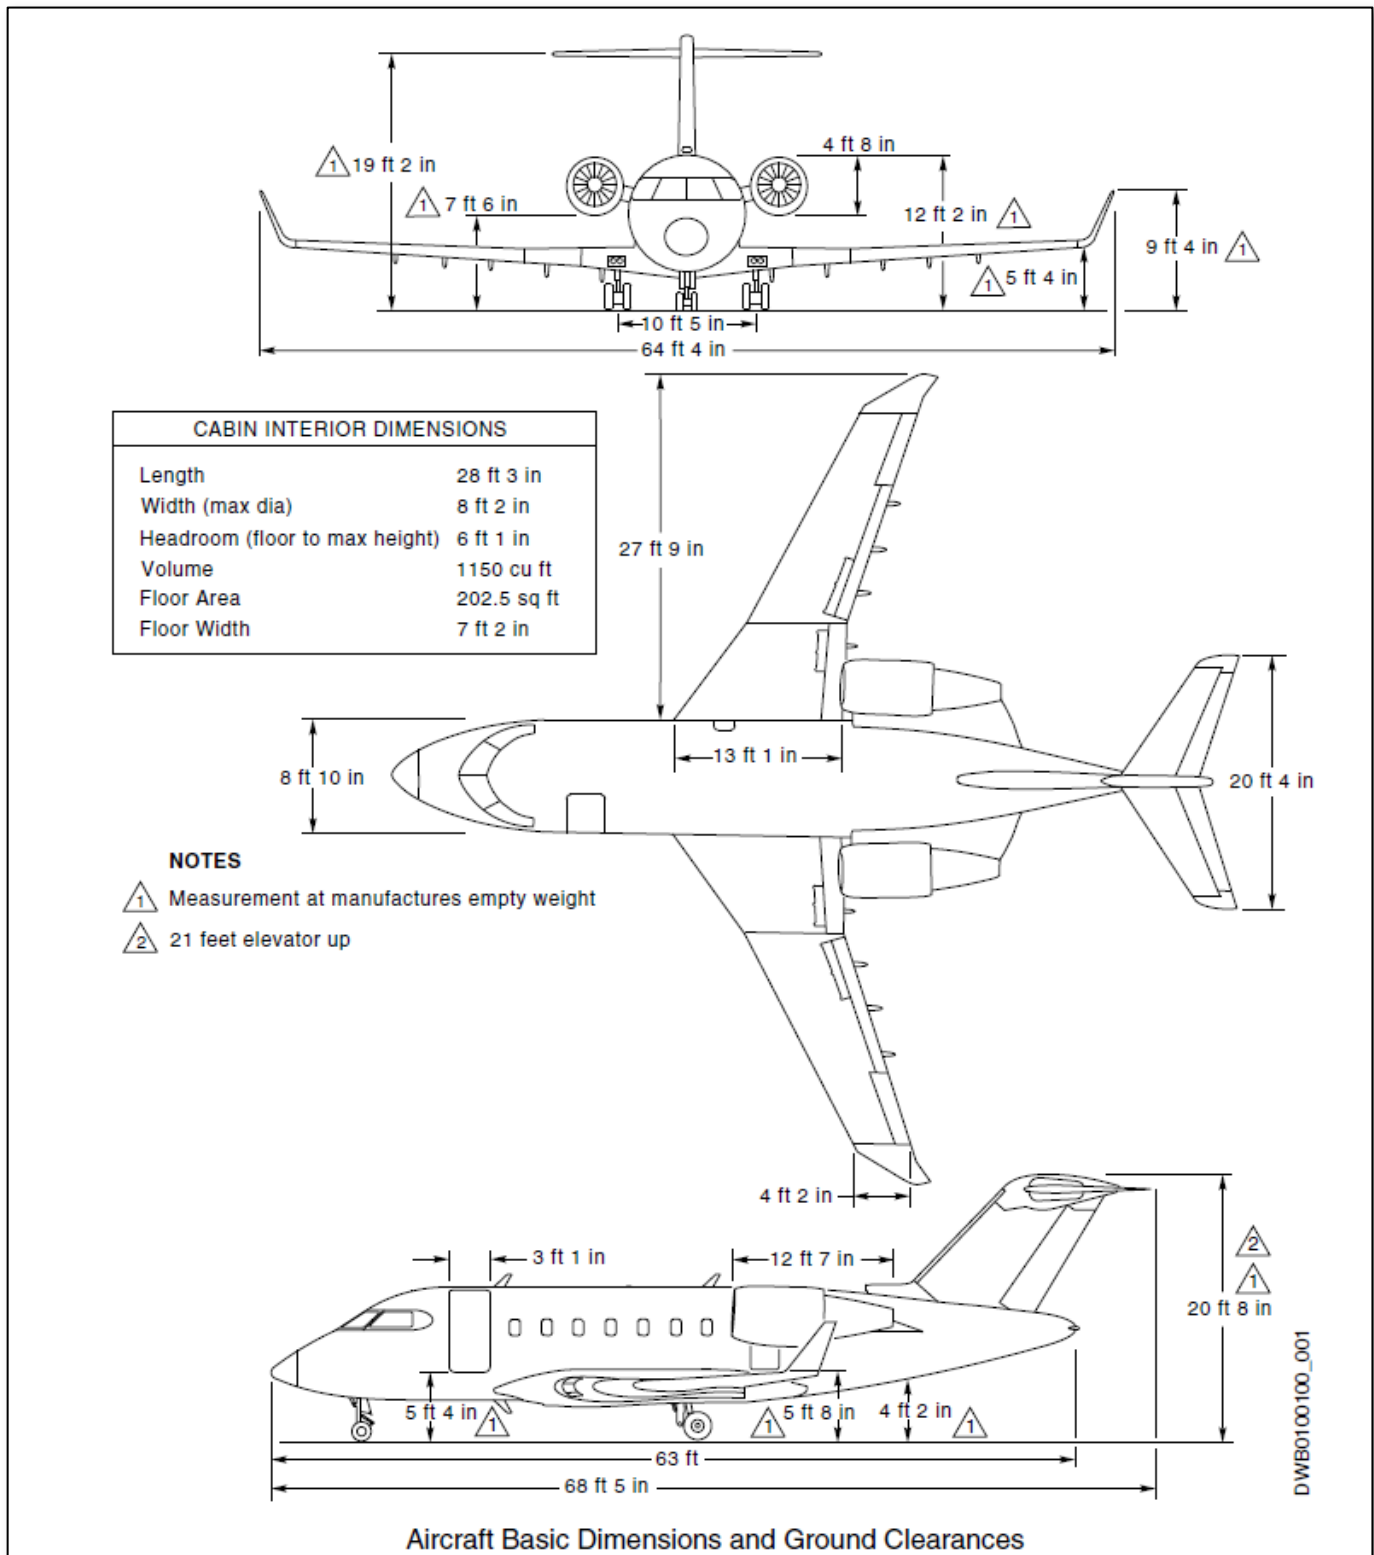
Figure 1. 3-view drawing of the Bombardier Challenger 605, from Reference 1.

The Bombarider CL-600-2B16, or “Challenger 605,” is a derivative of the Canadair Challenger 600 (CL-600-1A11) originally certificated in 1980.³ The Challenger 605 was certified in 2006, has a maximum takeoff weight of 48,200 lb., and is powered by two General Electric CF34-3B turbofan engines mounted on the aft fuselage, providing 8,700 lb. of takeoff thrust each.⁴ Figure 1 shows a 3-view image of the Challenger 605, taken from Reference 1. N605TR was Bombardier serial number 5715 and was manufactured in 2007. A pre-accident photograph of the airplane is shown in Figure 2.

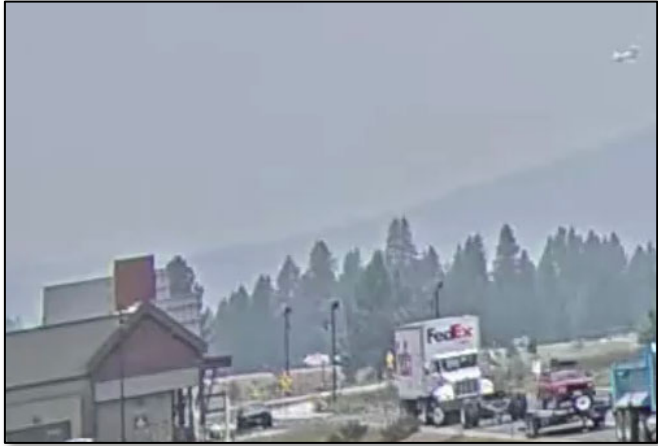
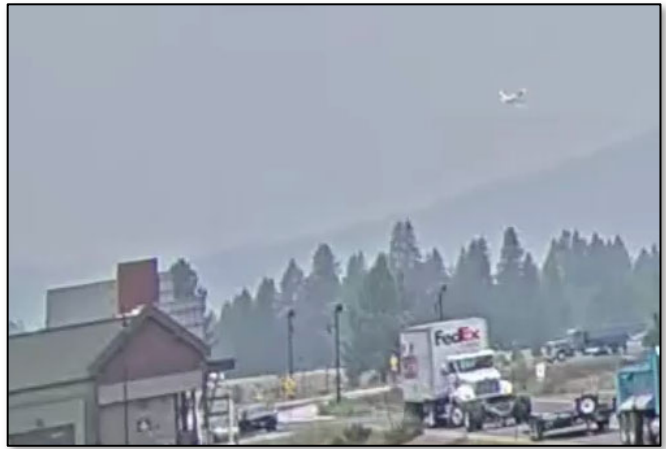
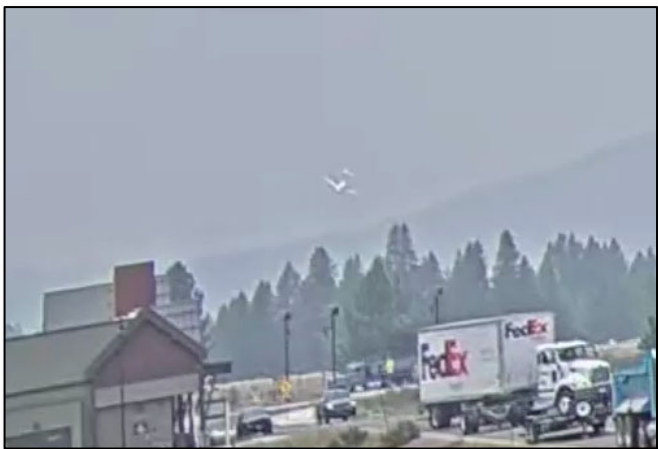
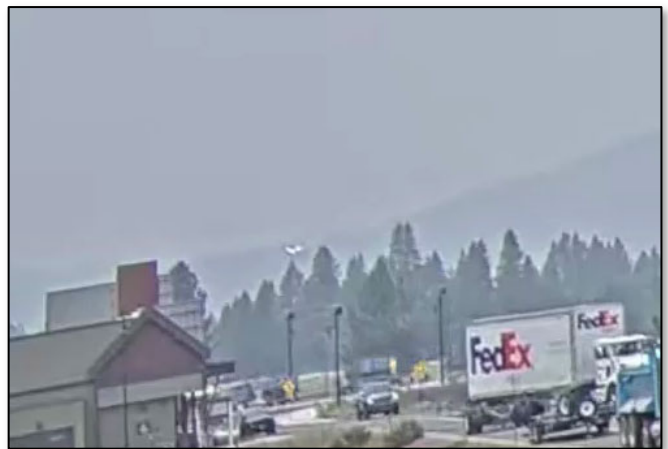
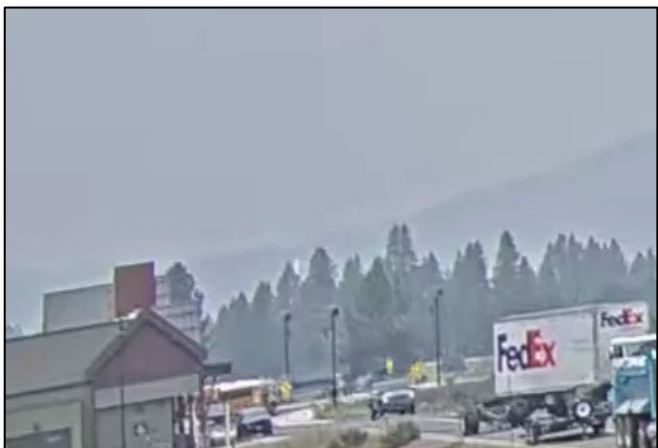
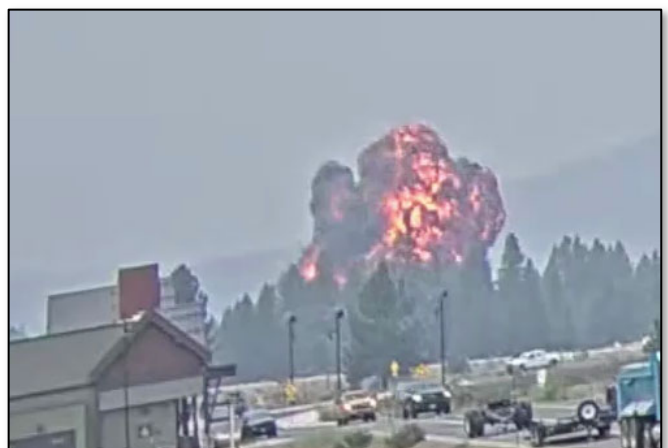
Figure 3. Selected cropped and enlarged frames from video with filename "TTLCO-version2-2021-07-26_17-18-07.mp4."

Reference 2 notes that “three surveillance videos captured the accident flight’s final movements.” Selected cropped and enlarged still frames from one of these videos, recorded by a surveillance camera located at the Truckee-Tahoe Lumber Co. Headquarters,⁵ are presented in Figure 3. The complete video, with filename “TTLCO-version2-2021-07-26_17-18-07.mp4,” is available in the public docket for this accident.

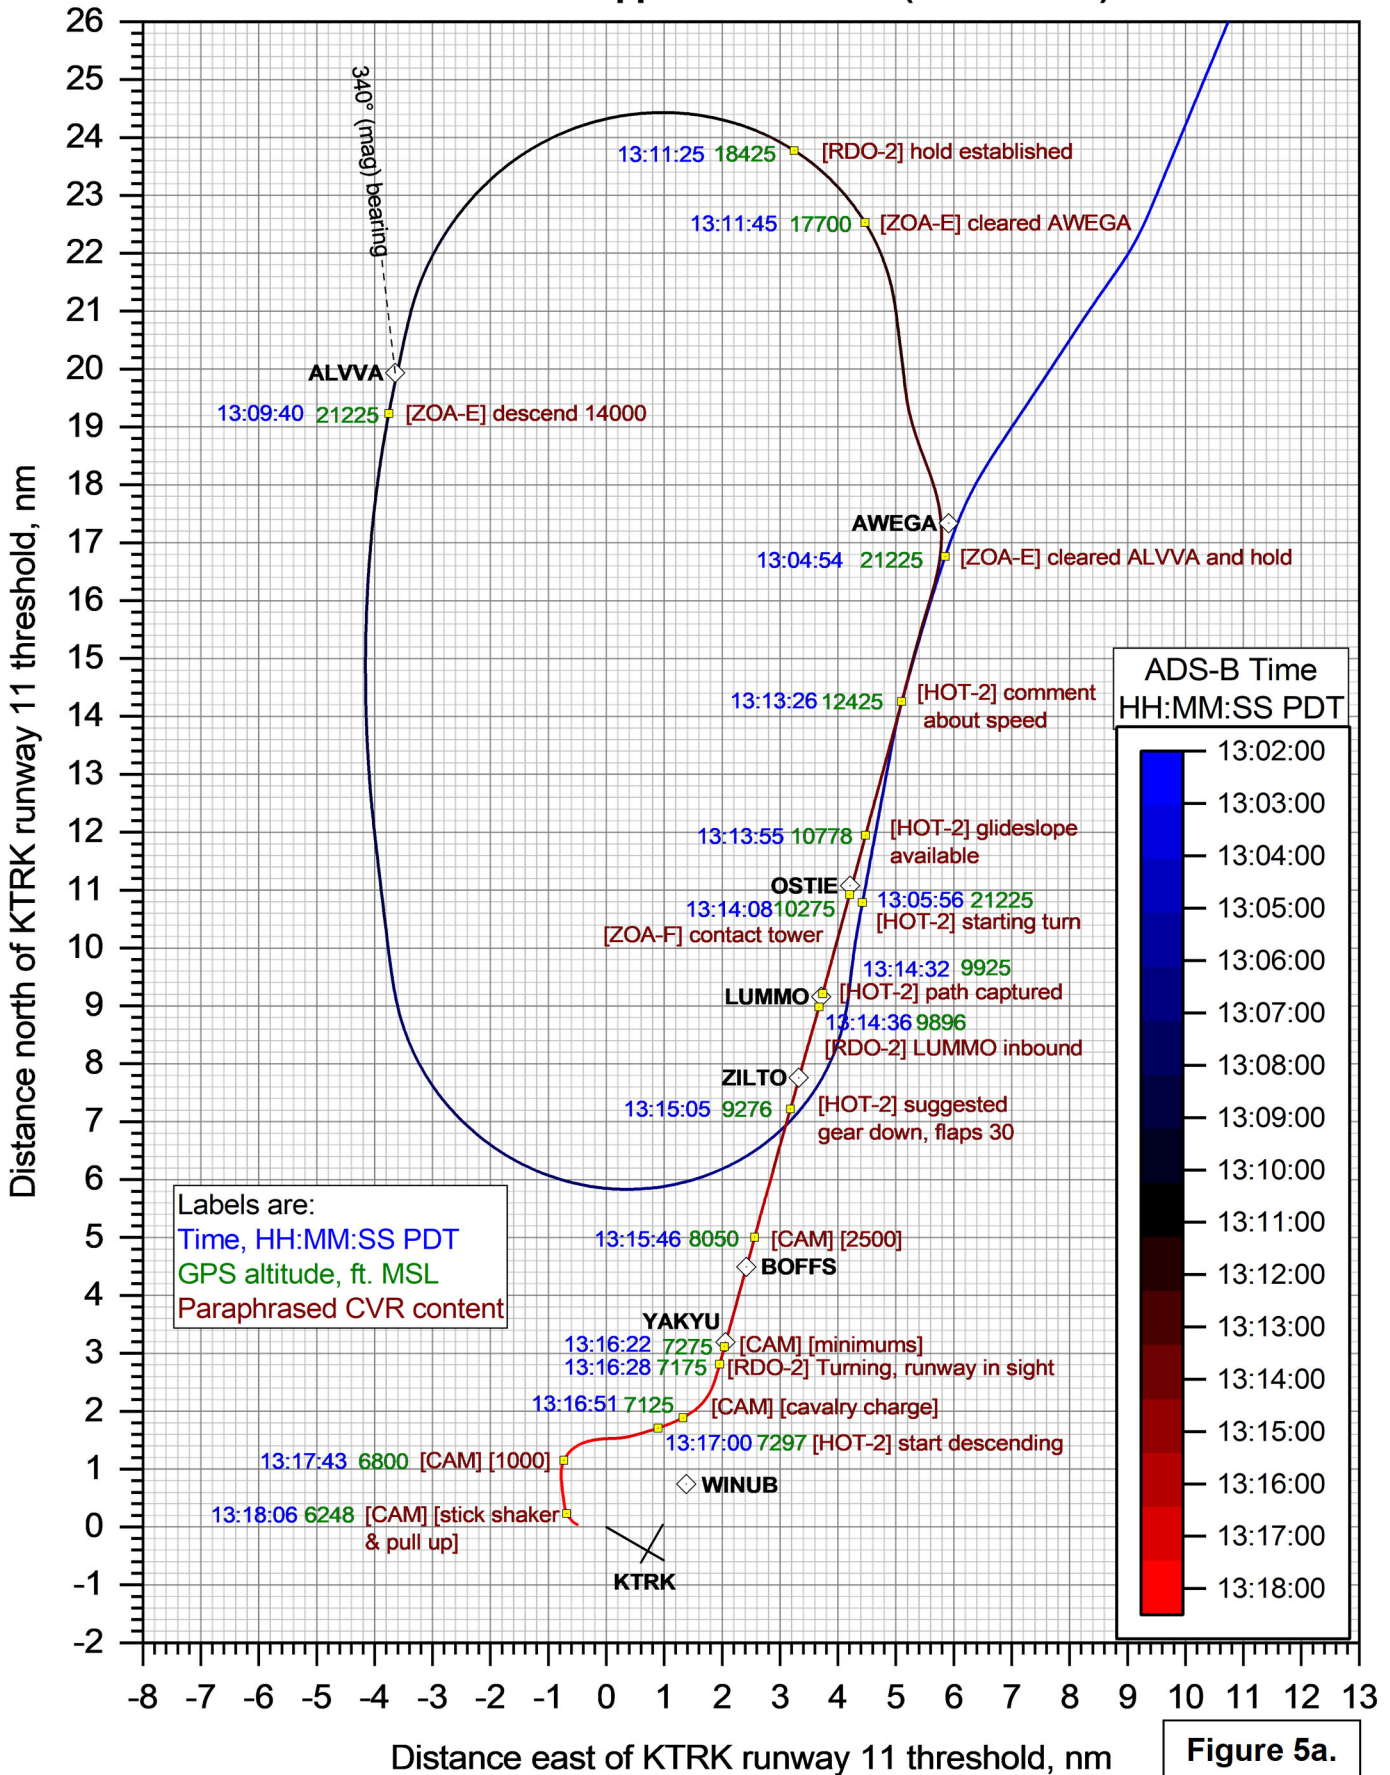
Figure 5a.

Plan view of approach to KTRK (ADS-B data)

During the circling maneuver, N605TR did not achieve a "downwind" leg parallel to runway 11, and the "base" leg of the approach was not perpendicular to runway 11 (see Figure 5). This contributed to the airplane crossing the extended centerline of runway 11 only 0.85 nm from the threshold, while heading 49° to the right of the runway heading and above a 3° glide path to the runway. The crew's conversation recorded on the CVR indicates that they were aware that they had overshot the centerline and were high, but intended to

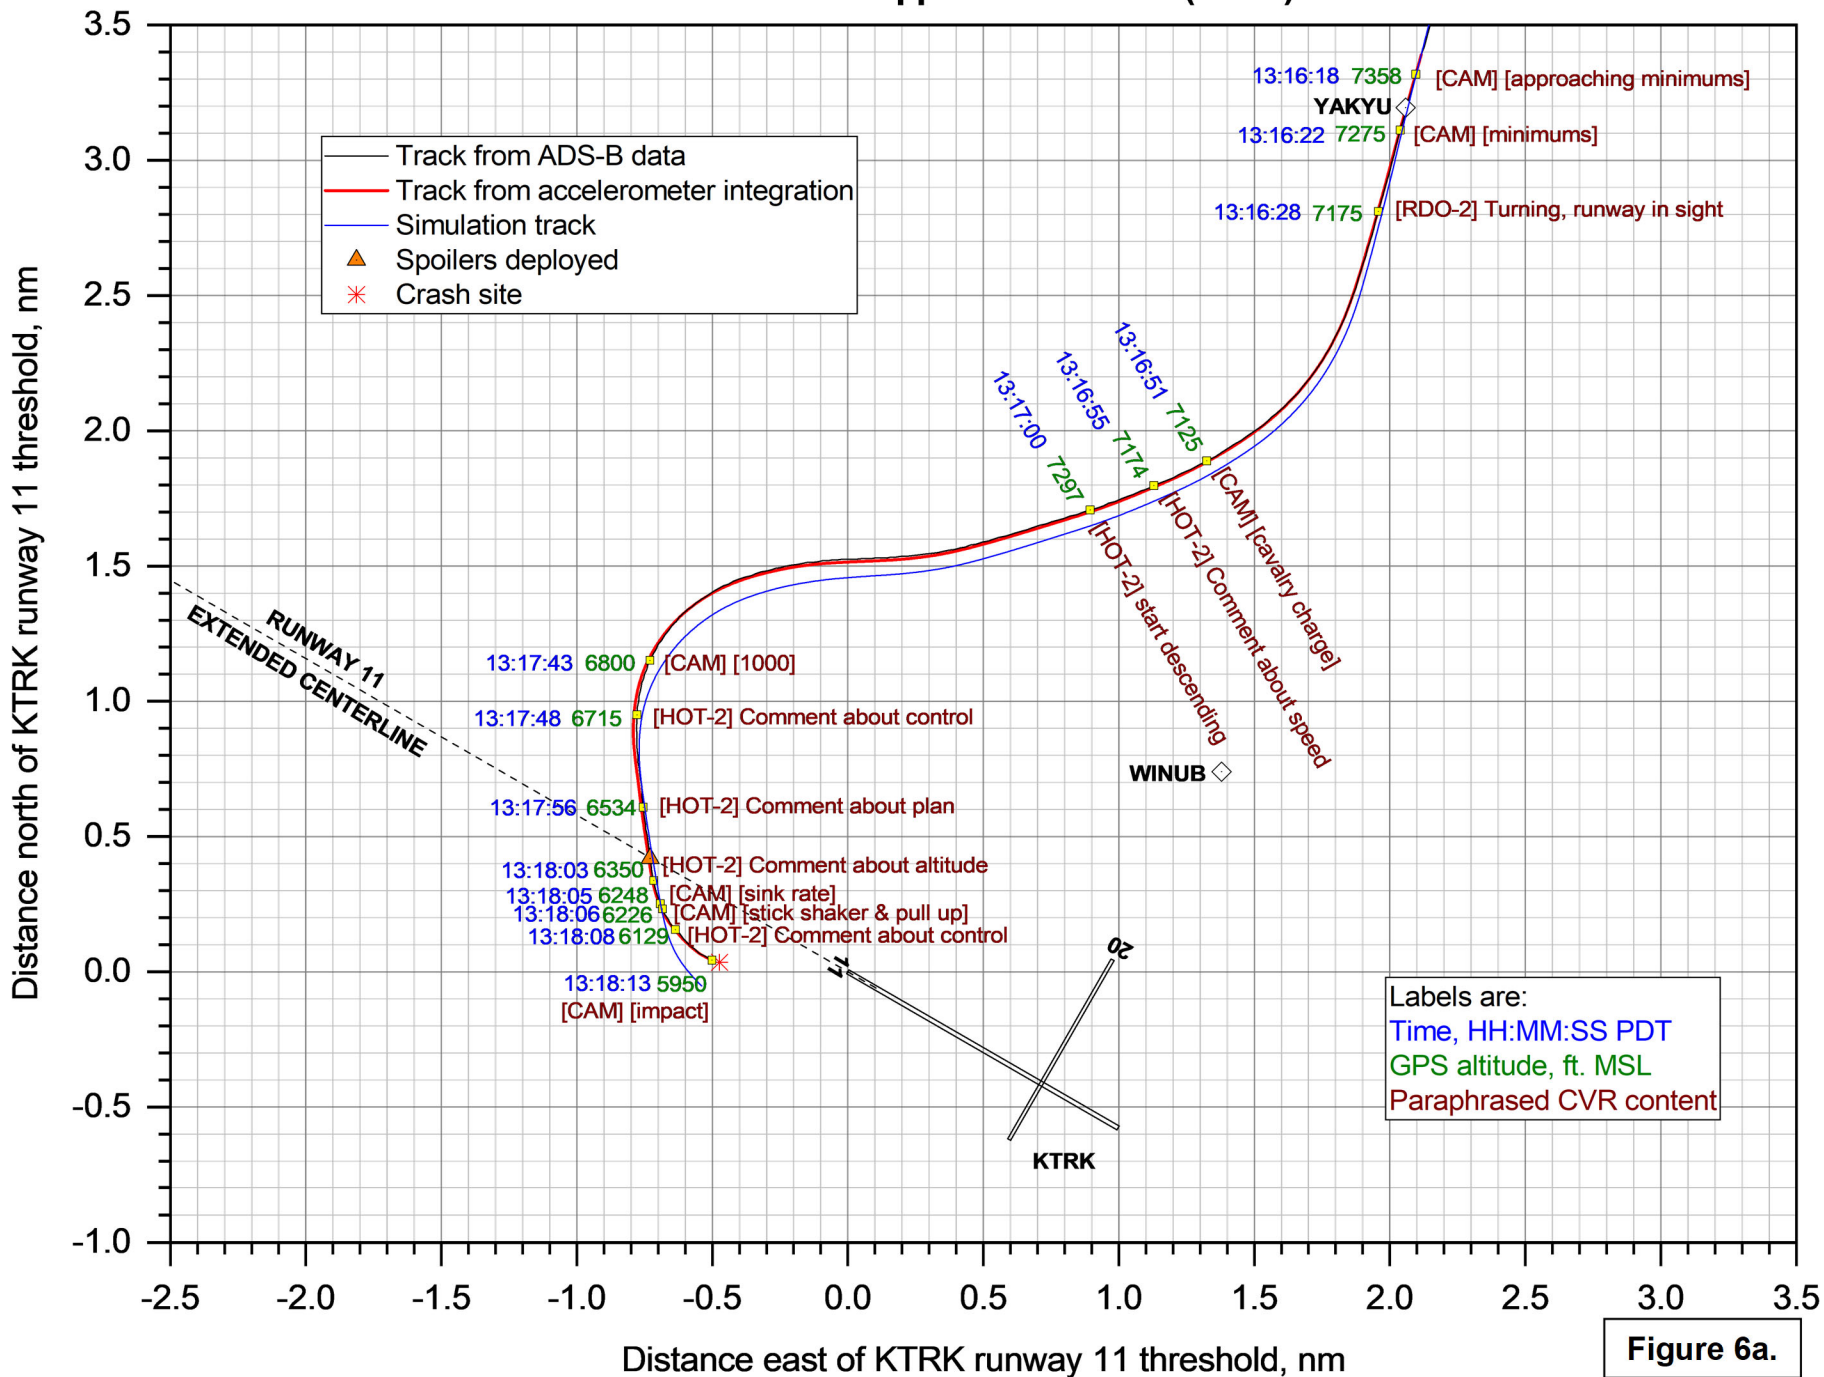
Figure 6a.

Plan view of approach to KTRK (detail)

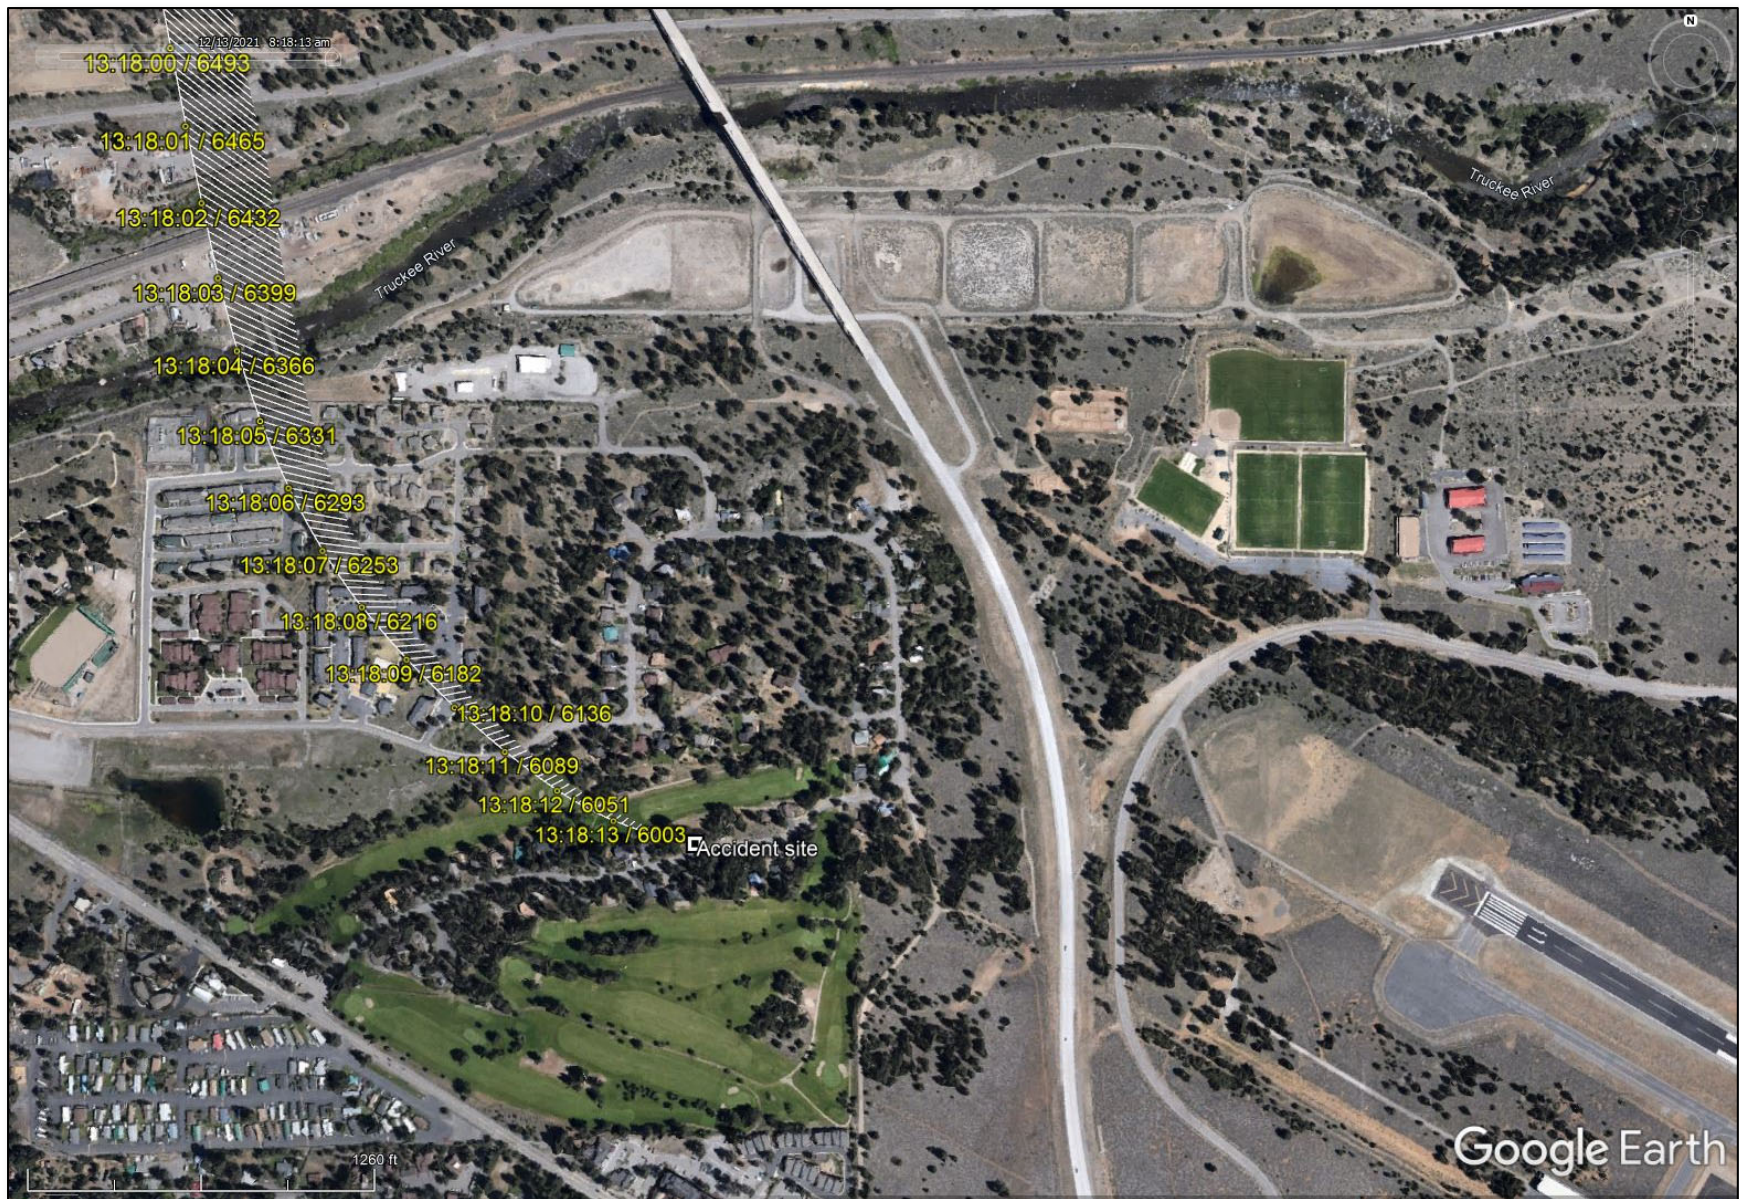
Figure 7. Final segment of N605TR's flight path and the accident site depicted over a *Google Earth* satellite image. Labels along the flight path indicate ADS-B time in PDT and altitude in feet MSL.

A *Google Earth* satellite view of the accident location, depicting the final portion of N605TR's flight path and part of runway 11, is presented in Figure 7.

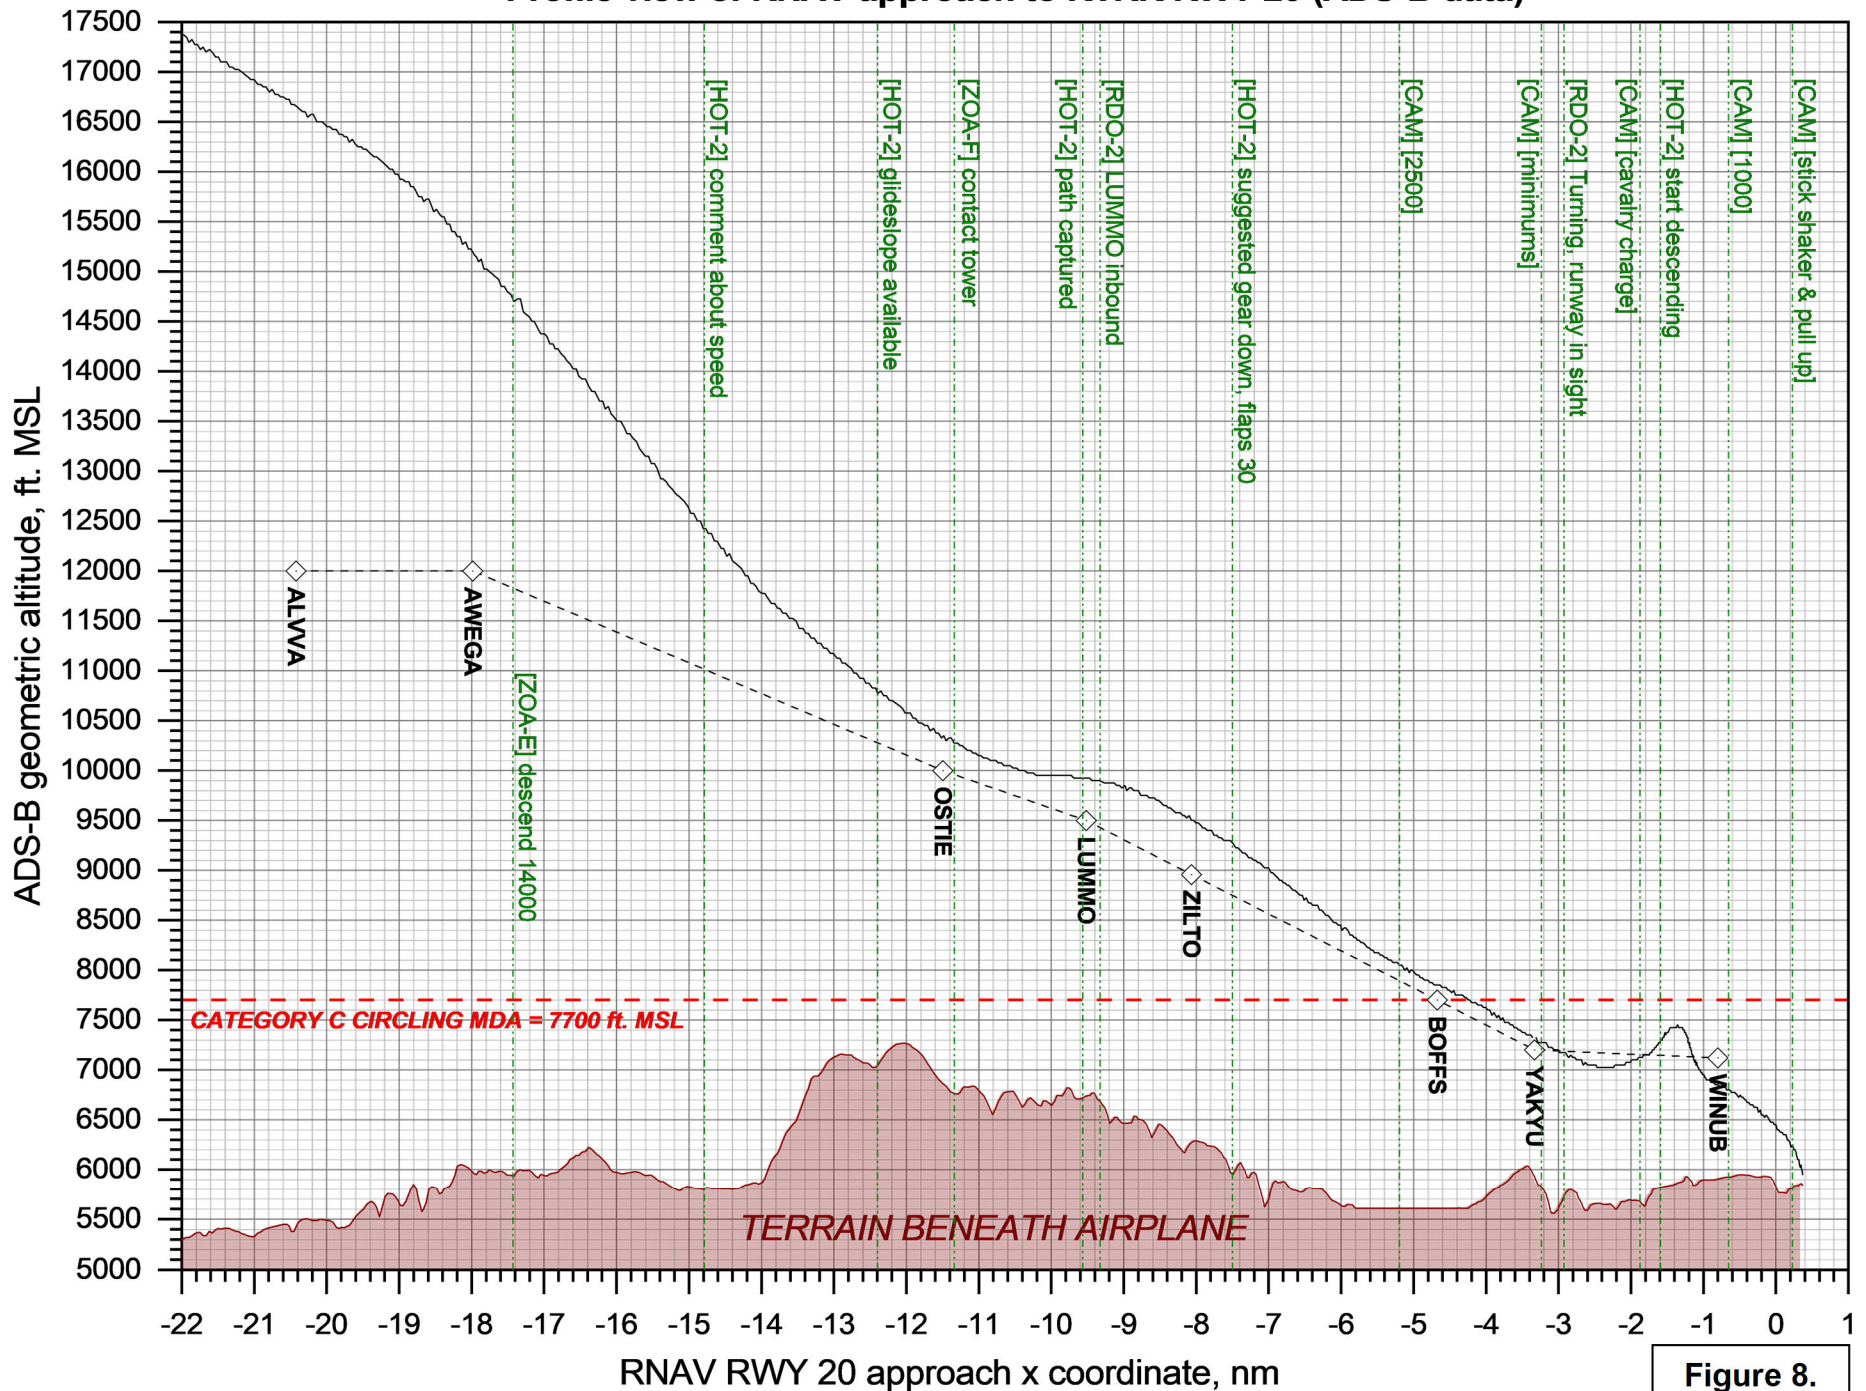
Figure 8.

WPR21FA286: Bombardier CL-600-2B16, N605TR, Truckee, CA, 07/26/2021
Profile view of RNAV approach to KTRK RWY 20 (ADS-B data)

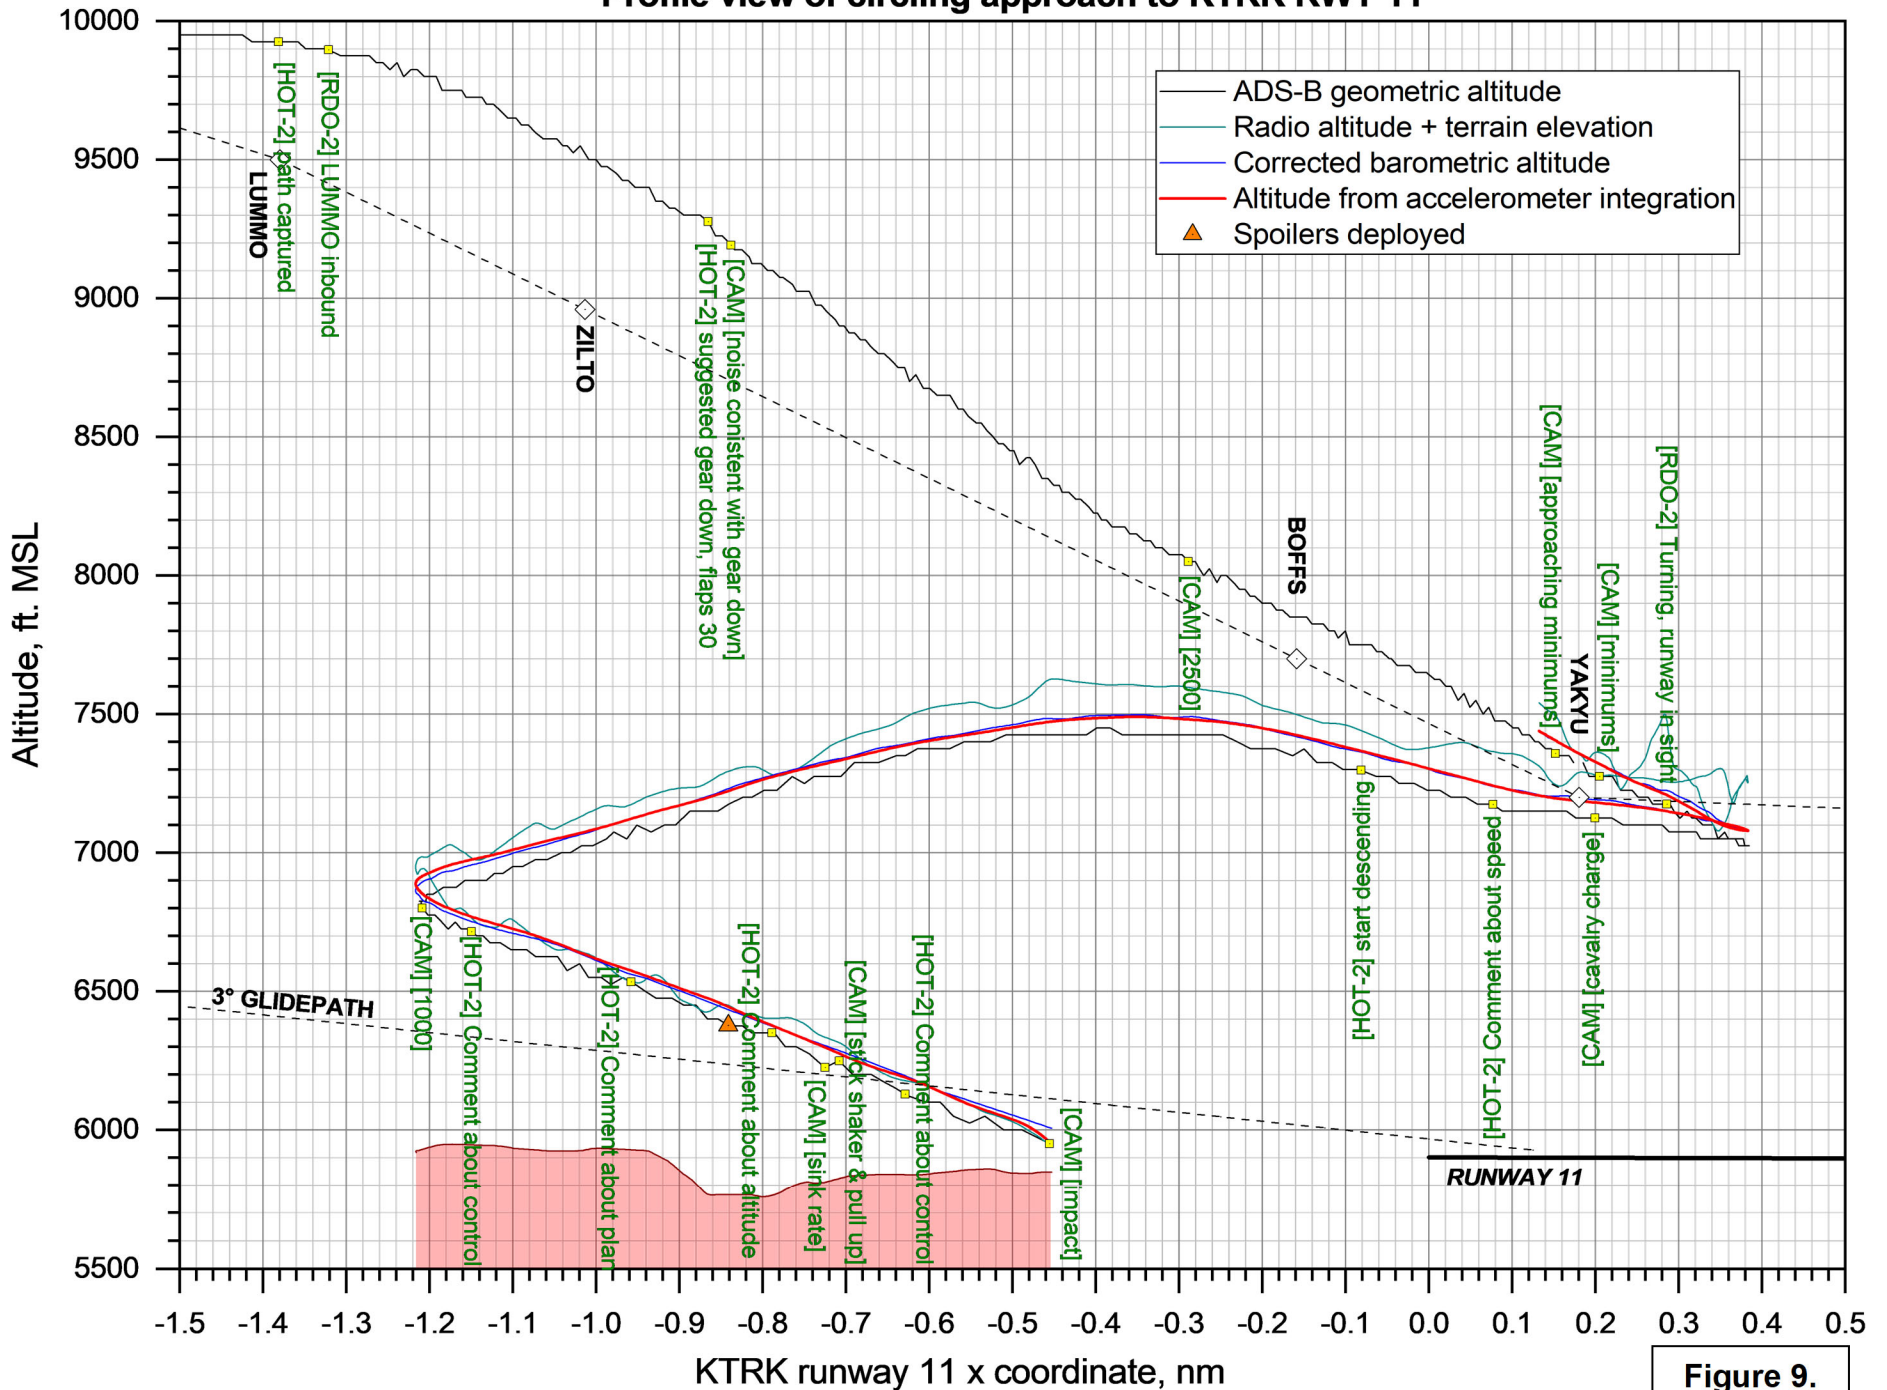
Figure 9.

Profile view of circling approach to KTRK RWY 11

The solution of the hydrostatic equation is shown in Figures 9 and 10 as the blue line labeled “Corrected barometric altitude.” This result is modified near the end of the data to smooth through oscillations and better match the altitude defined by the radio altitude plus the terrain elevation, so as to provide a better “target” altitude for the accelerometer integration calculation described below. Accounting for the higher-than-standard temperature of the day changes the rate of change of pressure with true altitude slightly, compared to the rate of change of pressure with pressure altitude.⁸

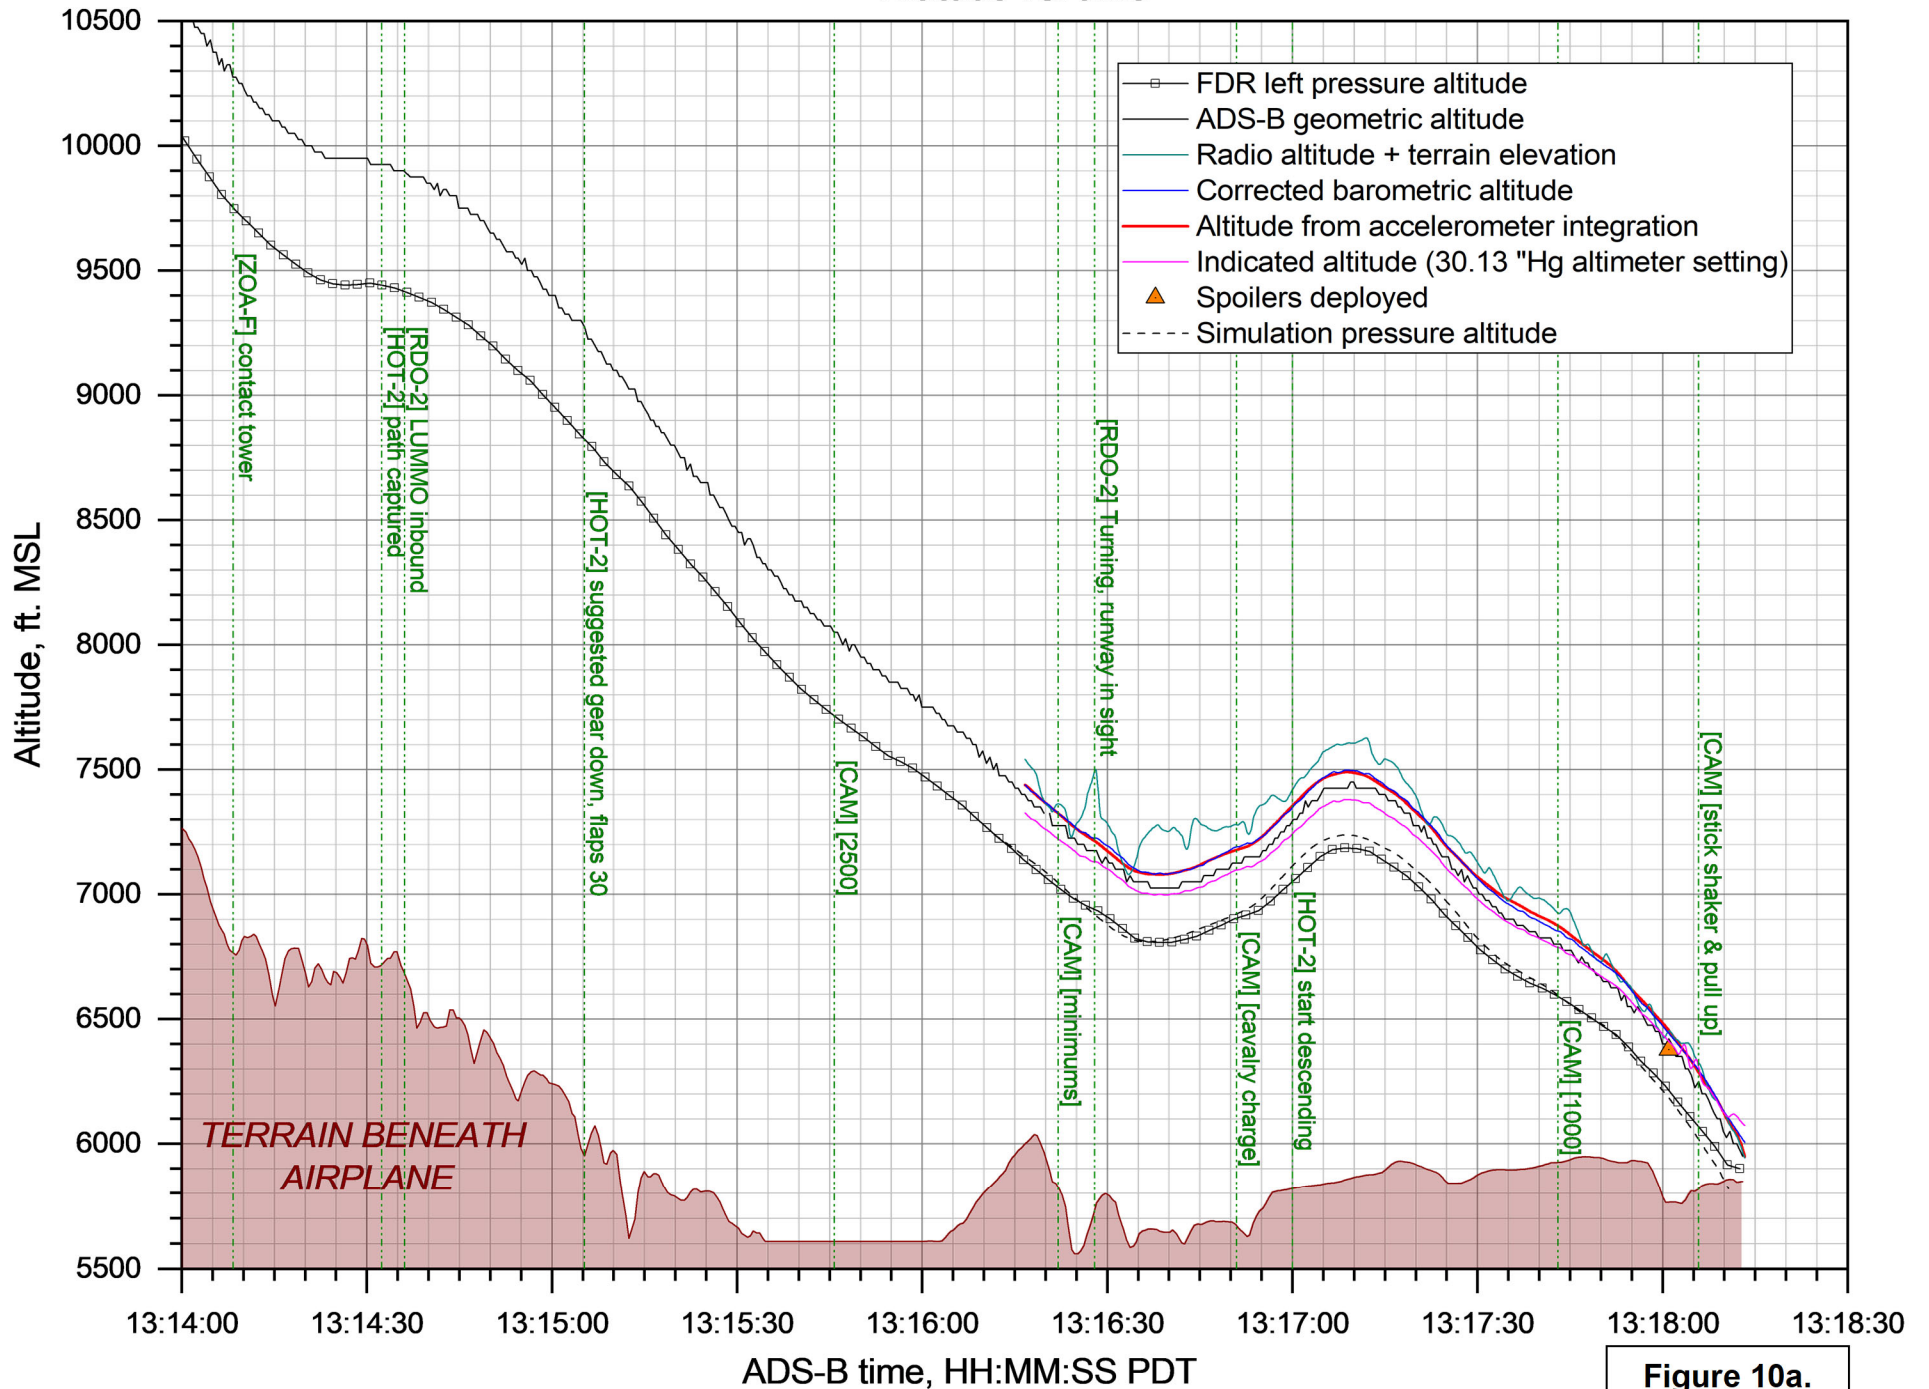
Figure 10a.

Altitude vs. time

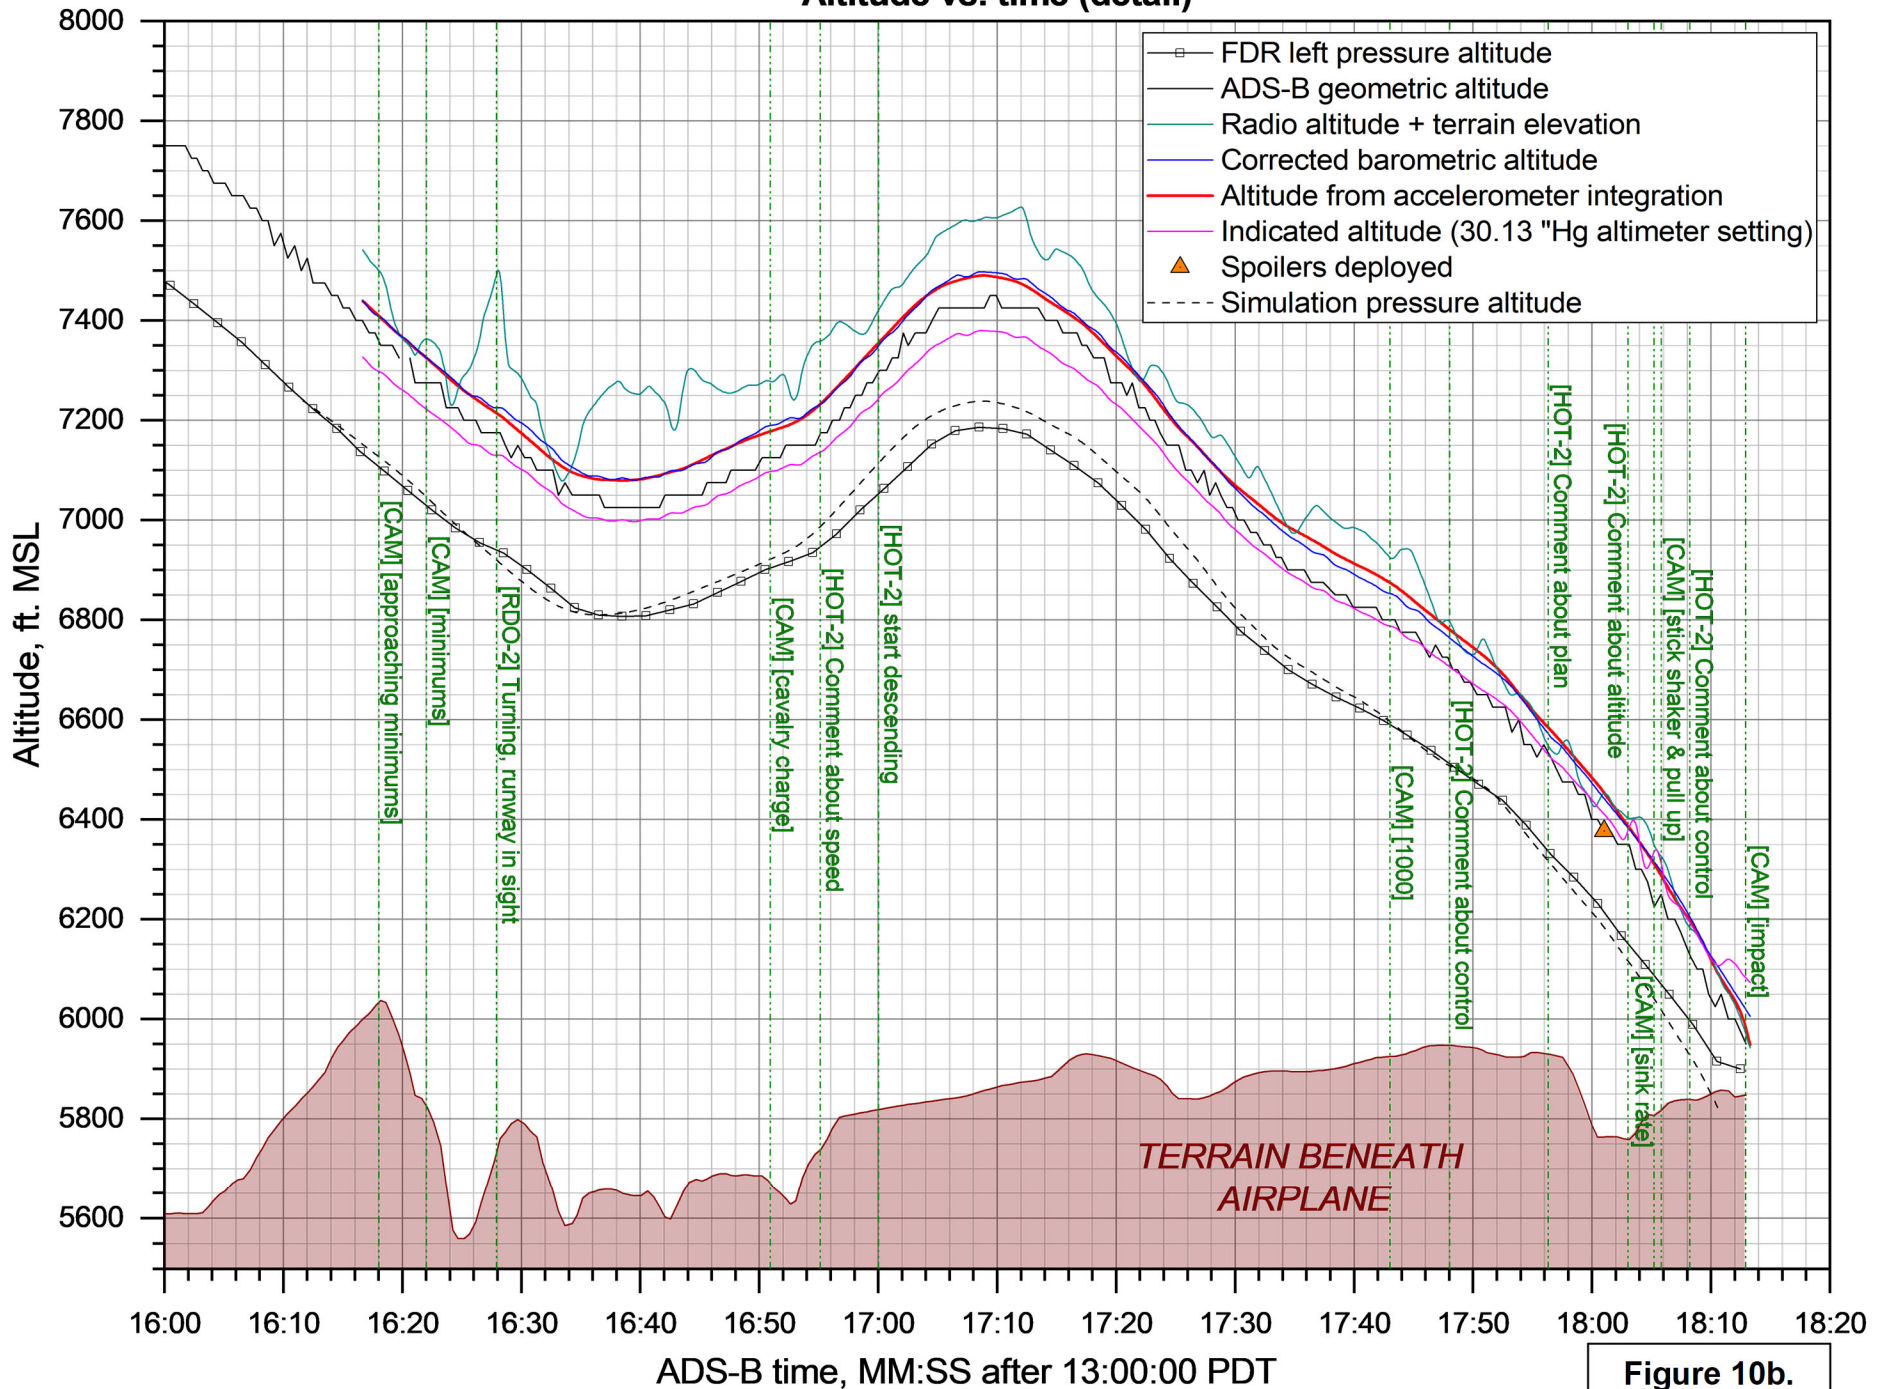
Figure 10b.

Altitude vs. time (detail)
