NATIONAL TRANSPORTATION SAFETY BOARD

Aircraft Performance Study

Aircraft: Bombardier CL-600-2B16, registration N605TR

NTSB#: WPR21FA286

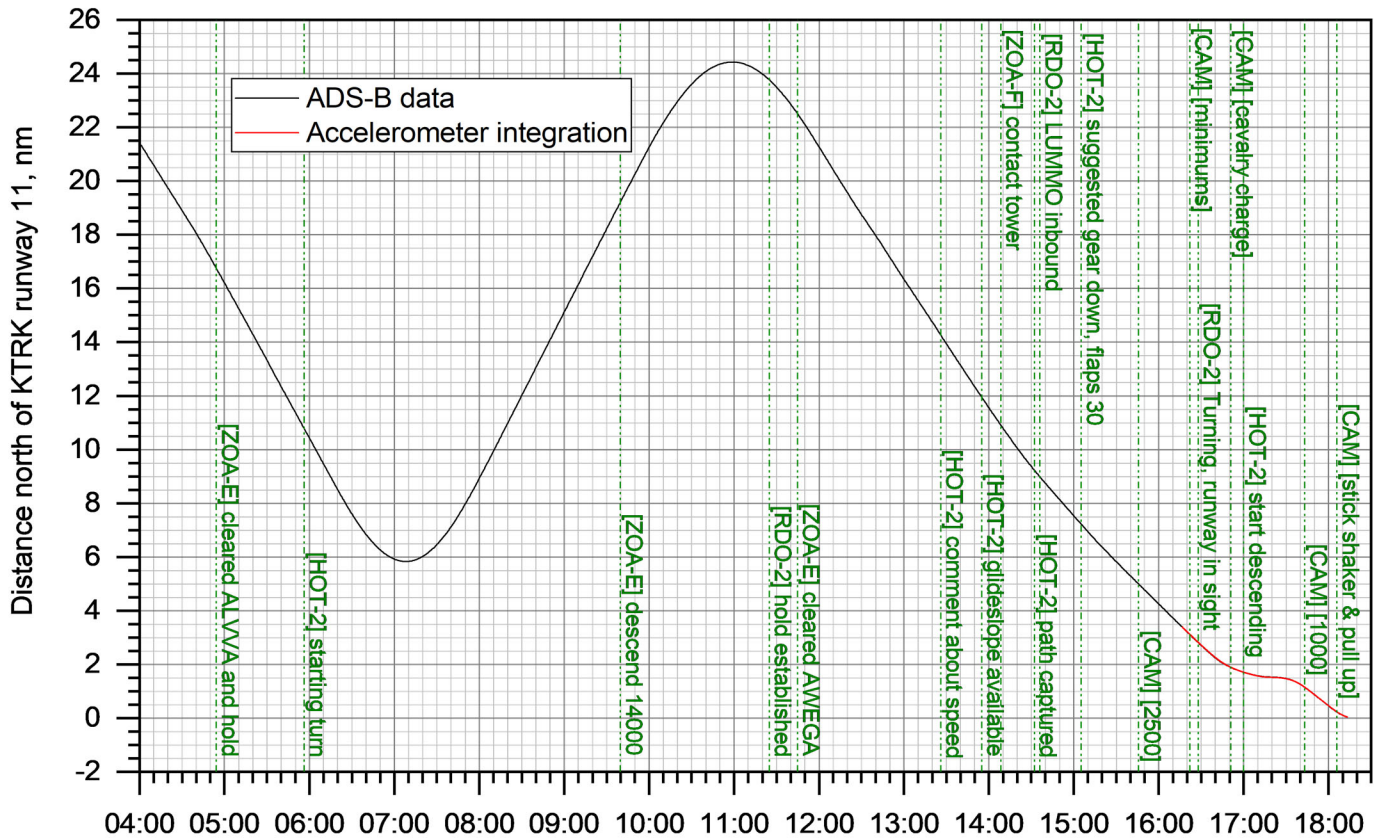
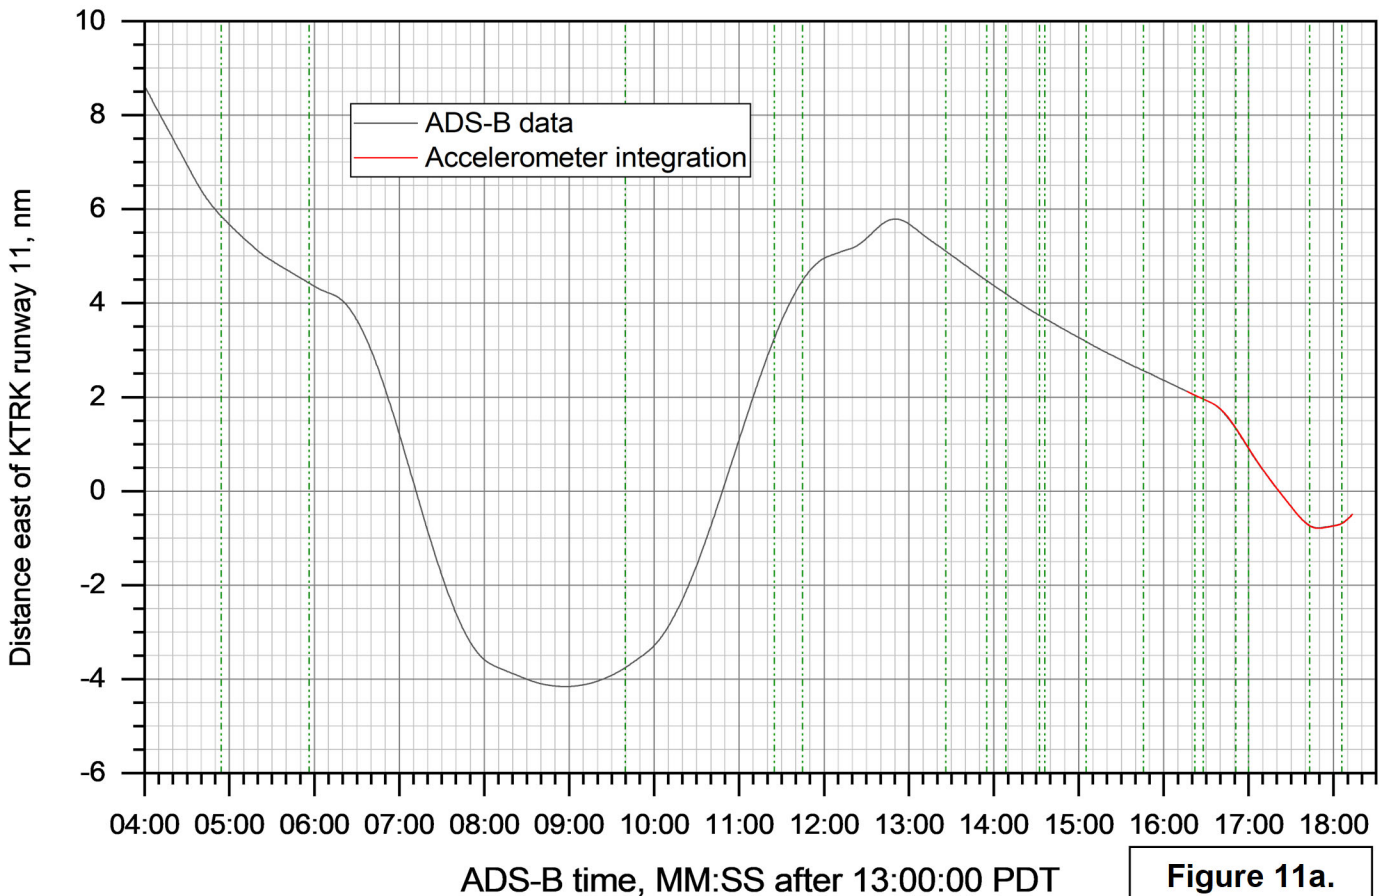
Figure 11a.

North & east coordinates vs. time

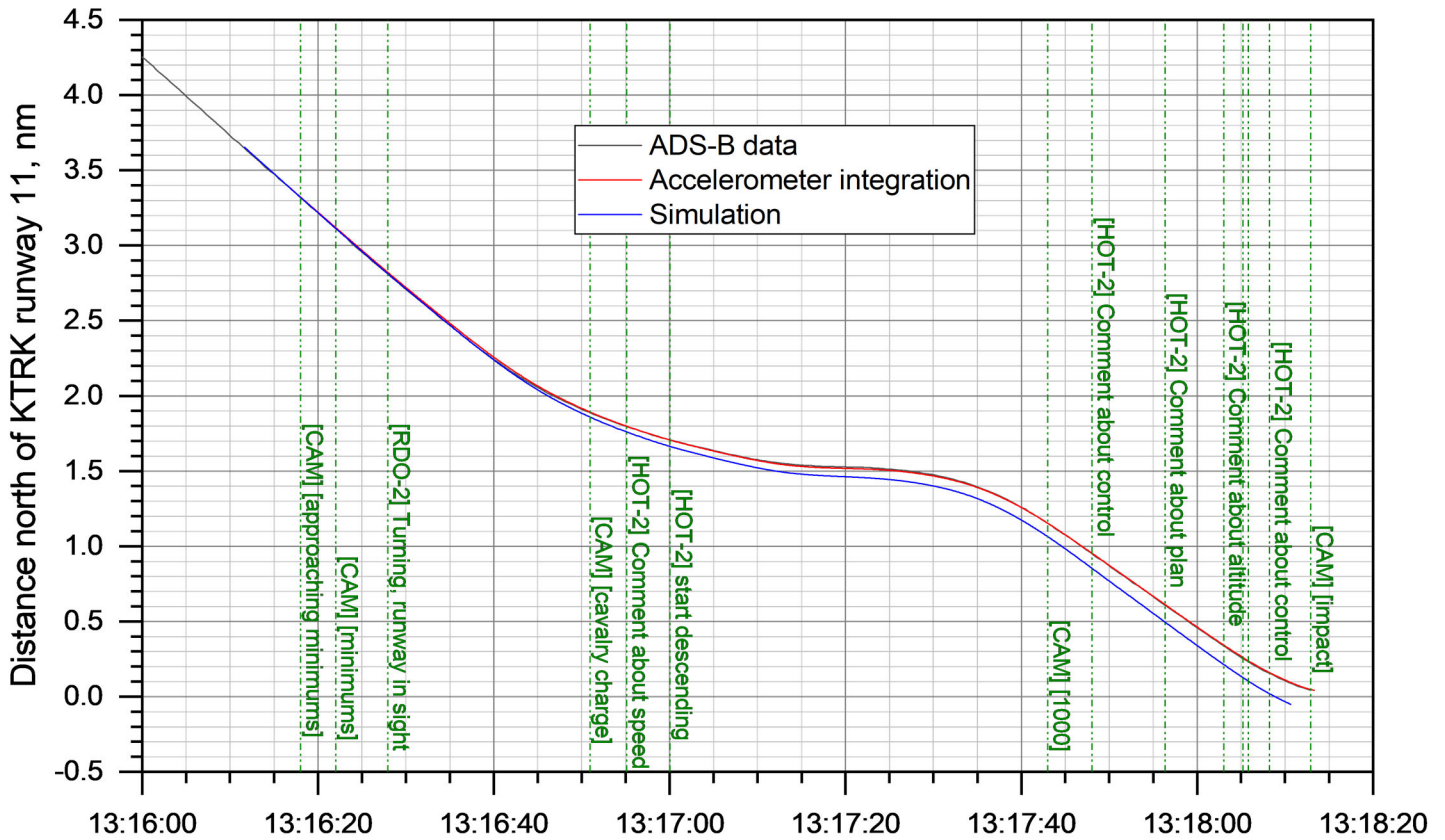
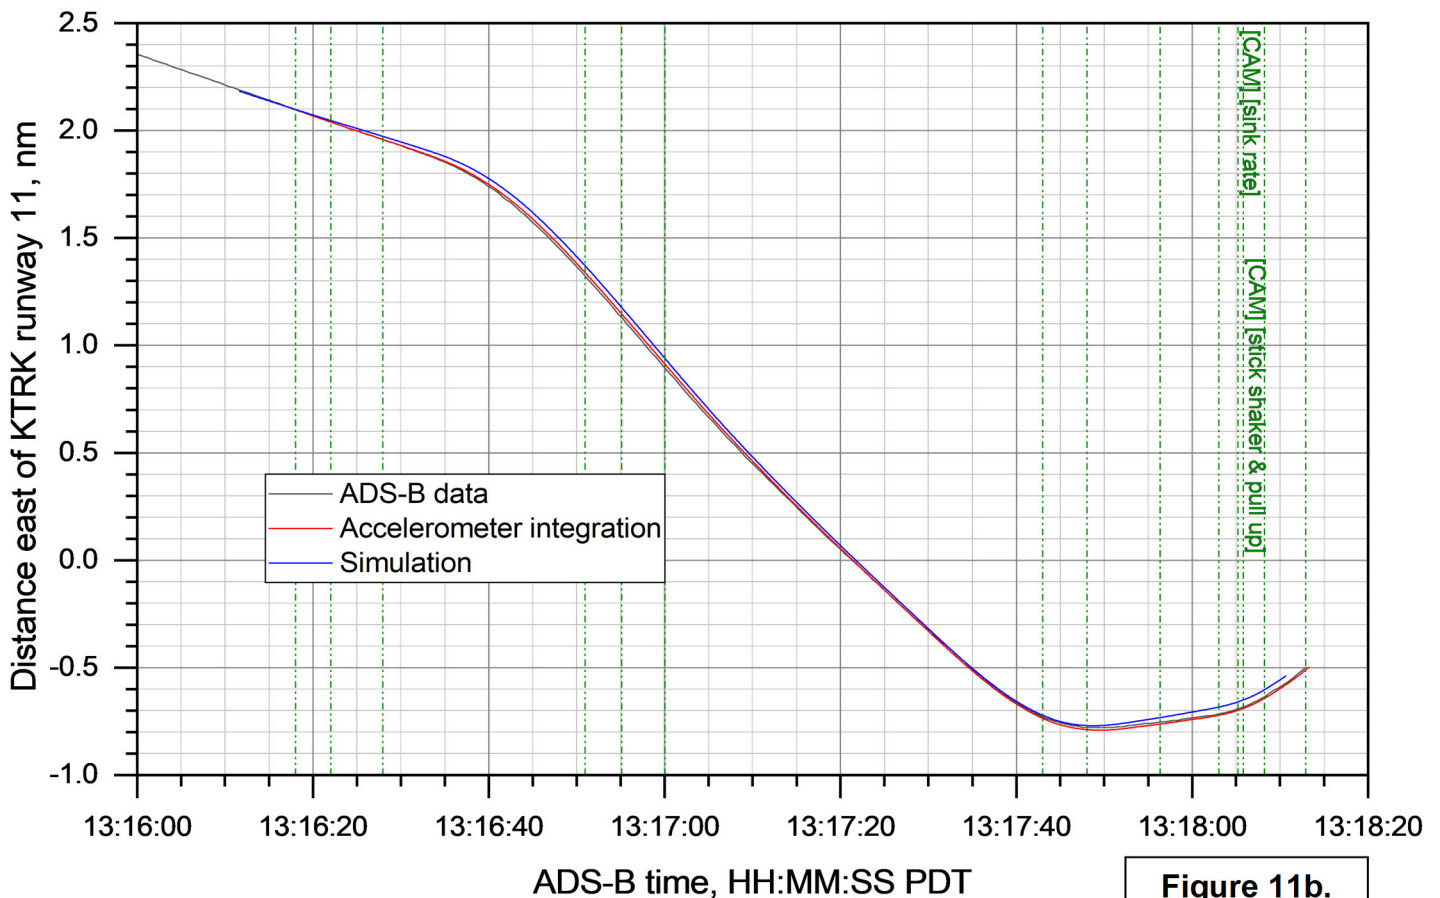
Figure 11b.

North & east coordinates vs. time (detail)

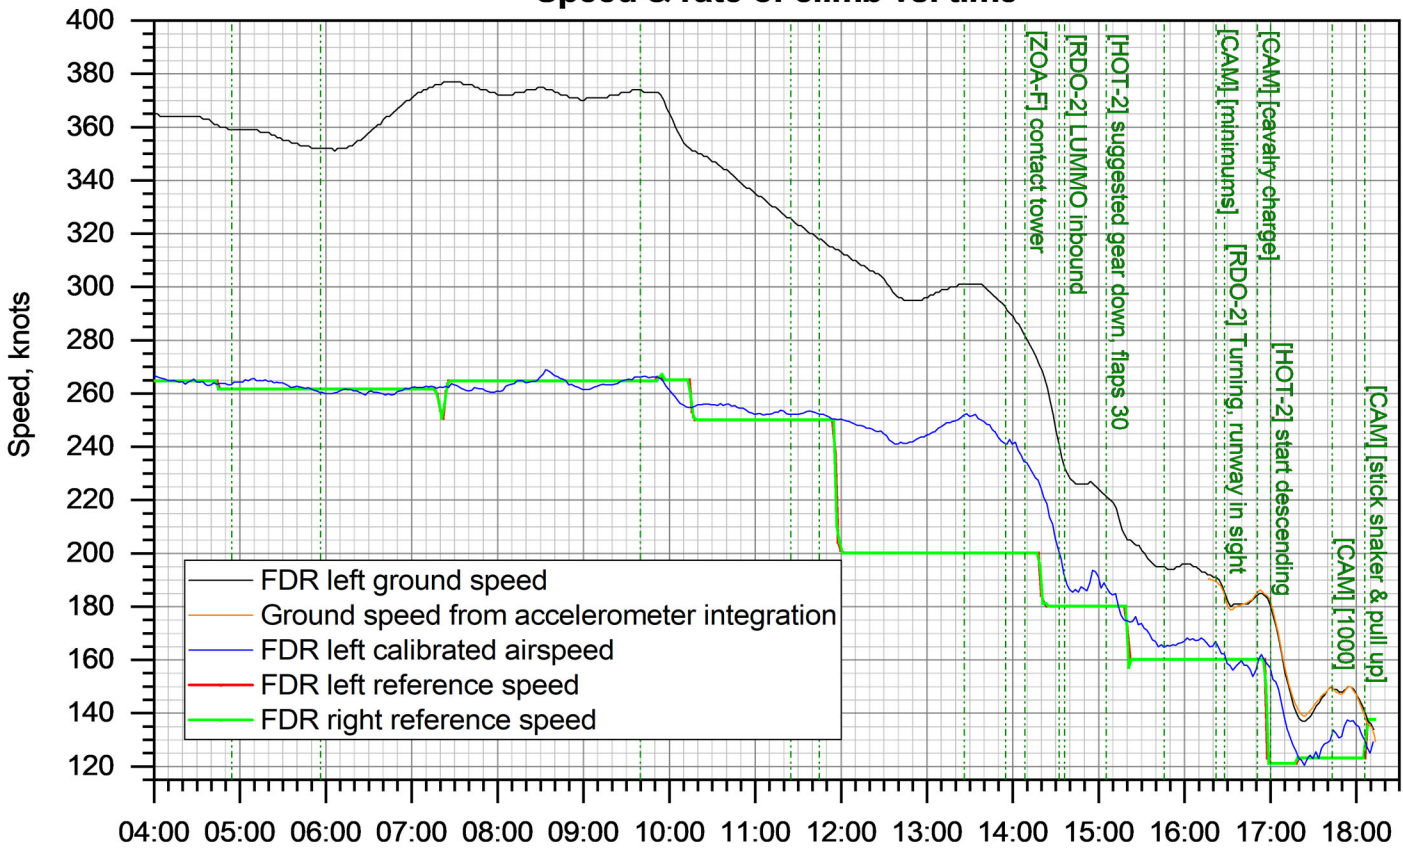
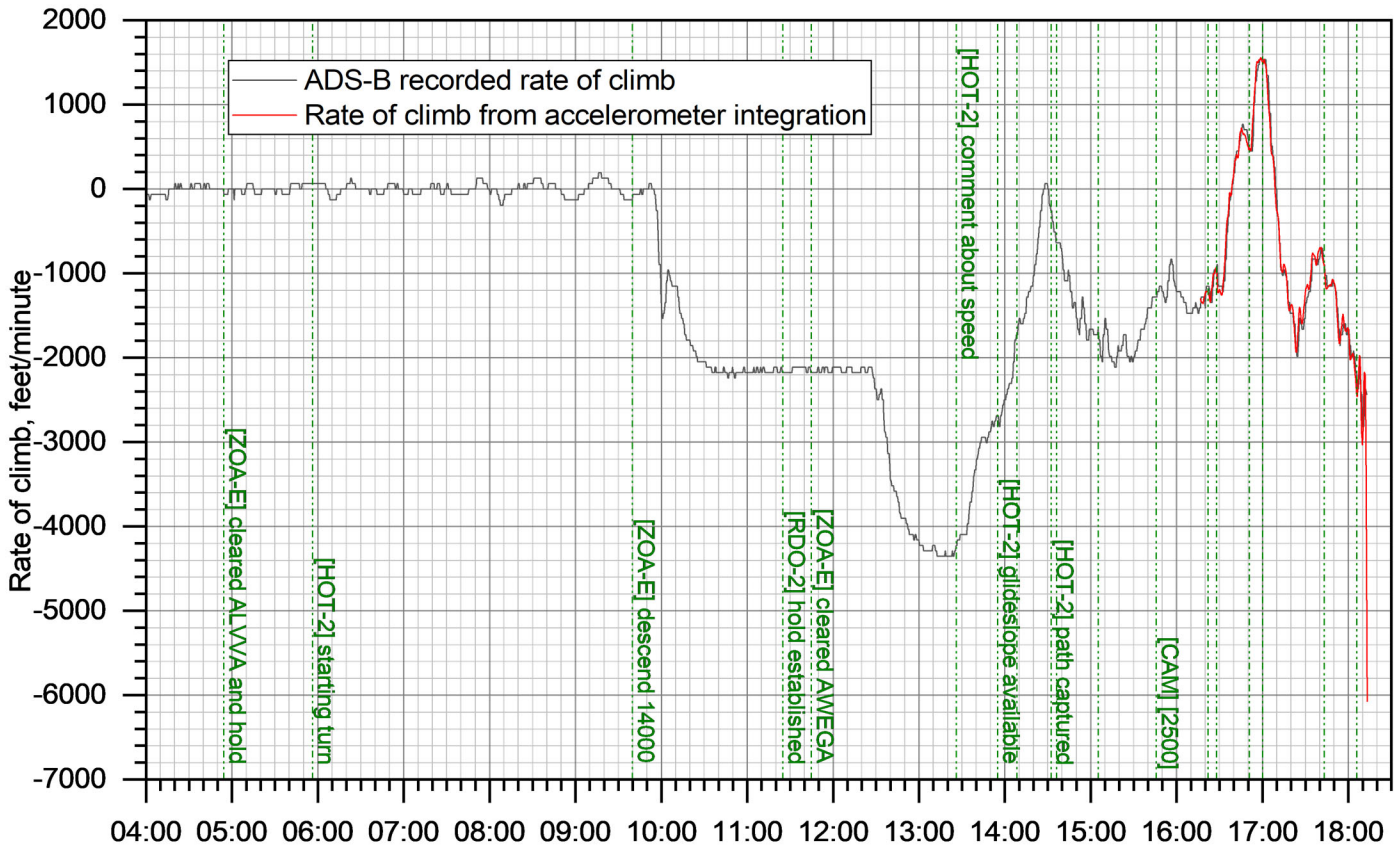
Figure 12a.

Speed & rate of climb vs. time

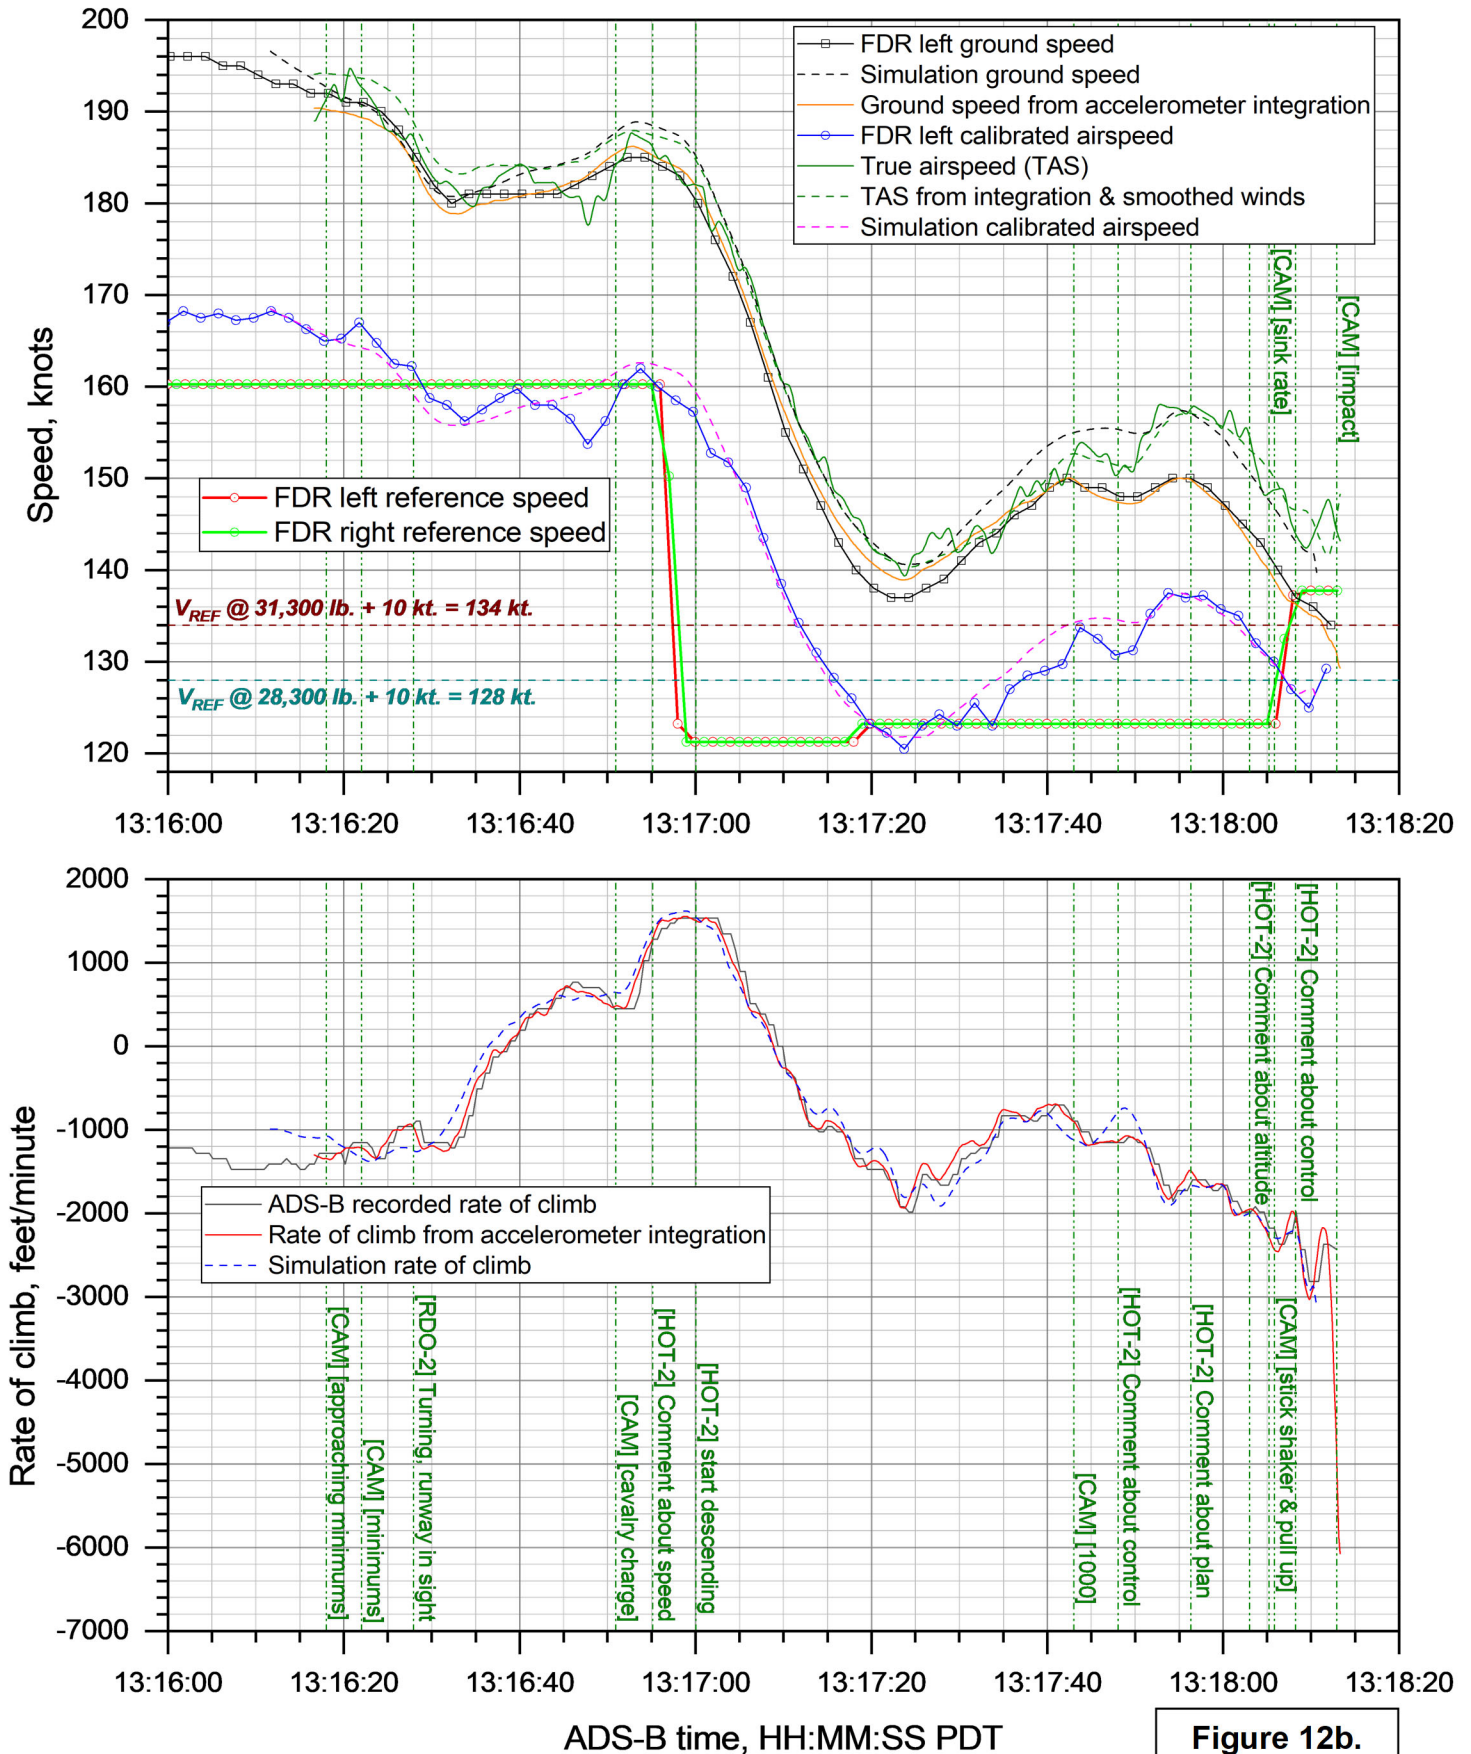
Figure 12b.

Speed & rate of climb vs. time (detail)

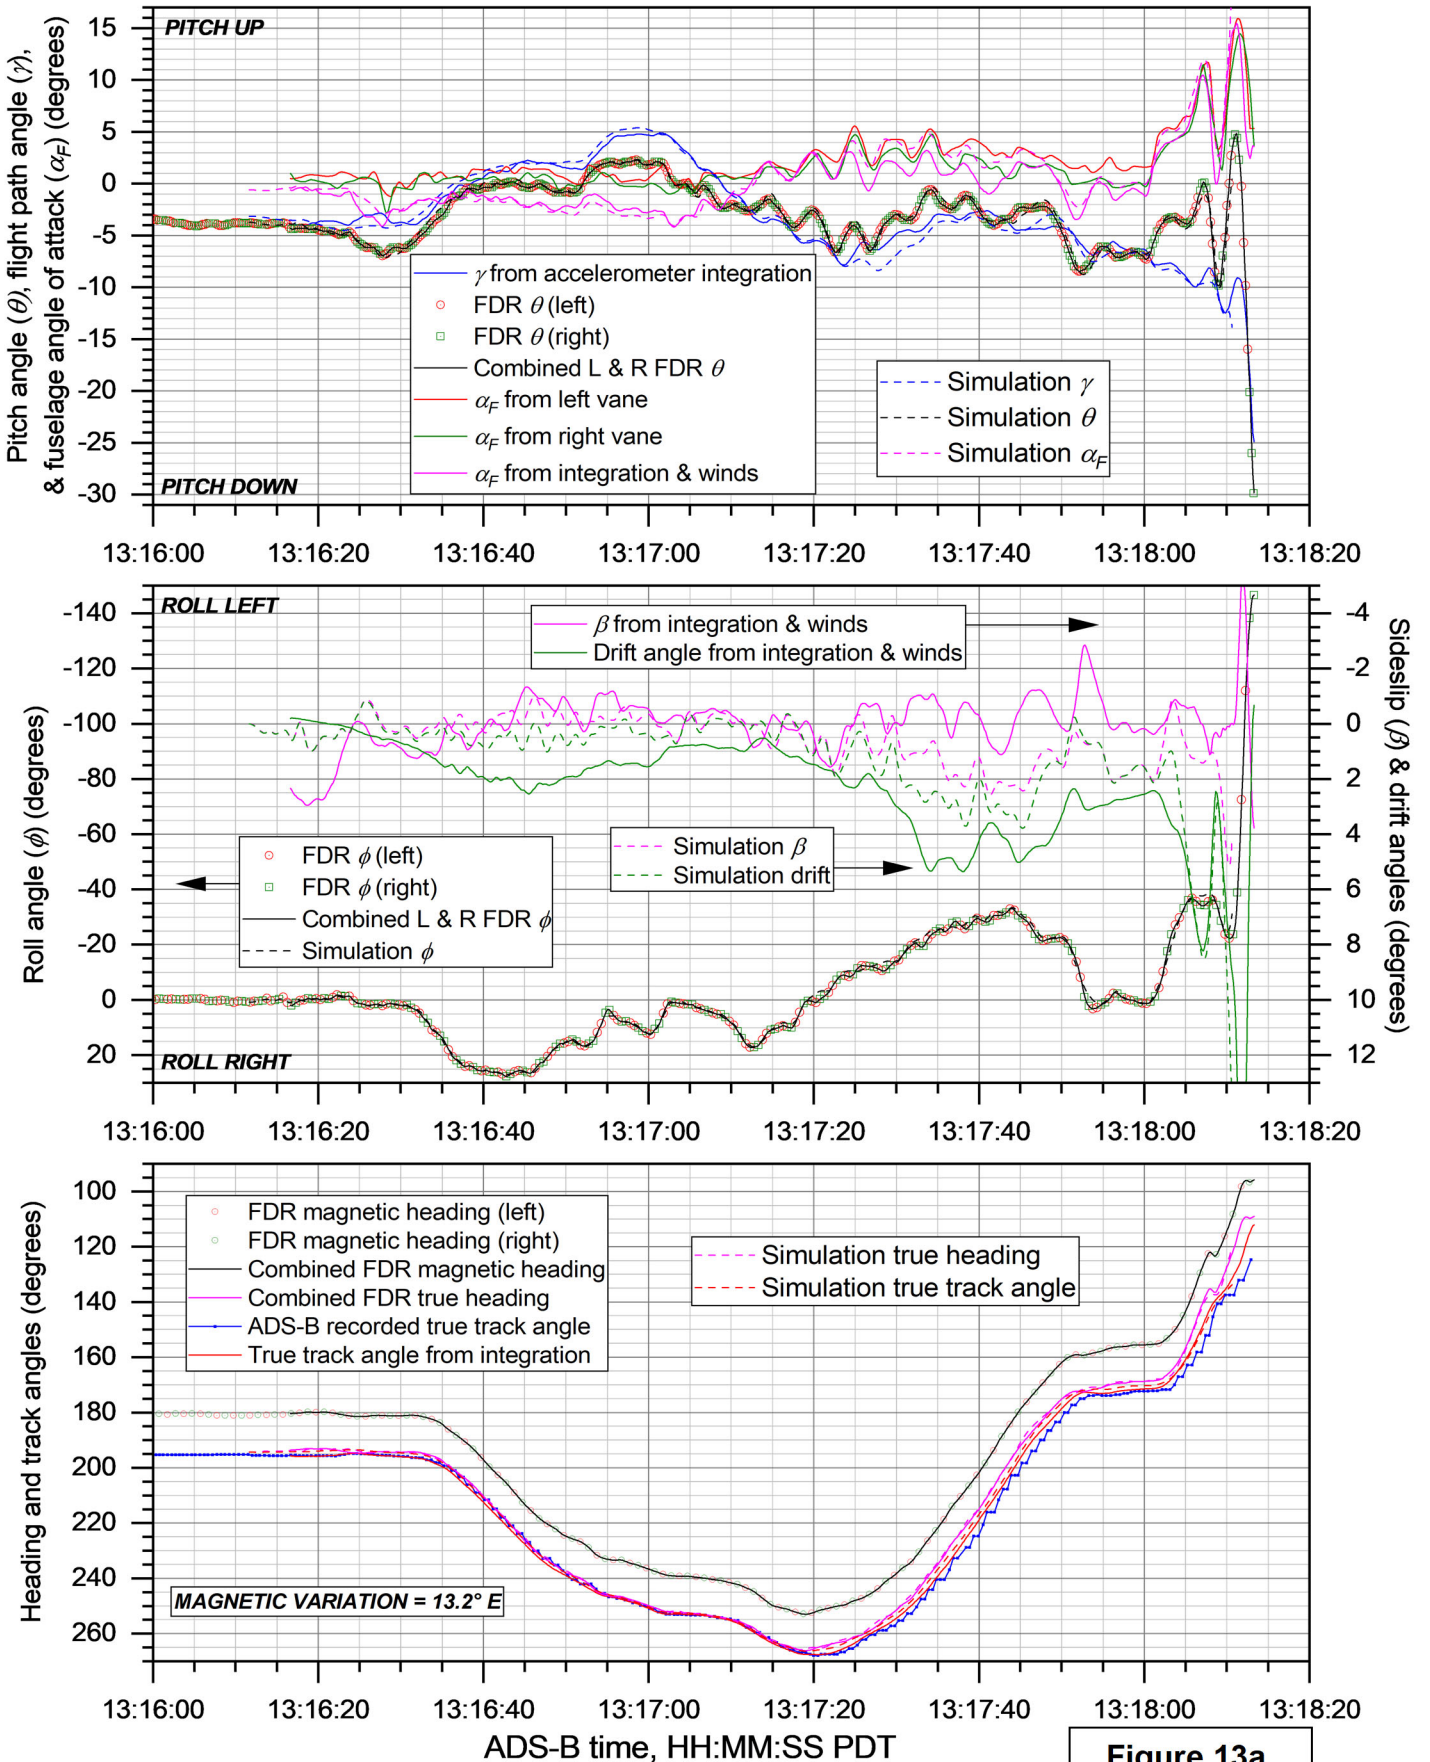
Figure 13a.

Euler angles during circling maneuver

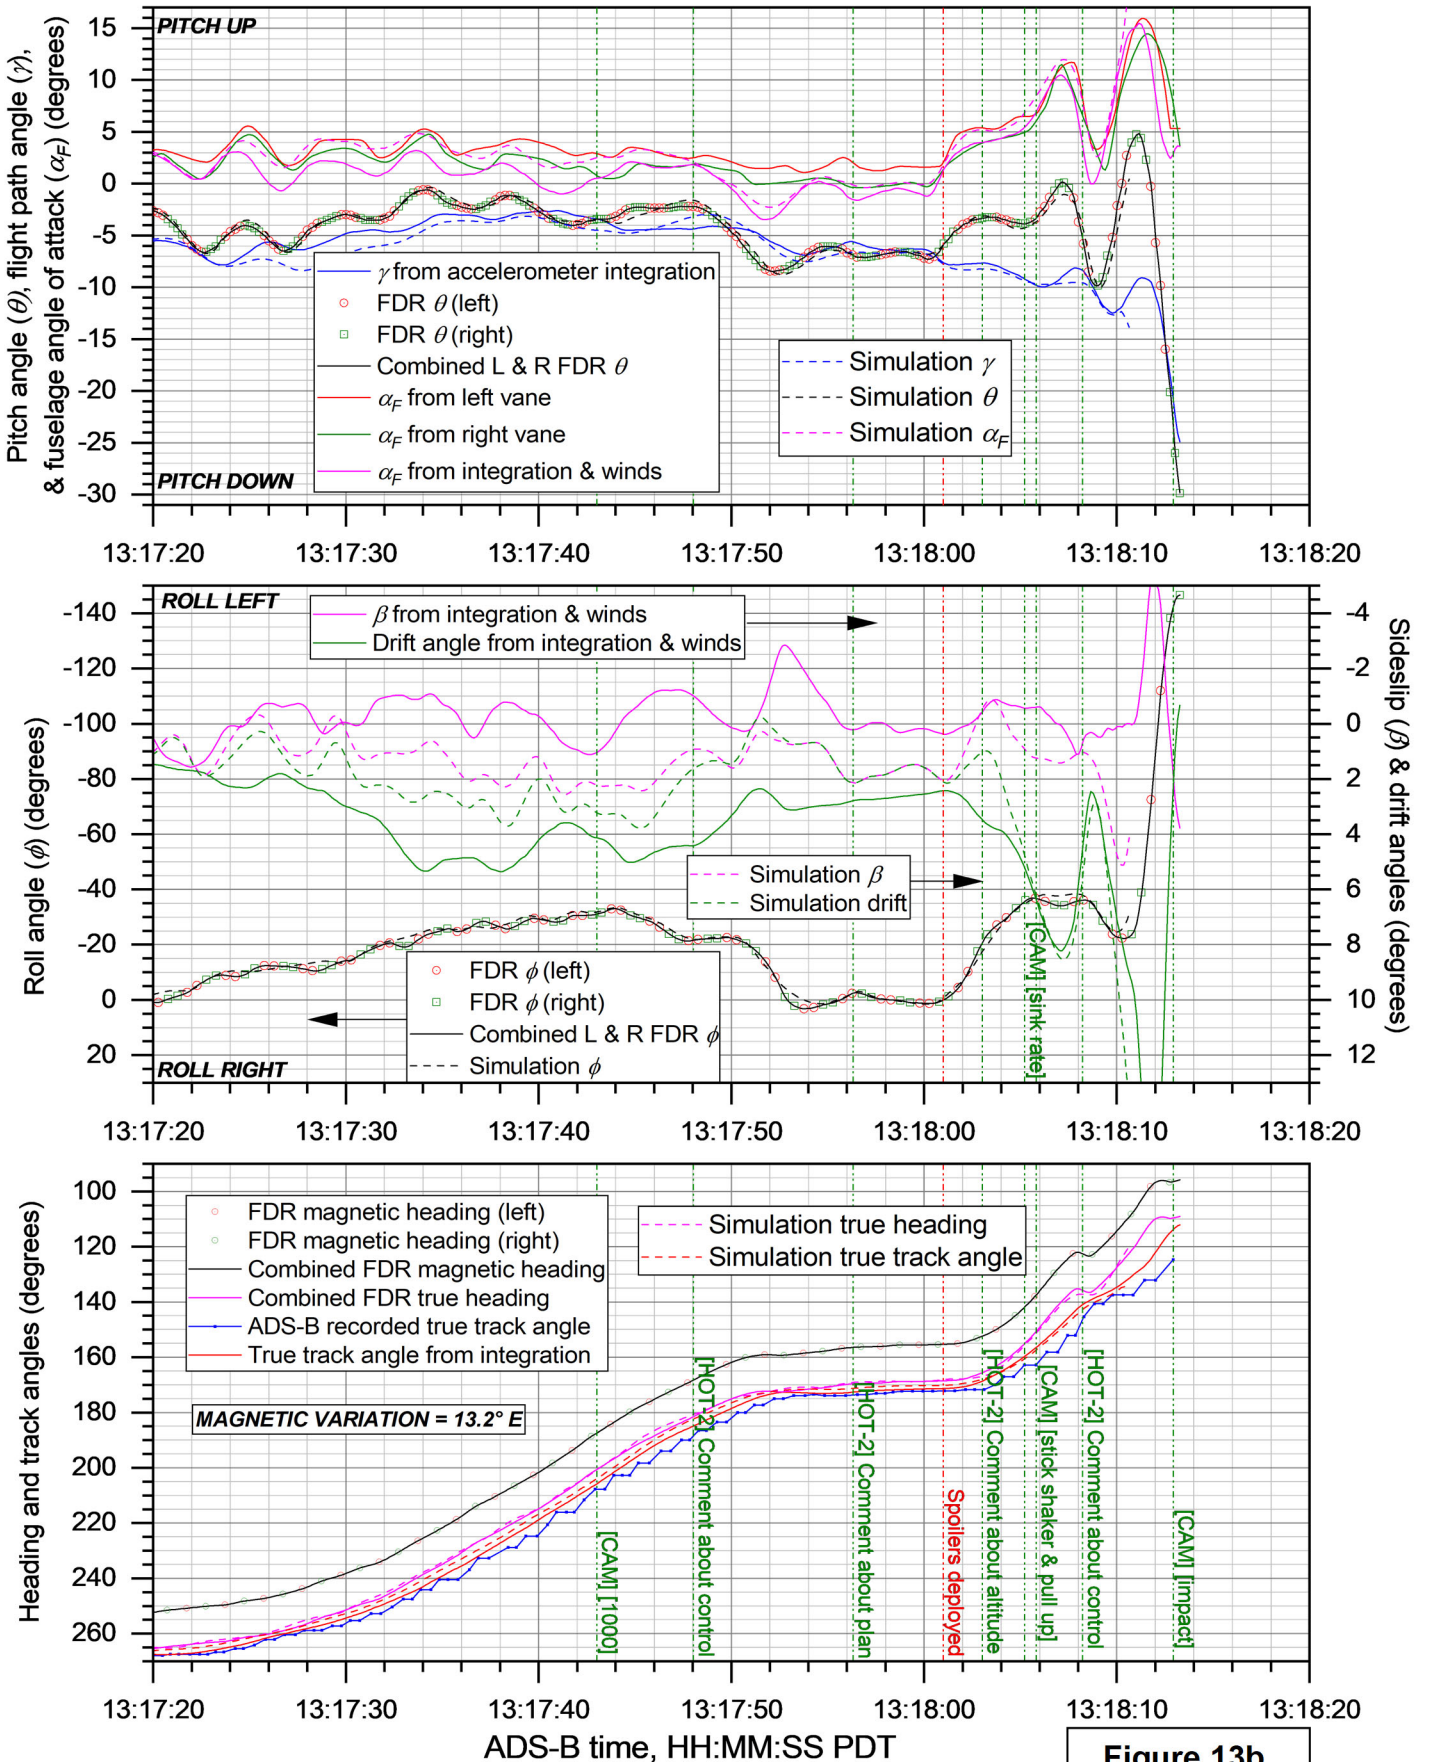
Figure 13b.

Euler angles during circling maneuver (detail)

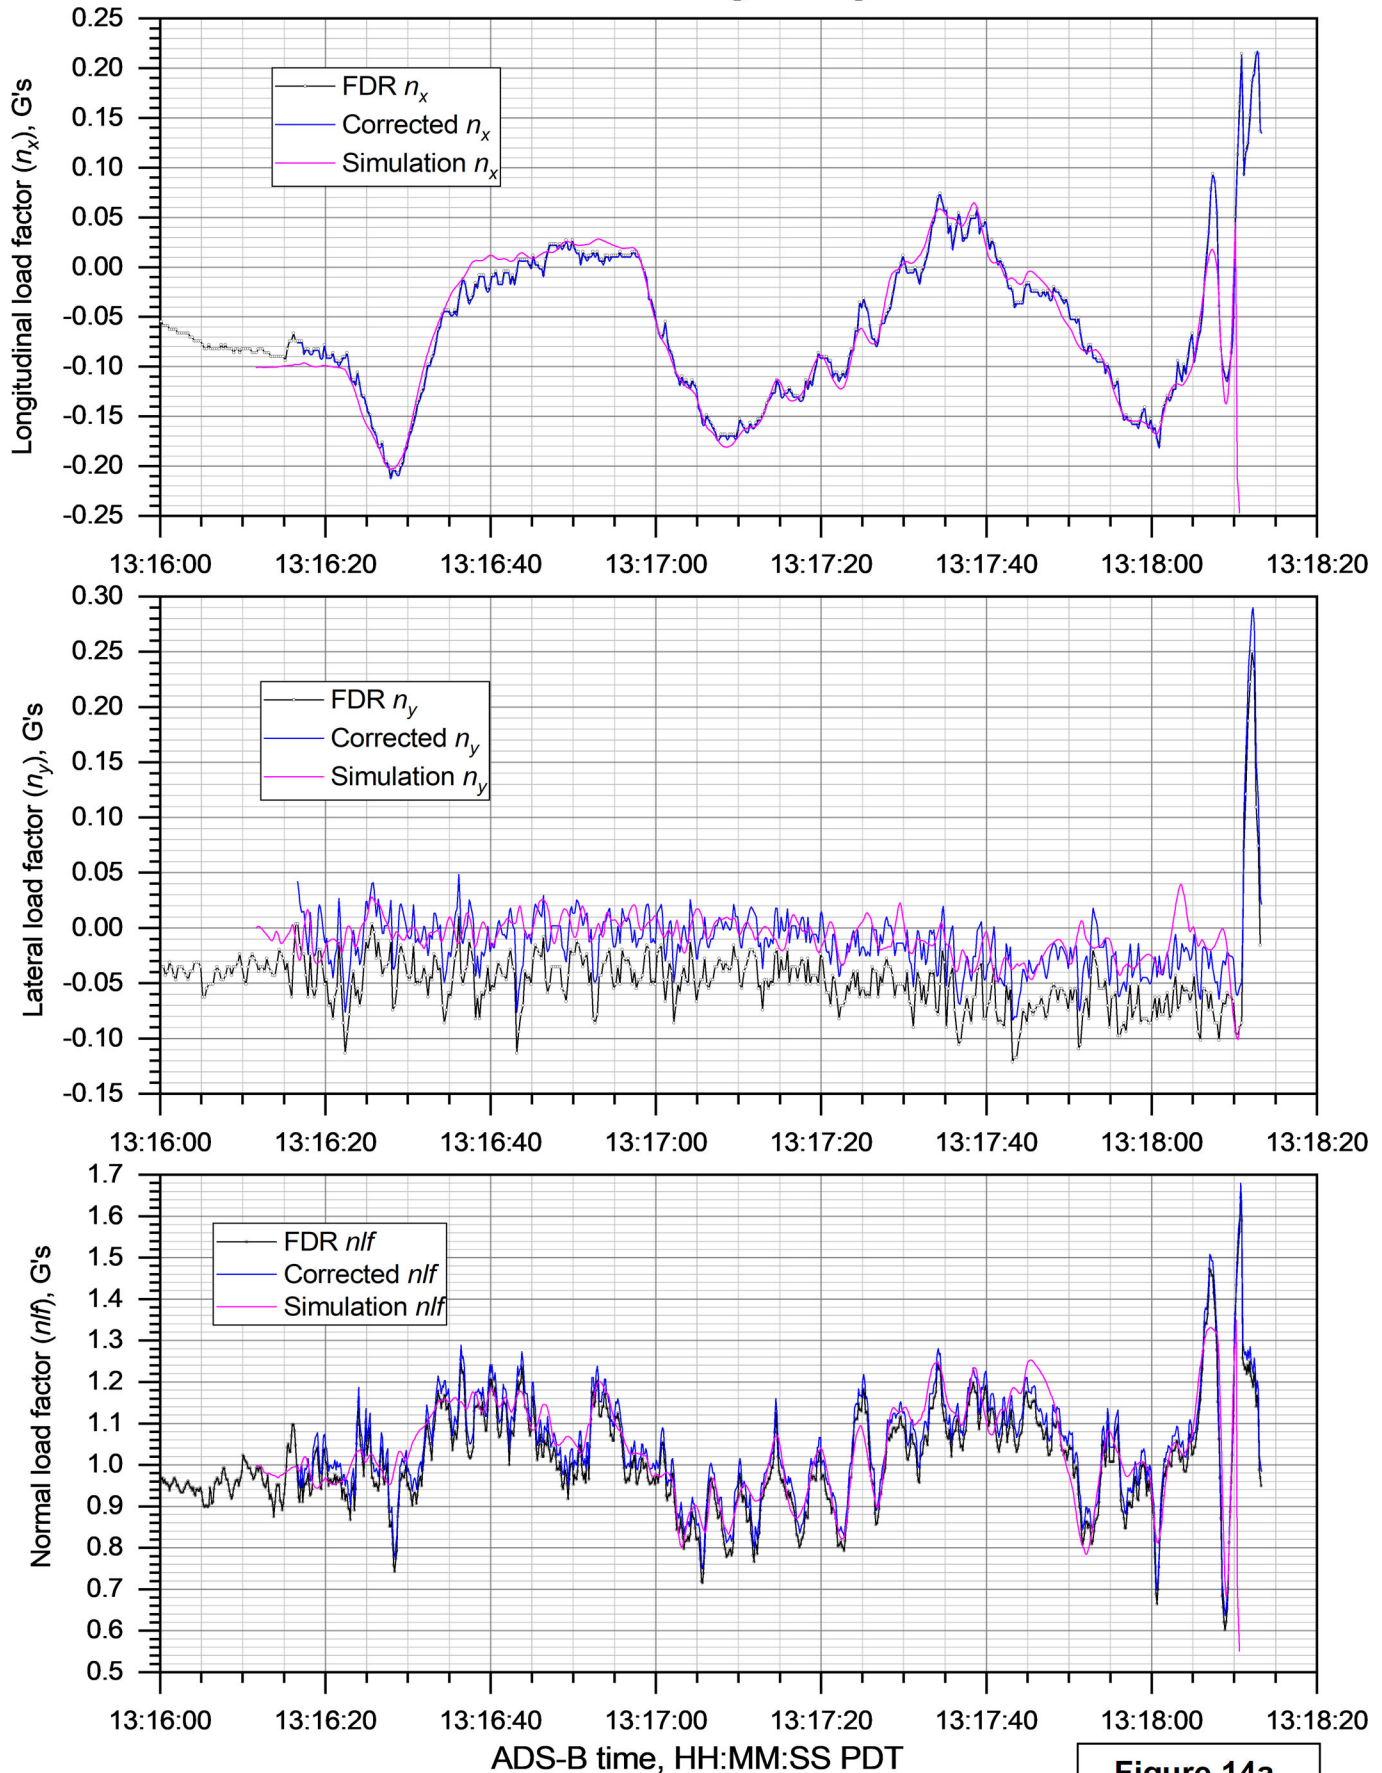
Figure 14a.

Load factors during circling maneuver

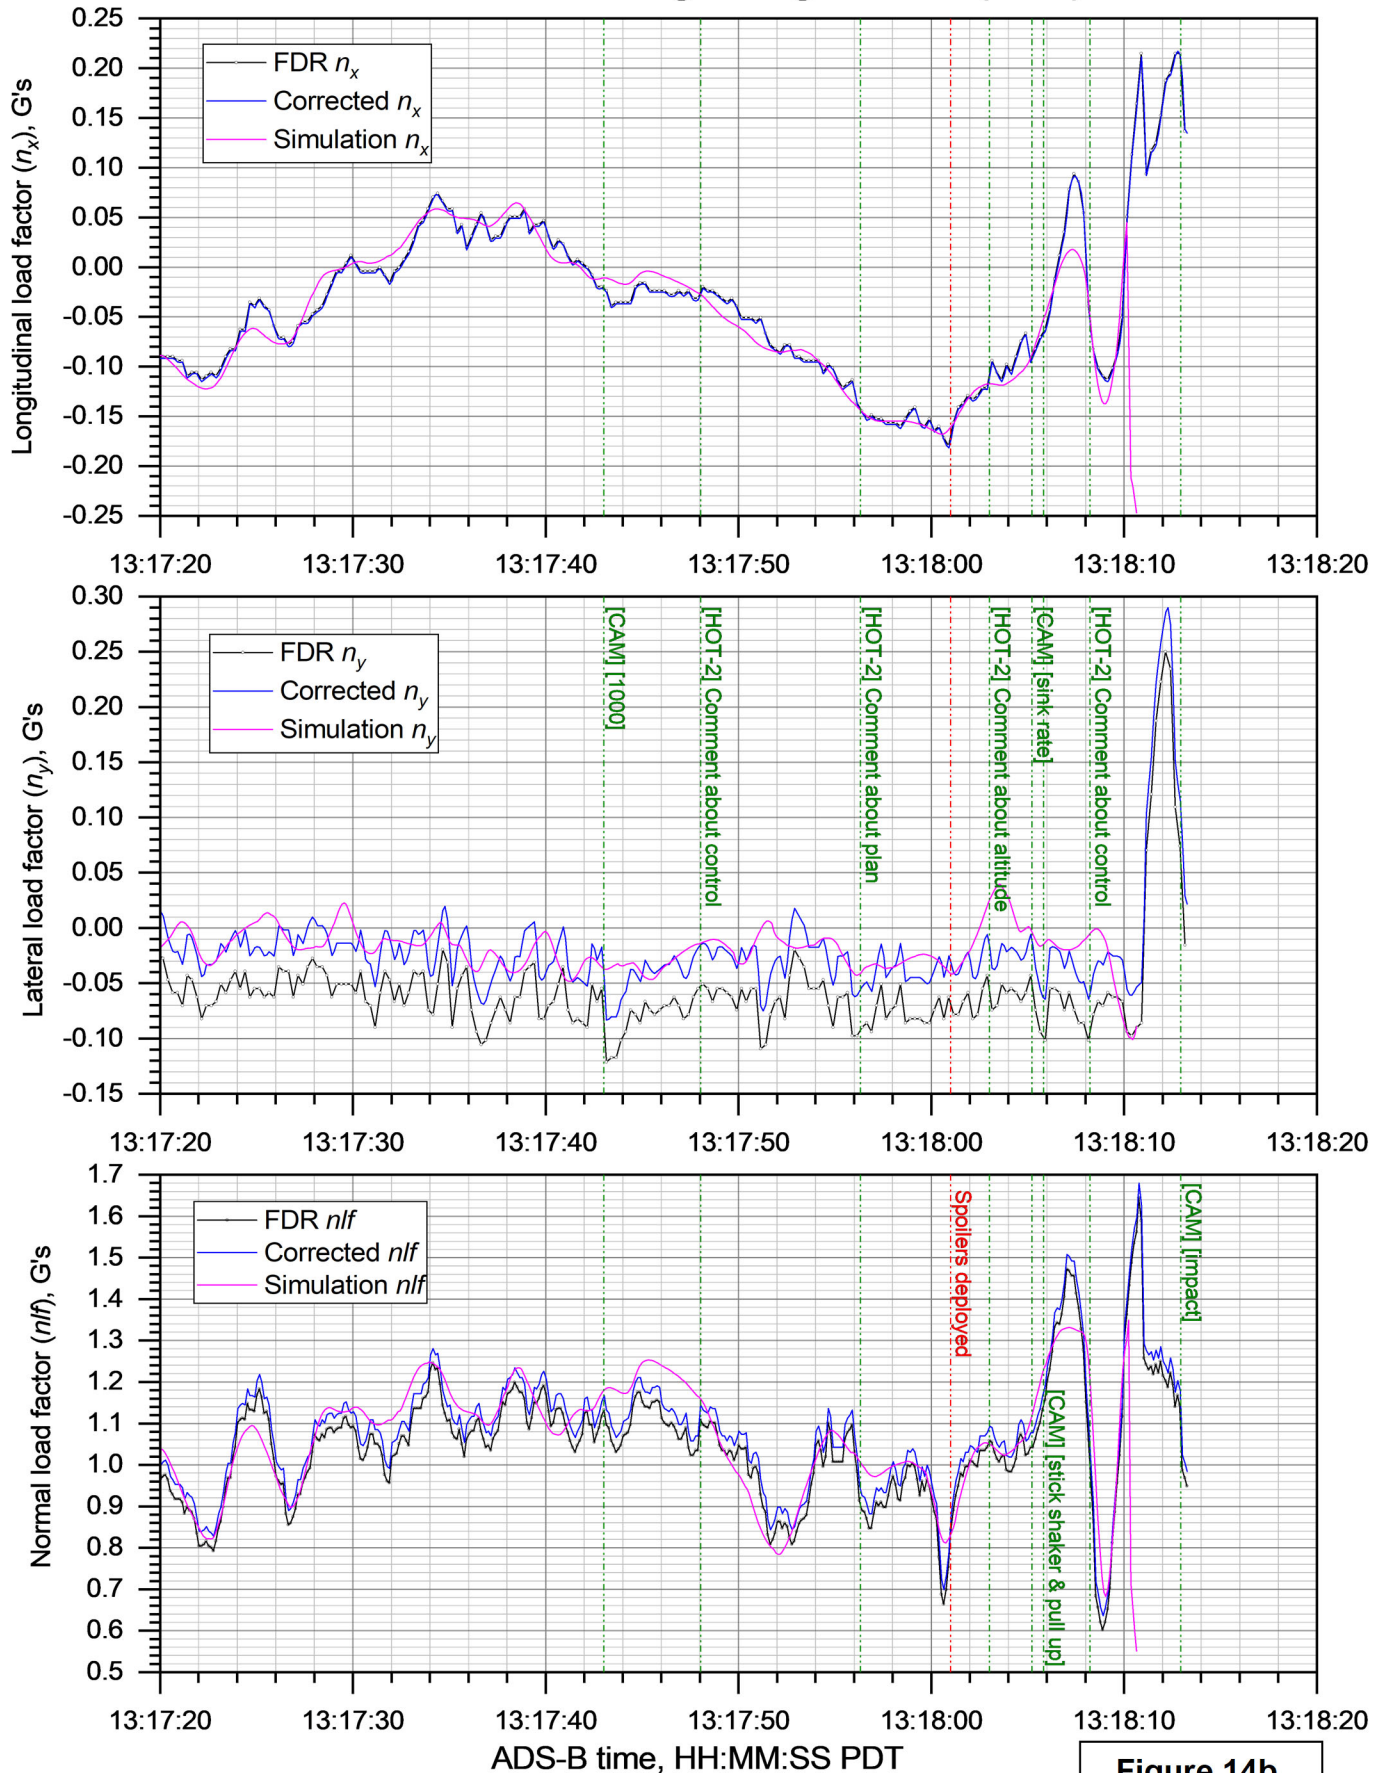
Figure 14b.

Load factors during circling maneuver (detail)

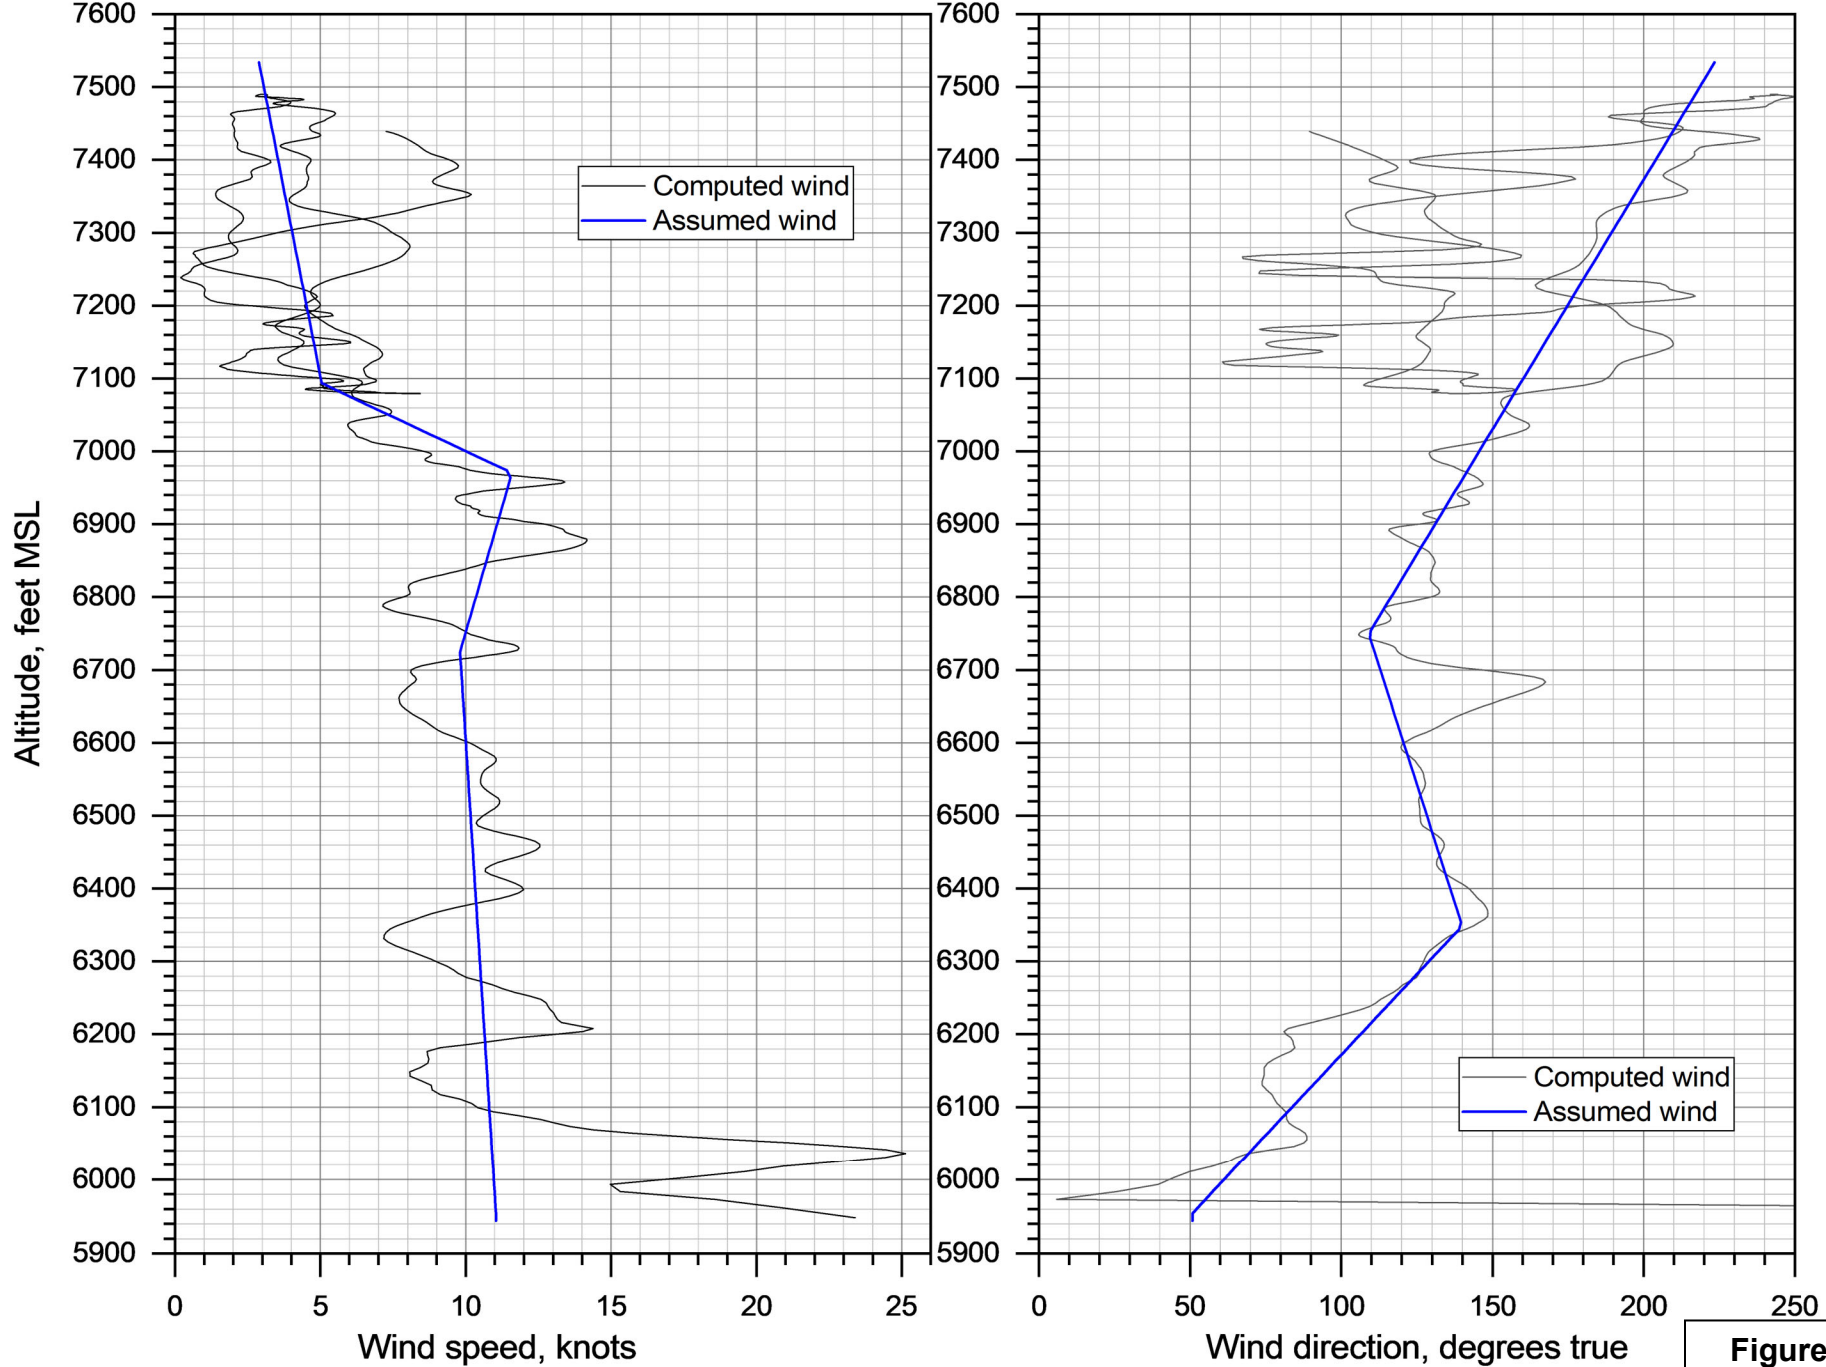
Figure 16.

Assumed winds vs. altitude for inertial α and β calculations
