NATIONAL TRANSPORTATION SAFETY BOARD

Aircraft Performance Study

Aircraft: Bombardier CL-600-2B16, registration N605TR

NTSB#: WPR21FA286

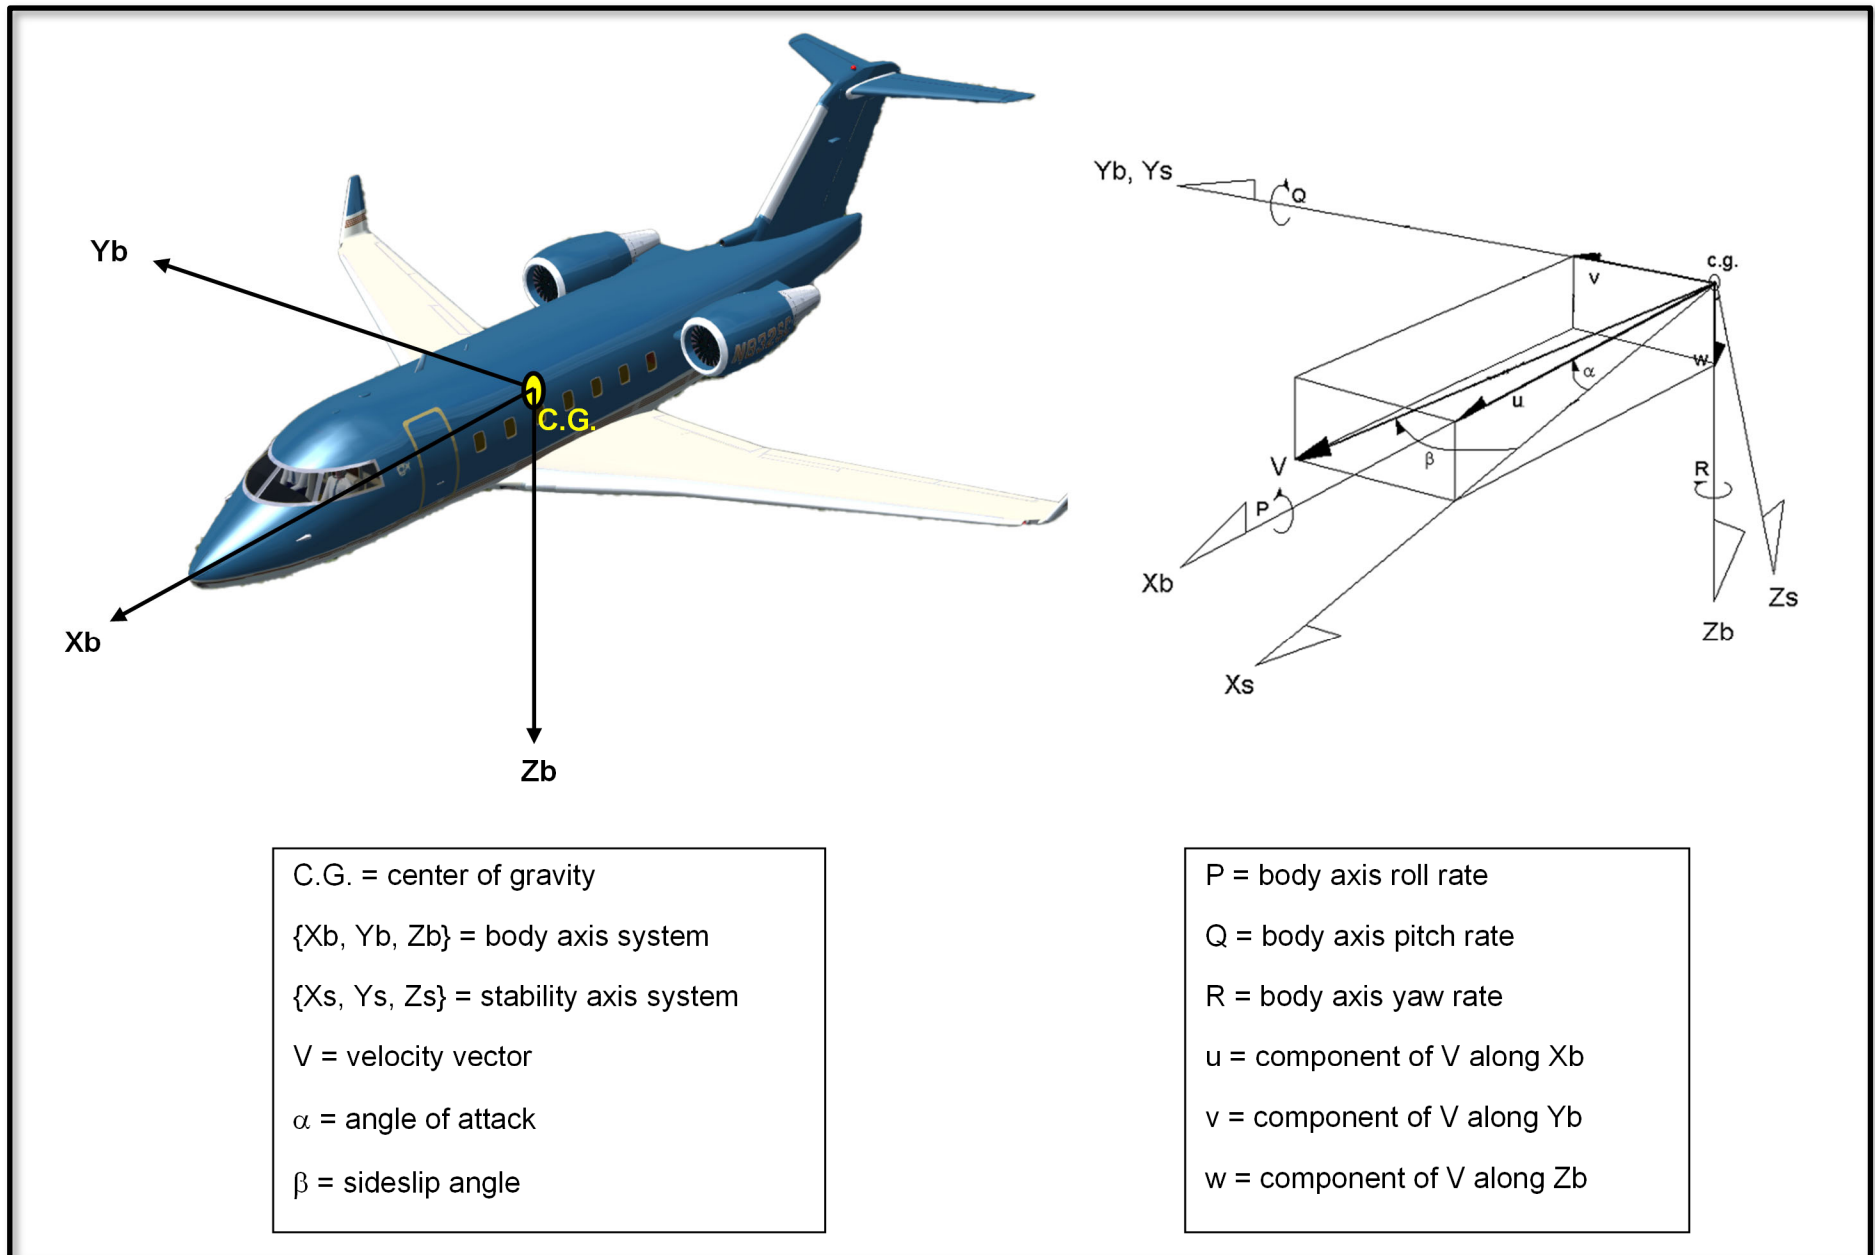
Figure 17. Airplane body axis system, body-axis components of linear and angular velocities, and definitions of α and β .

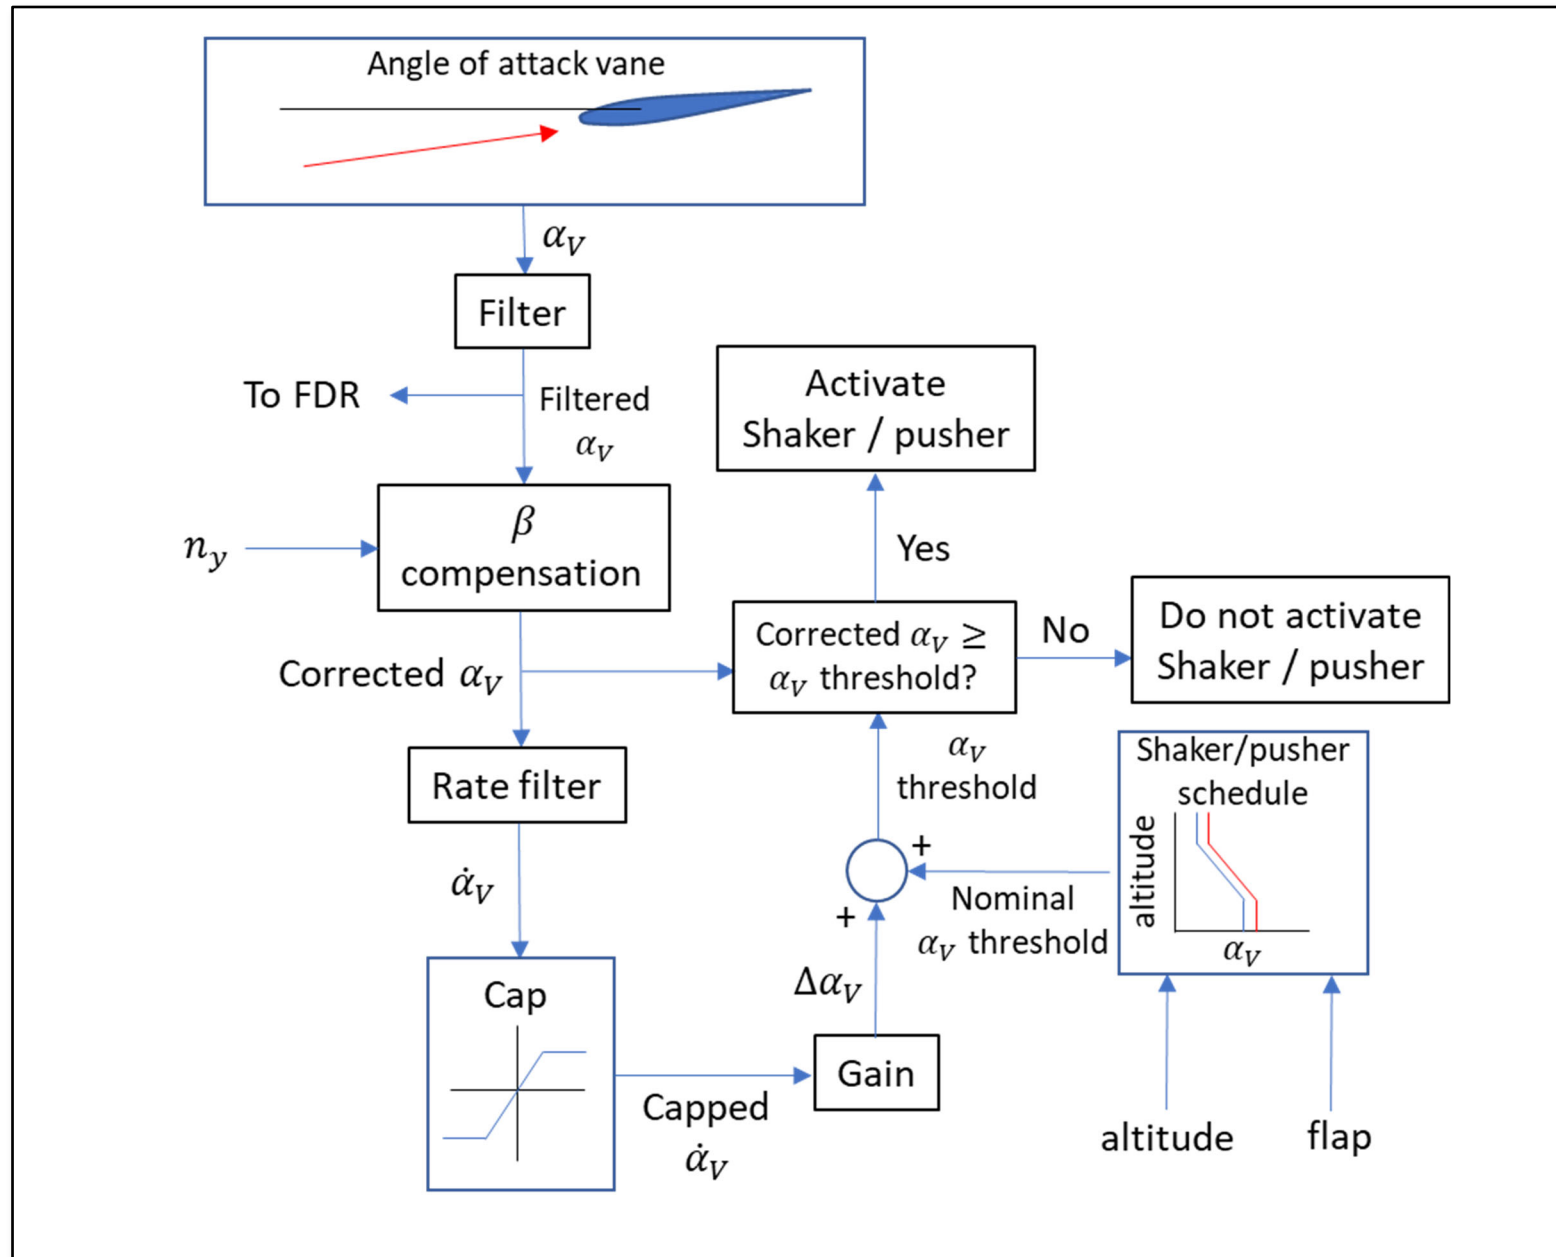
Figure 18. Diagram of SPC shaker / pusher activation logic (cancellation logic, including hysteresis, not shown).

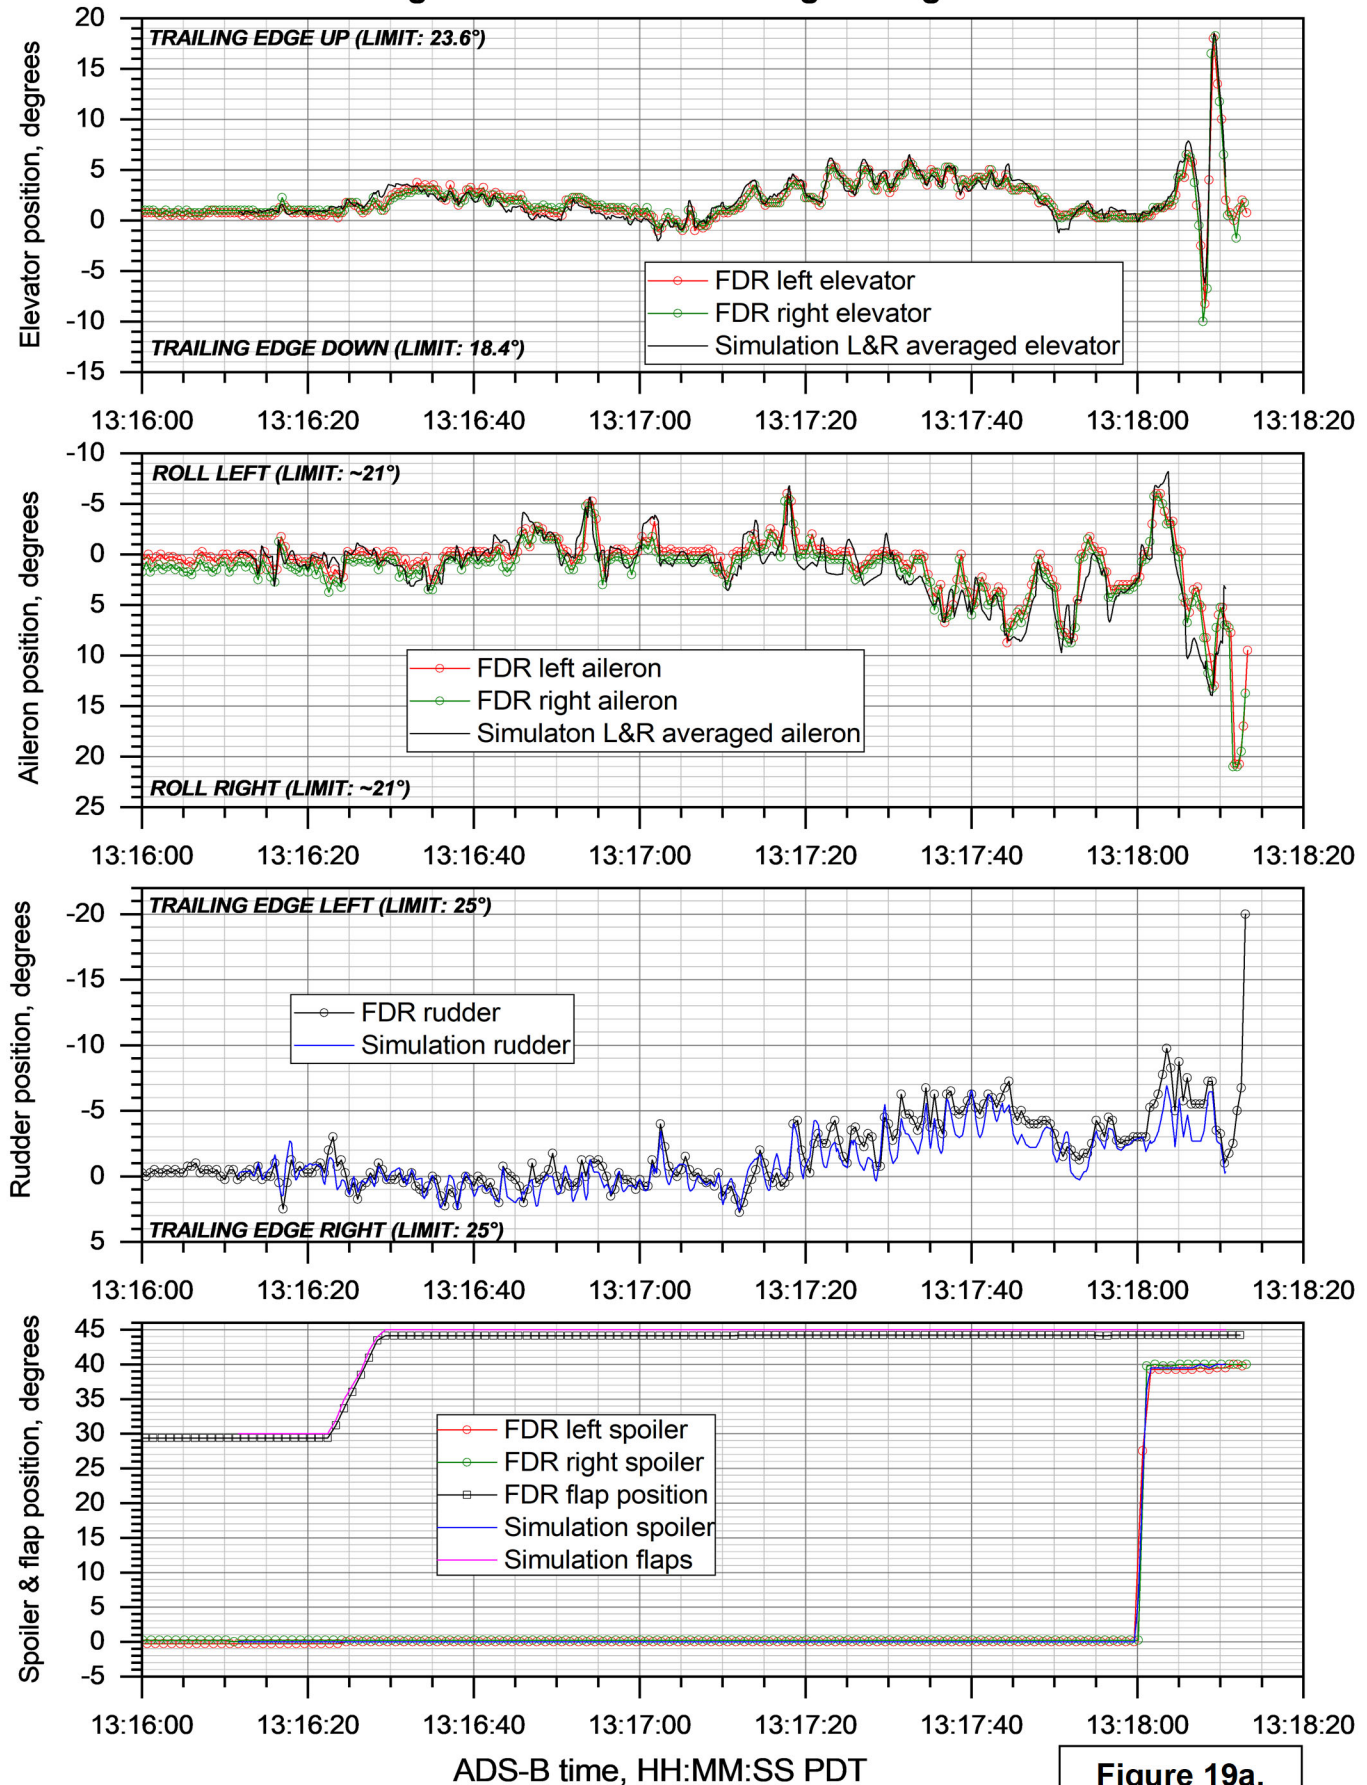
Figure 19a.

WPR21FA286: Bombardier CL-600-2B16, N605TR, Truckee, CA, 07/26/2021 Flight control surfaces during circling maneuver

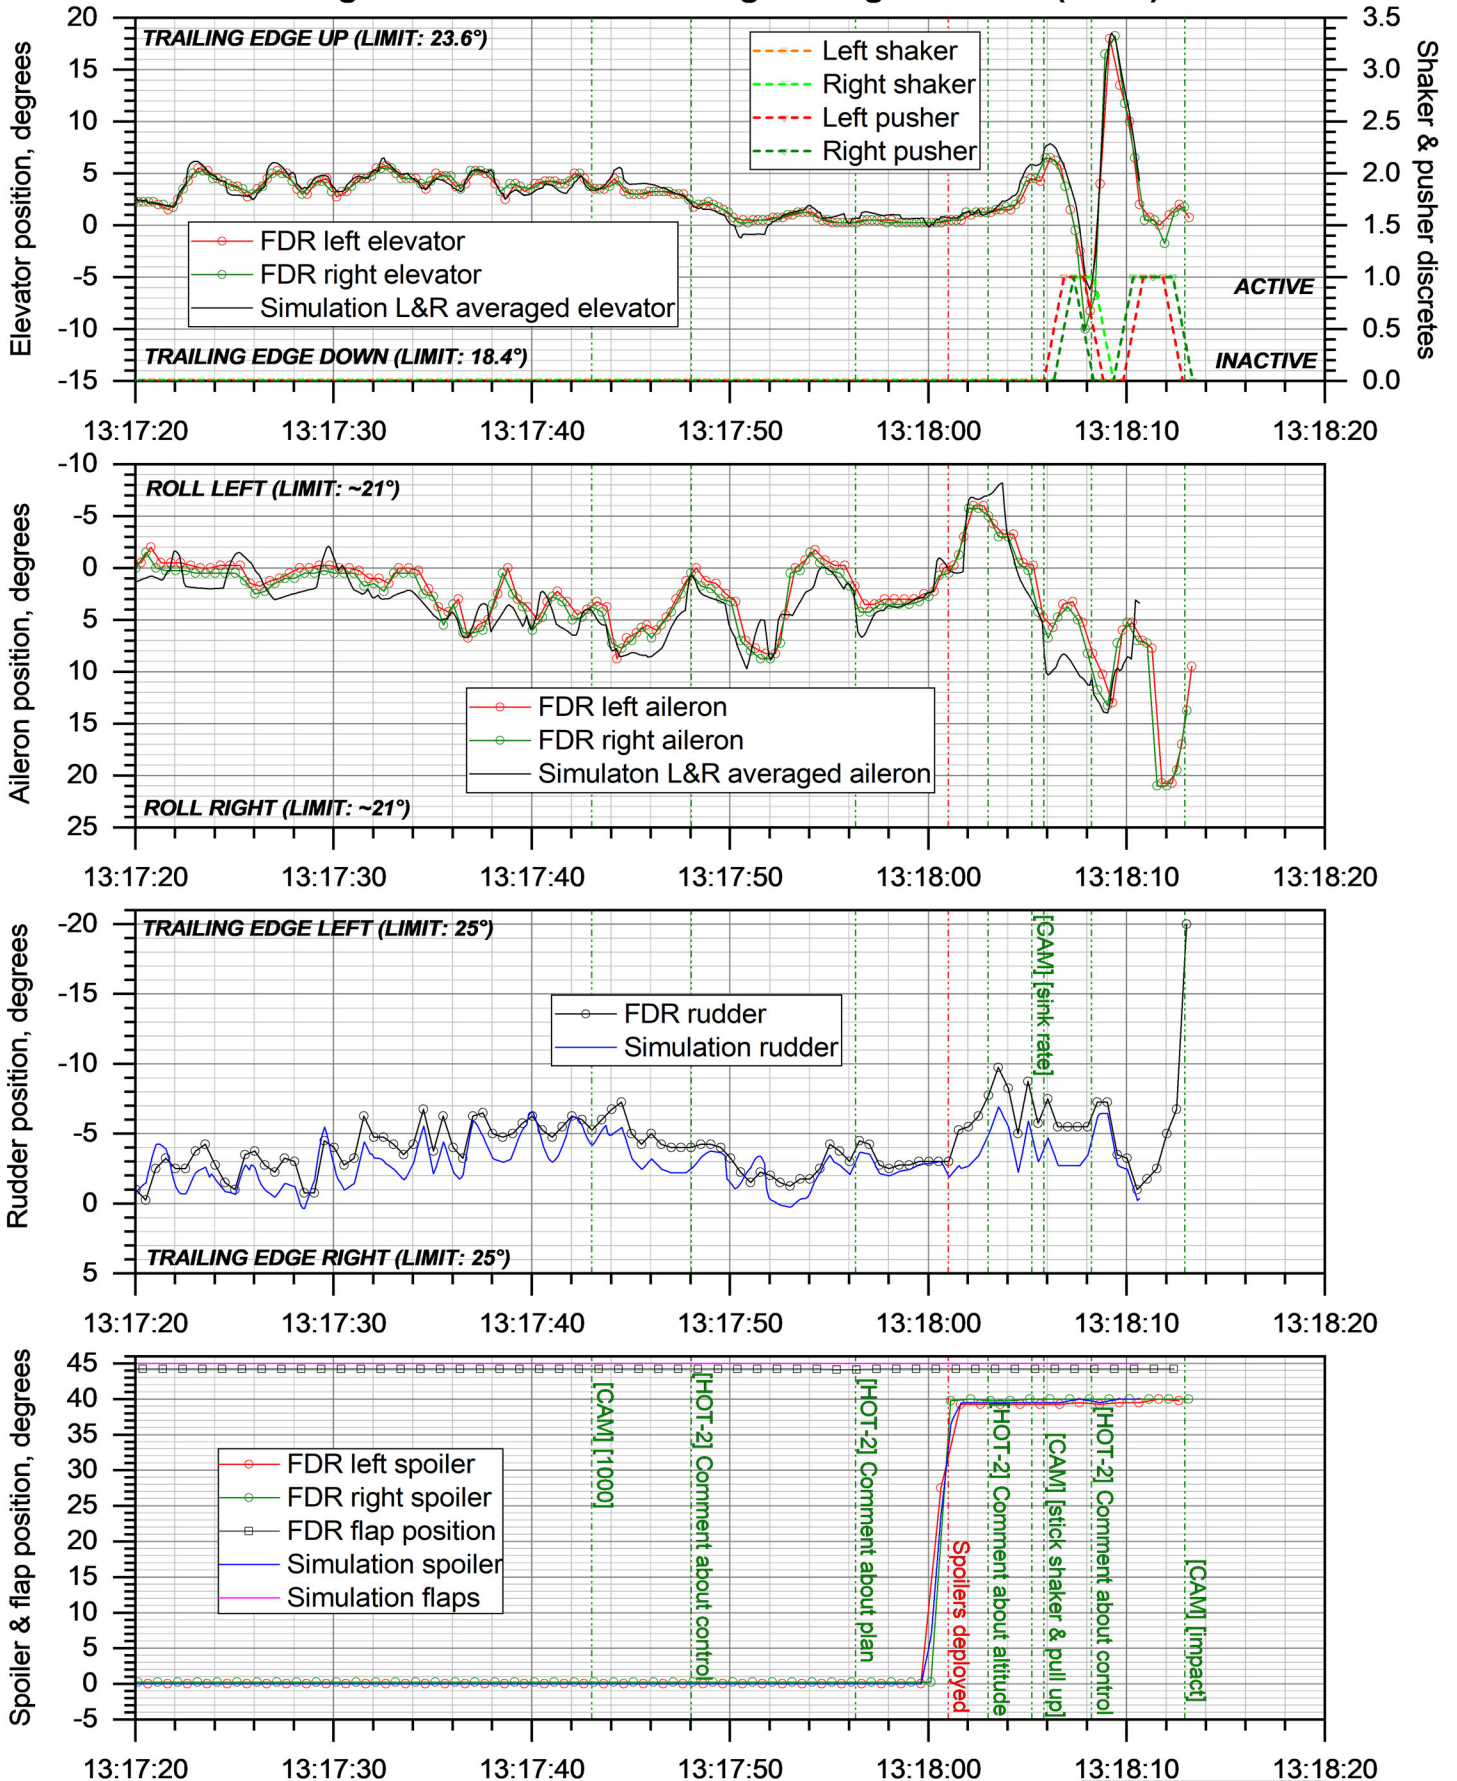
Figure 19b.

Flight control surfaces during circling maneuver (detail)

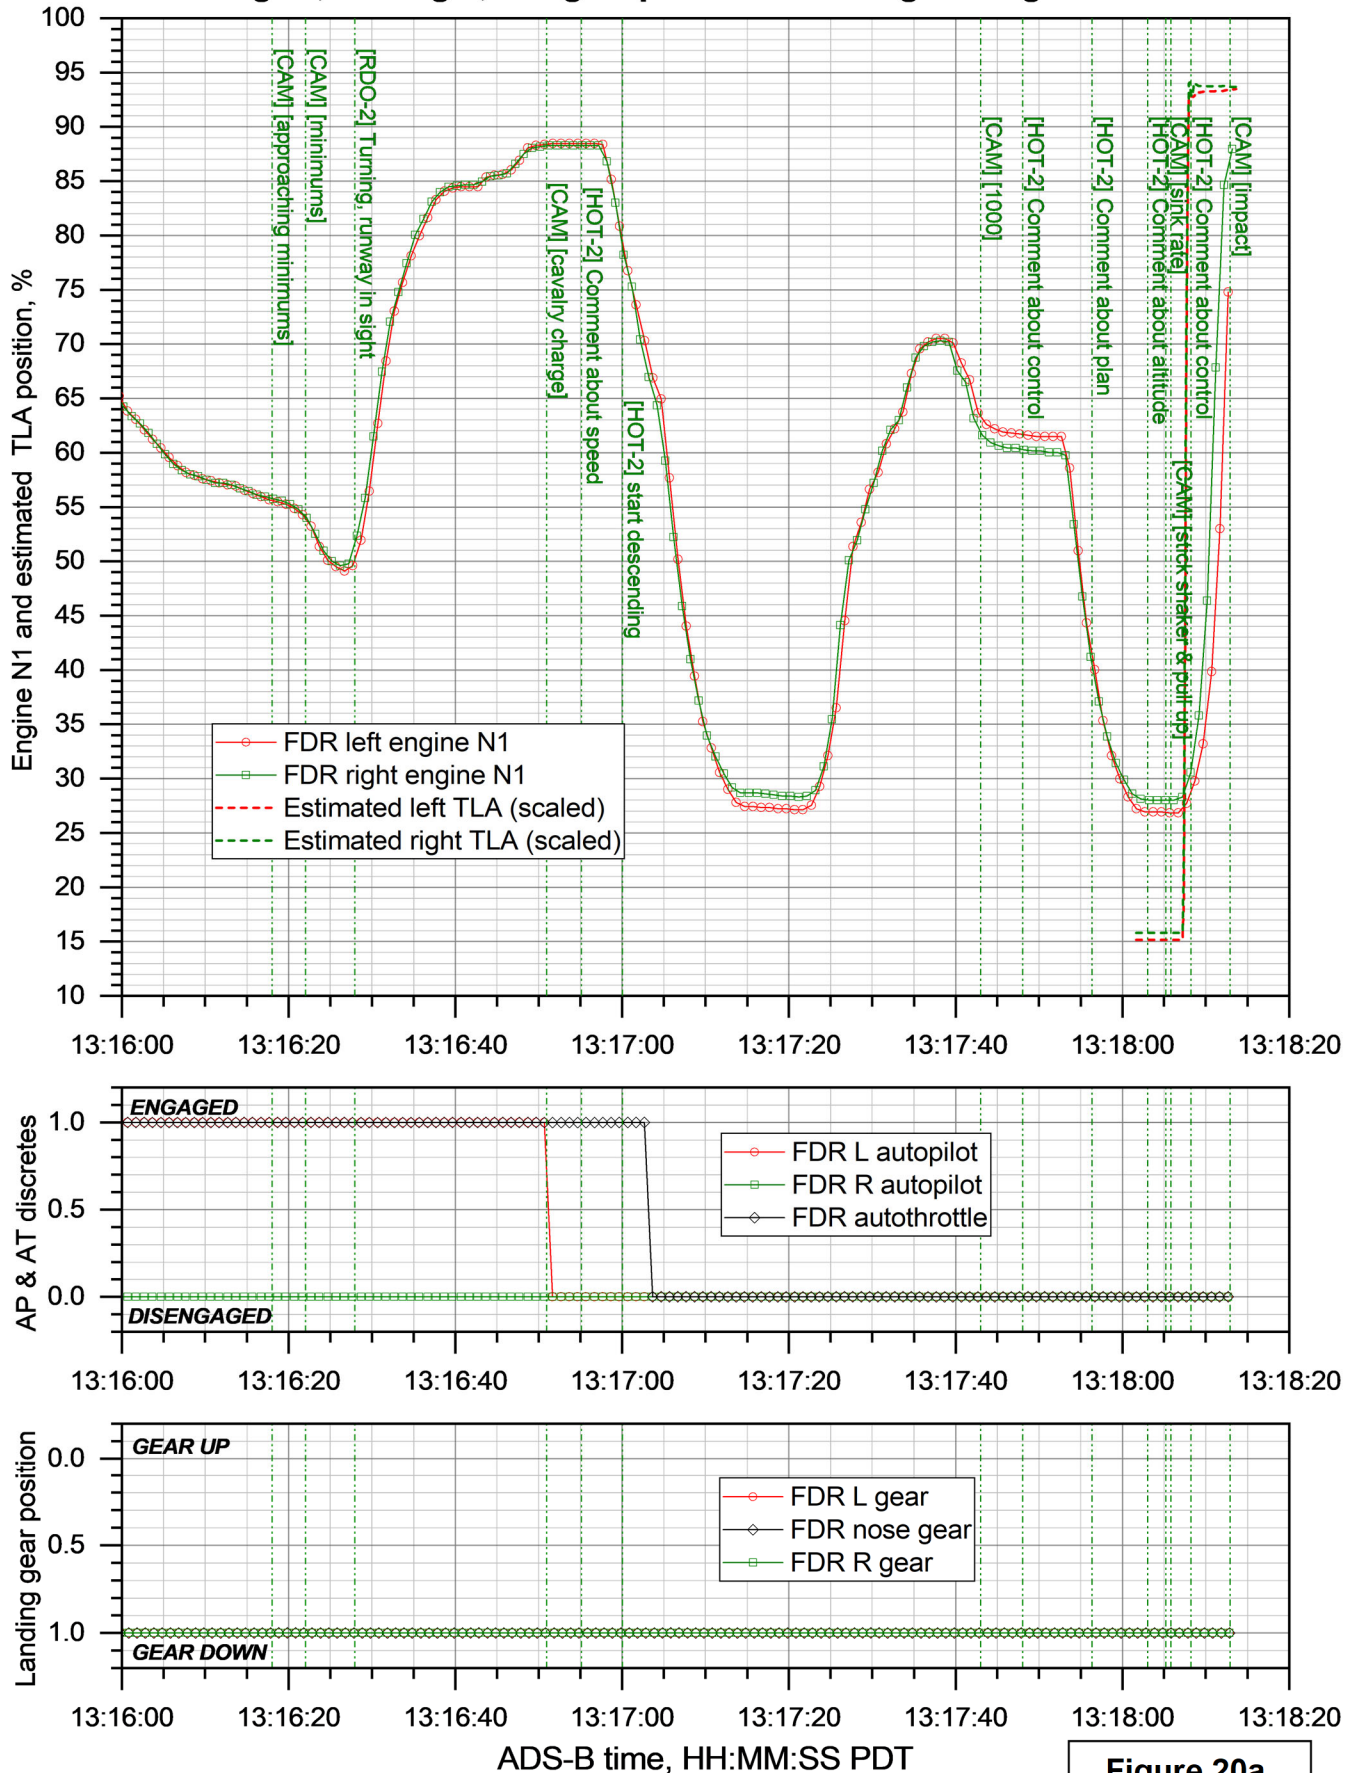
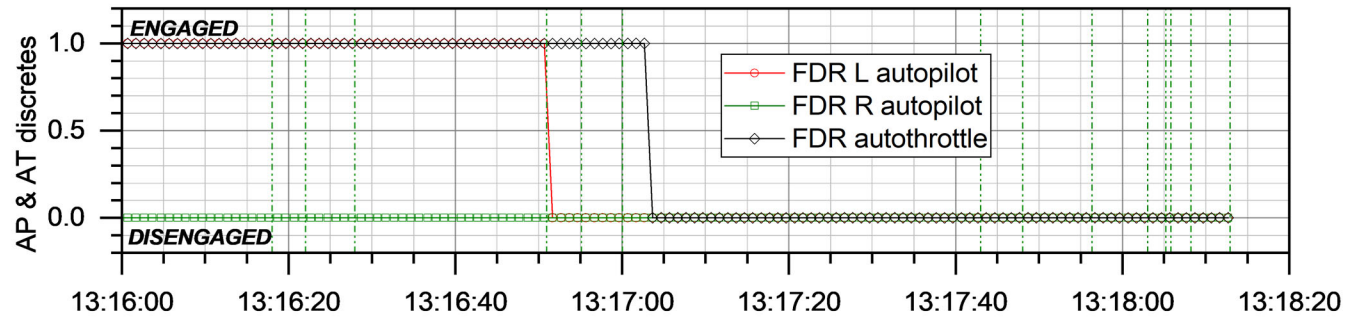
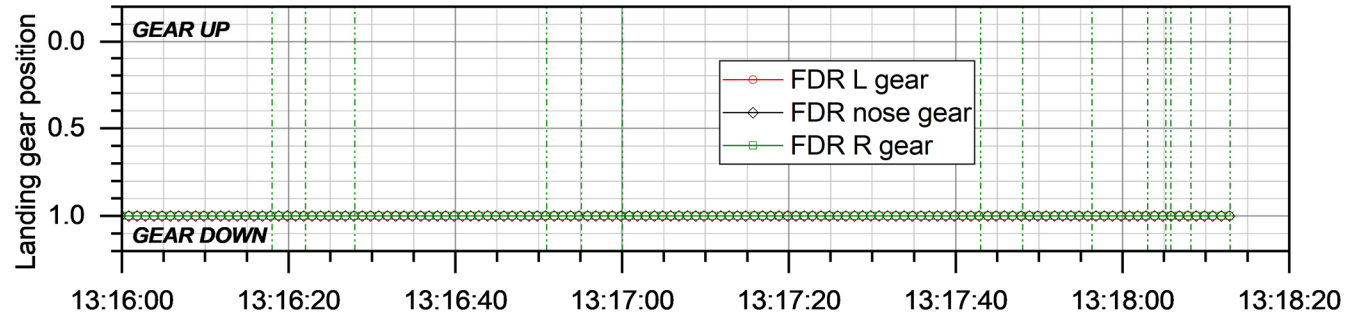
Figure 20a.

Engine, autoflight, and gear parameters during circling maneuver

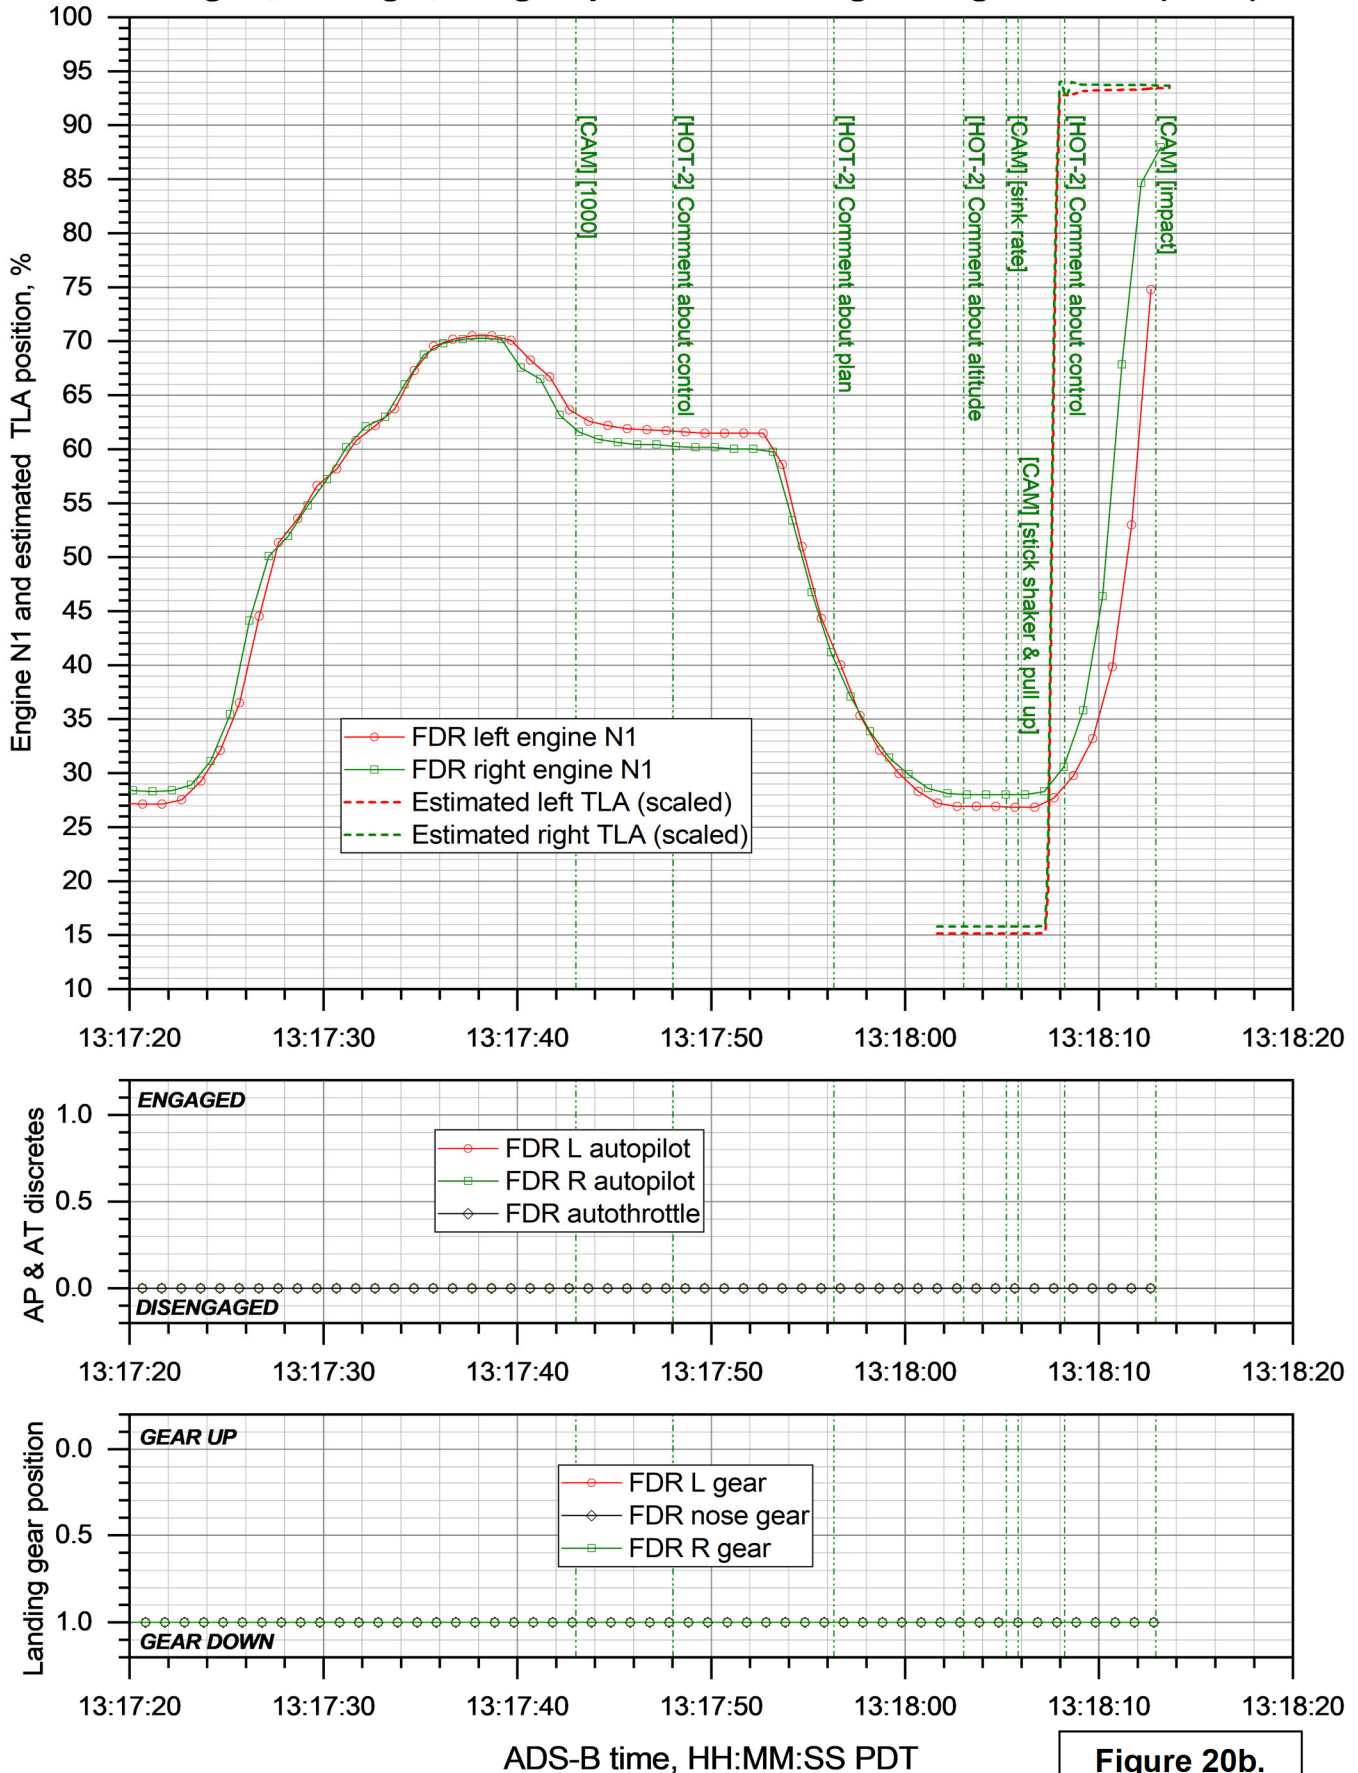
Figure 20b.

Engine, autoflight, and gear parameters during circling maneuver (detail)

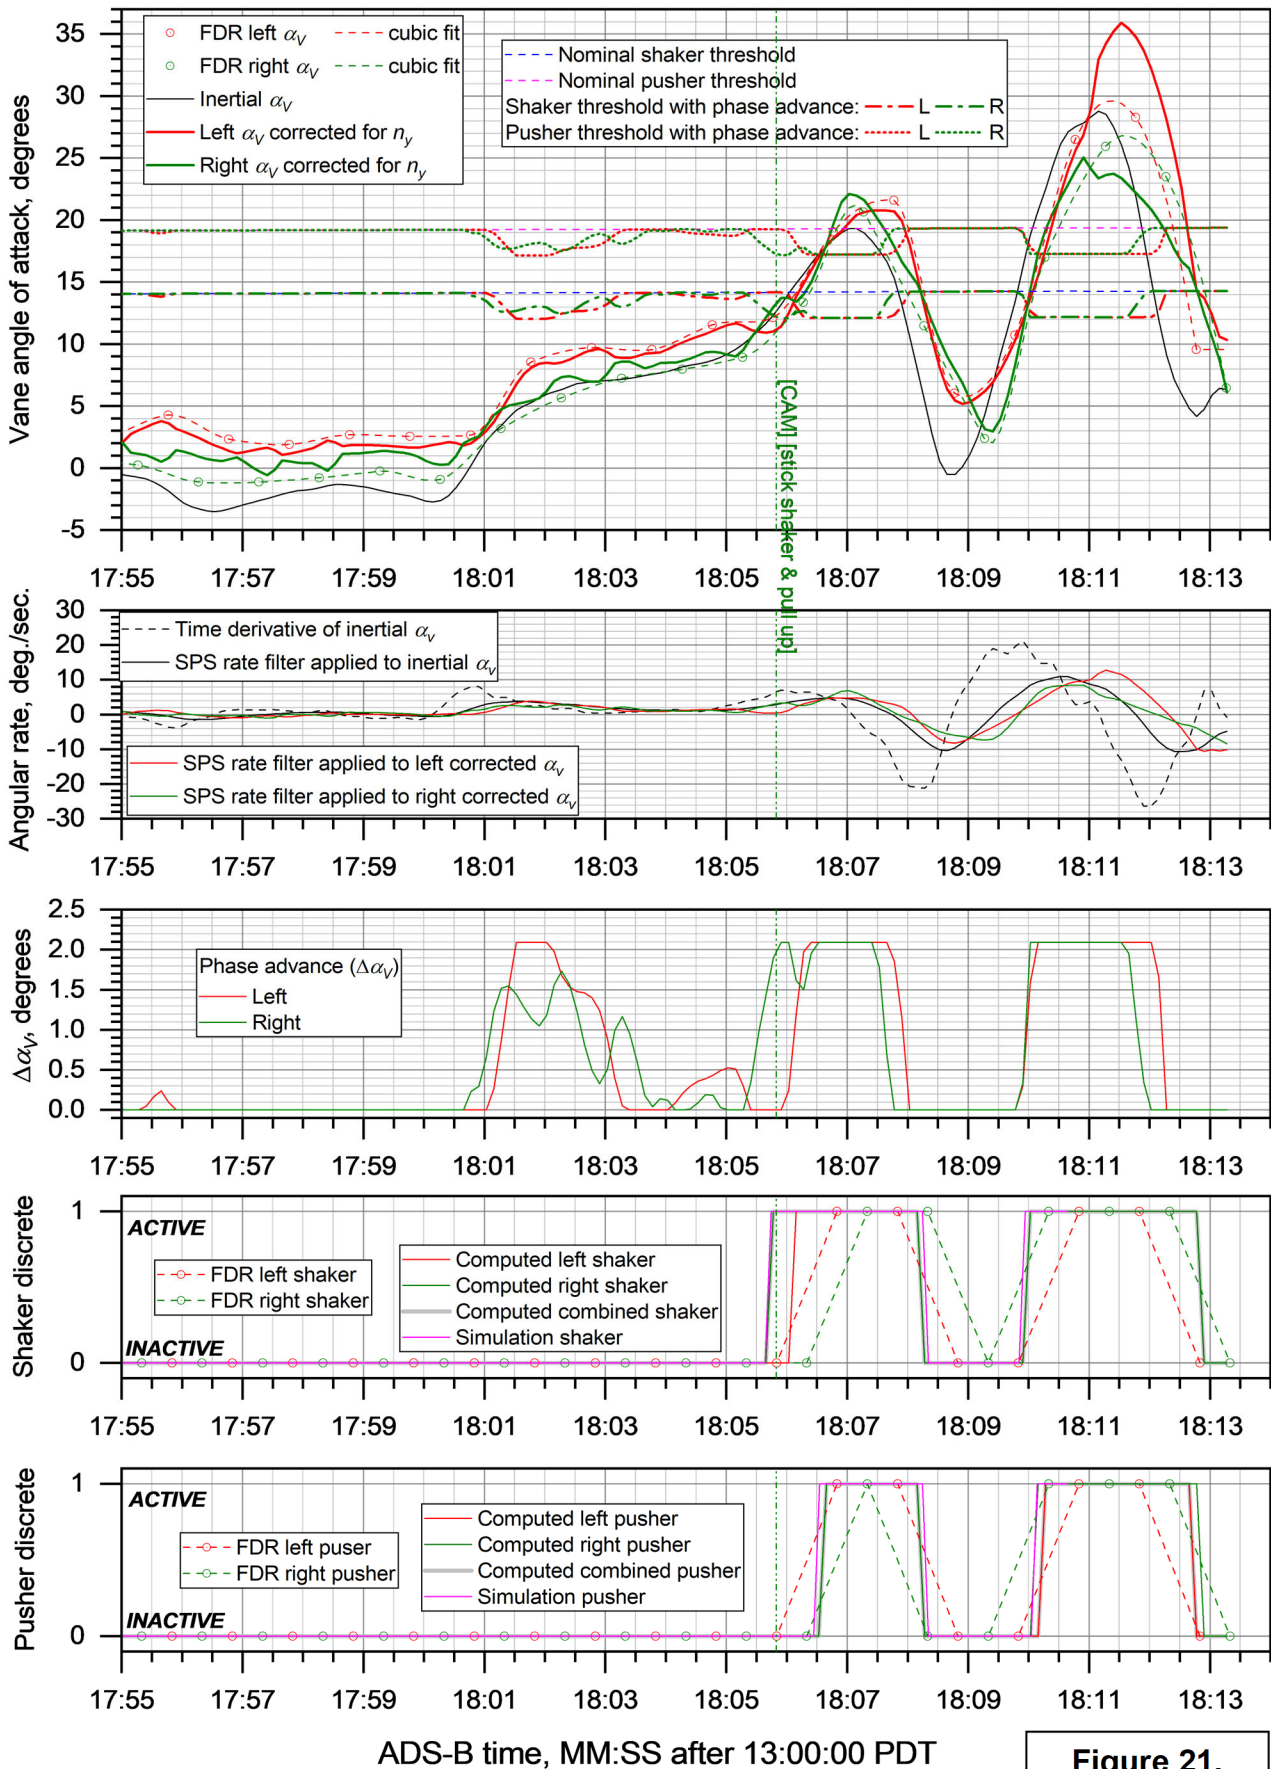
Figure 21.

Stall Protection System performance during final turn

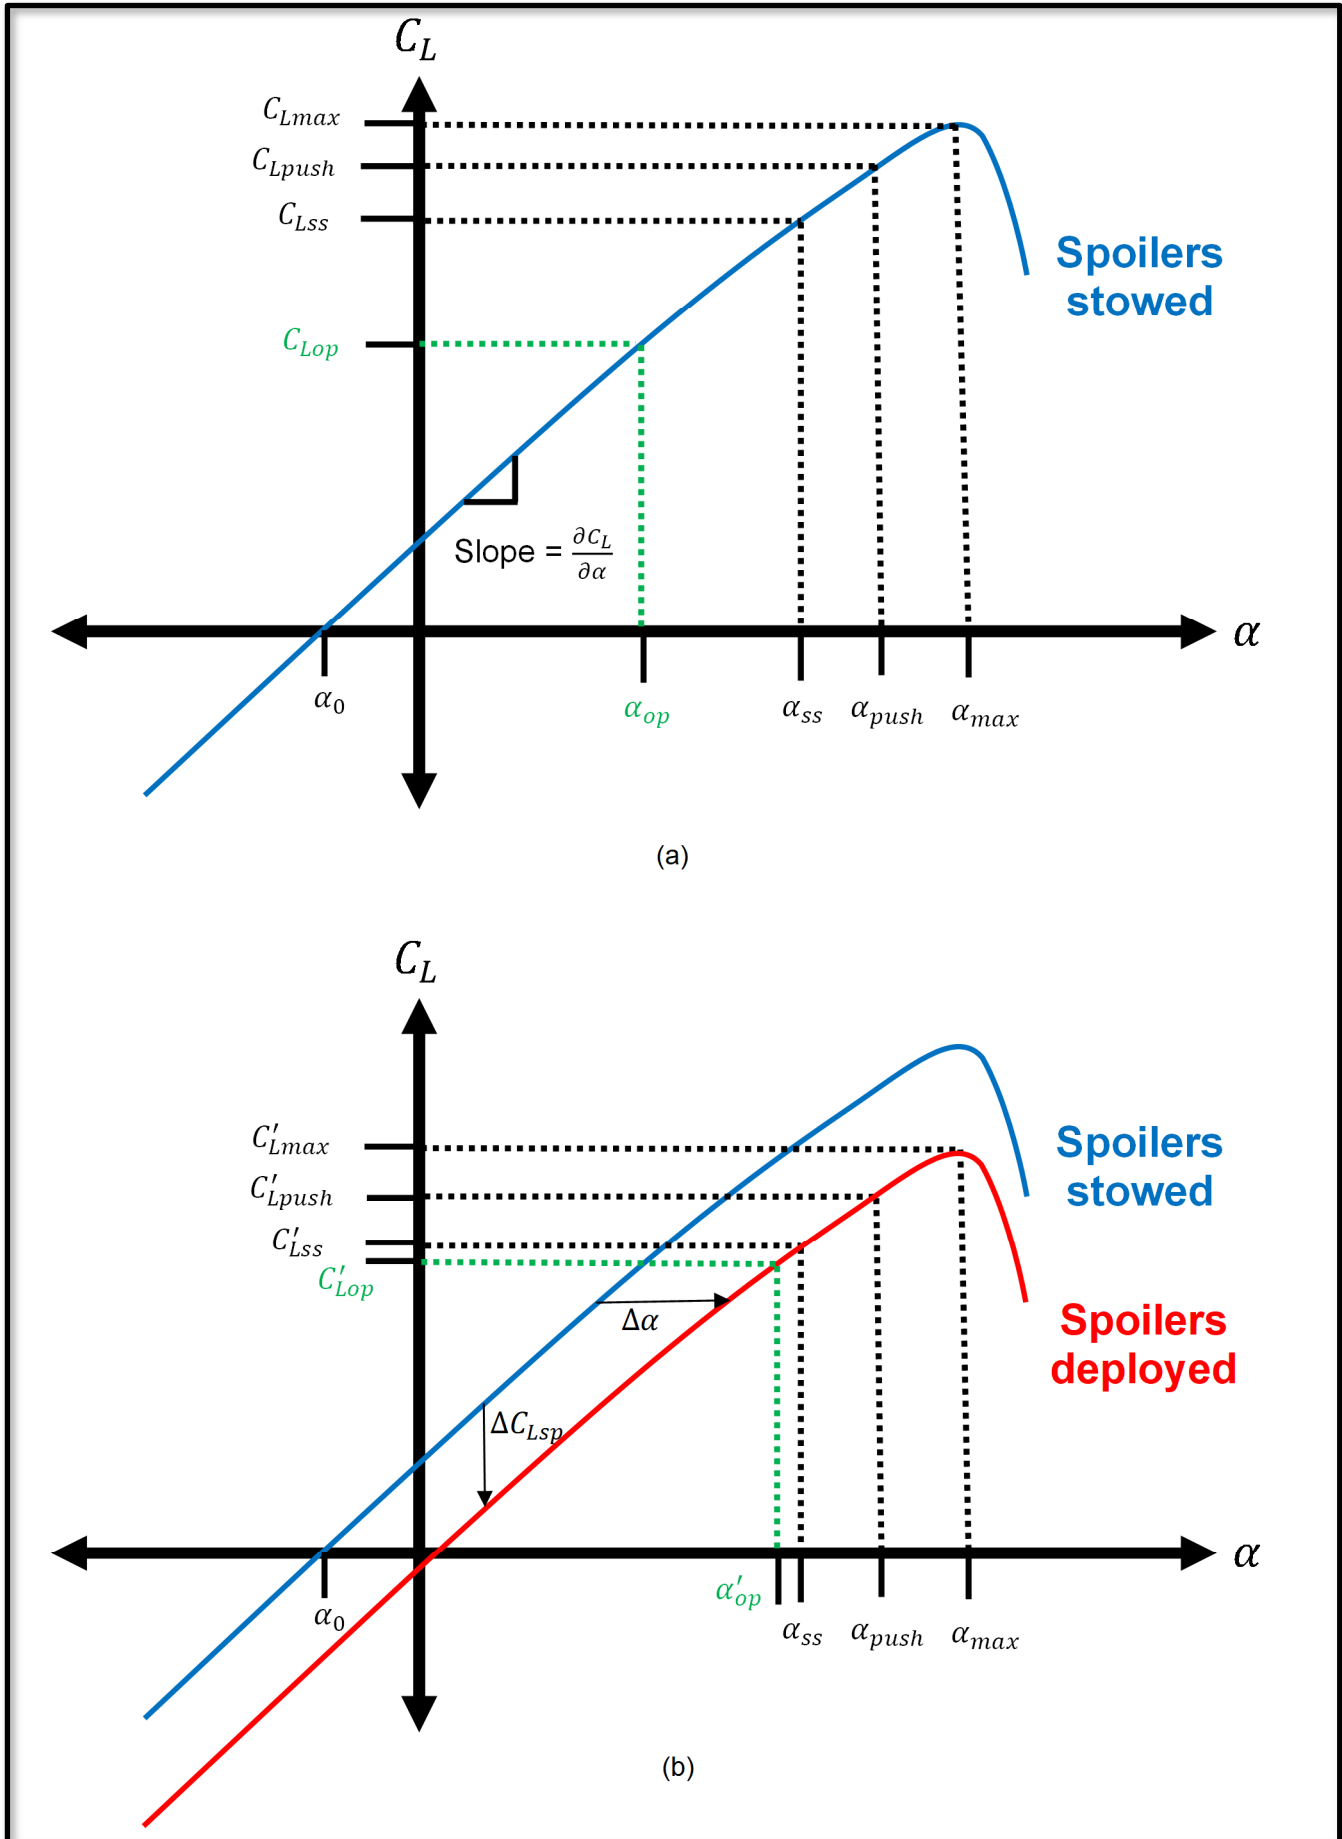
Figure 22. Effect of spoiler deployment on the airplane lift curve.

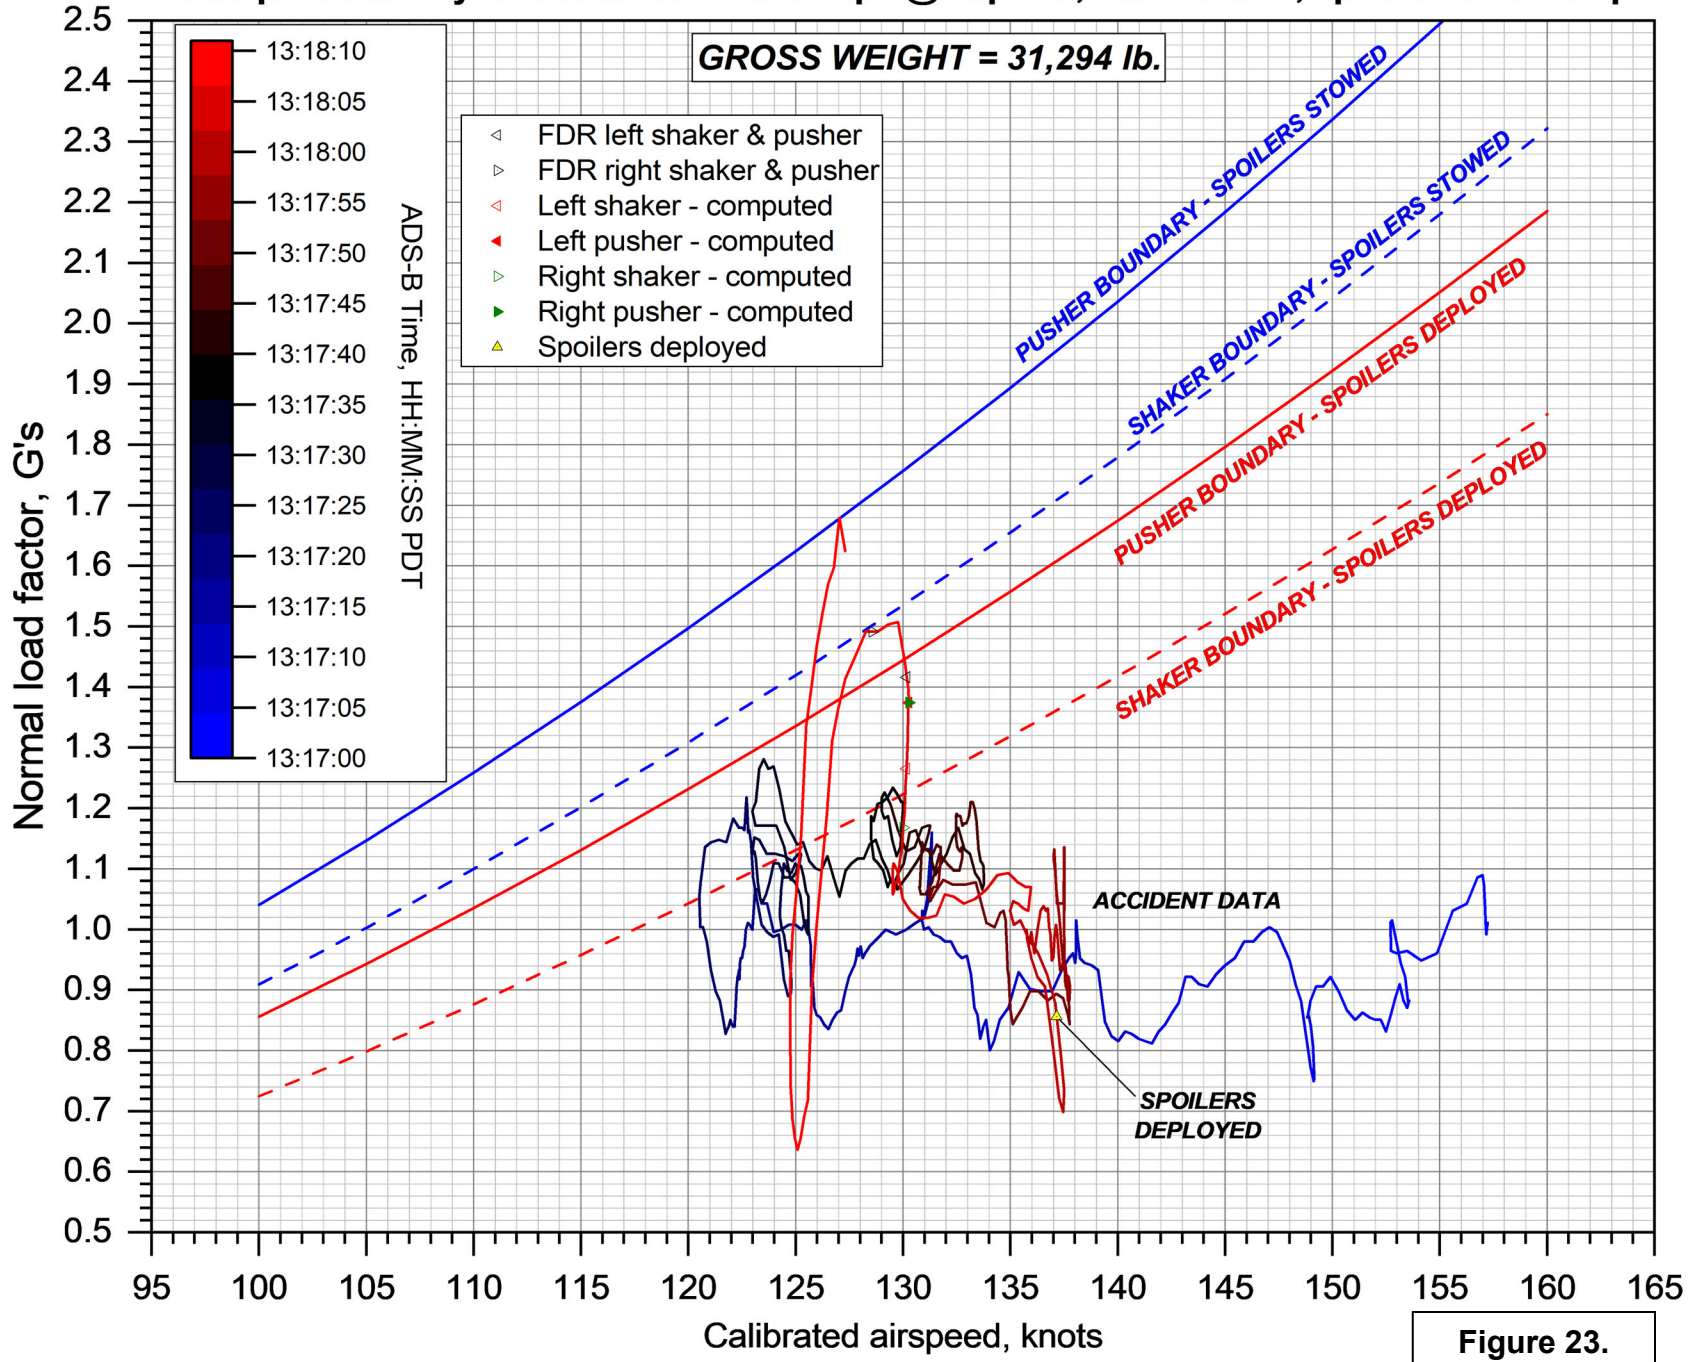
WPR21FA286: Bombardier CL-600-2B16, N605TR, Truckee, CA, 07/26/2021 Stall protection system load factor envelope @ flaps 45, 6300 ft. MSL, spoilers down & up

nlf_{ss} , nlf_{push} , nlf'_{ss} , and nlf'_{push} at flaps 45, 6,300 ft. MSL, and a gross weight of 31,294 lb. are plotted as a function of calibrated airspeed in Figure 23. The combination of nlf and calibrated airspeed during N605TR's circling maneuver is also plotted in Figure 23 as the multi-colored line; the time corresponding to each point on the line is depicted by the color scale. Flight events, such as the spoiler deployment and shaker and pusher activation times, are also noted at corresponding points on the line. Note in Figure 23 that at 130 KCAS, spoiler deployment results in about a 0.31 G reduction in nlf at shaker and pusher activation. On the accident flight, the stick shaker activated at 130 KCAS and an nlf of 1.23 G, exactly at the spoilers-deployed shaker boundary shown in Figure 23. If the spoilers had been stowed, at 130 KCAS the stick shaker would not have activated until an nlf of 1.54 G's. Since rolling the airplane into a turn requires increasing the nlf to maintain lift (see Figure 24), the deployment of the spoilers during the circling maneuver resulted in a reduction in maneuvering capability. Notably, the FCOM contains this statement concerning the use of the flight spoilers:
