NATIONAL TRANSPORTATION SAFETY BOARD

Aircraft Performance Study

Aircraft: Bombardier CL-600-2B16, registration N605TR

NTSB#: WPR21FA286

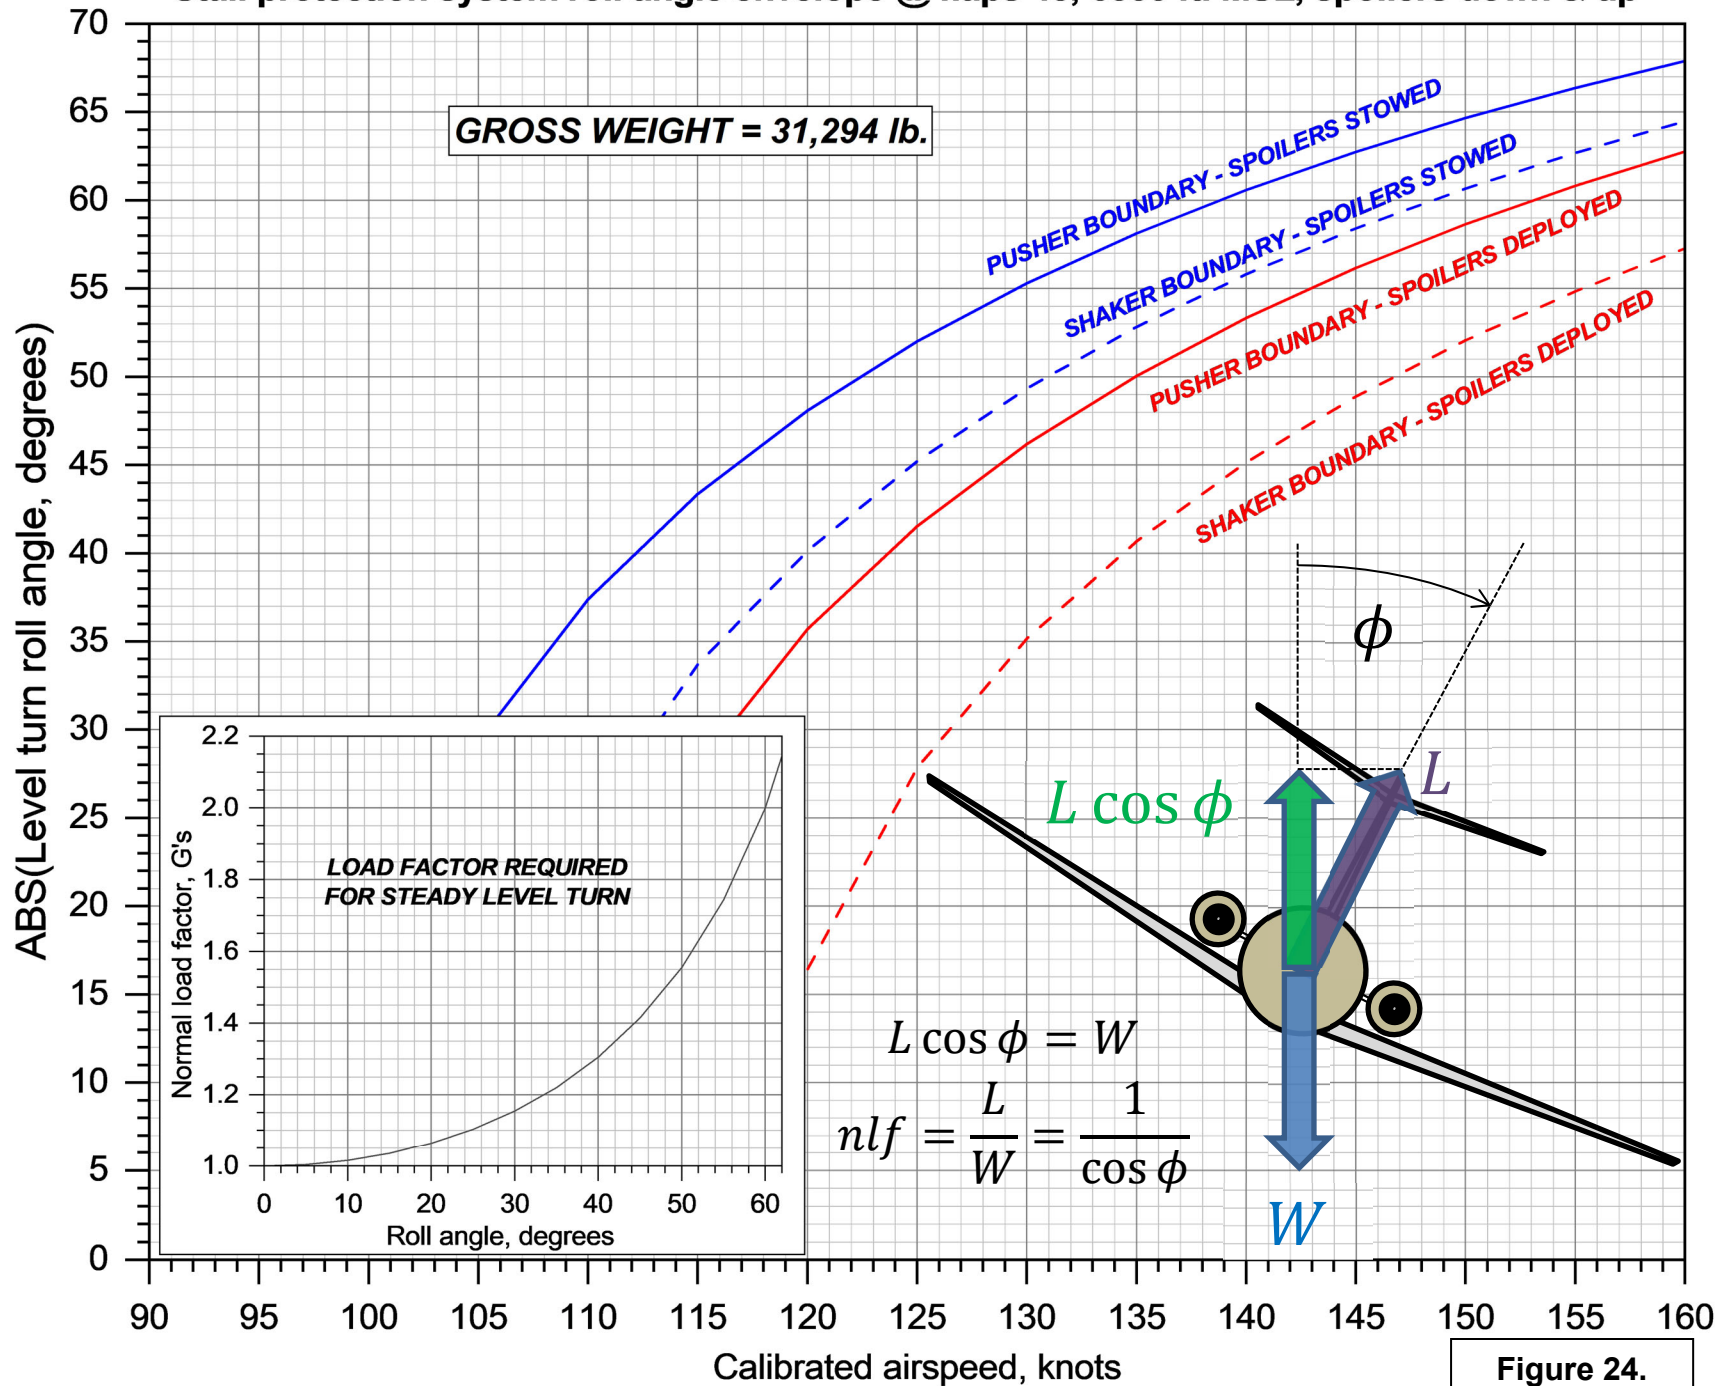
WPR21FA286: Bombardier CL-600-2B16, N605TR, Truckee, CA, 07/26/2021
Stall protection system roll angle envelope @ flaps 45, 6300 ft. MSL, spoilers down & up

Figure 24 depicts the maximum level-turn bank angle that could be achieved over a range of airspeeds at the stick shaker and pusher boundaries, with the spoilers stowed and deployed, under the accident conditions. Note that at 130 KCAS, the level-turn bank angle at the shaker boundary is about 49° with the spoilers stowed, but decreases to about 35° with the spoilers deployed.
