# NATIONAL TRANSPORTATION SAFETY BOARD

## Ballooning Electronic Instrument

**Specialist's Factual Report**  
**By Sean Payne**

Location: Rio Rancho, NM  
Date: January 23, 2021  
Aircraft: Lindstrand 77A Balloon  
Registration: N477LB  
Operator: Private  
NTSB Number: WPR21LA158

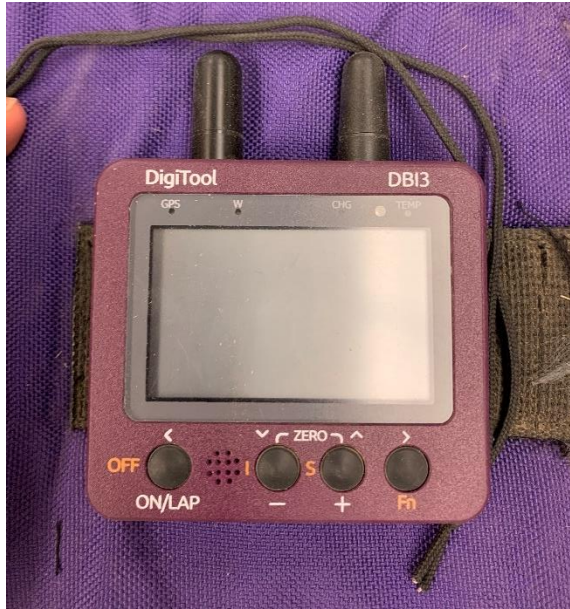
**Figure 1.** Photo of undamaged DigiTool DBI3.

The device was undamaged and is shown in figure 1. The device was connected to a PC running a software program suggested by the manufacturer of the device to extract data. The device behaved normally, and data from the accident day, and other days were successfully extracted from the device.

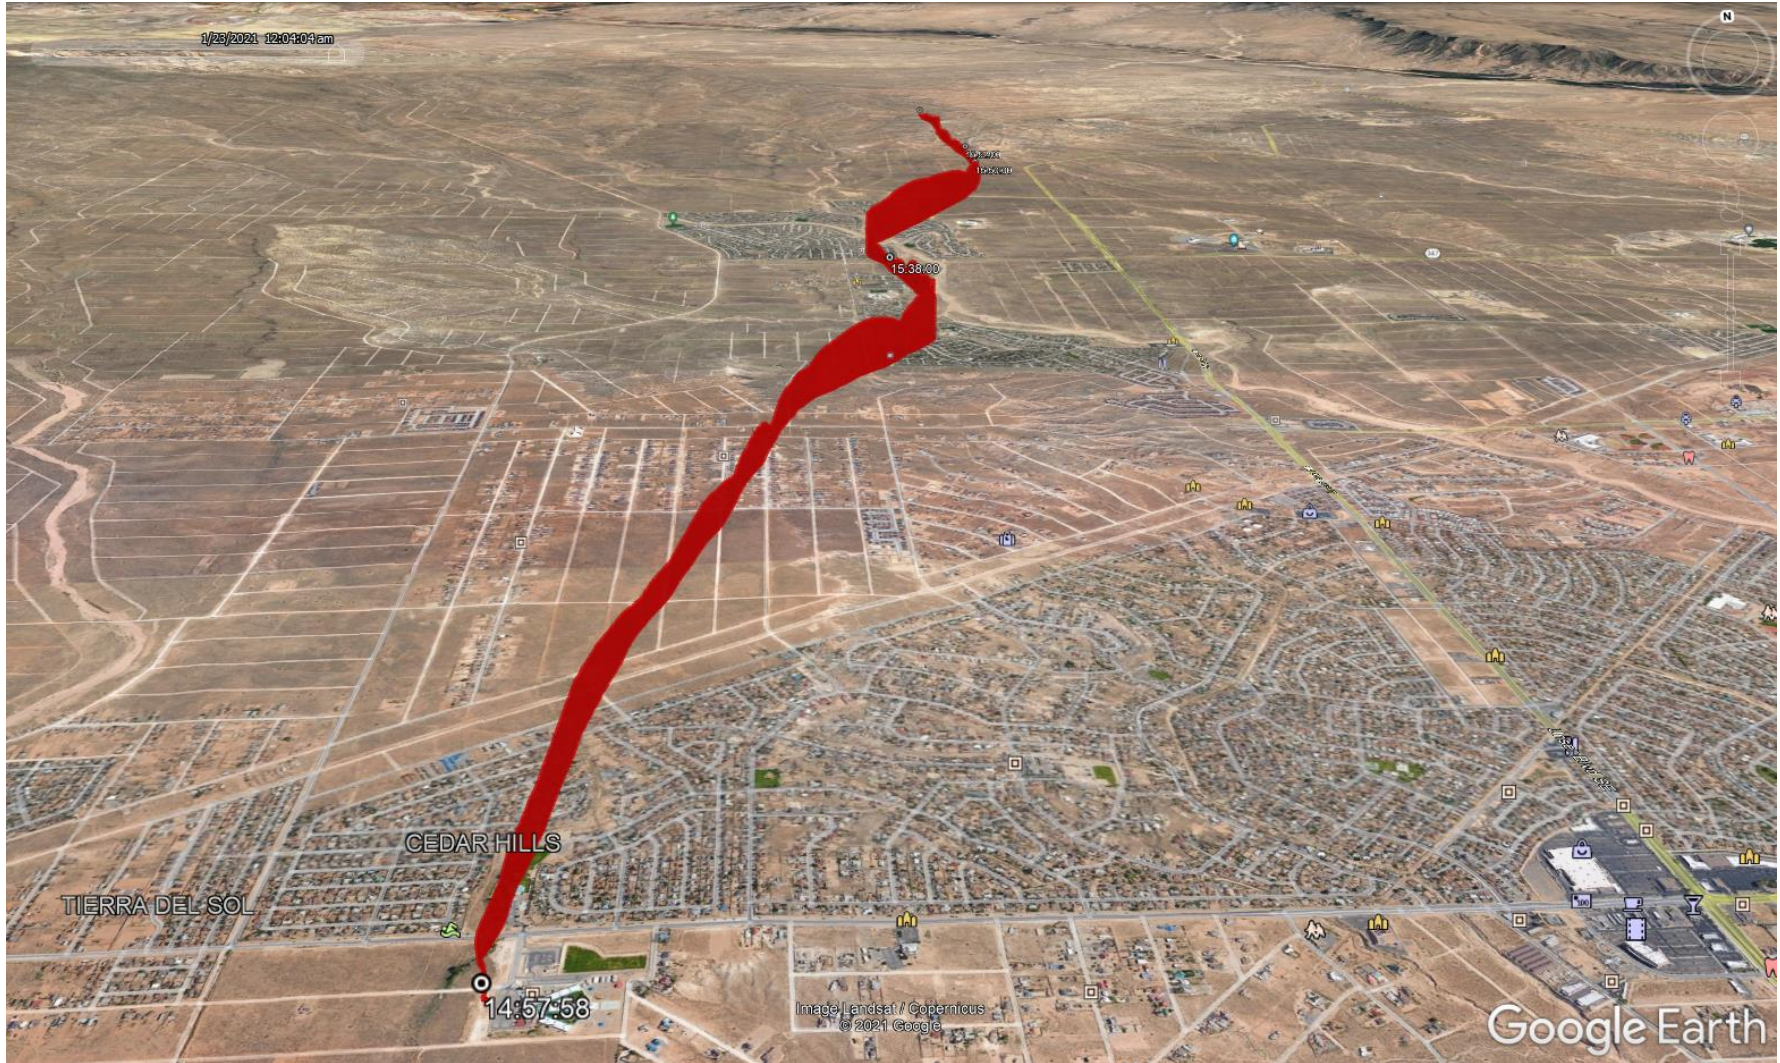
**Figure 2.** A depiction of the GPS tracks for the entire set of data relevant to the accident. The figure is oriented north up.

Figure 2 is a graphical overlay generated using Google Earth for the entire accident flight.

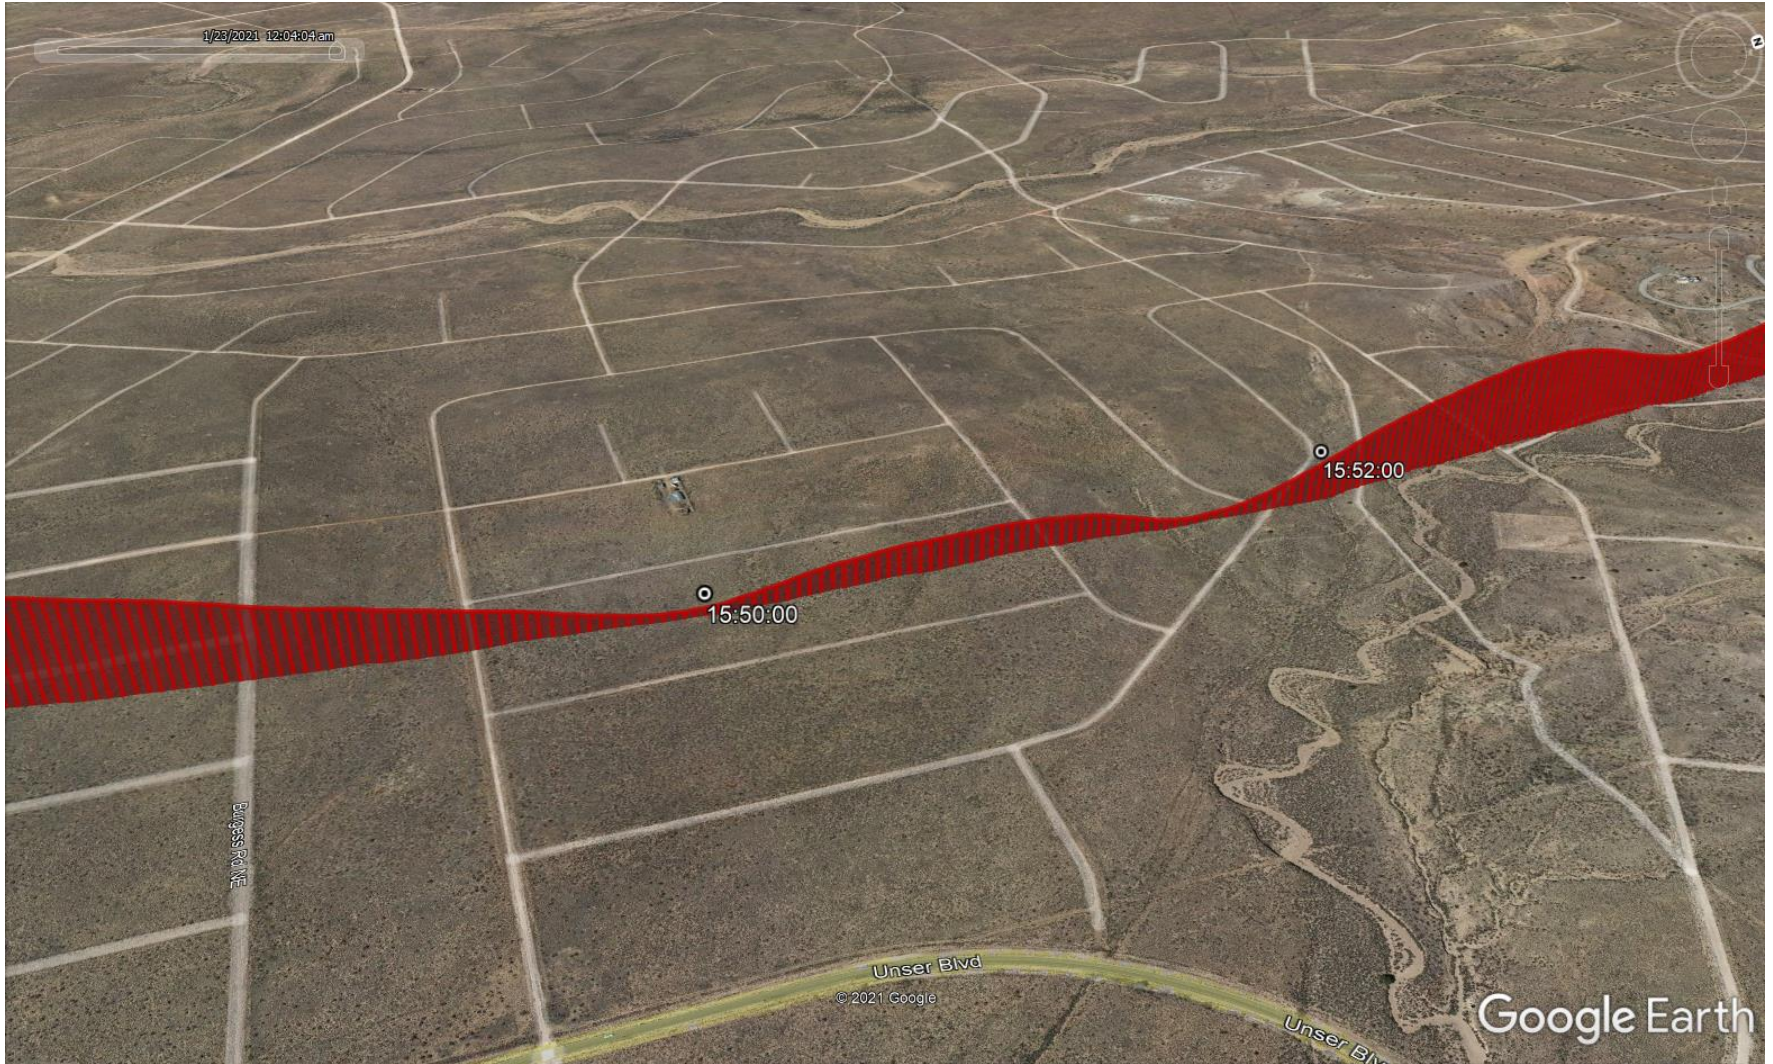
**Figure 5.** A depiction of the GPS tracks for an area of low altitude flight between 15:50 and 15:52.

Figure 5 is a graphical overlay depicting an area of low flight between 15:50 and 15:52.

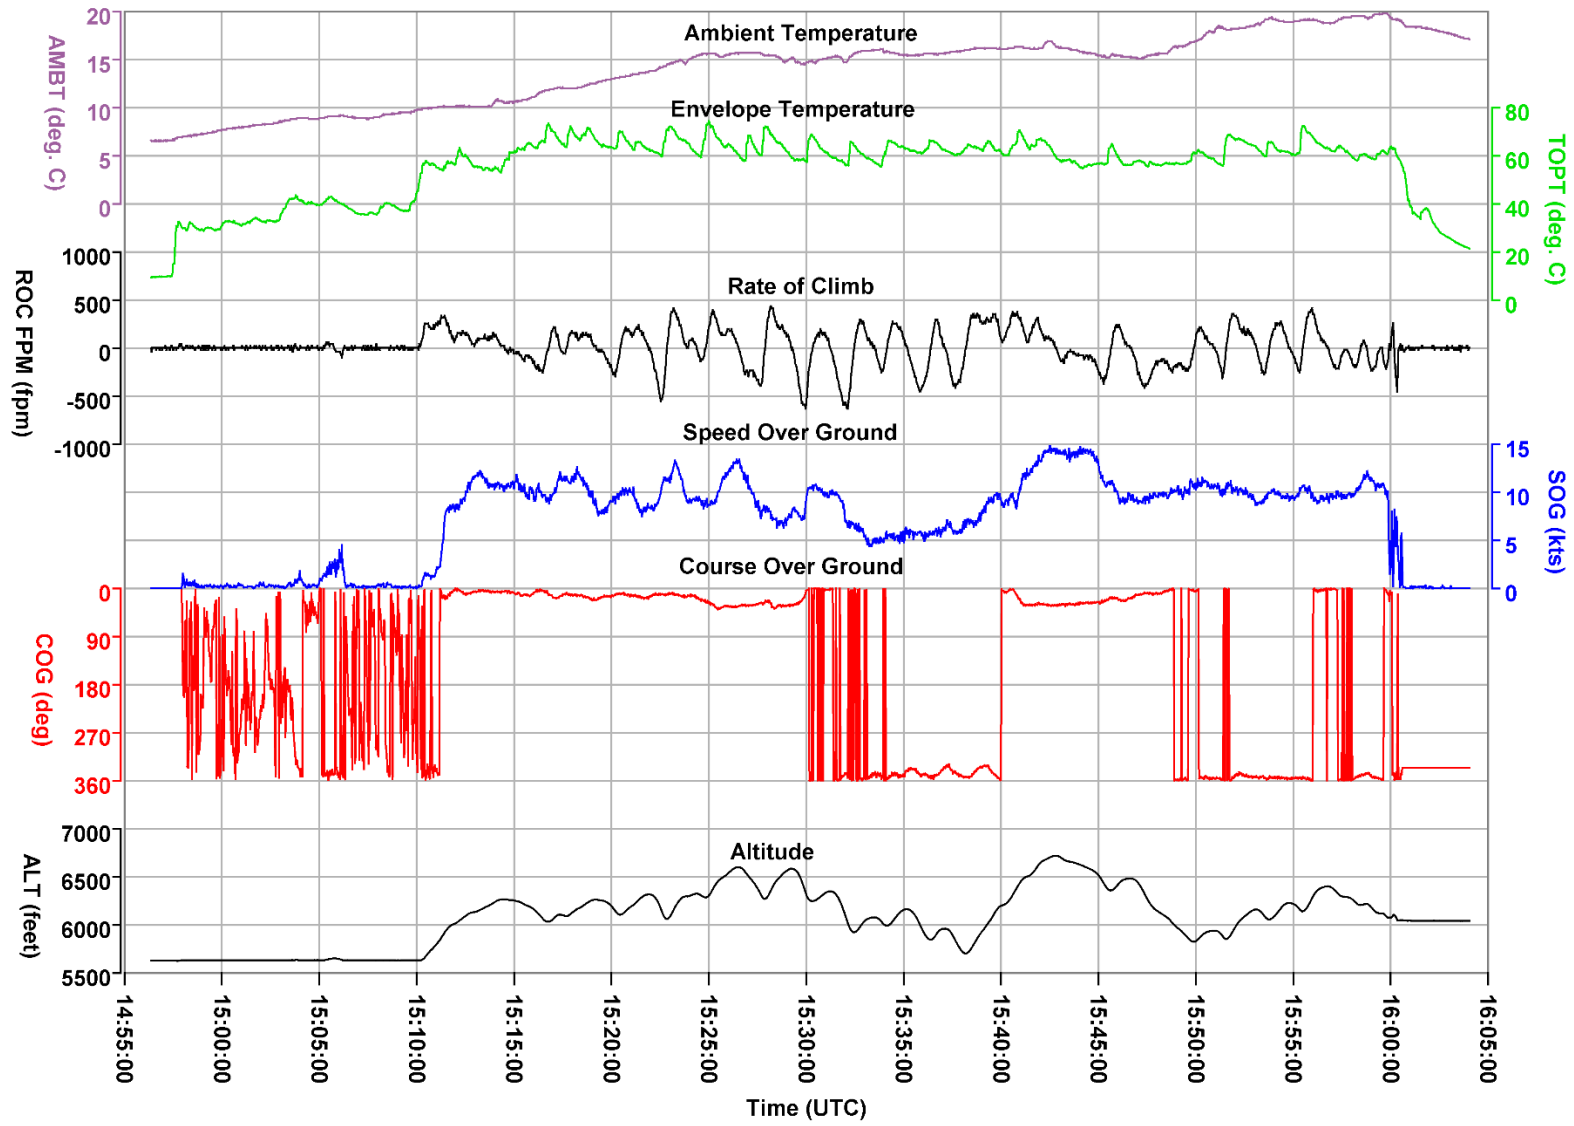
Figure 8. A plot of recorded parameters for the entire flight.

Figure 8 is a plot of available recorded data, including envelope temperature data, from the entire accident flight. The time interval shown is 14:55:00 to 16:05:00.

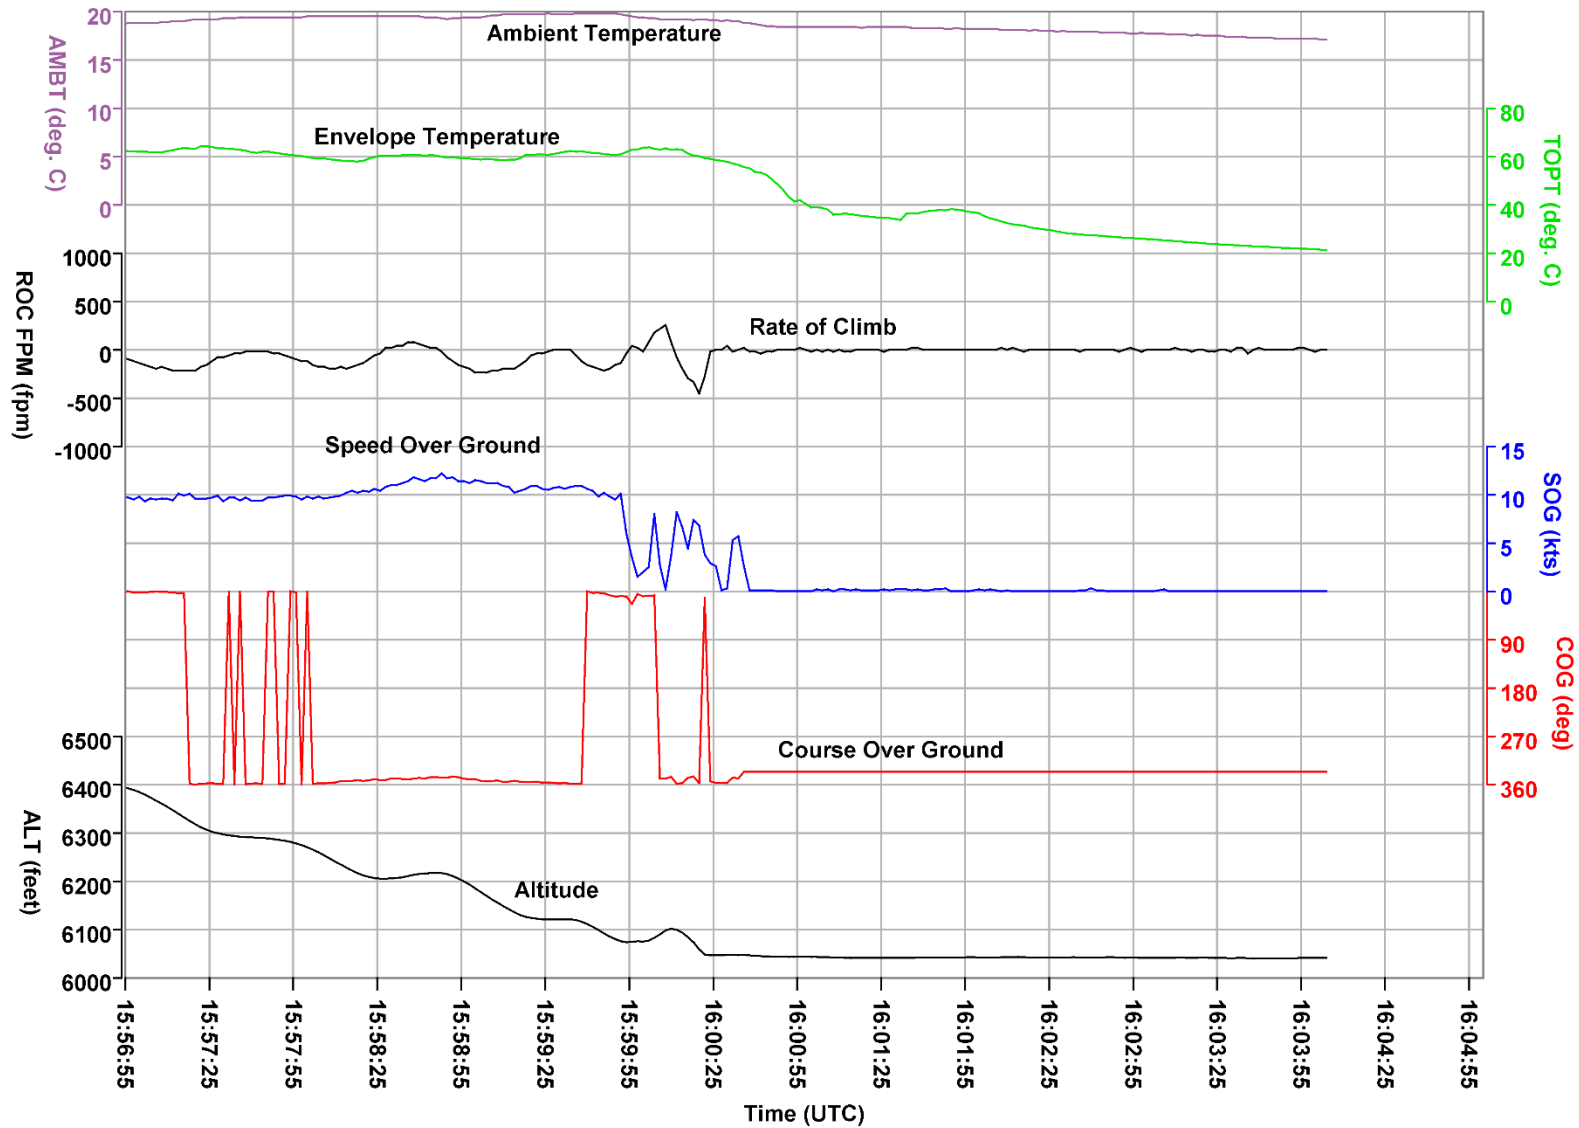
Figure 9. A plot of recorded parameters for the end of the accident flight.

Figure 9 is a plot of available recorded data, including envelope temperature data, from the accident flight, zoomed in on the end of flight. The time interval shown is 15:56:55 to 16:05:00.
