NATIONAL TRANSPORTATION SAFETY BOARD

Factual Report

METEOROLOGY

DCA19MA086

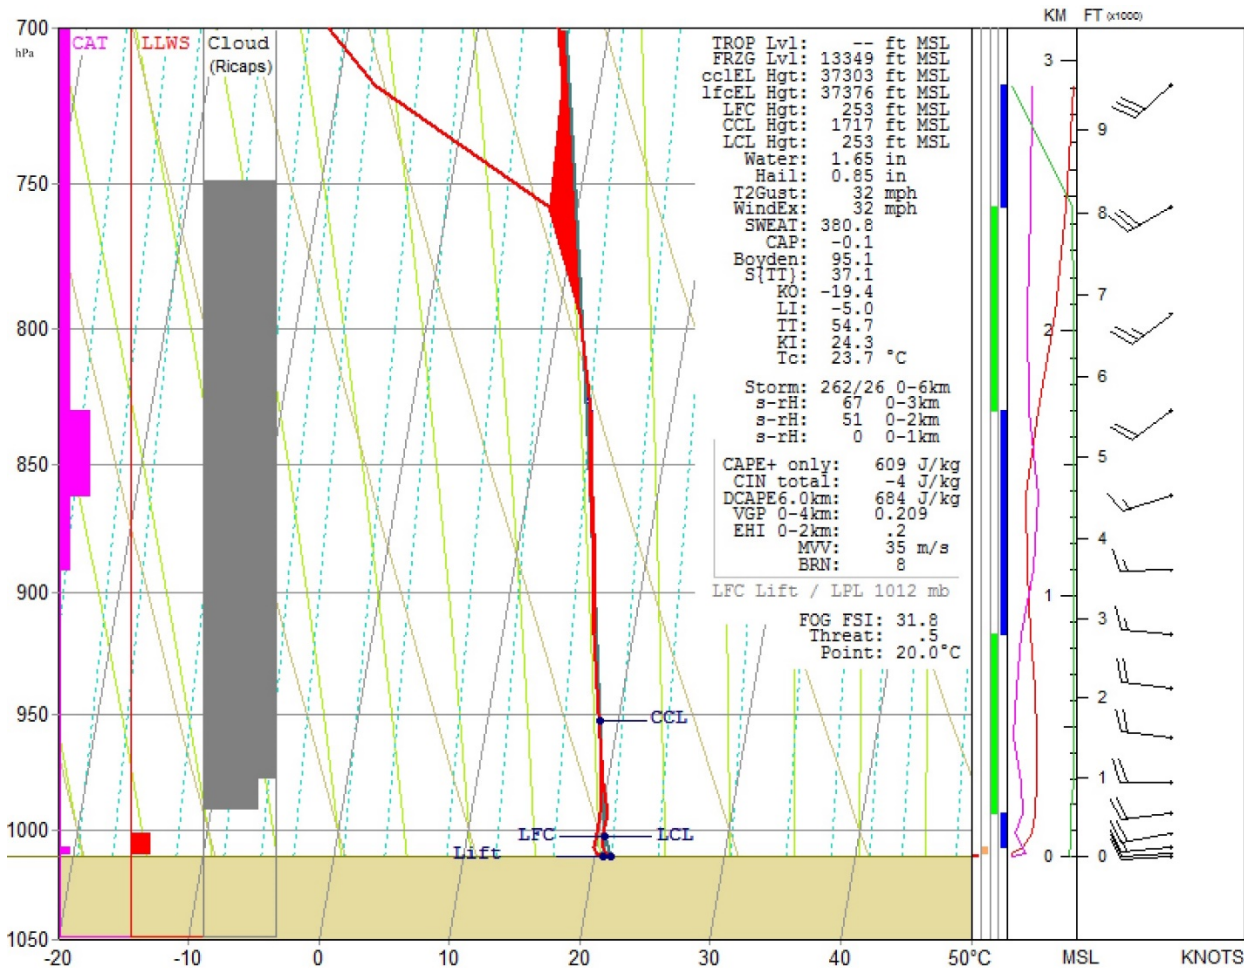
At 1300 CST, the wind near the surface was from the west at about 10 knots. Above this level the wind remained westerly and below 20 knots though about 3,600 feet. Above this level the wind backed to a southwest wind and increased in magnitude with height to a southwest wind of about 50 knots at about 15,300 feet. Analysis by RAOB identified cloudy conditions between about 600 and 8,300 feet. RAOB also identified the potential for at least light clear air turbulence above about 3,600 feet and identified the potential for moderate clear air turbulence between about 4,500 and 5,600 feet. The most-unstable CAPE parameter was 620 Joules/kilogram (from 862 hPa) which would be considered a weak value. The LCL and LFC were calculated to be 253 feet. MVV

for this atmosphere was calculated as 35 meters/second (about 6,890 feet per minute). DCAPE (6 kilometers agl) was measured at 684 Joules/kilogram which, according to RAOB, would be considered a moderate value. The freezing level was at about 13,300 feet.

Figure 14 – HRRR model sounding data in SkewT/LogP format for 1300 CST at the accident site, surface to 700 hPa.

High-Resolution Rapid Refresh (HRRR) model¹⁰ soundings (figures 13 and 14) valid over the accident location at 1200 and 1300 CST were retrieved from the NOAA Air Resources Laboratory.

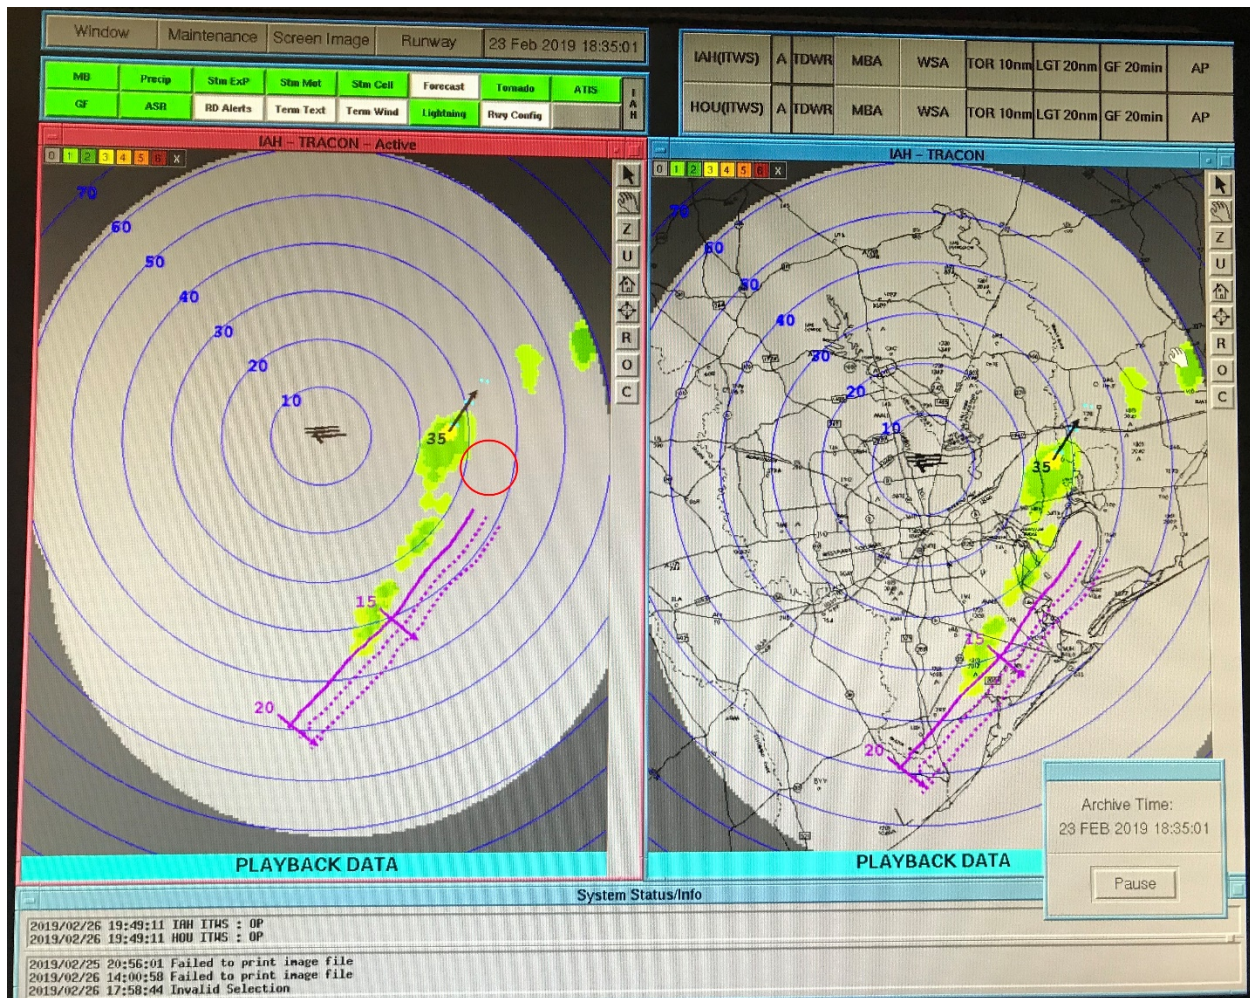
The Integrated Terminal Weather System (ITWS) is an air traffic management tool that provides terminal air traffic managers and controllers plus airline dispatchers with highly accurate, easily understood and immediately useable graphical weather information and hazard alerts on a single, integrated color display (the “Situation Display”). An ITWS Situation Display was present in the Houston TRACON facility on the day of the accident. Screenshots of the ITWS Situation Display TRACON windows applicable for IAH for the time period surrounding the accident time (at five-minute intervals) are present in Attachment 5. The screenshot for the ITWS Situation Display TRACON window applicable for IAH at 1235 CST is presented in figure 20, with the approximate location of the accident marked on the screenshot. The solid purple line represents a “gust front,” the closest dotted purple line to the solid purple line represents the forecasted position of the gust front in 10 minutes, the other dotted purple line represents the forecasted position of the gust front in 20 minutes and the arrows and associated numbers represent the wind direction and magnitude, respectively, ten minutes behind the gust front.

Figure 20 - Screenshot for the ITWS Situation Display TRACON windows (at two different zoom levels) applicable for IAH at 1235 CST. The red circle has been added to the screen shot and approximates the accident location.

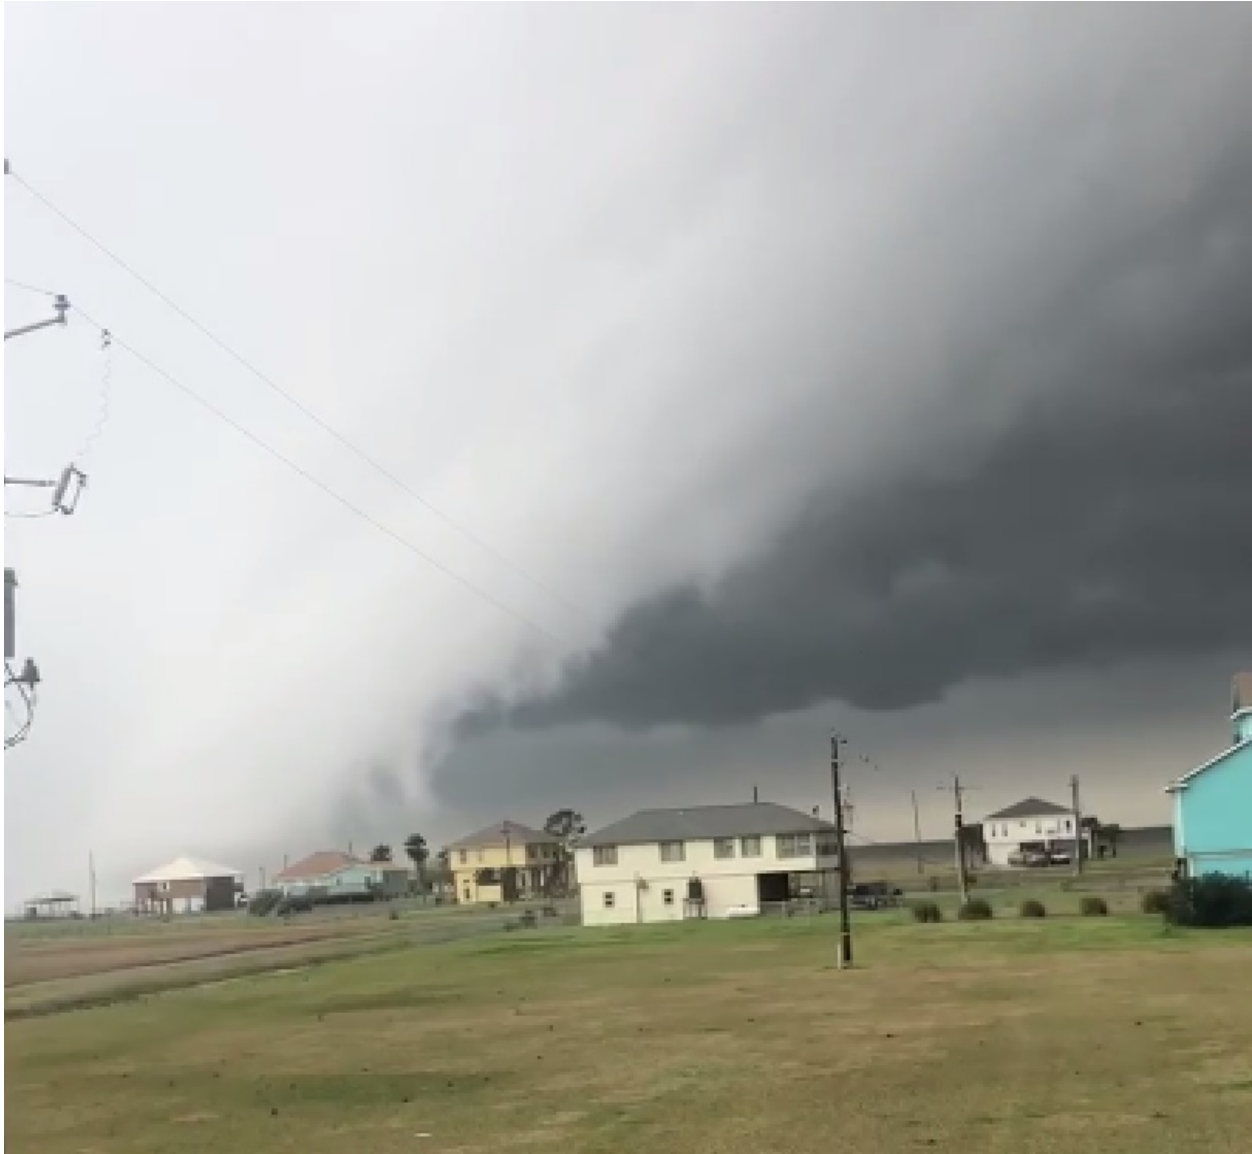
A video was taken of the shelf cloud²⁴ associated with the fine line by a witness on the ground as it passed over Trinity Bay about 5 minutes after the accident time. According to the witness, the video was taken from Bob White Lane²⁵ facing generally west over the bay. The video in its entirety may be found in the public docket for this accident.

Figure 26 – A cropped screenshot of the local video.
