Factual Report – Attachment 5

HEMS tool imagery

METEOROLOGY

DCA20MA059

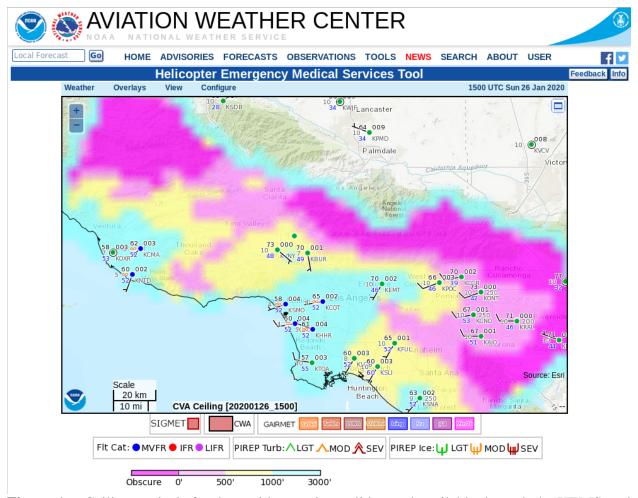
Figure A – Ceiling analysis for the accident region valid at and available through the HEMS tool at about 0700 PST.

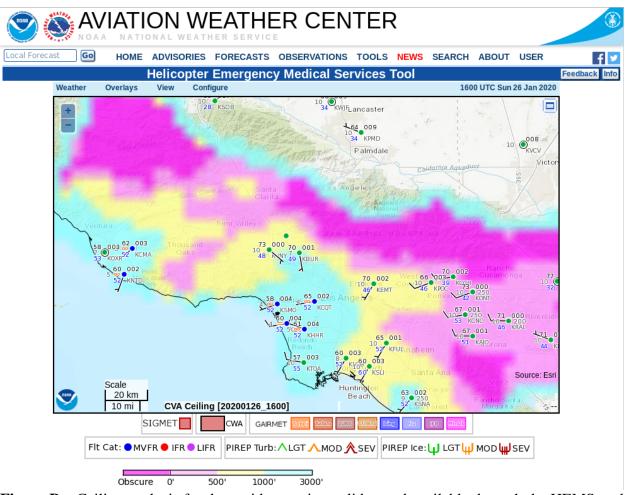
Figure B – Ceiling analysis for the accident region valid at and available through the HEMS tool at about 0800 PST.

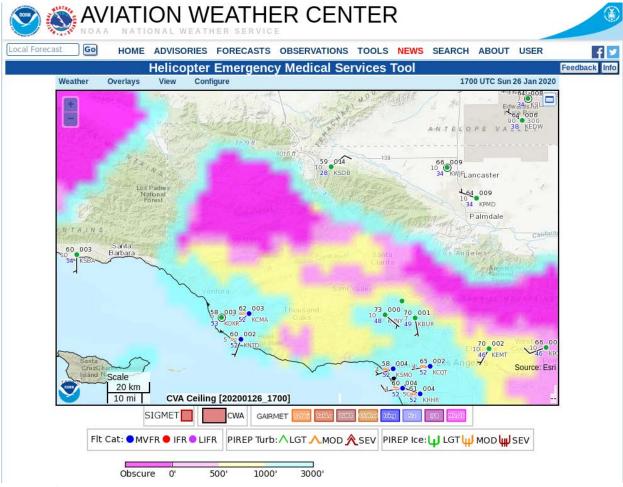
Figure C – Ceiling analysis for the accident region valid at and available through the HEMS tool at about 0900 PST.

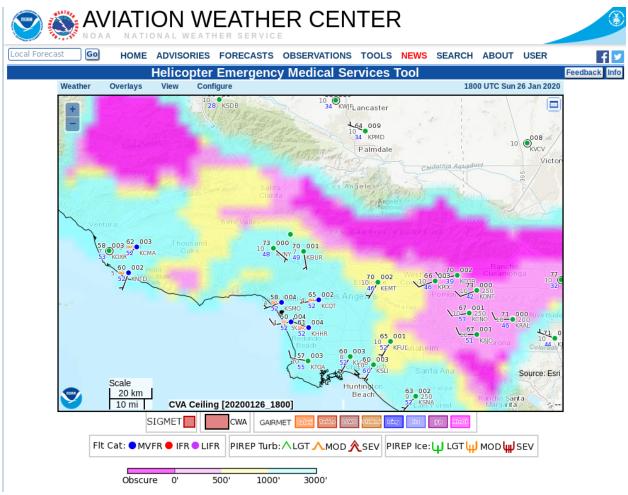
Figure D – Ceiling analysis for the accident region valid at and available through the HEMS tool at about 1000 PST.

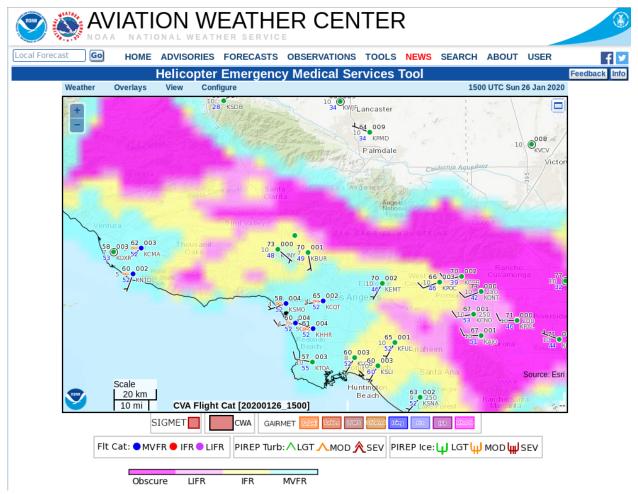
Figure E – Flight rule condition analysis for the accident region valid at and available through the HEMS tool at about 0700 PST.

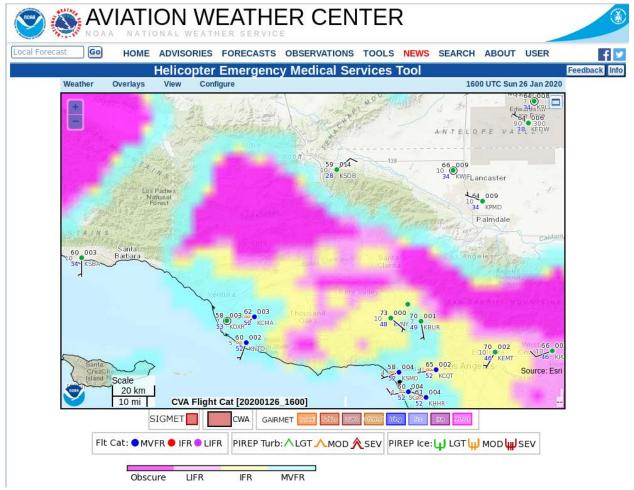
Figure F – Flight rule condition analysis for the accident region valid at and available through the HEMS tool at about 0800 PST.

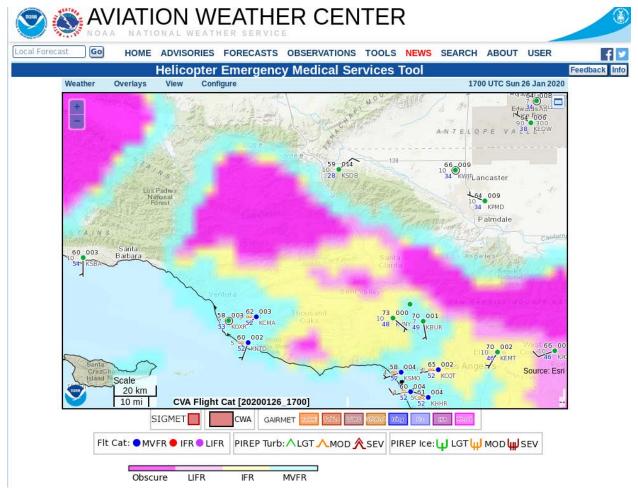
Figure G – Flight rule condition analysis for the accident region valid at and available through the HEMS tool at about 0900 PST.

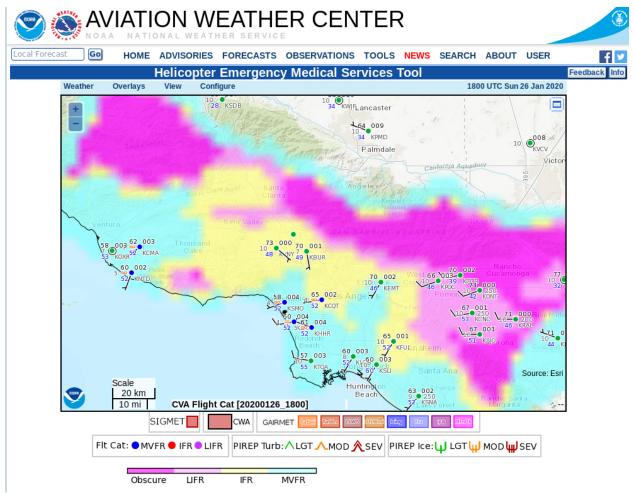
Figure H – Flight rule condition analysis for the accident region valid at and available through the HEMS tool at about 1000 PST.

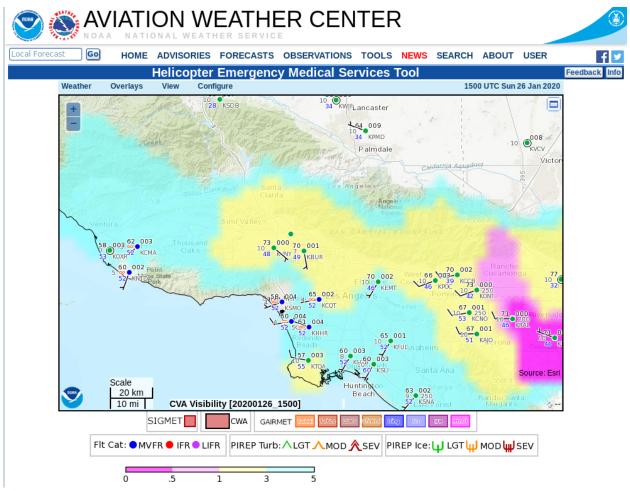
Figure I – Surface visibility analysis for the accident region valid at and available through the HEMS tool at about 0700 PST.

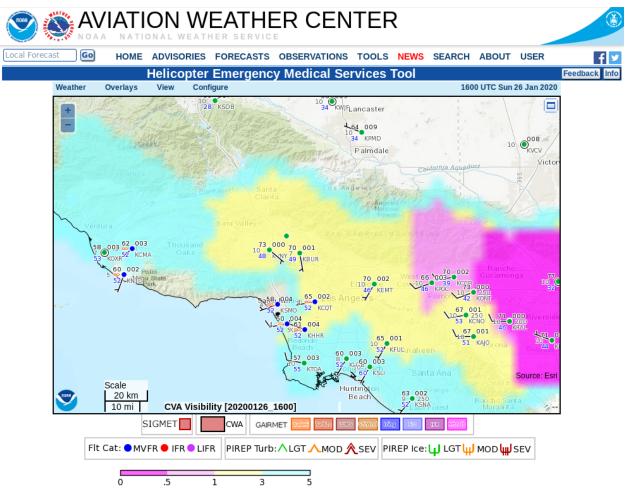
Figure J – Surface visibility analysis for the accident region valid at and available through the HEMS tool at about 0800 PST.

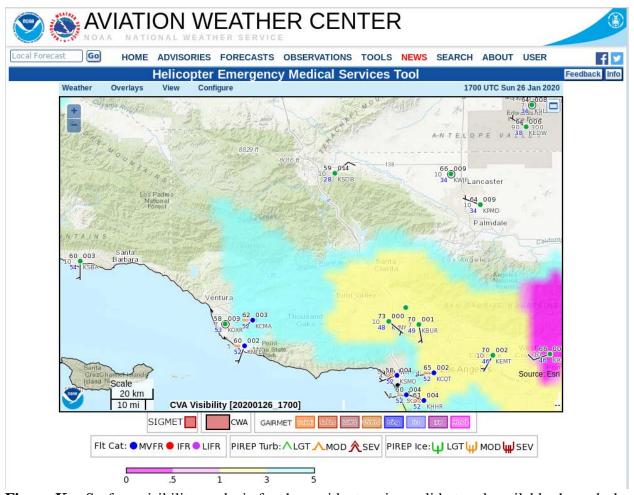
Figure K – Surface visibility analysis for the accident region valid at and available through the HEMS tool at about 0900 PST.

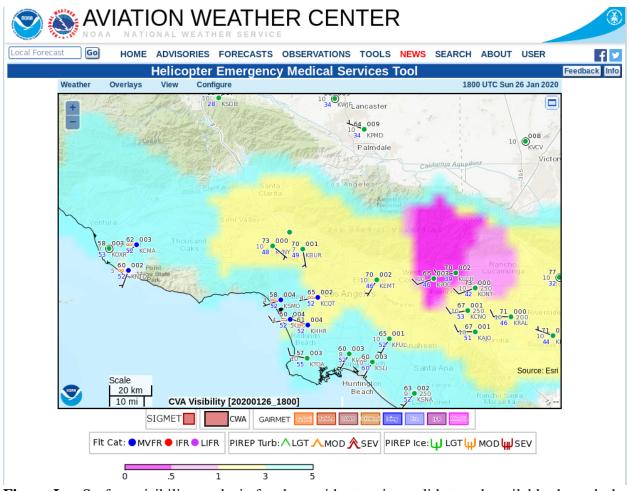
Figure L – Surface visibility analysis for the accident region valid at and available through the HEMS tool at about $1000 \, \text{PST}$.
