## **NATIONAL TRANSPORTATION SAFETY BOARD**

### **Factual Report**

# **METEOROLOGY**

DCA20MA059

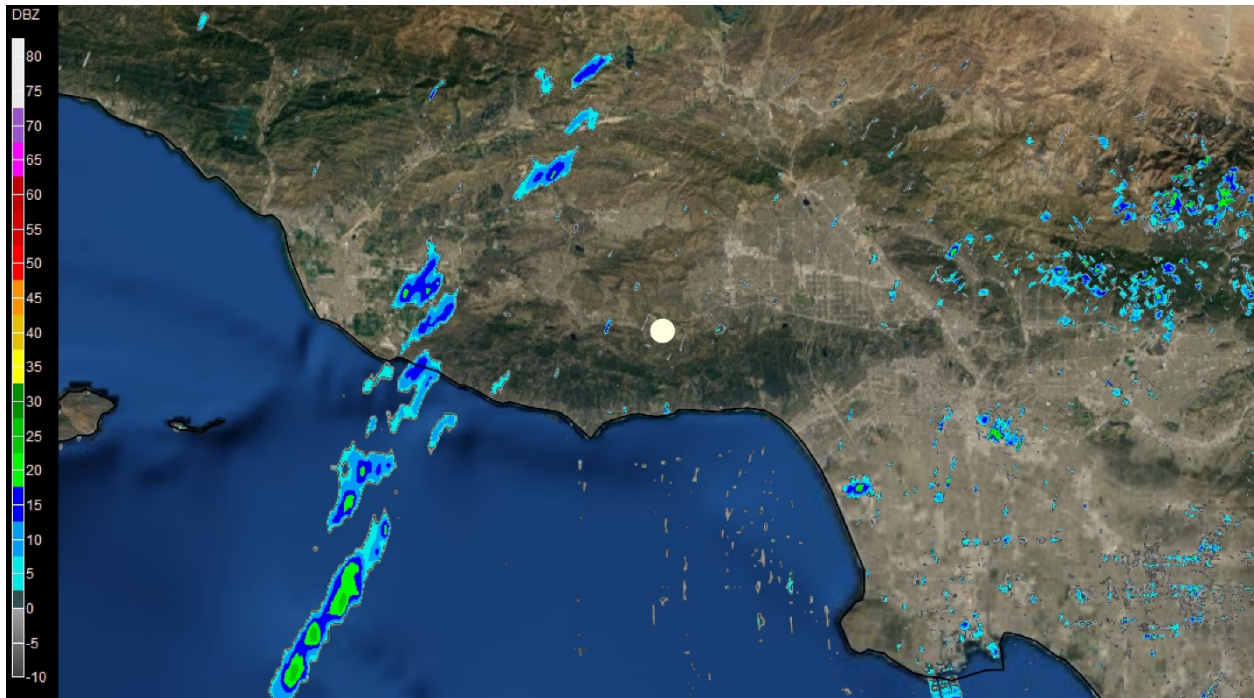
**Figure 2** – KSOX 0.484° Level-II reflectivity product from a sweep initiated at 0946:17 PST. Accident location denoted by white circle. The KSOX radar is not located within the map area.

Level-II weather radar imagery from two WSR-88D radars (KSOX and KVTX) located in the accident region are presented in figures 2 and 3. KSOX was located approximately 65 miles east-southeast of the accident site at an elevation of about 3,100 feet. Assuming standard refraction and considering the  $0.95^\circ$  beam width for the WSR-88D radar beam, the KSOX  $0.484^\circ$  tilt would have “seen” altitudes above the accident location of between about 6,000 and 12,500 feet msl. KVTX was located approximately 33 miles northwest of the accident site at an elevation of about 2,800 feet. Assuming standard refraction and considering the  $0.95^\circ$  beam width for the WSR-88D radar beam, the KVTX  $0.527^\circ$  tilt would have “seen” altitudes above the accident location of between about 3,700 and 7,000 feet msl. Imagery from both radars near the accident time depicted distinct areas of mostly light reflectivity north, northwest, west and southwest of the accident site. A loop of images from these radars around these times identified these areas of reflectivity moving to the east.

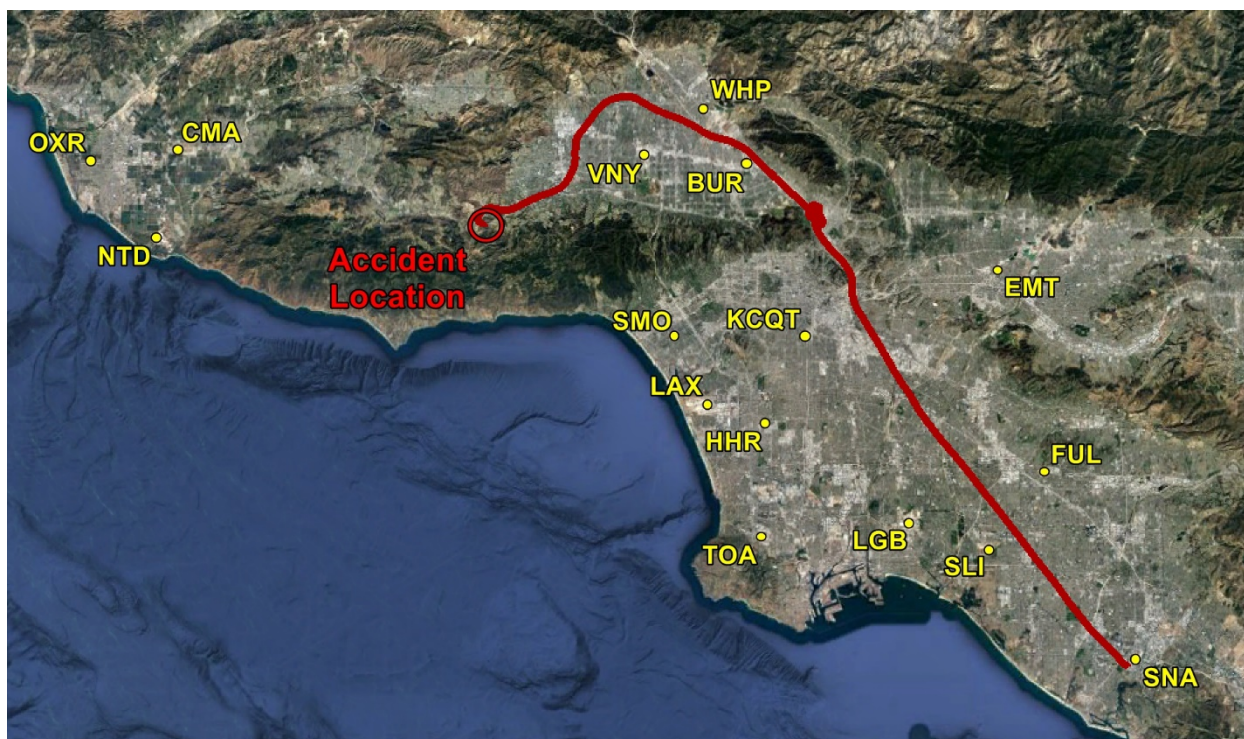
**Figure 4** – Ceiling and visibility reporting weather station locations along and nearby the accident aircraft's route of flight (depicted as the red line) on the accident day.

Figure 4 identifies ceiling and visibility reporting weather station locations along and nearby the accident aircraft's route of flight on the accident day. Longline-disseminated<sup>2</sup> reports from some of these stations for times surrounding the accident time are provided below. Longline-disseminated reports from all these stations for the time period of 0000 PST on 25 January 2020 through 1100 PST on 26 January 2020 can be found in Attachment 1. Five-minute data from most of these stations during this time period are also included in Attachment 1.

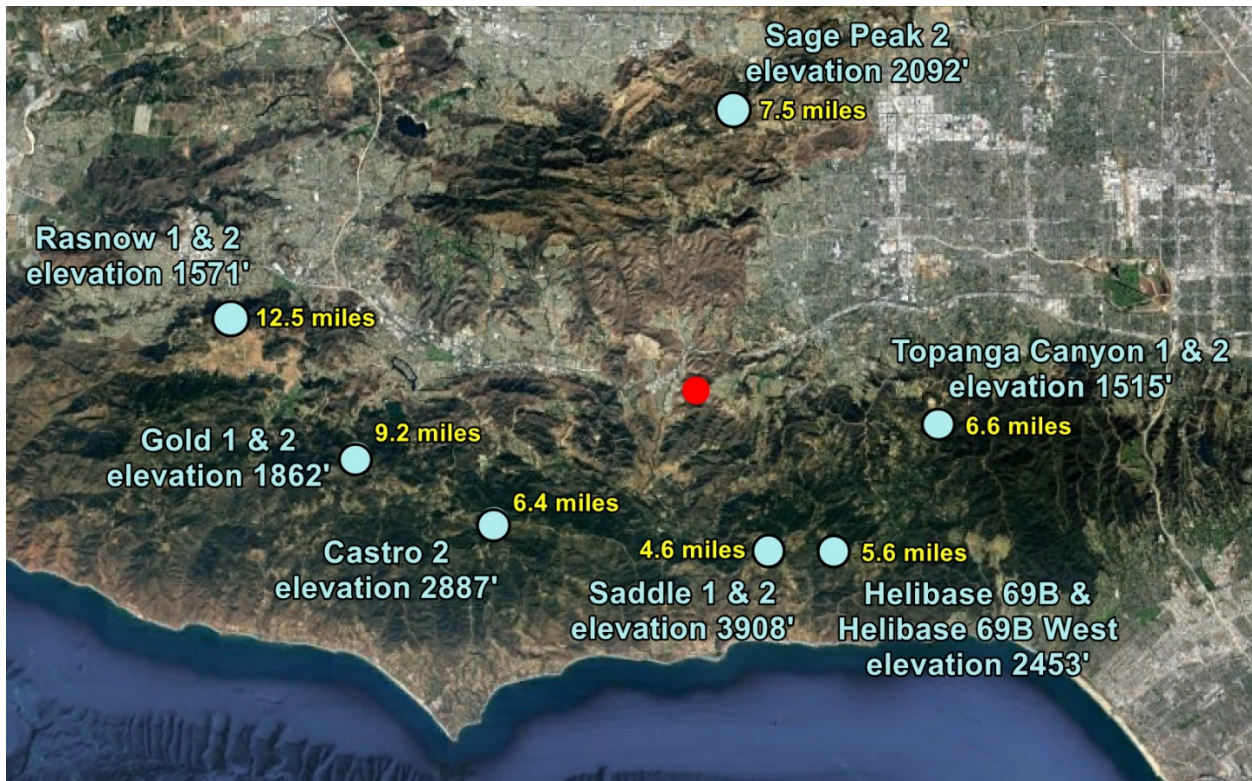
**Figure 9** – ALERTWildfire camera locations. Camera elevations provided by UNR. Yellow text identifies approximate distance from camera to accident location. Accident location denoted by the red circle.

Imagery from ALERTWildfire cameras located in the accident region for times surrounding the accident time were provided by SCE by way of the University of Nevada Reno (UNR).<sup>11</sup> These imagery were taken from the following cameras, whose locations are presented in Figure 9: Castro 2, Gold 1, Gold 2, Helibase 69B, Helibase 69B West, Rasnow 1, Rasnow 2, Saddle 1, Saddle 2, Sage Peak 2, Topanga Canyon 1 and Topanga Canyon 2. Video loops of the camera images may be found in the docket for this investigation. Several images are reproduced below.

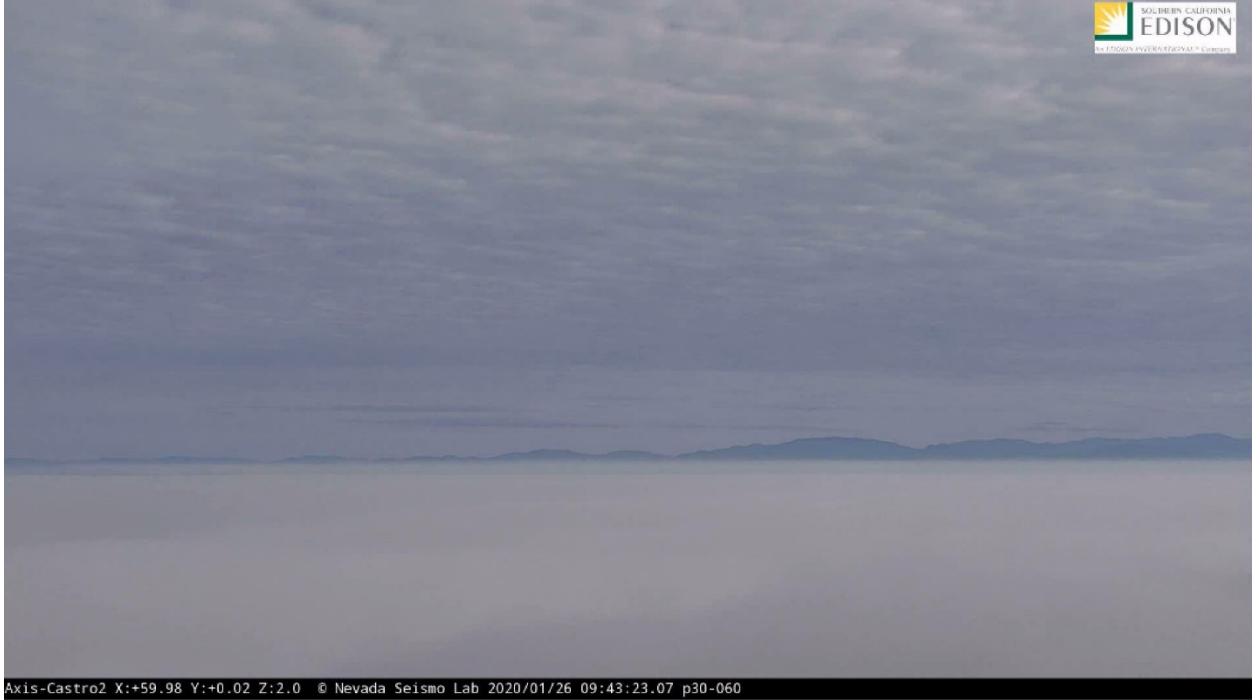
**Figure 10** – ALERTWildfire Castro 2 camera image from 0943:23 PST, facing east-northeast.

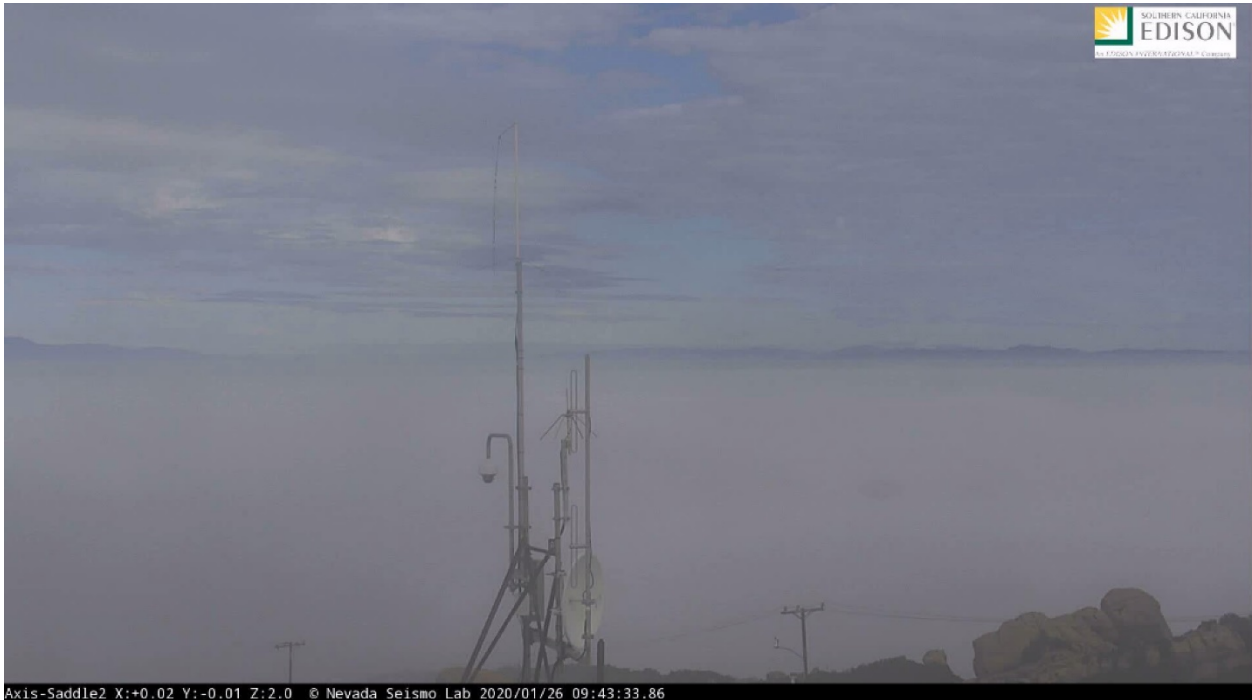
**Figure 11** – ALERTWildfire Saddle 2 camera image from 0943:33 PST, facing north.

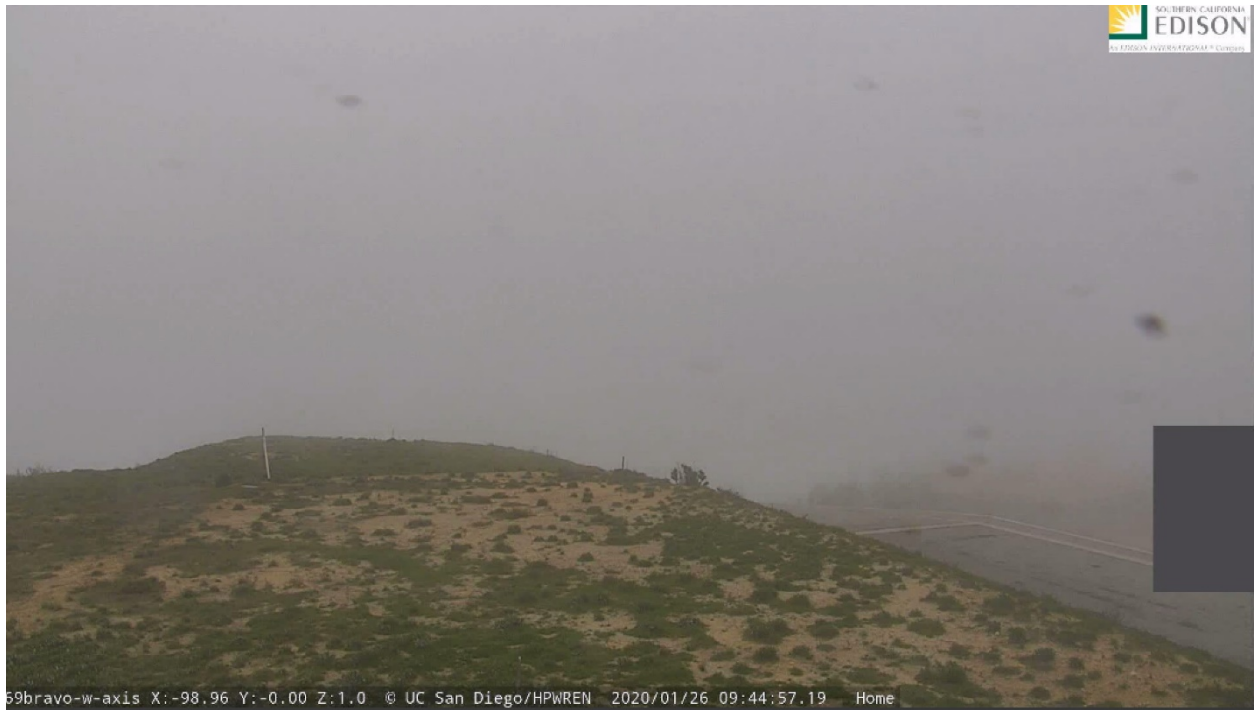
**Figure 12** – ALERTWildfire Helibase 69B West camera image from 0944:57 PST, facing west.

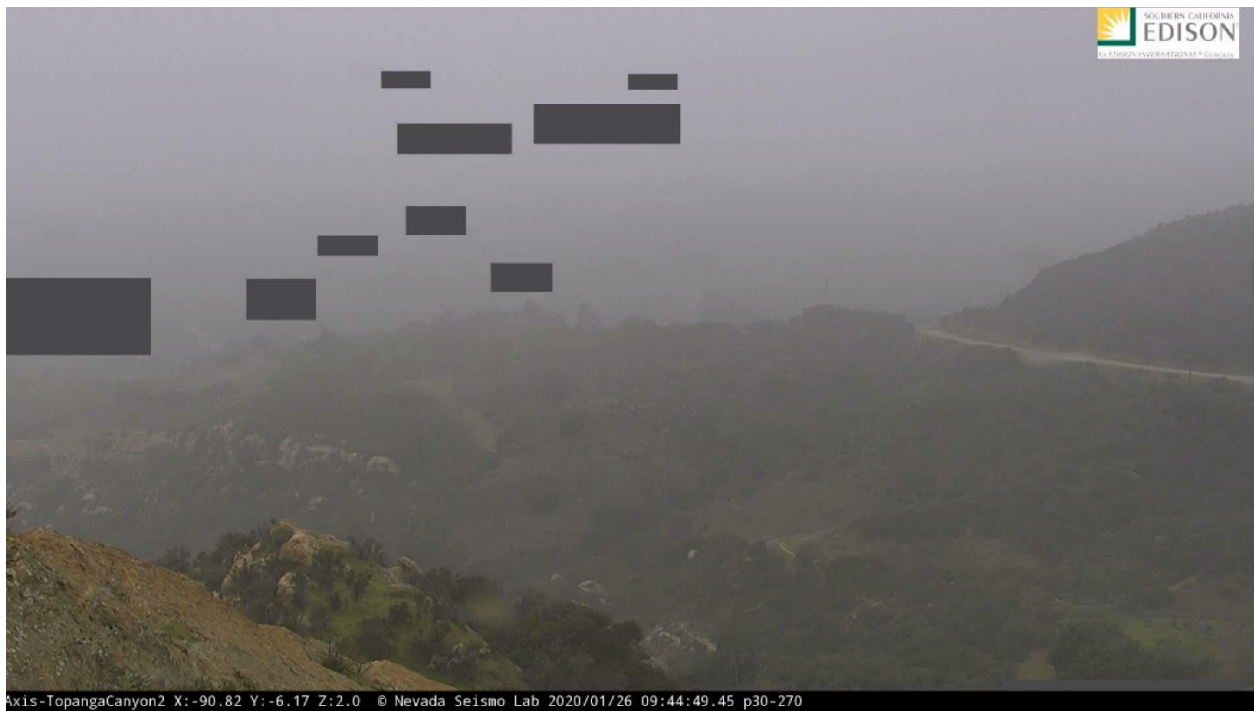
**Figure 13** – ALERTWildfire Topanga Canyon 2 camera image from 0944:49 PST, facing west.

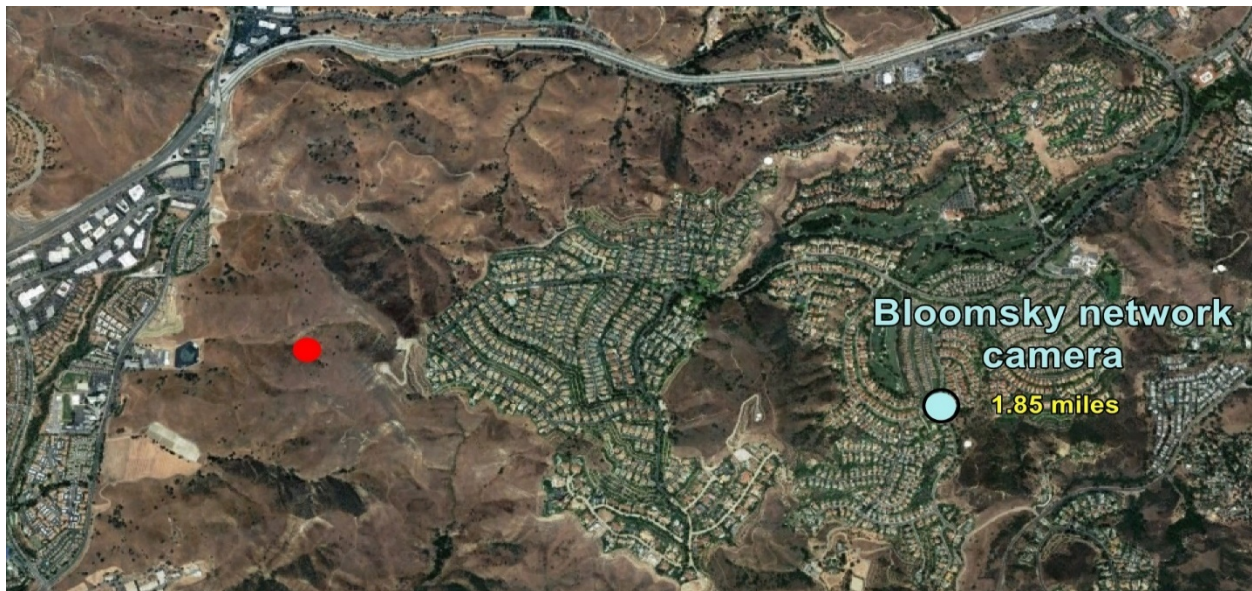
**Figure 15** – Bloomsy network west-facing camera location. Yellow text identifies approximate distance from camera to accident location. Accident location denoted by the red circle.

A west-facing video camera connected to the Bloomsy network<sup>12</sup> was located almost two miles east of the accident location (see Figure 15) at an elevation of about 1,320 feet and captured images on the accident day. Footage from this camera can be found in the docket for this investigation. An image from this camera is presented in Figure 16.

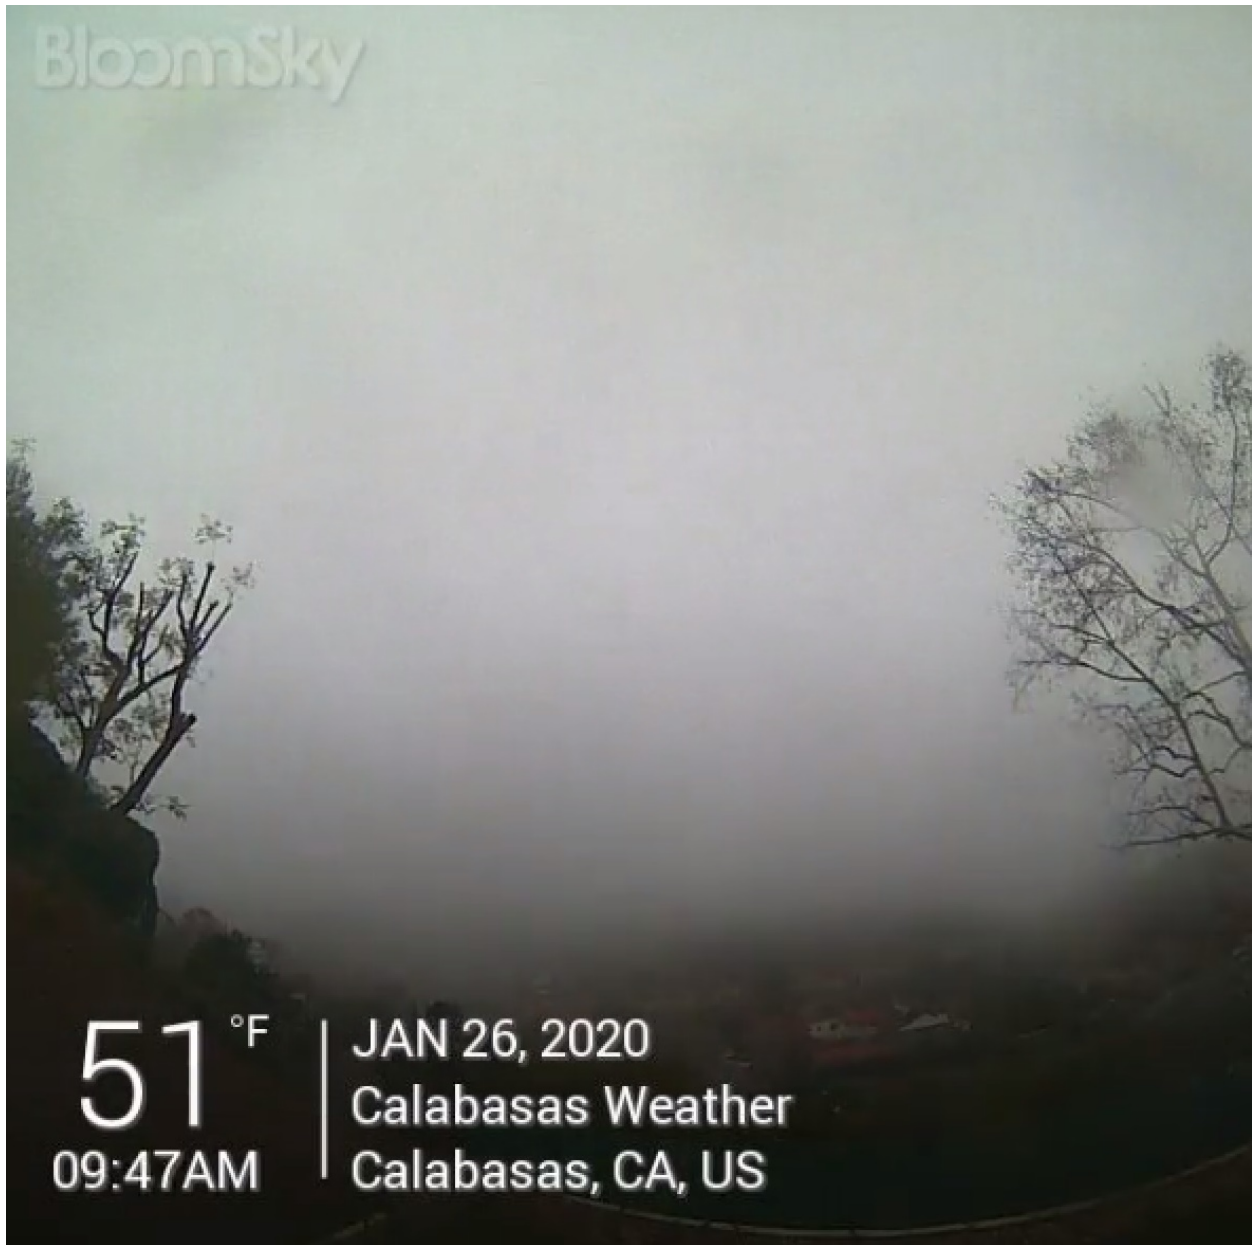
**Figure 16** – West-facing Bloomsy network camera image from 0947 PST.

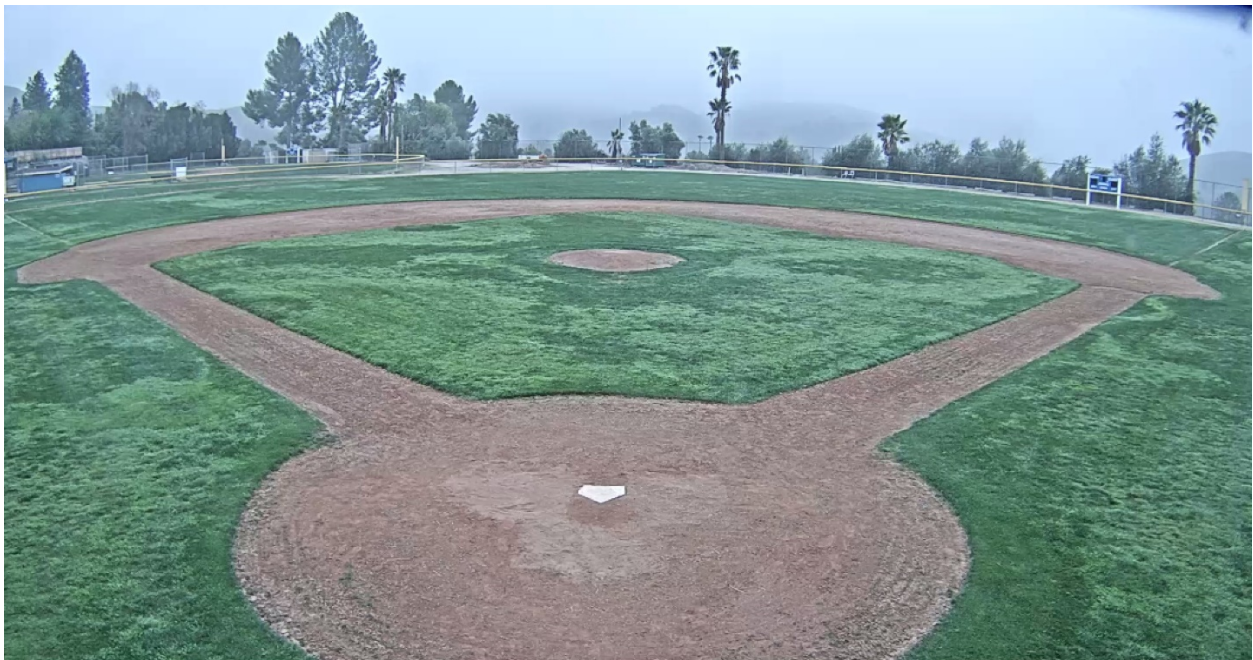
**Figure 18** – Still image from one of the south-facing baseball field cameras about the accident time. See the *Video-Based Visibility Analysis* in the docket for this investigation for further information.

Several south-facing cameras located at baseball fields north of the accident site (see Figure 17) recorded conditions at the time of the accident. Footage recorded from these cameras during the accident time can be found in the docket for this investigation. A visibility analysis titled *Video-Based Visibility Analysis* was performed using these cameras' footage and can also be found in the docket for this investigation. The time stamps in these videos did not reflect real-time. The *Video-Based Visibility Analysis* documents the clocks' errors. An image from these cameras is presented in Figure 18.

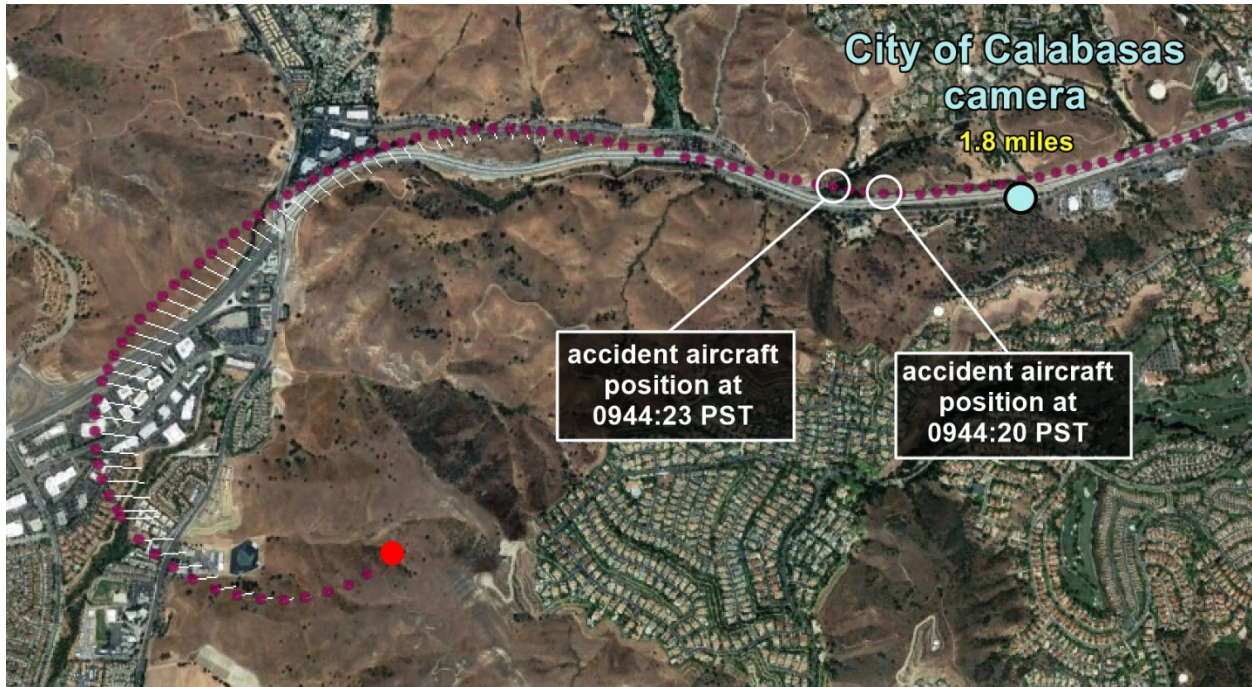
**Figure 19** – City of Calabasas west-facing camera location. Yellow text identifies approximate distance from cameras to accident location. Accident location denoted by the red circle. The accident aircraft's ADS-B flight track is plotted by the purple circles/line with aircraft positions matching timestamps in Figures 20 and 21 identified.

Footage from a west-facing camera located under the accident aircraft's flight path (see Figure 19) operated by the City of Calabasas can be found in the docket for this investigation. Figures 20 and 21 present still images from this footage (note: the time stamp in the video was 59 minutes and 37 seconds behind real time).

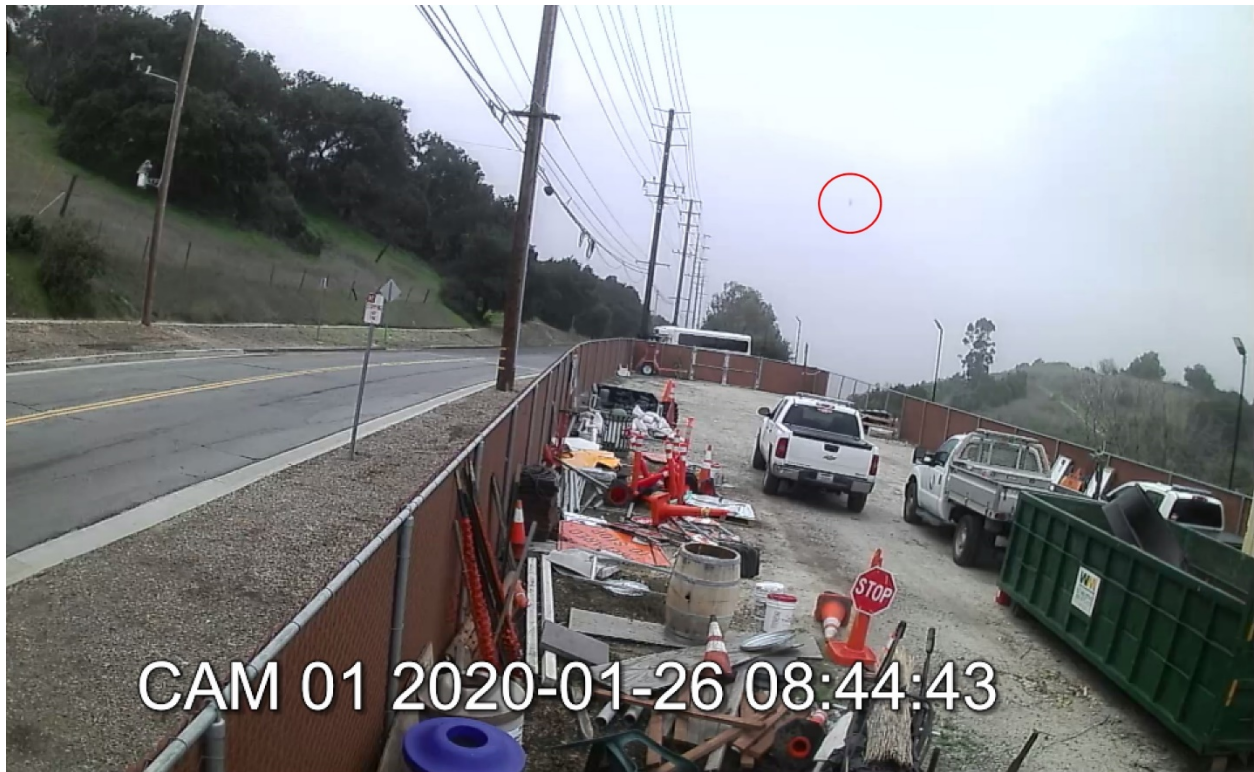
**Figure 20** – City of Calabasas west-facing camera image from 0944:20 PST. Accident aircraft circled in red moving away from the camera.

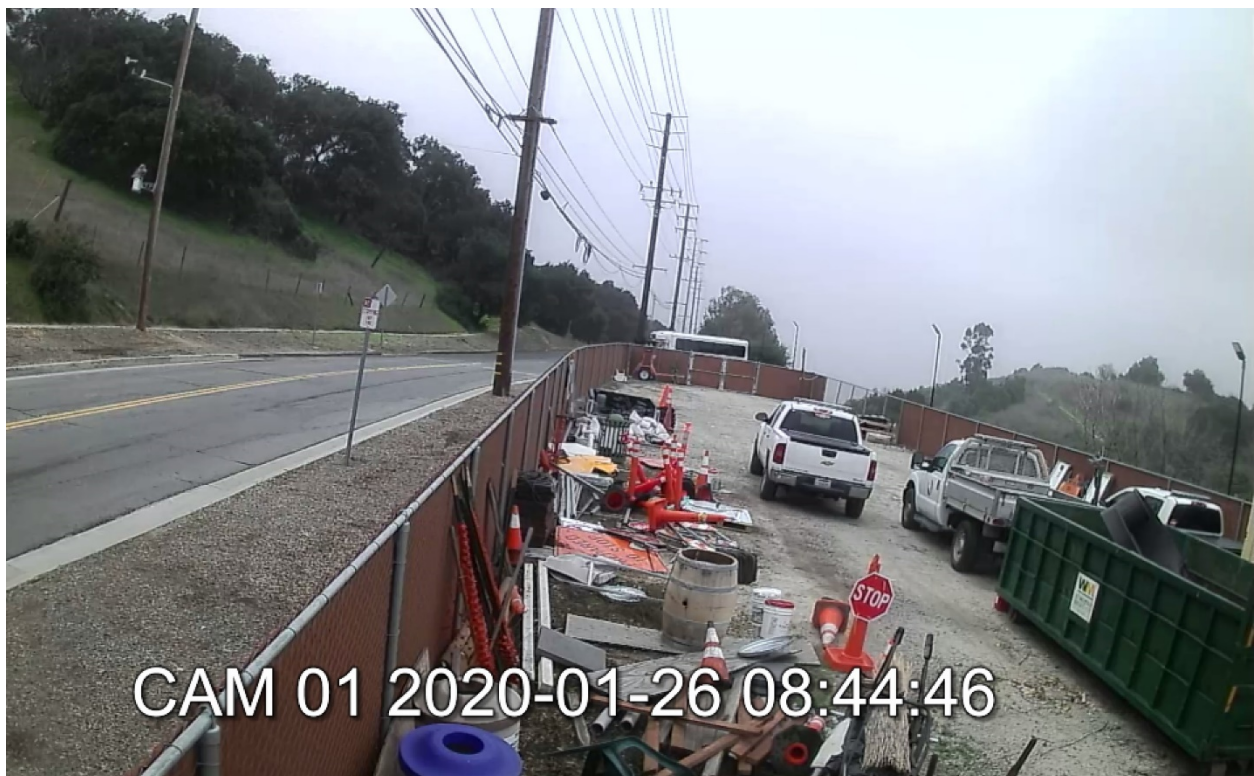
**Figure 21** – City of Calabasas west-facing camera image from 0944:23 PST. Accident aircraft is not pictured in the video.

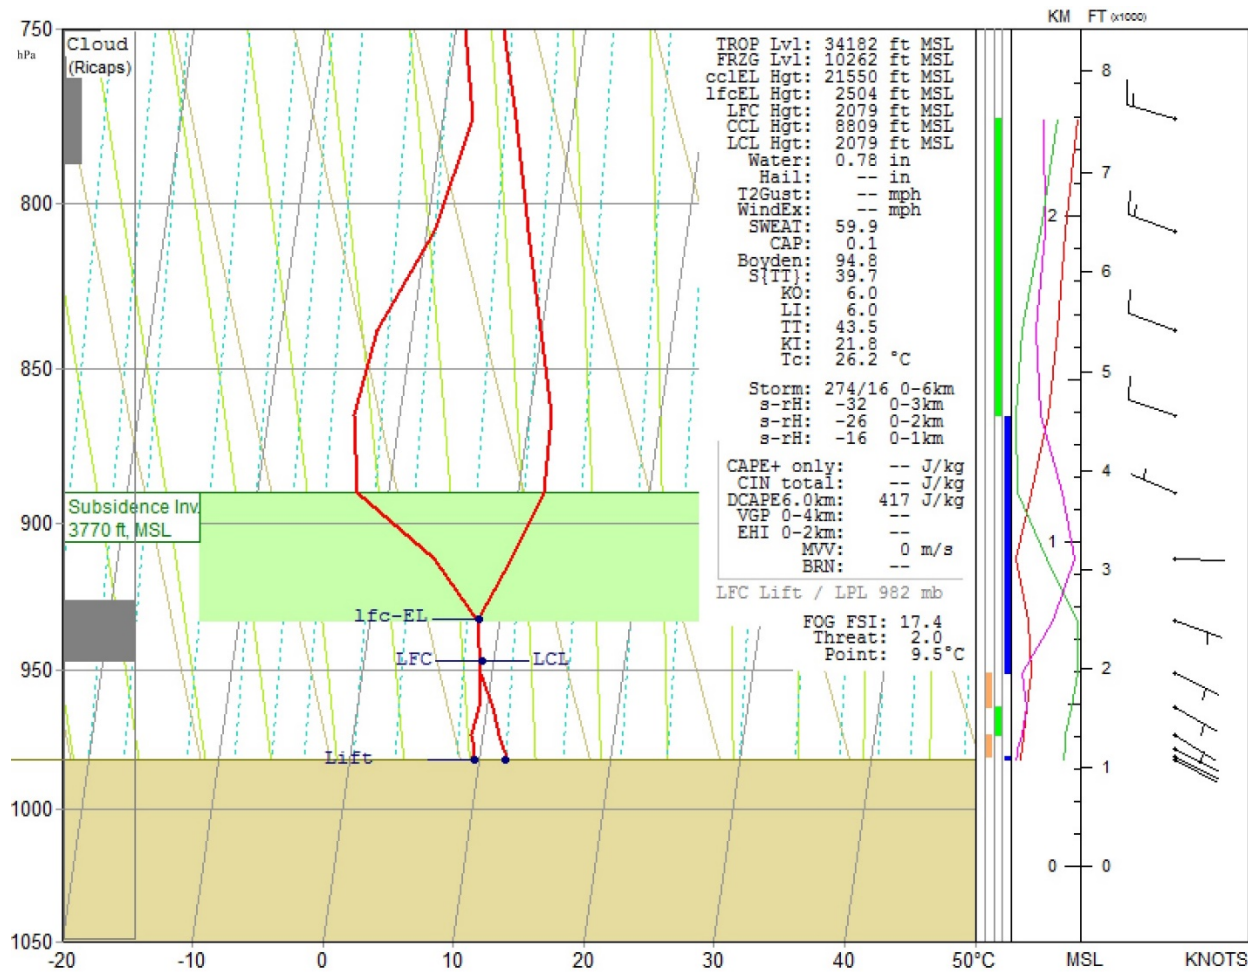
**Figure 22** – HRRR model sounding data in SkewT/LogP format for 1000 PST at the accident site, surface to 750 hPa.

A High-Resolution Rapid Refresh (HRRR) model<sup>13</sup> sounding (figure 22) for the accident location at 1000 PST was retrieved from the National Oceanic and Atmospheric Administration’s (NOAA) Air Resources Laboratory.<sup>14</sup> Below 2,500 feet the wind was from the east-southeast at less than 5 knots. Above this level the wind veered very slightly with height to a 1 knot easterly wind at about 3,100 feet. Above this level the wind was from the west-northwest at magnitudes of about 10 knots or less below 5,500 feet. The Rawinsonde OBServation Program identified overcast stratus cloud conditions between about 2,000 and 2,600 feet. A temperature inversion was noted between about 2,400 and 3,700 feet.

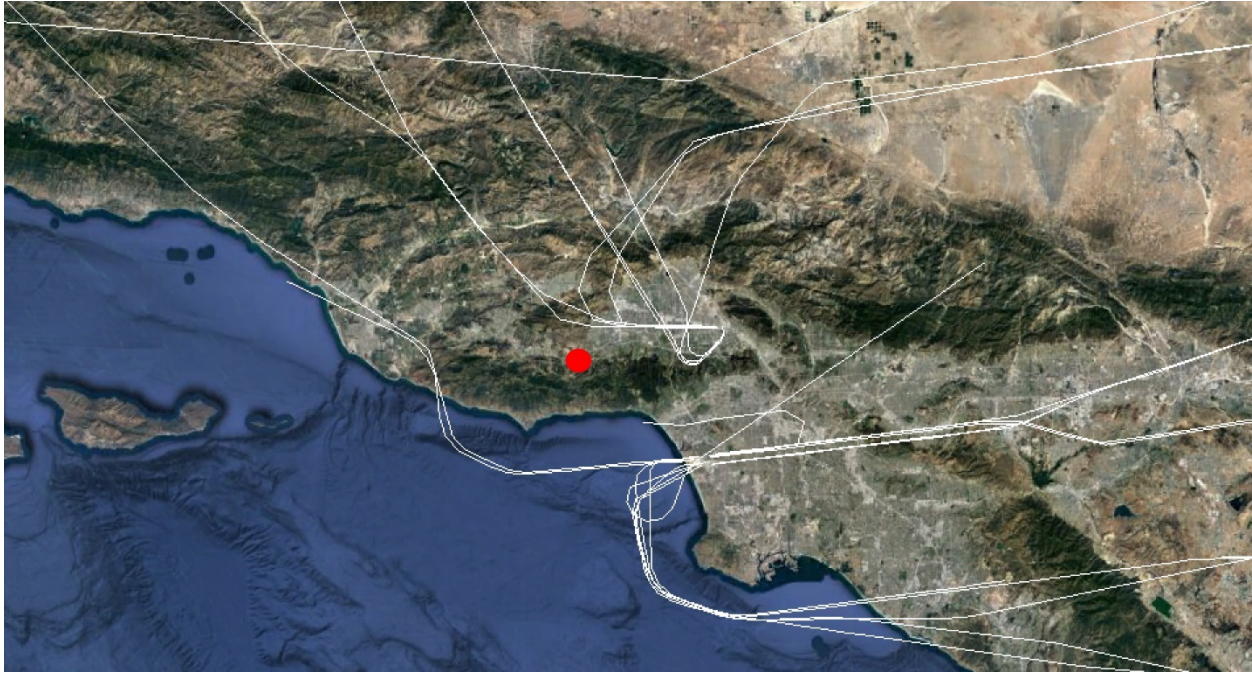
**Figure 23** – Flight tracks (white lines) for aircraft whose AMDAR data are provided in Attachment 4. The accident location is denoted by the red circle.

Aircraft Meteorological Data Relay (AMDAR) data<sup>15</sup> from aircraft in the accident region between 0900 and 1000 PST were obtained from NOAA and are available in Attachment 4. Figure 23 presents plots of the flight tracks of these aircraft.

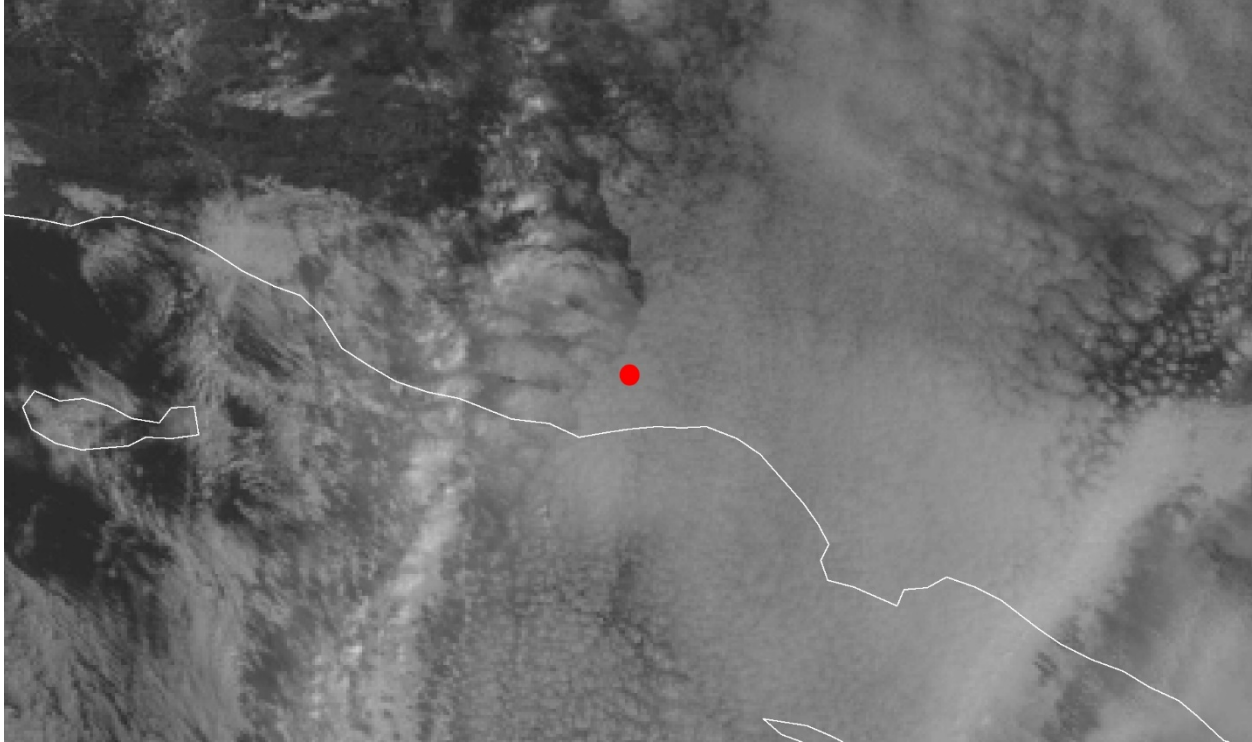
**Figure 24** – GOES-17 visible imagery from 0941 PST. Accident location denoted by red dot.

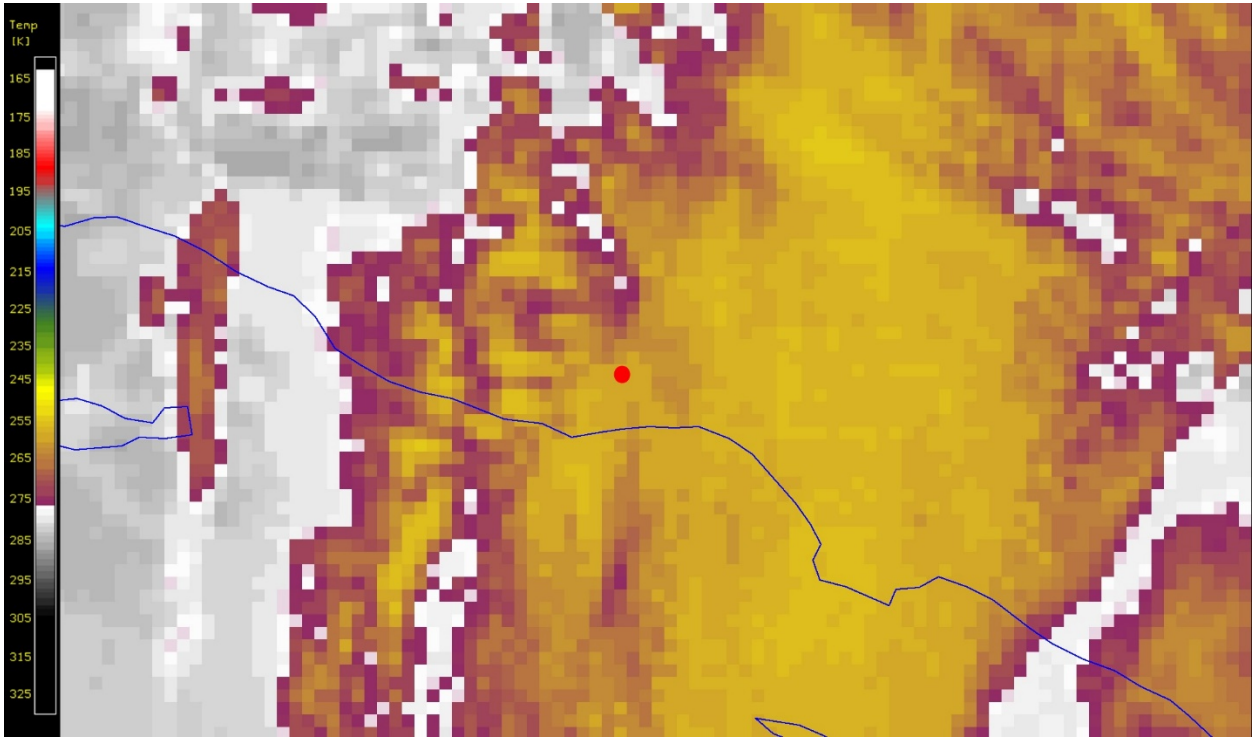
**Figure 25** – GOES-17 brightness temperature imagery from 0941 PST. Accident location denoted by red dot.

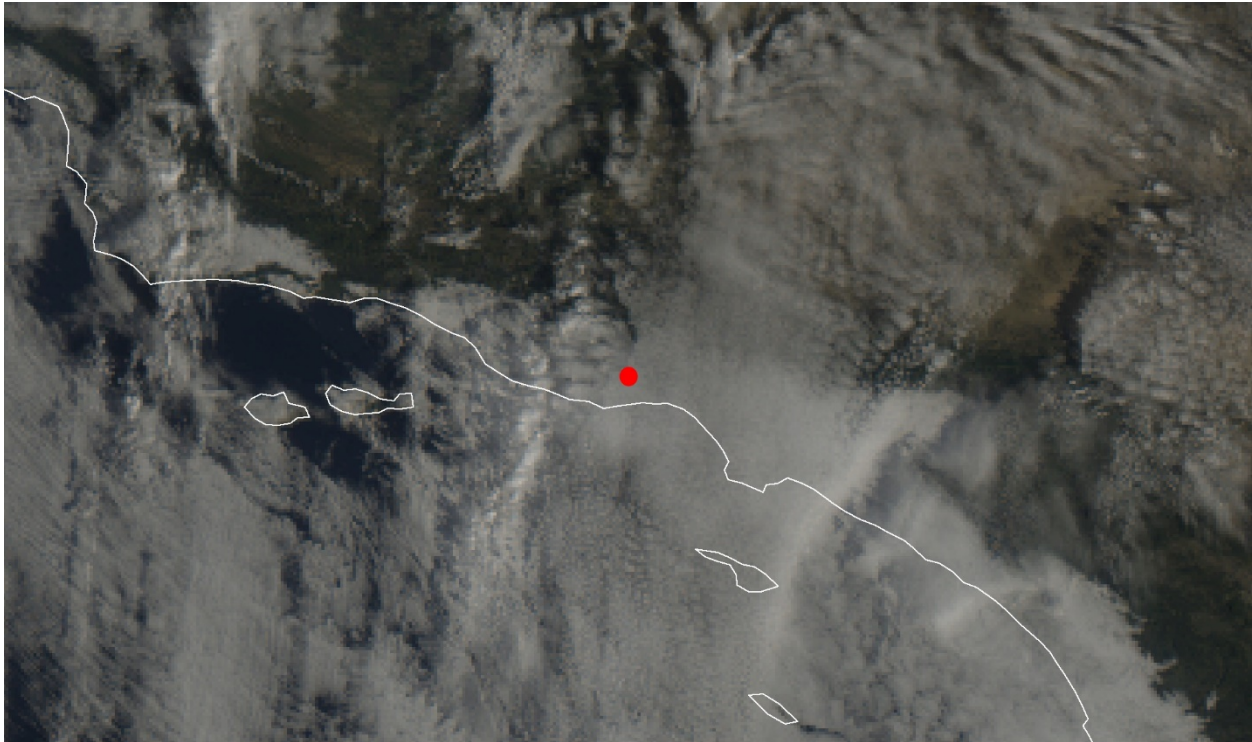
**Figure 26** – GOES-17 true-color imagery from 0941 PST. Accident location denoted by red dot.

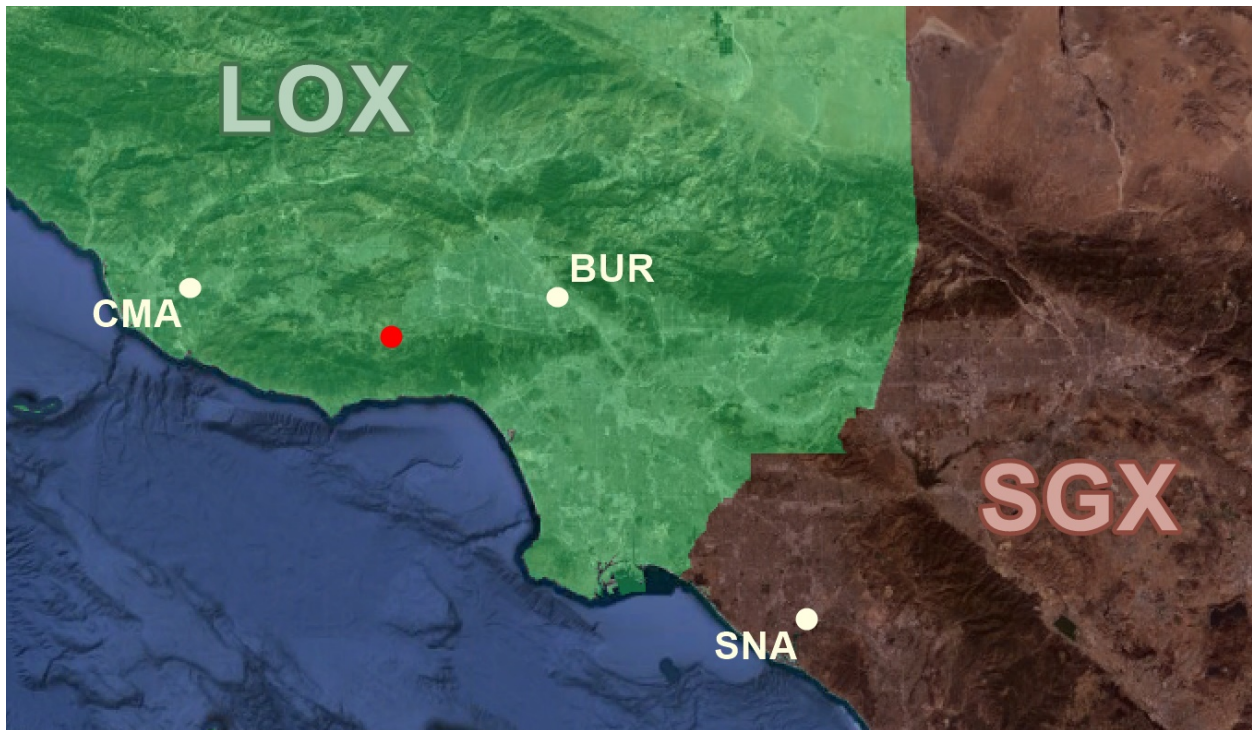
**Figure 27** – Depiction of LOX and SGX County Warning Areas. Accident location denoted by red dot.

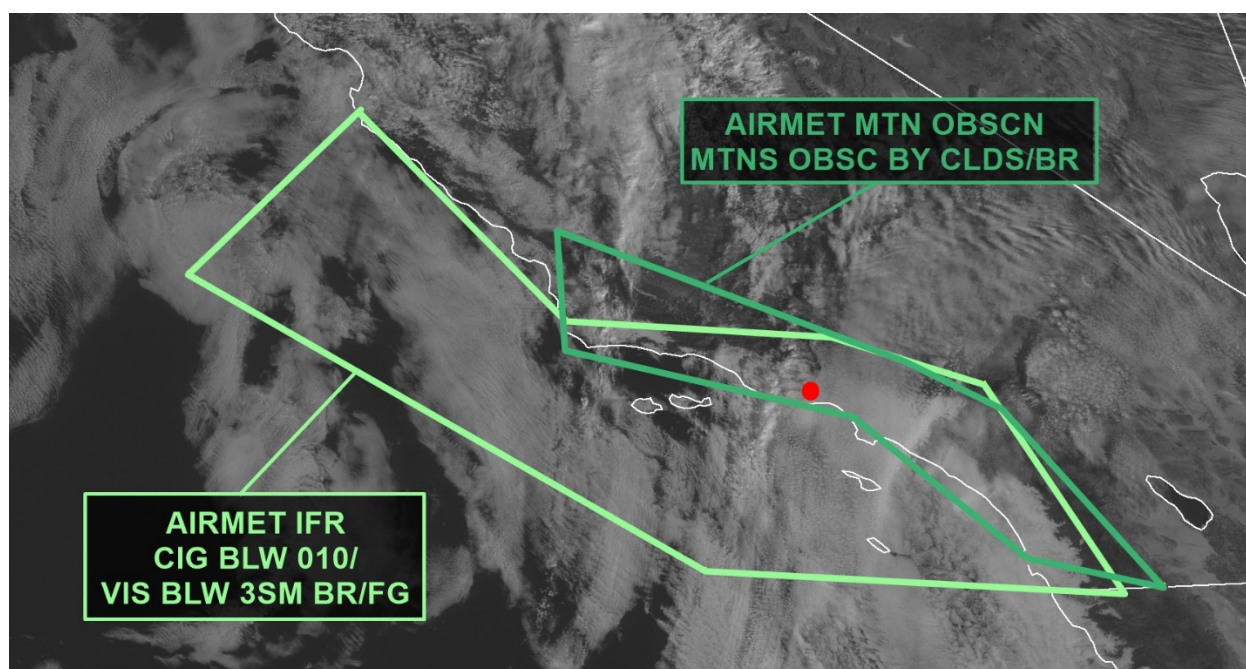
**Figure 28** – AIRMETs for IFR conditions and mountain obscuration active for the accident location at the accident time. Accident location denoted by the red dot.

At 0645 PST, the NWS Aviation Weather Center issued Airmen's Meteorological Information (AIRMET) SIERRA advisories for instrument flight rule (IFR)<sup>17</sup> conditions in mist and fog and for mountain obscuration for areas that included the accident location (see Figure 28). These AIRMETs were valid at the accident time.
