NATIONAL TRANSPORTATION SAFETY BOARD

Weather Study

WPR20CA267

Location: Jackson, Wyoming
Date: August 3, 2020
Time: 0813 mountain daylight time (1413 UTC)¹
Aircraft: Type – Lindstrand 310A; Registration – N971LB

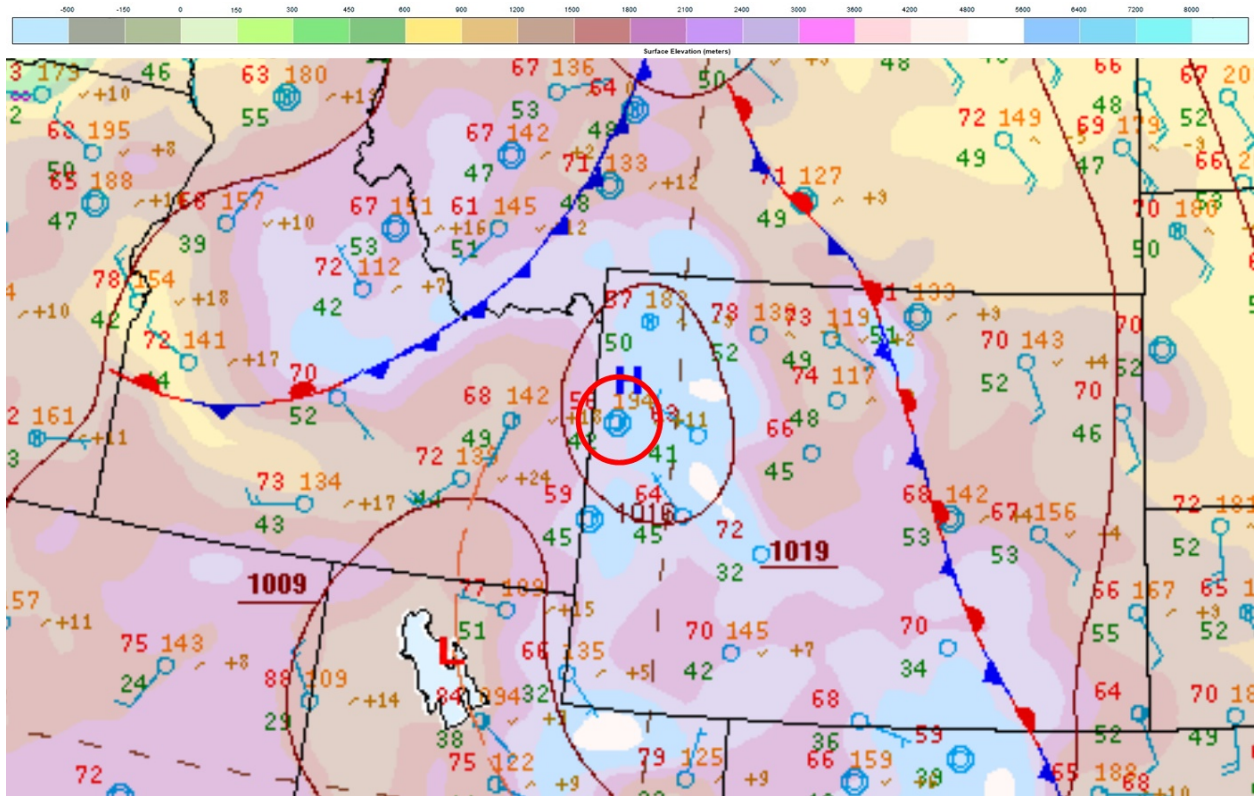
Figure 1 - NWS Surface Analysis Chart for 0900 MDT. Accident location is inside the red circle.

A western portion of the National Weather Service (NWS) Surface Analysis Chart for 0900 MDT is presented in figure 1. The surface analysis chart identified a high-pressure center near the accident site. A cold front stretched from western Montana southwestward into southern Idaho, and a stationary front extended from central Montana in central Wyoming. A trough of low-pressure was also depicted extending from southeastern Idaho into northern Utah. Temperatures in the accident region were in the mid-50°s Fahrenheit (F) to mid-60°s F, with dew point temperatures generally in the low 40°s F. Station models in the region depicted clear skies and a calm wind was observed near the accident location.

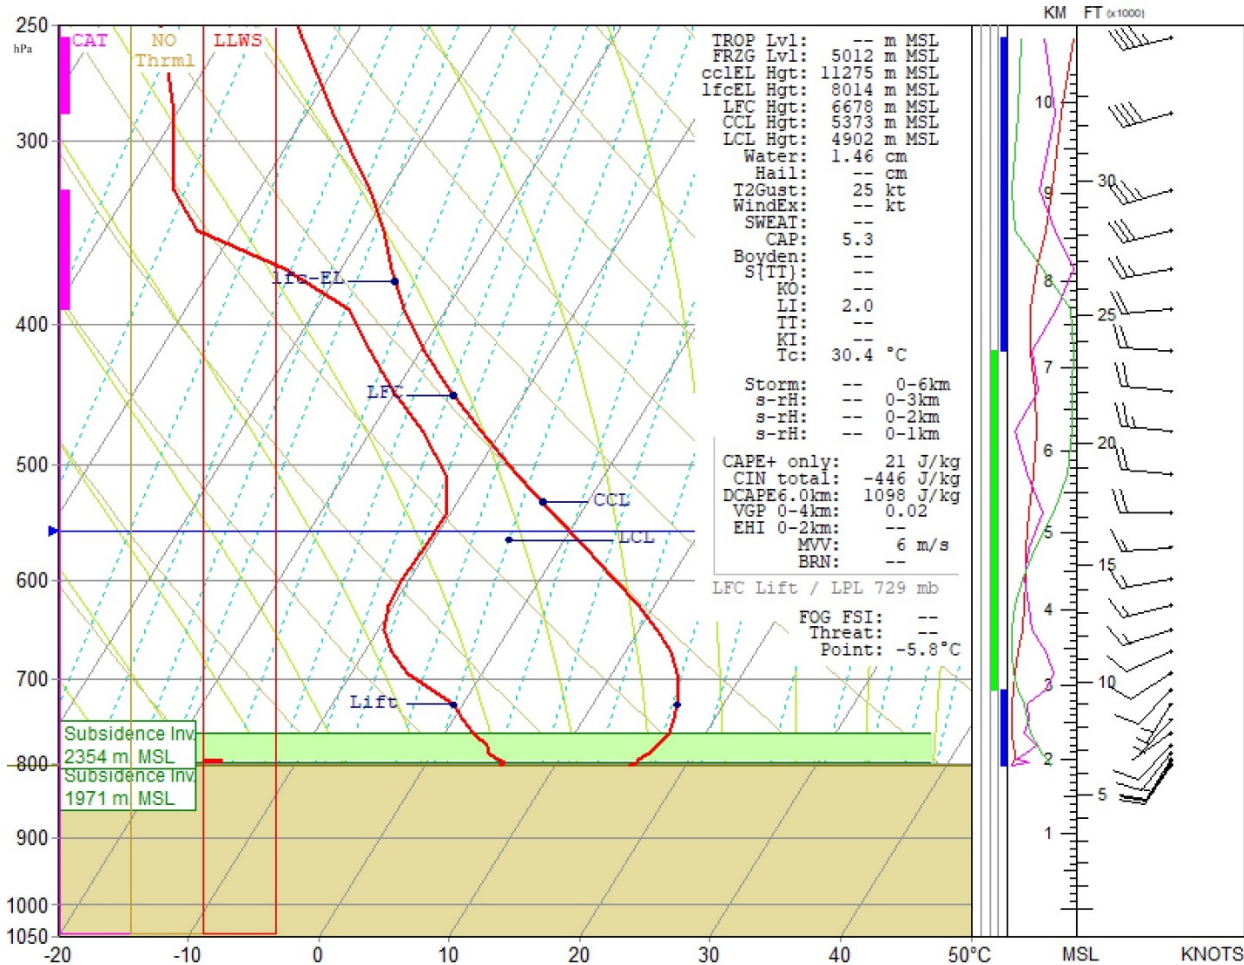
Figure 2 – HRRR model sounding data in SkewT/LogP format for 0800 MDT at the accident site, surface to 250 hPa.

A High-Resolution Rapid Refresh (HRRR) model⁴ sounding (figure 2) for the accident site at 0800 MDT was retrieved from the National Oceanic and Atmospheric Administration's Air Resources Laboratory. Nearest the surface the wind was from the southwest at 8 knots; the wind veered⁵ slightly to an approximately west wind of 17 knots near 12,000 feet. Calculations made by the Rawinsonde OBservation Program (RAOB) indicated the potential for "light" low-level wind shear around 6,500 feet (about 200 feet agl). The sounding exhibited characteristics of an "Inverted-V" sounding⁶, and the downdraft convective available potential energy (DCAPE; 6 kilometers above ground level; density weighted average method) was measured at 1,098 Joules/kilogram which was considered a strong value.⁷

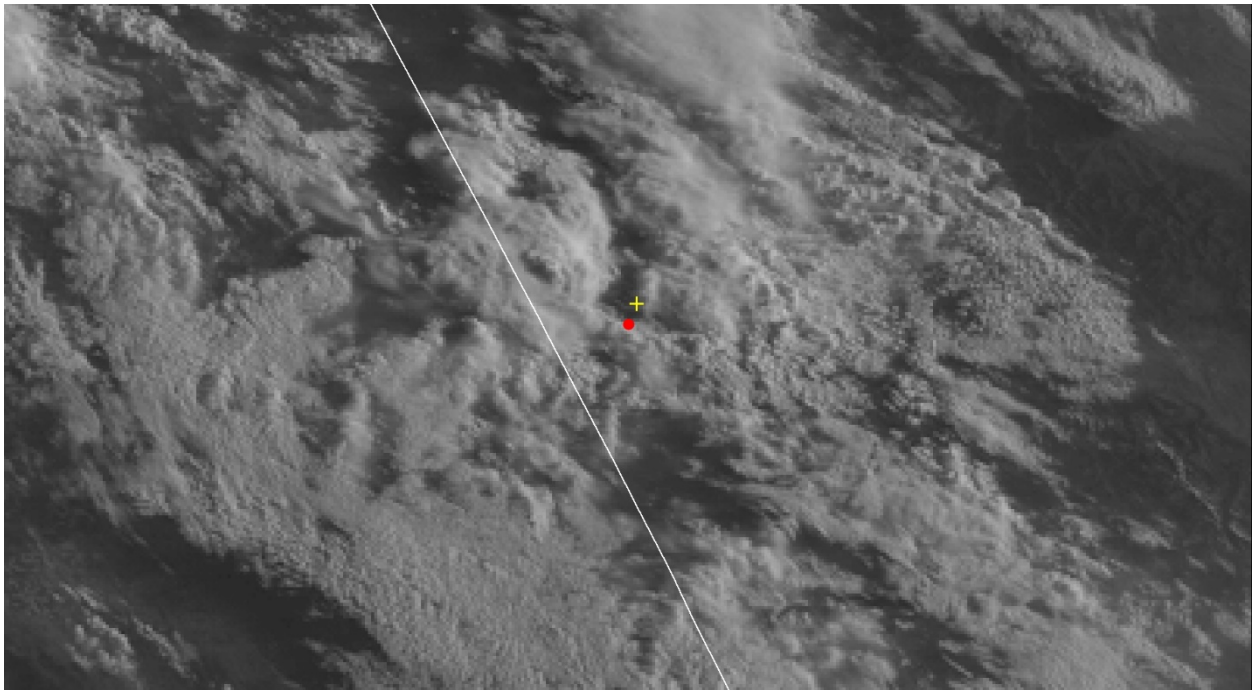
Figure 3 – GOES-17 visible imagery from 0811 MDT. Accident location denoted by red dot. The yellow “plus” symbol is the accident location relative to clouds that were at the height of 15,000 feet.

Geostationary Operational Environmental Satellite (GOES)-17 visible (0.64 μ m) and infrared (10.3 μ m) data were obtained from an archive at the Space Science Engineering Center at the University of Wisconsin-Madison. Imagery from 0811 MDT are presented in figures 3 and 4. The GOES-17 visible imagery depicted cloudy conditions over most of the accident region. Infrared cloud-top temperatures over the accident site were about -13°C, which, when considering the 0800 MDT HRRR sounding, corresponded to cloud top heights of about 19,000 feet.⁸ In the visible image, it appears that the accident location was under cloudy conditions with a small clear area to its north. Because the image is not corrected for parallax error⁹, to better understand if the accident

location was under clouds at the time of the satellite image, where the accident location would be moved to (in the image) if it was at a height of about 4.5 kilometers (about 15,000 feet) was calculated. The yellow “plus” symbols in figures 3 and 4 are the locations of the accident location relative to clouds that were at the height of 15,000 feet, and indicated that the accident location was more likely in clear conditions, or was under the eastern side of a cloudy area, at the time these satellite images were taken.

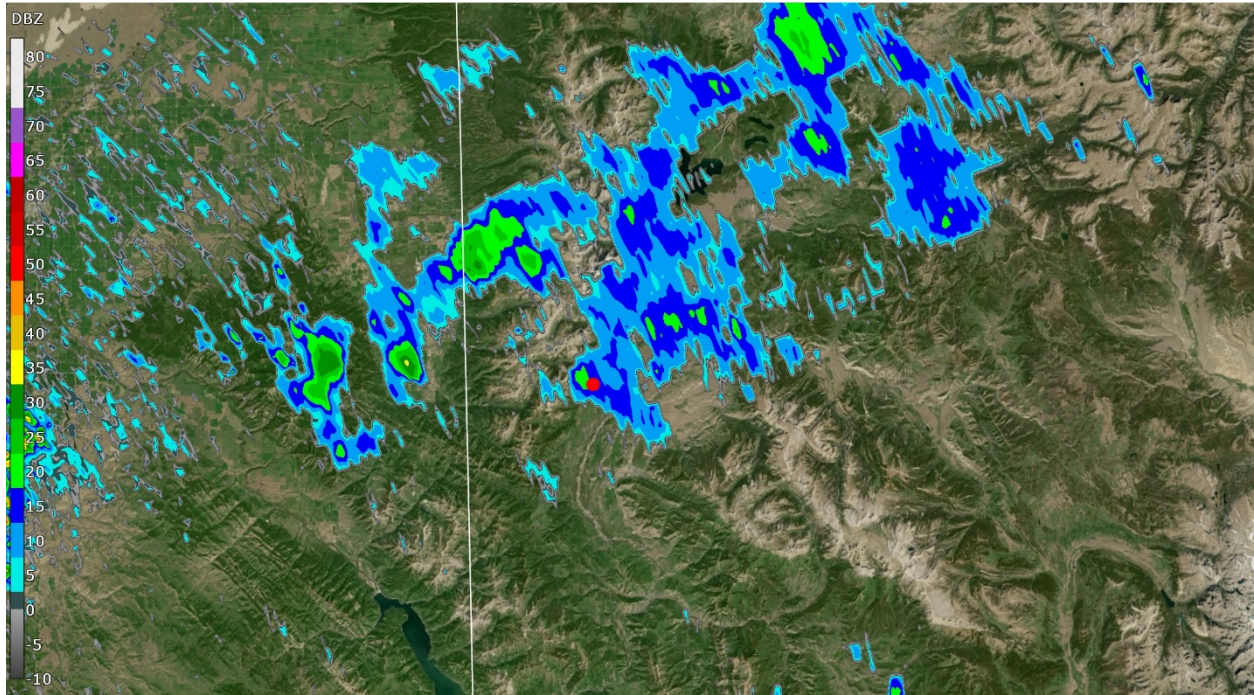
Figure 5 – KSFX 0.527° Level-II base reflectivity product from a sweep initiated at 0807:05 MDT. Accident location marked by red circle.

The WSR-88D¹⁰ Level-II base reflectivity weather radar imagery from the Pocatello, Idaho, site (KSFY) are presented in figures 5-7. KSFY was located approximately 86 miles west-southwest of the accident location at an elevation of about 4,540 feet. Assuming standard refraction and considering the 0.95° beam width¹¹ for the WSR-88D radar beam, the KSFY 0.527° tilt would have “seen” altitudes above the accident location of between about 9,900 and 18,600 feet above msl. Around the time of the accident, the weather radar depicted reflectivity with values of less than 25 dBZ moving from the west-southwest over the accident site.

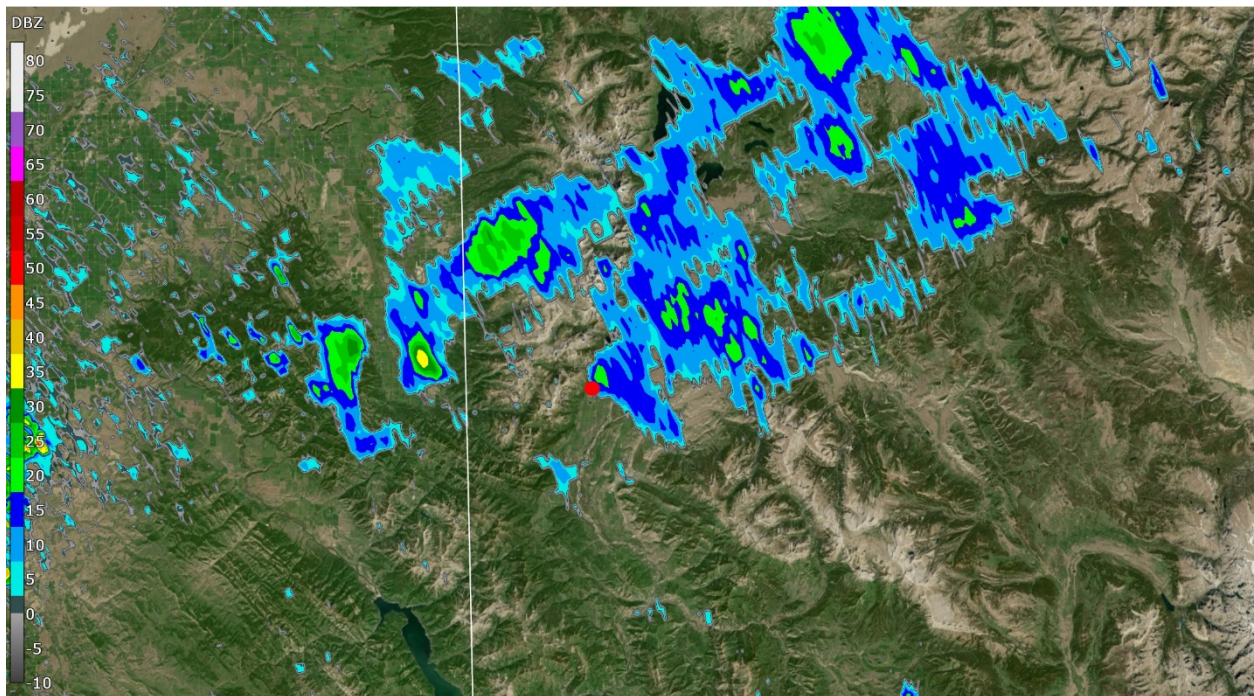
Figure 6 – KSFX 0.527° Level-II base reflectivity product from a sweep initiated at 0811:24 MDT. Accident location marked by red circle.

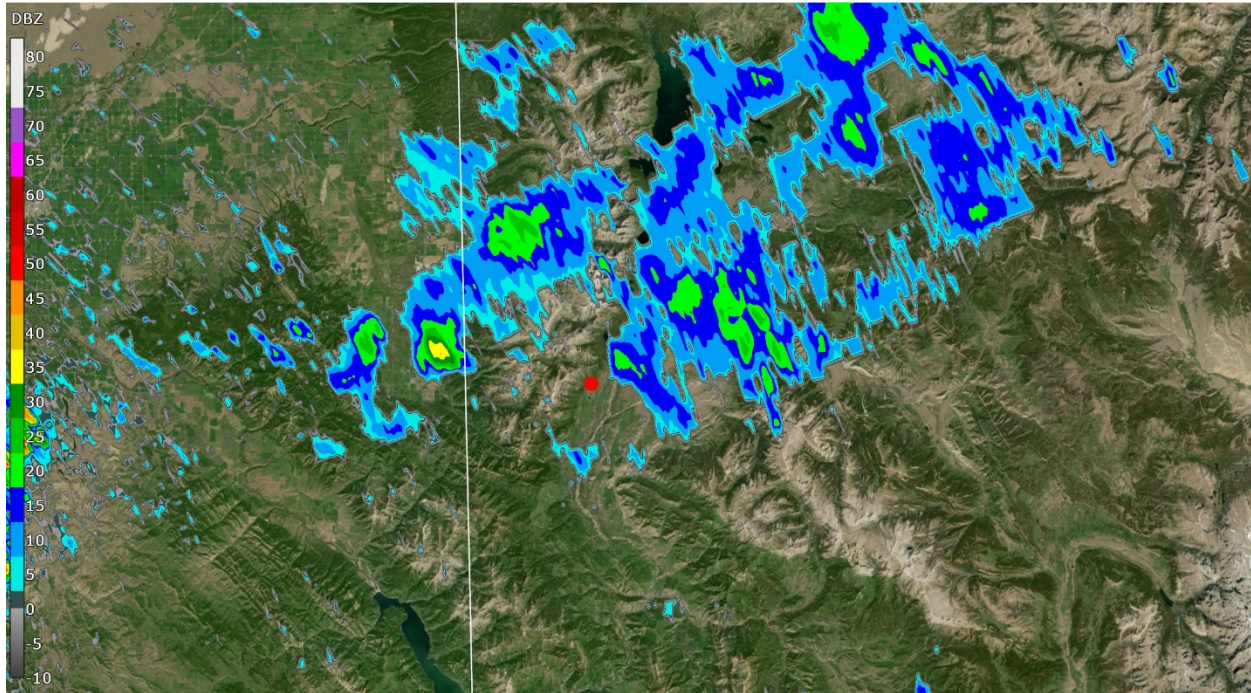
Figure 7 – KSFY 0.527° Level-II base reflectivity product from a sweep initiated at 0815:43 MDT. Accident location marked by red circle.
