# National Transportation Safety Board

HWY23MH004

## **SUAS SPECIALISTS REPORT**

Specialist's Factual Report

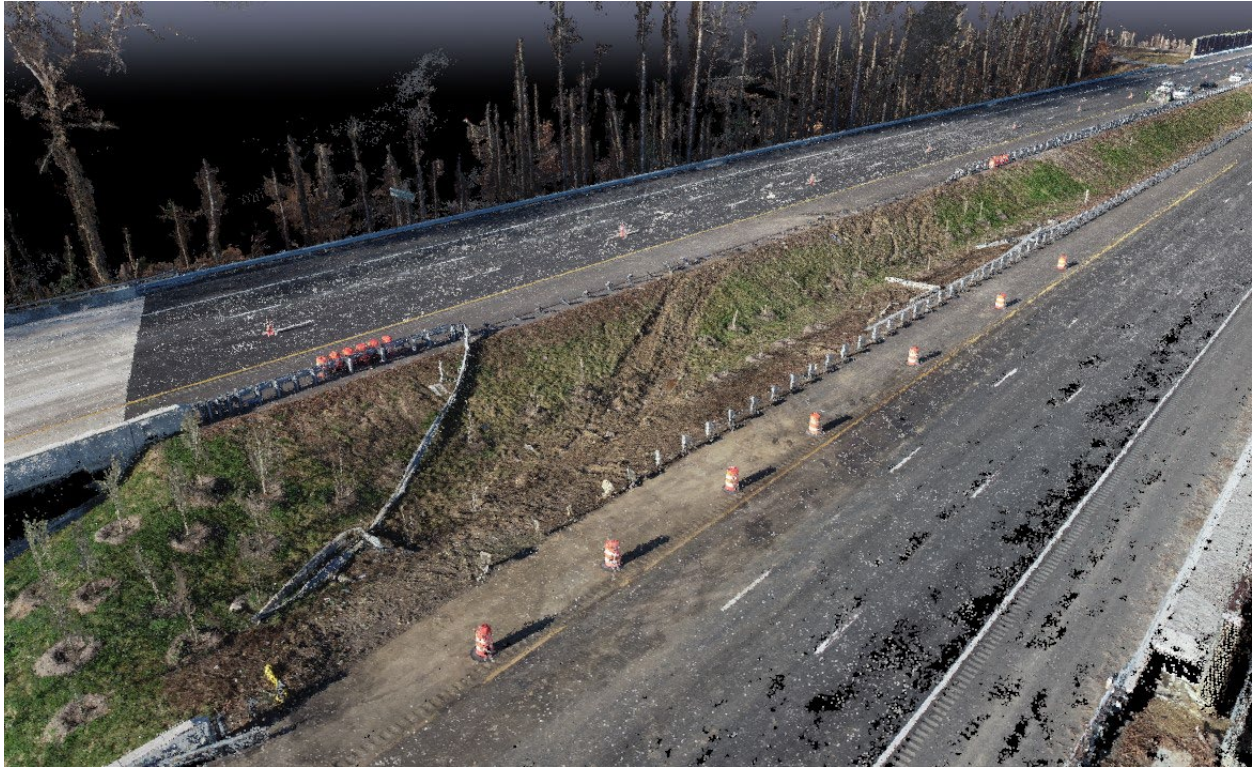
**Figure 2.** Screen capture of the generated three-dimensional point cloud from Pix4D

The photographs taken using the sUAS were processed using Pix4D to create a point cloud of the crash scene. An oblique view of the point cloud can be seen in **Figure 2**. From the point cloud, a high resolution orthomosaic image was created of the crash scene and can be seen in **Figure 3**.

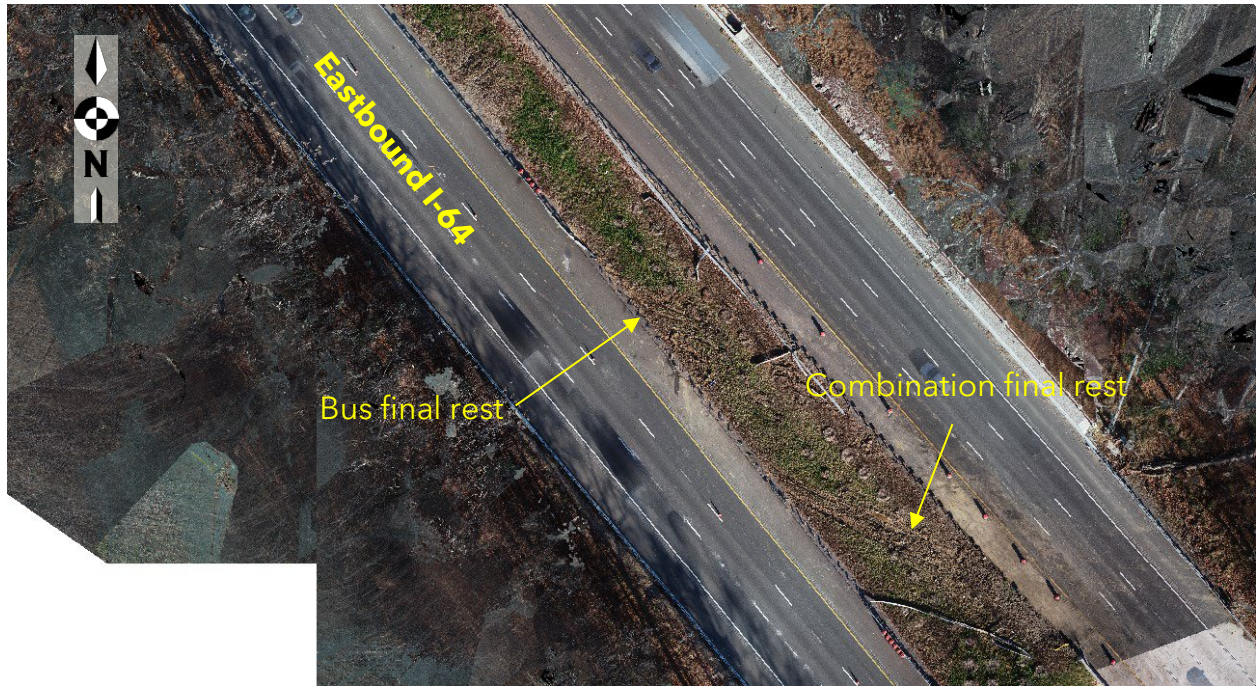
**Figure 3.** Orthomosaic image.

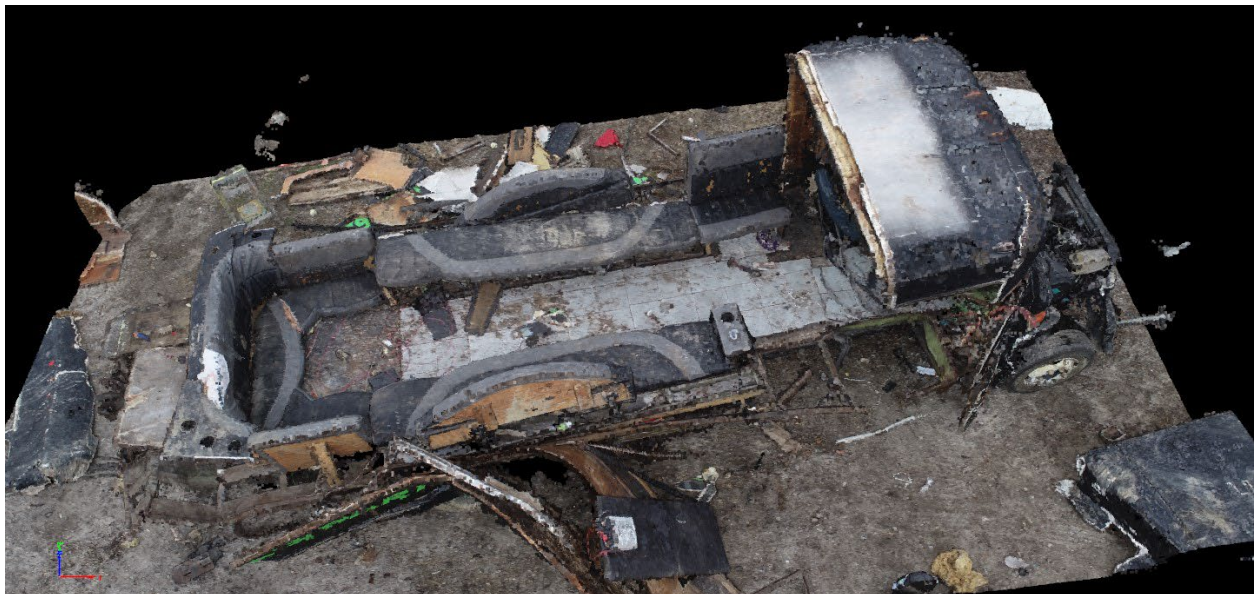
**Figure 4.** Screen shot of the three-dimensional point cloud.

The sUAS was used to capture 76 high resolution, georeferenced photographs of the bus involved in the crash suitable for processing in the Pix4D photogrammetry software. The resulting point cloud of the bus can be seen in **Figure 4**.
