NATIONAL TRANSPORTATION SAFETY BOARD

Global Positioning System Device

Specialist's Factual Report

Location: Uganik Lake, Alaska
Date: September 9, 2016
Aircraft: de Havilland DHC-2 (Beaver)
Registration: N91AK
Operator: Island Air
NTSB Number: ANC16LA062

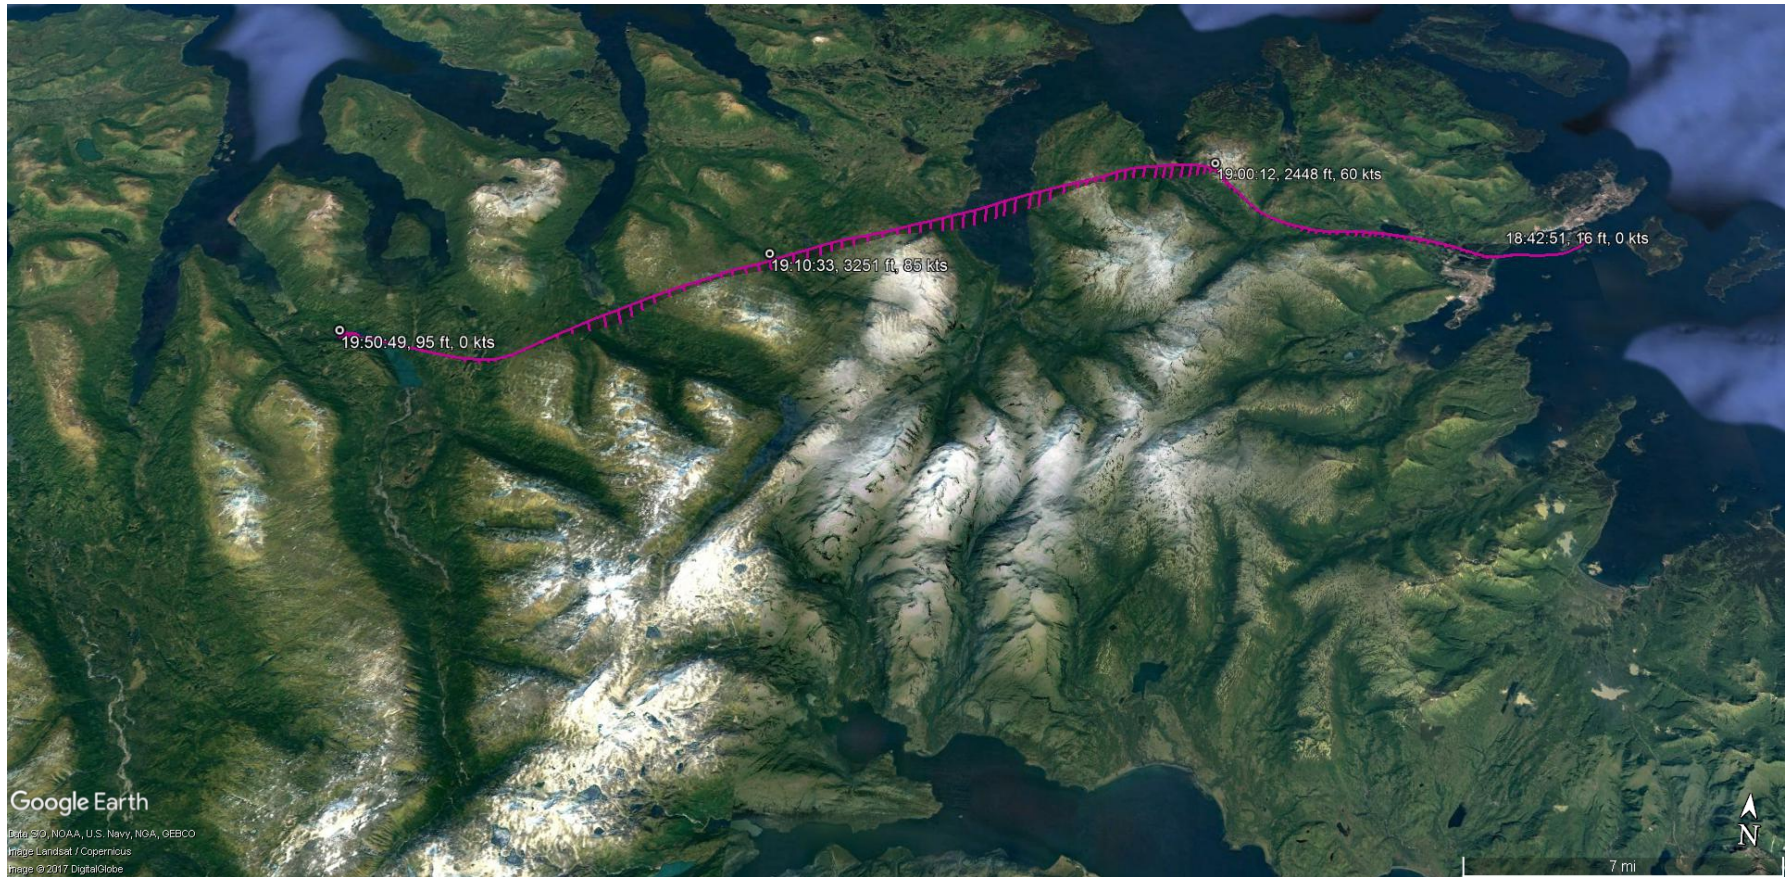
Figure 1. Overview of inbound flight, landing, and subsequent accident takeoff.

Figure 1 shows an overview of the entire recording, originating in Kodiak at 18:42:51 UTC, and landing at Uganik Lake at 19:18 UTC.

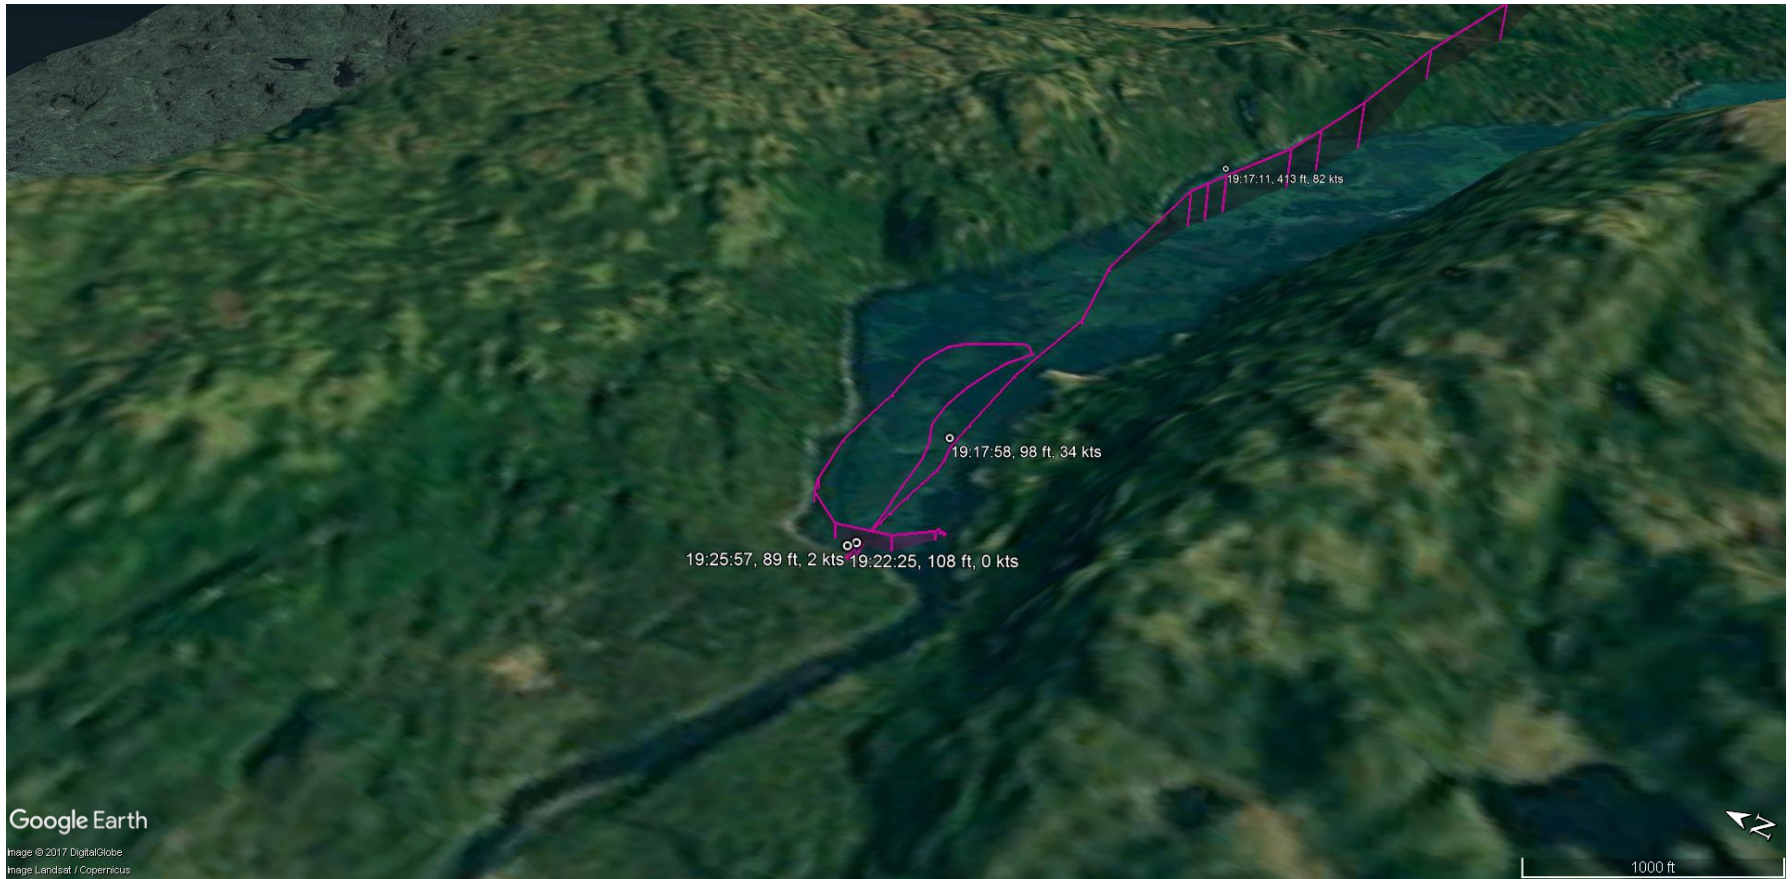
Figure 2. Detail of inbound landing.

Figure 2 shows the landing at Uganik Lake. The aircraft landed at about 19:18:00 UTC, and then about 19:26:00 UTC, began to water taxi away from the shoreline

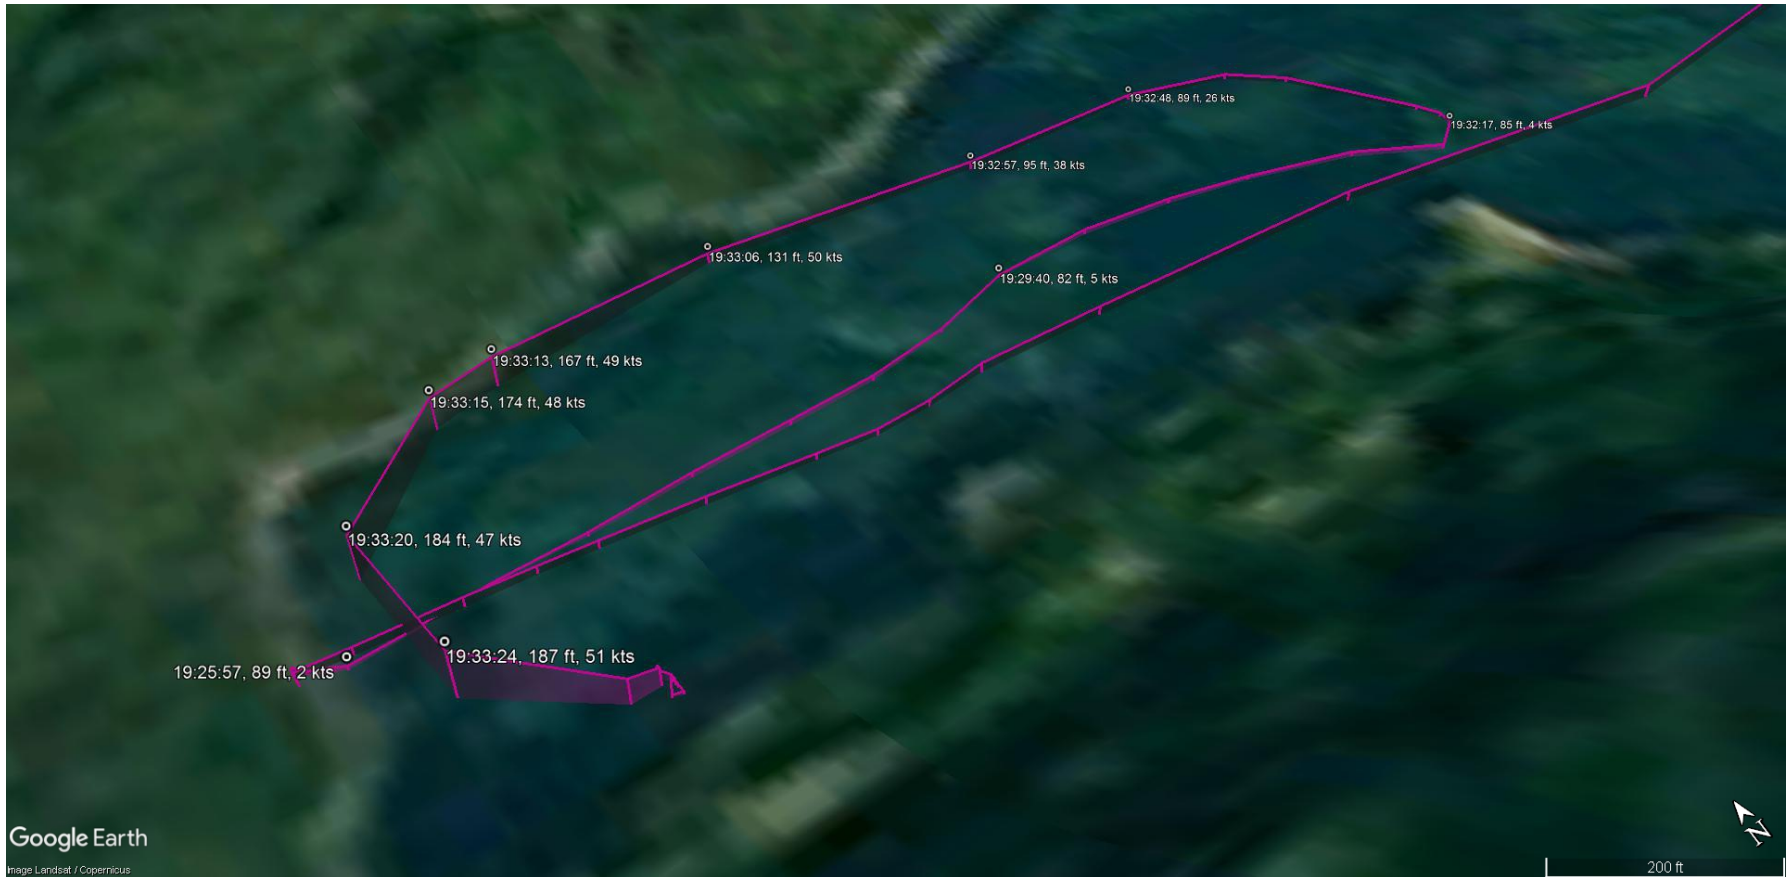
Figure 3. Accident takeoff.

Figure 3 shows the water taxi and takeoff. Between 19:32:17 UTC and 19:32:48 UTC, the groundspeed began to accelerate as the aircraft track turned left from northwest to west. At 19:32:17 UTC, the aircraft was about 2,980 feet from the shoreline.

Figure 3 additionally shows the aircraft climbed and turned, at groundspeeds just below 50 knots. Between 19:33:15 and 19:33:24 UTC, the aircraft track turned left from west to south.

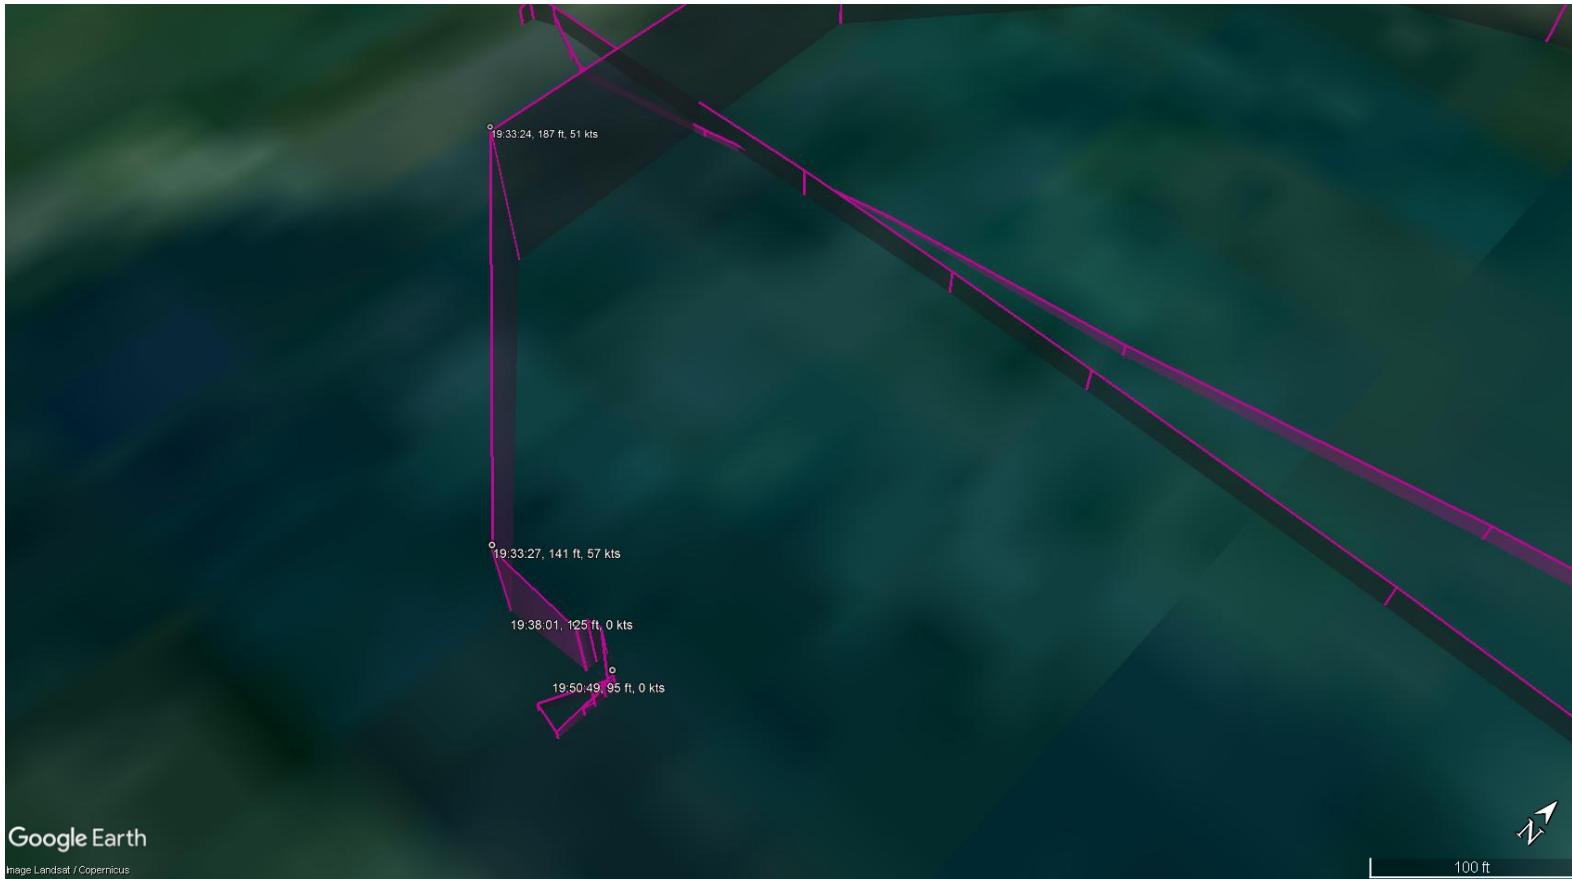
Figure 4. End of accident recording.

Figure 4 shows the final recorded points, including a decrease in altitude. The last sequential flight-recorded point was at 19:33:27 UTC; subsequent points starting at 19:38:01 UTC were recorded after the collision with water.
