National Transportation Safety Board

CEN23FA333

IMAGE RECORDER

Specialist's Factual Report

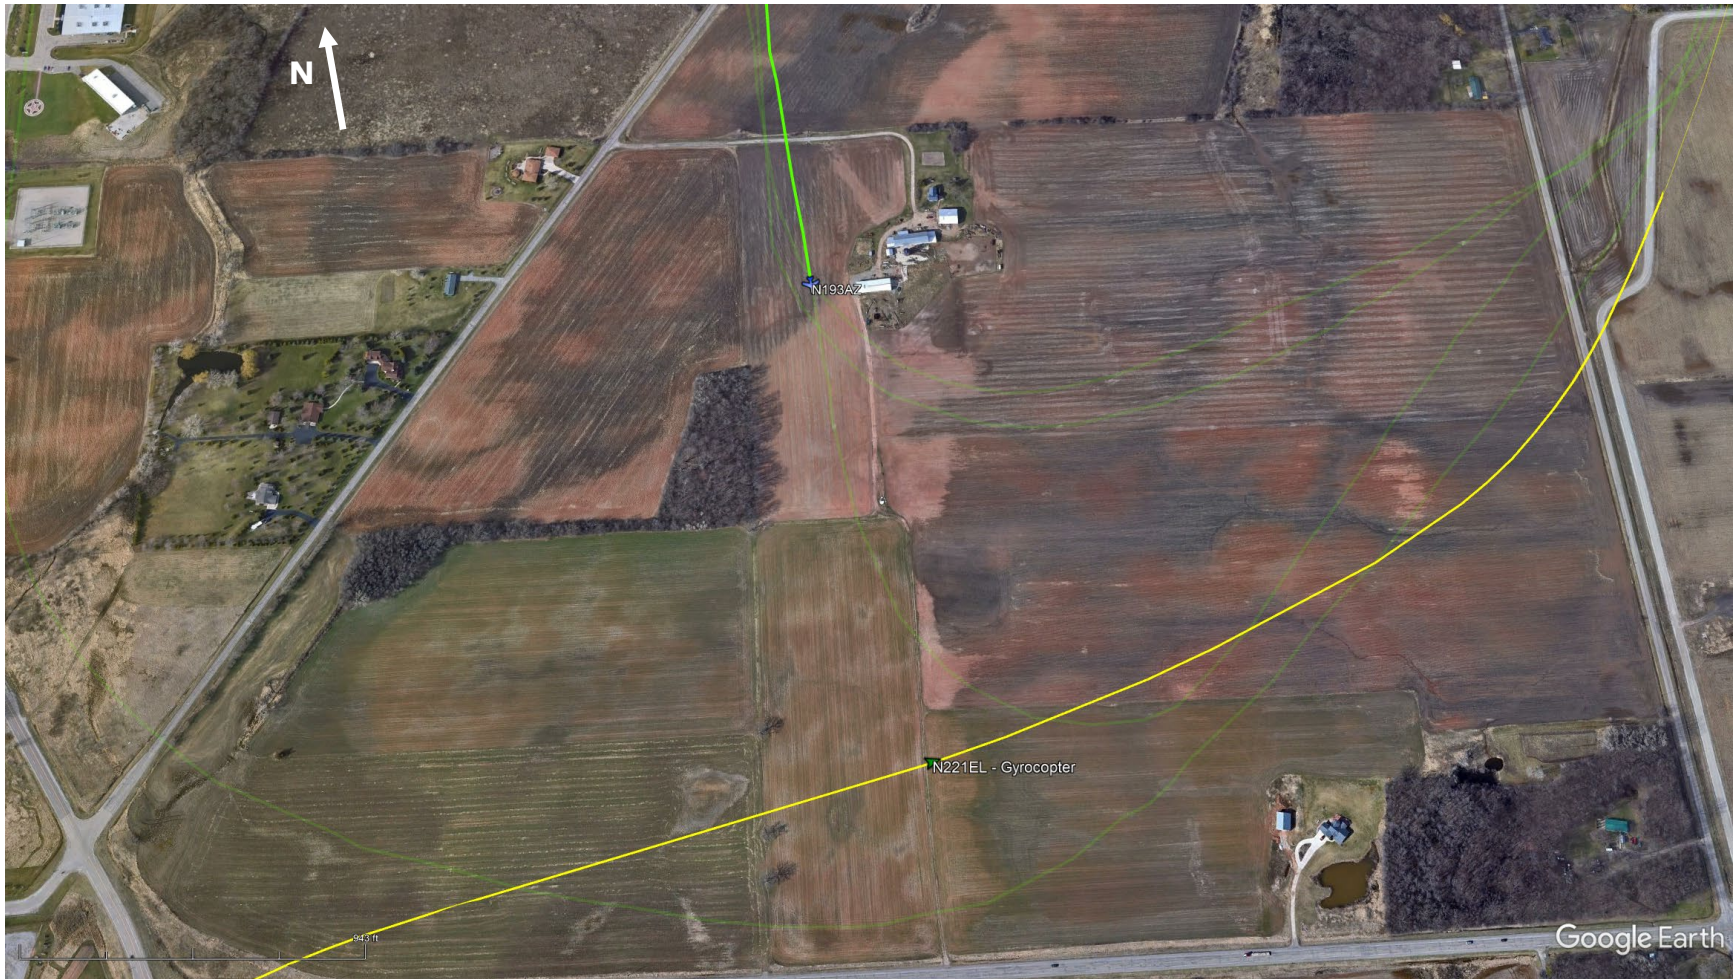
Figure 1. Position and direction of flight at approximately 12:25:21.¹

12:24:41.4 Heli	[the helicopter turned southbound.]		
12:25:17.9 Heli	[two rotorcraft were visible through the windscreen. a dark colored rotorcraft was crossing from right to left at the approximate 11 o' clock position followed by a lighter colored rotorcraft crossing from right to left at the approximate 12 o' clock position. the left seat occupant pointed in the direction lighter colored rotorcraft (the accident gyrocopter was painted white). see Figure 1 for relative position of helicopter and gyrocopter at this approximate time.]
