NATIONAL TRANSPORTATION SAFETY BOARD

Electronic Devices

Specialist's Factual Report

Location: Lady Lake, Florida
Date: September 06, 2019
Aircraft: Vans RV-12
Registration: N767FS
Operator: Yankee Flyers LLC
NTSB Number: ERA19FA265

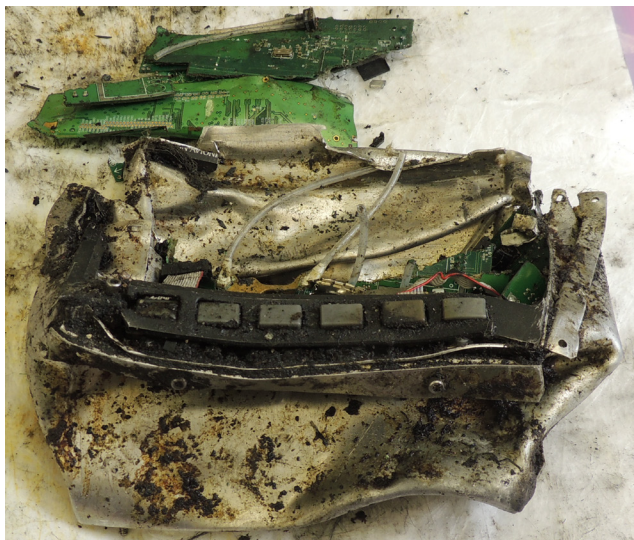
Upon arrival at the Vehicle Recorder Laboratory, an examination revealed the unit had sustained severe impact damage. The extent of the damage is shown in Figure 1.

Figure 1. Photo of damaged Dynon device.

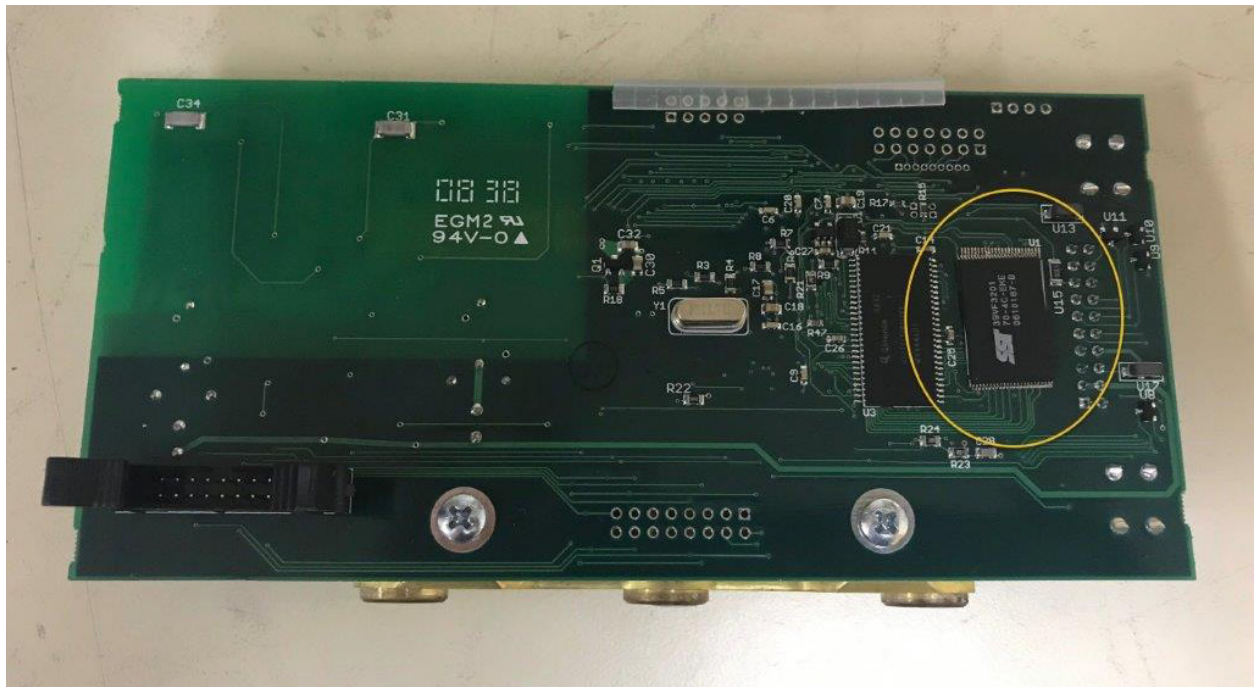
This device can store data in the non-volatile memory (NVM)¹. The location on the printed circuit board (PCB) where the NVM chip was installed on an undamaged unit is shown circled in Figure 2. Figure 3 shows the PCB recovered from the accident device with the NVM chip missing and a fracture where the NVM chip was originally installed. The NVM chip for the accident device could not be located, thus, no data pertinent to the event were recovered.

Figure 2. Photo of PCB with NVM installed - undamaged exemplar unit.

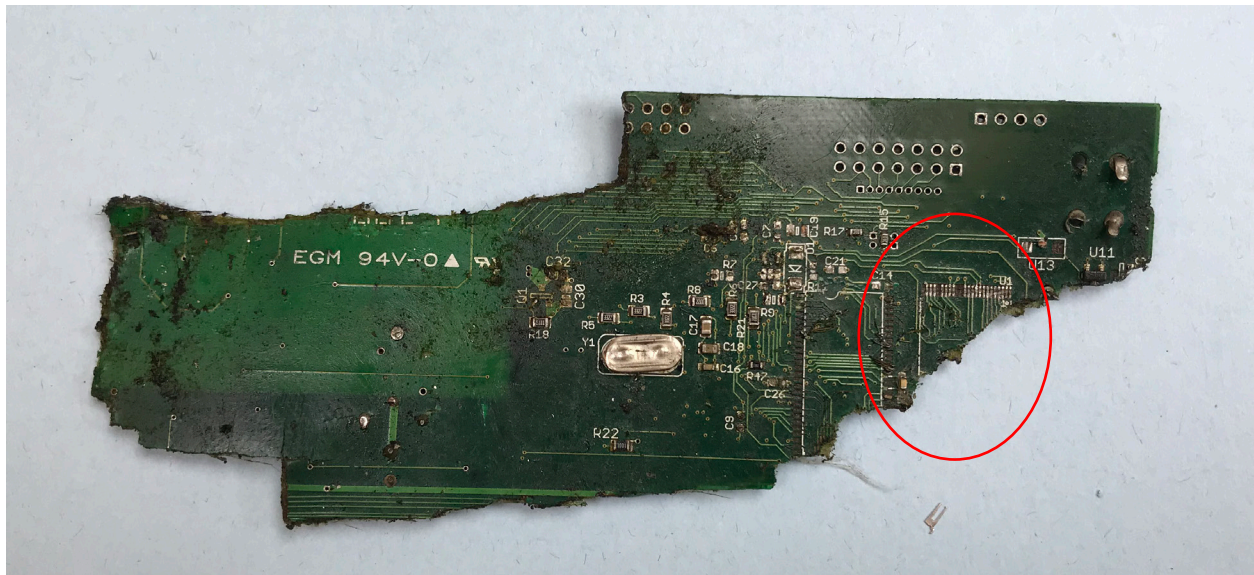
Figure 3. Photo of PCB where NVM was originally installed – accident unit.

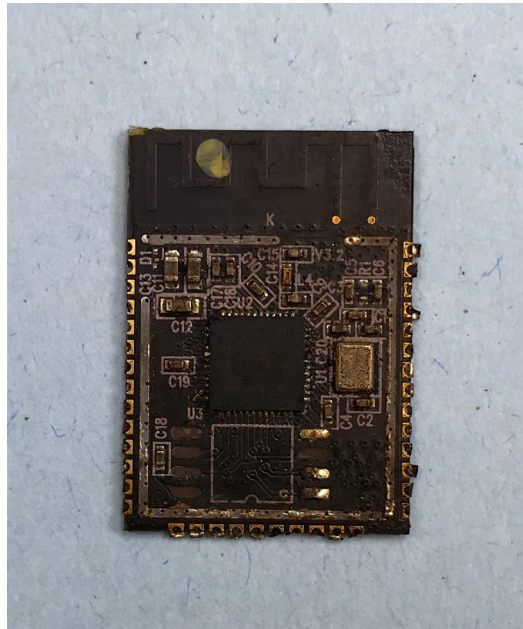
Upon arrival at the Vehicle Recorder Laboratory, an examination revealed the unit had sustained damage. The device in which the microcontroller was installed could also not be determined. The extent of the damage is shown in Figure 4.

Figure 4. Photo of damaged microcontroller.

The ESP32 microcontroller does not have any NVM available for data storage, thus, no data pertinent to the event were recovered.
