NATIONAL TRANSPORTATION SAFETY BOARD
Vehicle Recorder Division
Washington, D.C. 20594

Specialist's Factual Report by Kyle Garner

Location: Mokuleia, HI
Date: June 21, 2019
Aircraft: Hawker Beechcraft 65-A90
Registration: N256TA
Operator: Oahu Parachute Center
NTSB Number: WPR19MA177

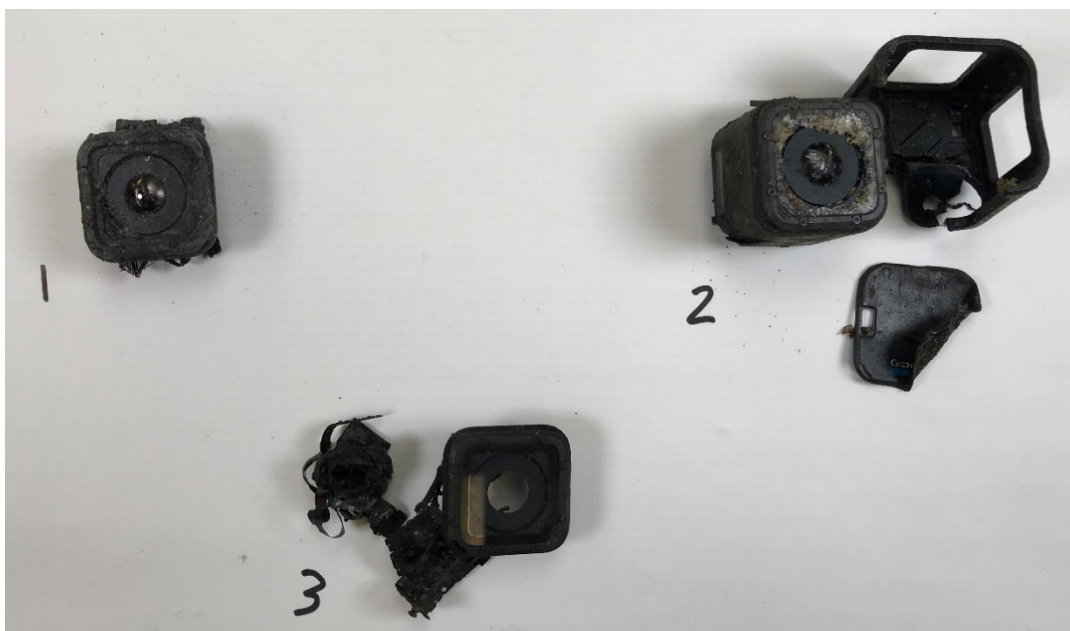
Upon arrival at the NTSB Vehicle Recorder Division, it was evident that the GoPro HERO5 Session cameras had sustained severe thermal and structural damage (see Figure 1). Device #1 contained a microSD card; however, the card was melted inside the card slot and could not be recovered. Device #2 contained a 32GB microSD card that appeared undamaged, as shown in Figure 2. Device #3 did not contain a microSD card, thus, no data were recovered.

Figure 1. Condition of GoPro HERO5 Session cameras as received.

Recovery of the microSD card from device #2 was first attempted by inserting the card into a forensic reader attached to a computer, however, the computer did not recognize the card and no filesystem was found. The only option the computer presented was to format the device, which would have resulted in the loss of any accident flight data. Due to the cracks and deformation on the microSD card recovered from the accident site at a later date, a read-out using a forensic reader was not attempted.

The extent of the damage precluded normal and advanced recovery procedures and additional attempts were unsuccessful in yielding usable data. Therefore, no data pertinent to the event were recovered.

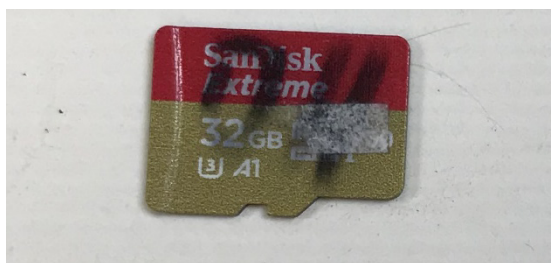
Figure 2. 32GB microSD card recovered from device #2.

Both microSD cards were sent to the State University of New York (SUNY) at Binghamton's Integrated Electronics Engineering Center (IEEC) for specialized analysis, including optical and acoustic microscopy and x-ray. Analysis of the card from device #2 found no evidence of thermal or mechanical damage. Analysis of the card discovered at the accident site at a later date found no evidence of thermal damage, however, an x-ray found that multiple internal wire bonds were broken and sonic imaging found the two cracks extended into the chip and circuitry in the laminate below the surface. Due to these anomalies, the possibility of data recovery on this card was considered doubtful. A copy of the analysis performed by SUNY IEEC on both microSD cards is provided as Attachment 1 to this report.

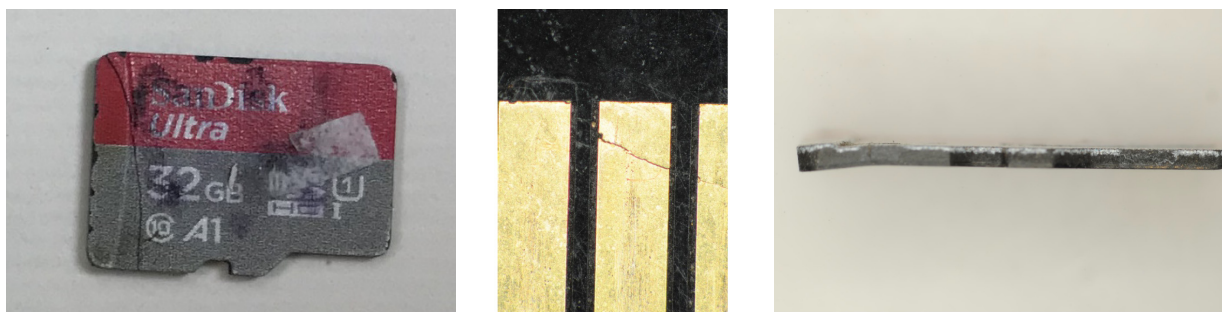
On August 5th, 2019 the Investigator-in-Charge was notified that another GoPro HERO5 Session was found at the accident site after surfacing during a period of heavy rain. A 32GB microSD card was removed from the GoPro camera at the accident site and shipped to the Vehicle Recorder Division for analysis. The condition of this microSD card as received is shown in Figure 3 (left). An initial visual inspection noted a large surface crack beginning in the upper left corner of the card and terminating in the lower left corner. Another surface crack was found on the back side of the card across the pads, as shown in Figure 3 (center). The card also had a slight deformation, shown in Figure 3 (right).

Figure 3. 32GB microSD card recovered after heavy rain from accident site.

Both microSD cards were then sent to an outside firm that specializes in data recovery of flash memory devices for further analysis. Data recovery attempts by the outside firm for both microSD cards were unsuccessful.

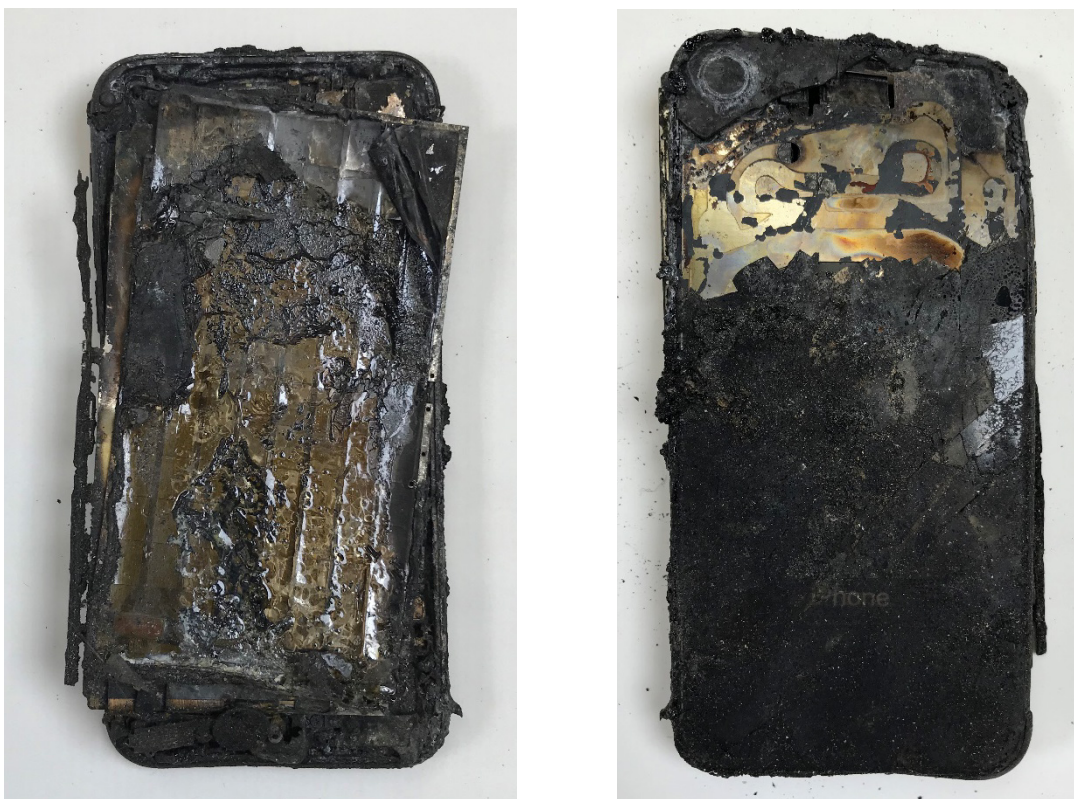
Upon arrival at the NTSB Vehicle Recorder Division it was evident that the iPhone 8 had sustained severe thermal damage, as shown in Figure 4.

Figure 4. Condition of iPhone 8 as received

The extent of the damage precluded normal recovery procedures, therefore, no data pertinent to the event were recovered.

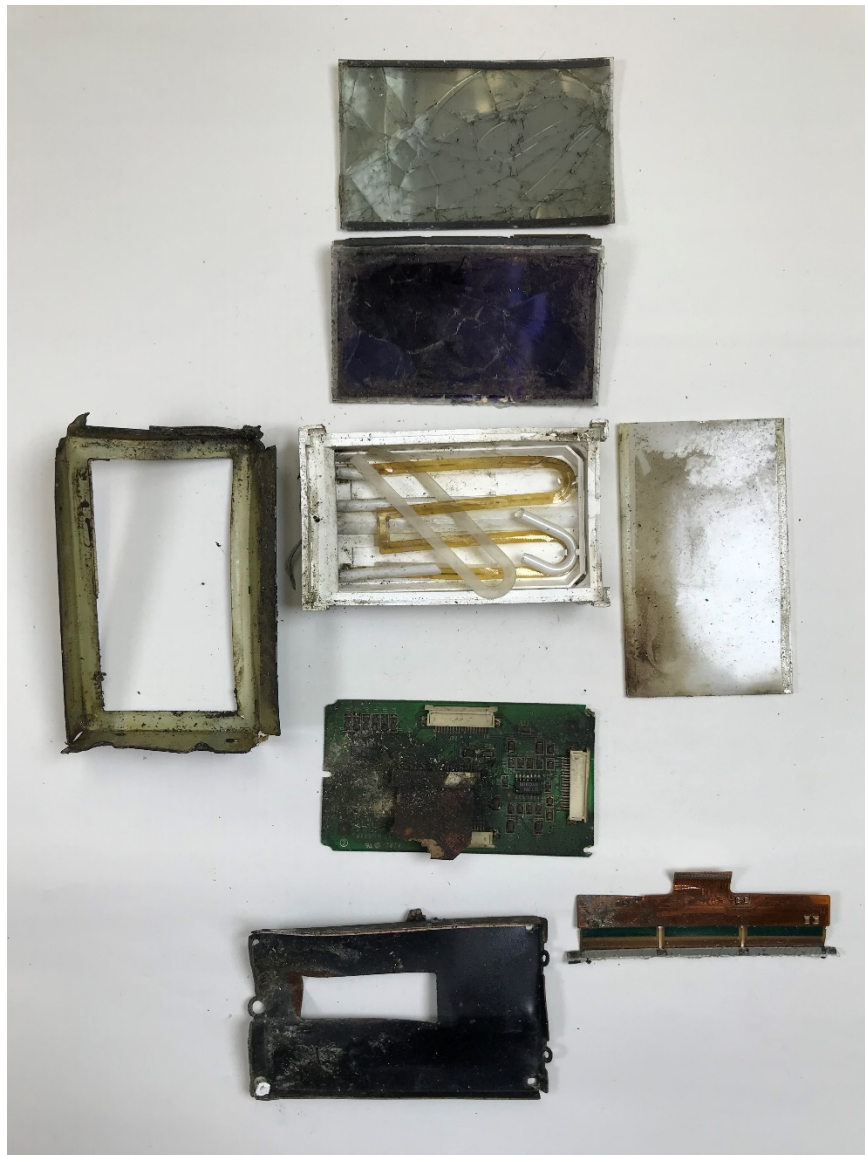
An unidentified display was shipped to the NTSB Vehicle Recorder Division for analysis. Upon arrival it was evident that the display had sustained severe thermal damage and had no identifiable markings, as shown in Figure 5.

Figure 5. Condition of unknown display as received.

There was no NVM located on the unknown display, thus, no data pertinent to the event were recovered.
