Photo 1 – Side View of Accident Airplane (Photo Courtesy of FAA)

Photo 2 – Accident Site (Photo Courtesy of FAA)

Photo 3 – Diagram of Accident Site (Photo Courtesy of the FAA)

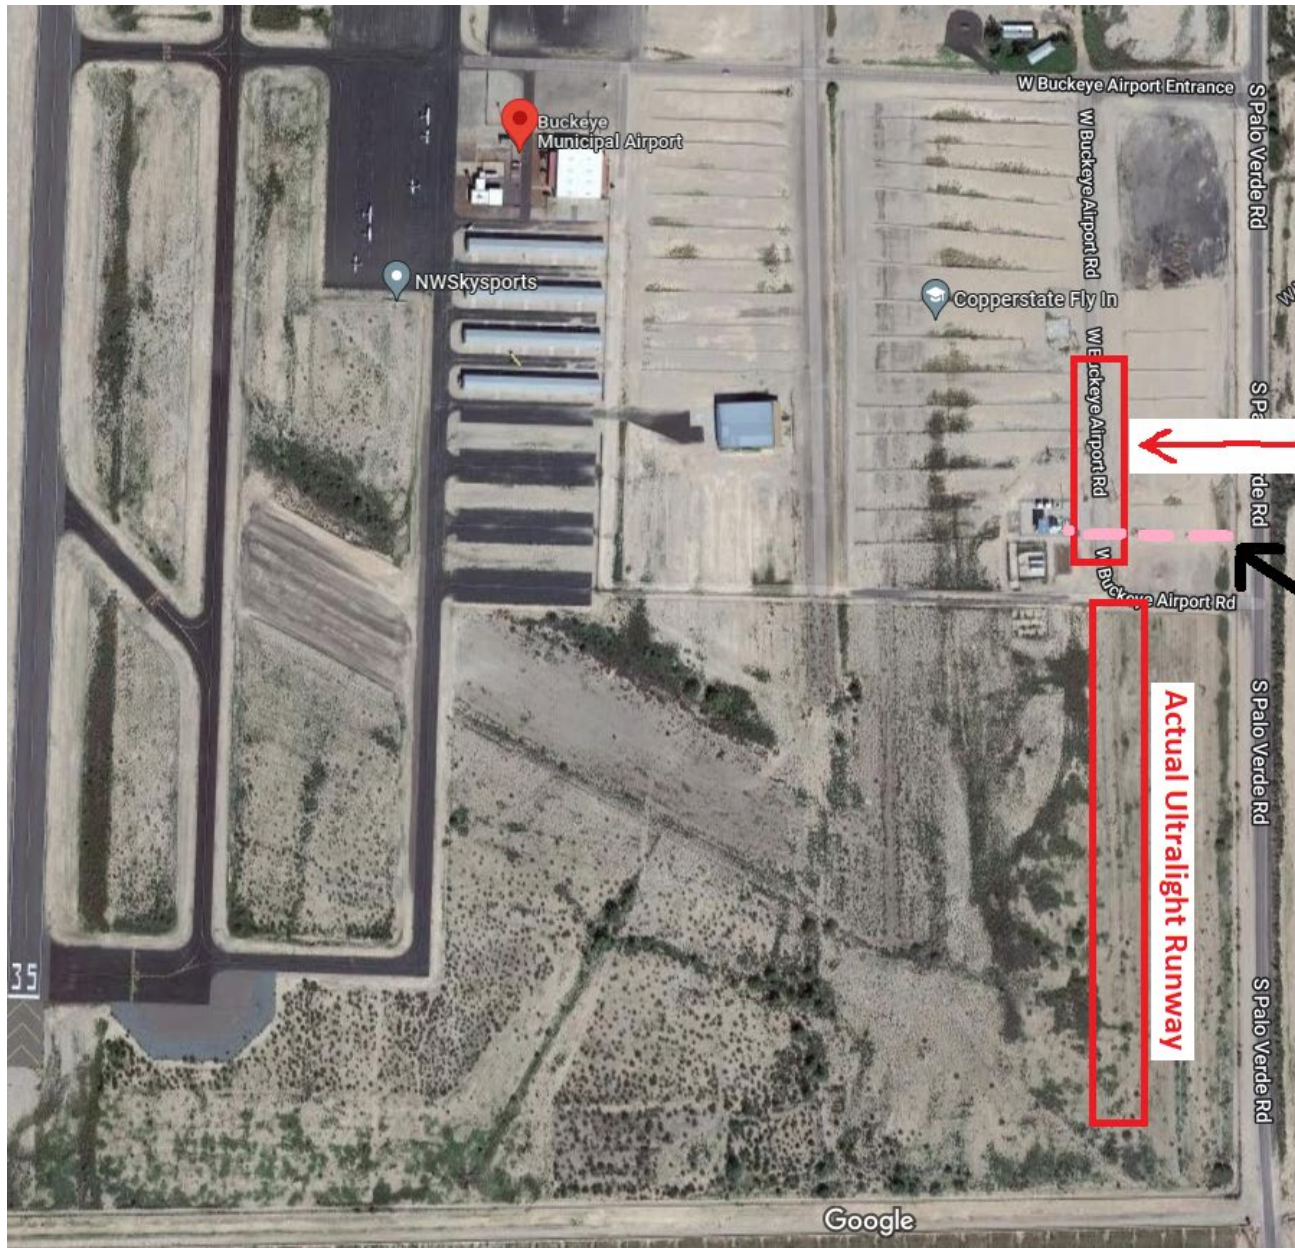
Actual landing spot. It's a dirt parking lot and the strip was dark from a water truck spray-down, which he mistook for the runway. There were no cars there.

Pink line represents power lines between Palo Verde rd and the small water treatment building right there.
