NATIONAL TRANSPORTATION SAFETY BOARD

Global Positioning System (GPS) Device

Specialist's Factual Report
By Sean Payne

Location: Palmer, AK
Date: March 27, 2021
Aircraft: Airbus Helicopter AS-350 B3
Registration: N351SH
Operator: Soloy Helicopters LLC
NTSB Number: WPR21FA143

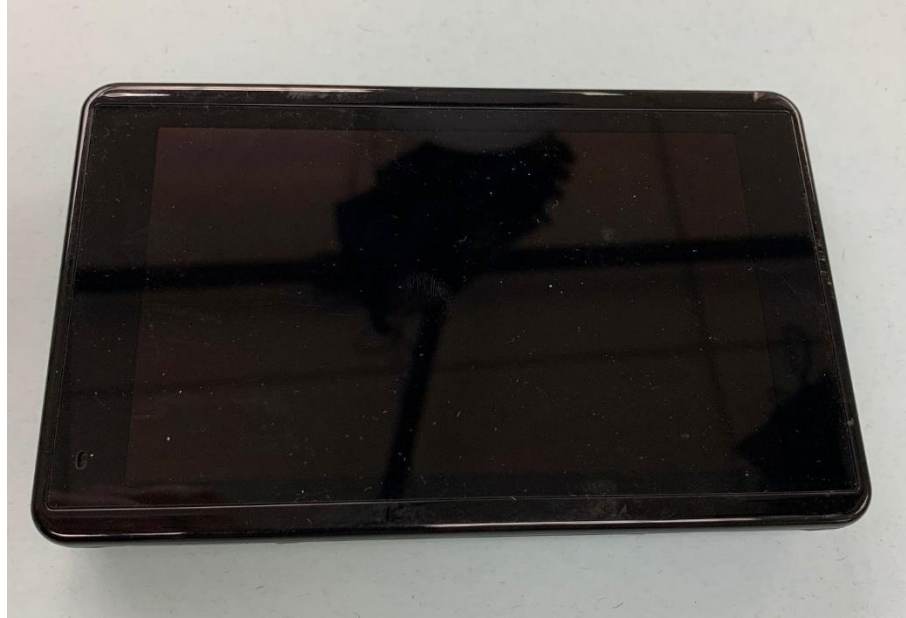
The device was undamaged and is shown in figure 1. The device was connected to a PC running the manufacturer's suggested software and was downloaded normally.

Figure 1. Photo of undamaged Garmin Aera 660 GPS.

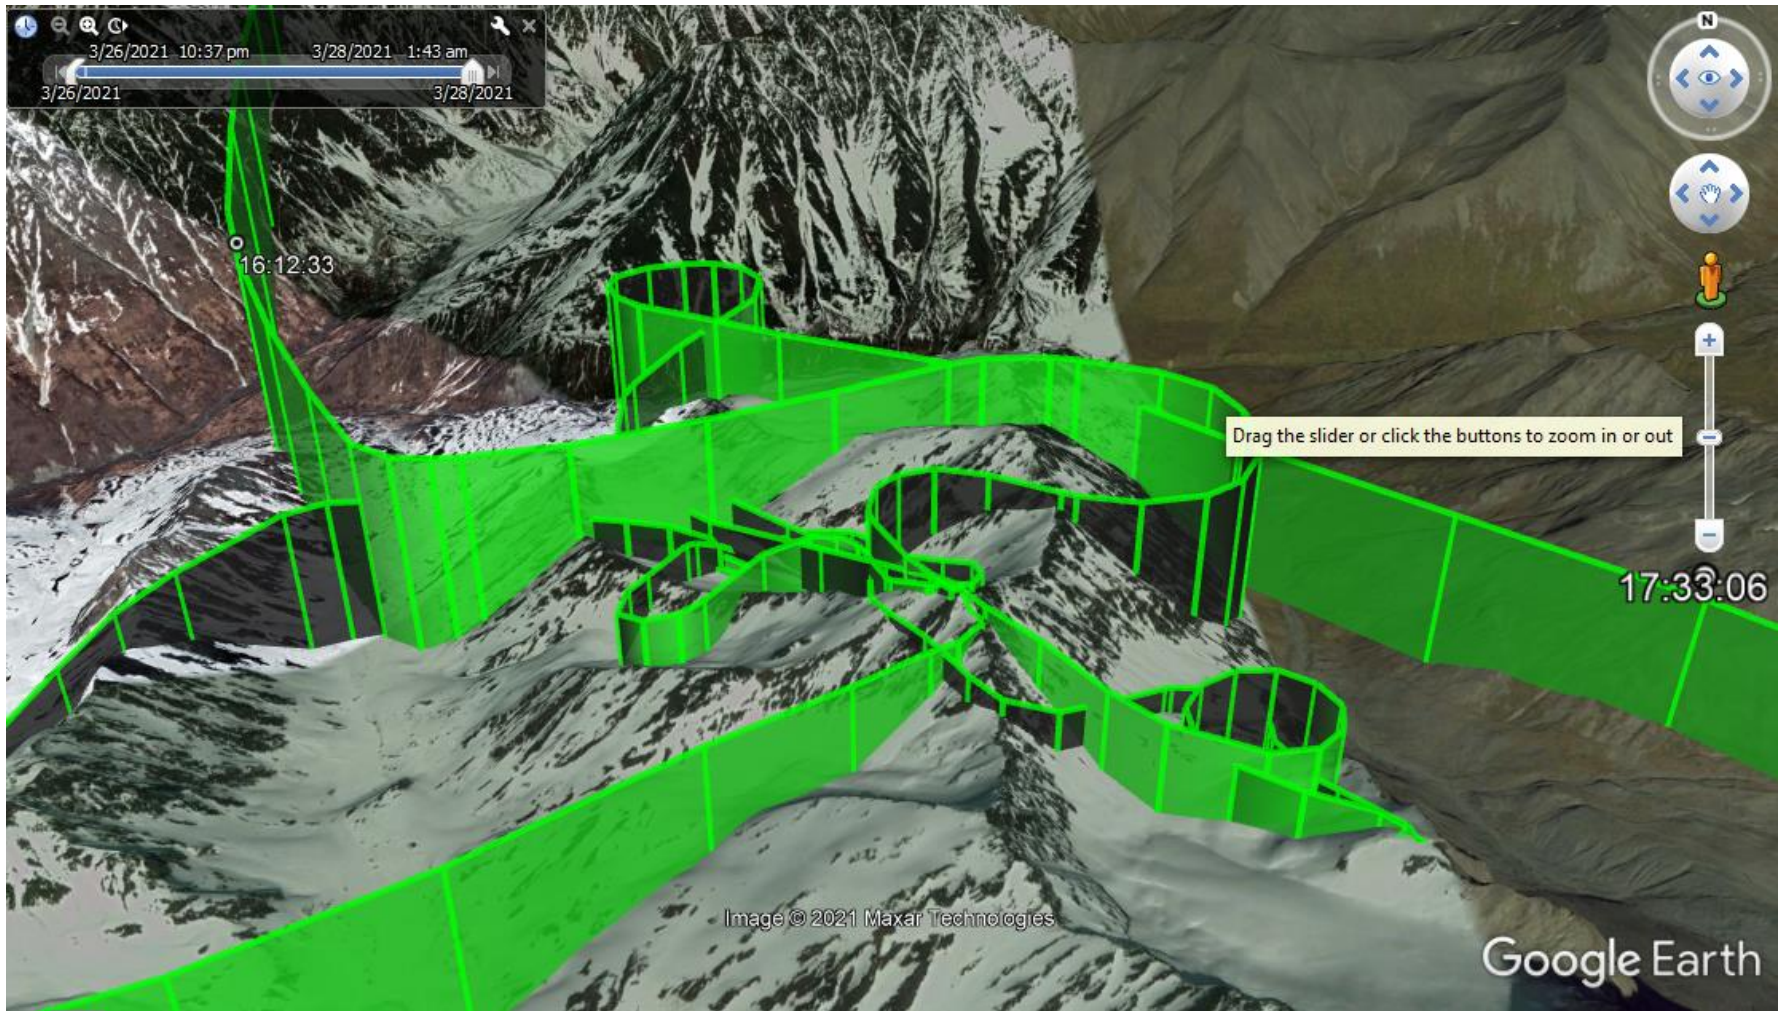
Figure 7 is a slanted view of the helicopter's GPS tracks in the vicinity of a mountainous area along leg two. The slanted view highlights the terrain in this region.

Figure 7. A slanted view of the helicopter's GPS tracks in the vicinity of a mountainous area along leg two. The slanted view highlights the terrain in this region.

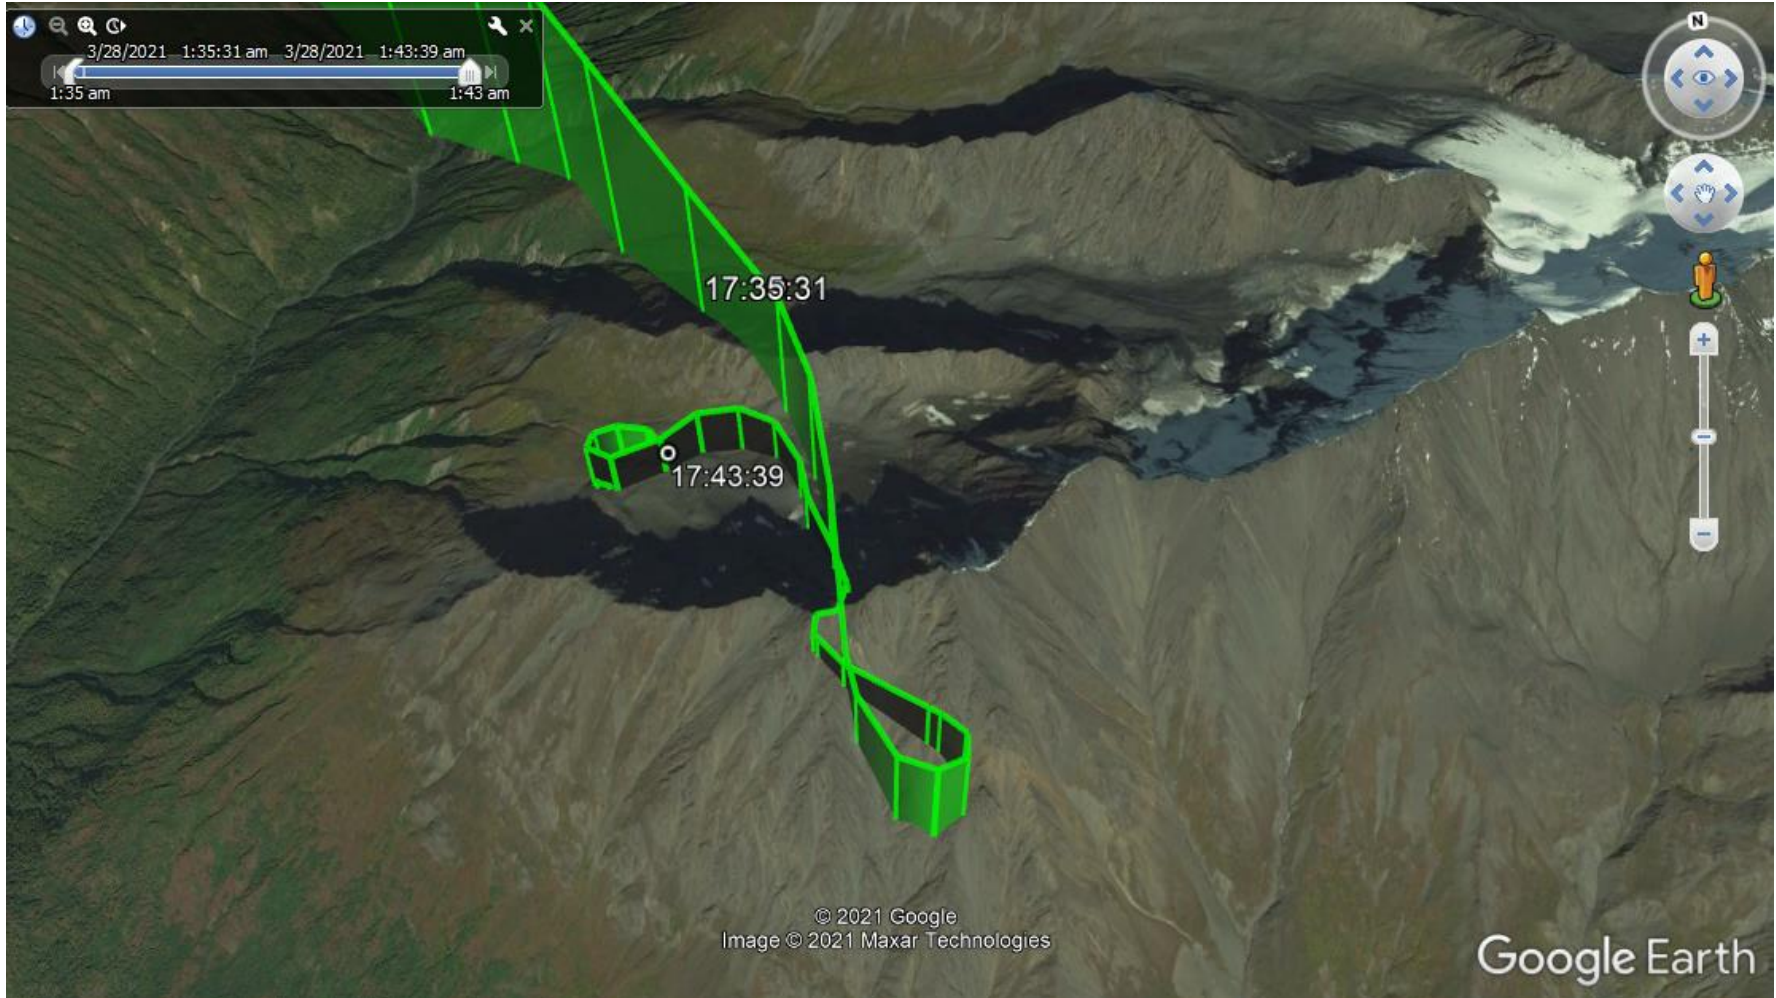
Figure 8 is a depiction of the GPS track for the helicopter's arrival from leg two to a second mountainous area. Subsequent tracks have been removed for clarity. Data ended in this region at 17:43:39.

Figure 8. A depiction of the GPS tracks for the helicopter's arrival from leg two to a second mountainous area. Subsequent tracks have been removed for clarity. Data ended for this recorded session at 17:43:39.

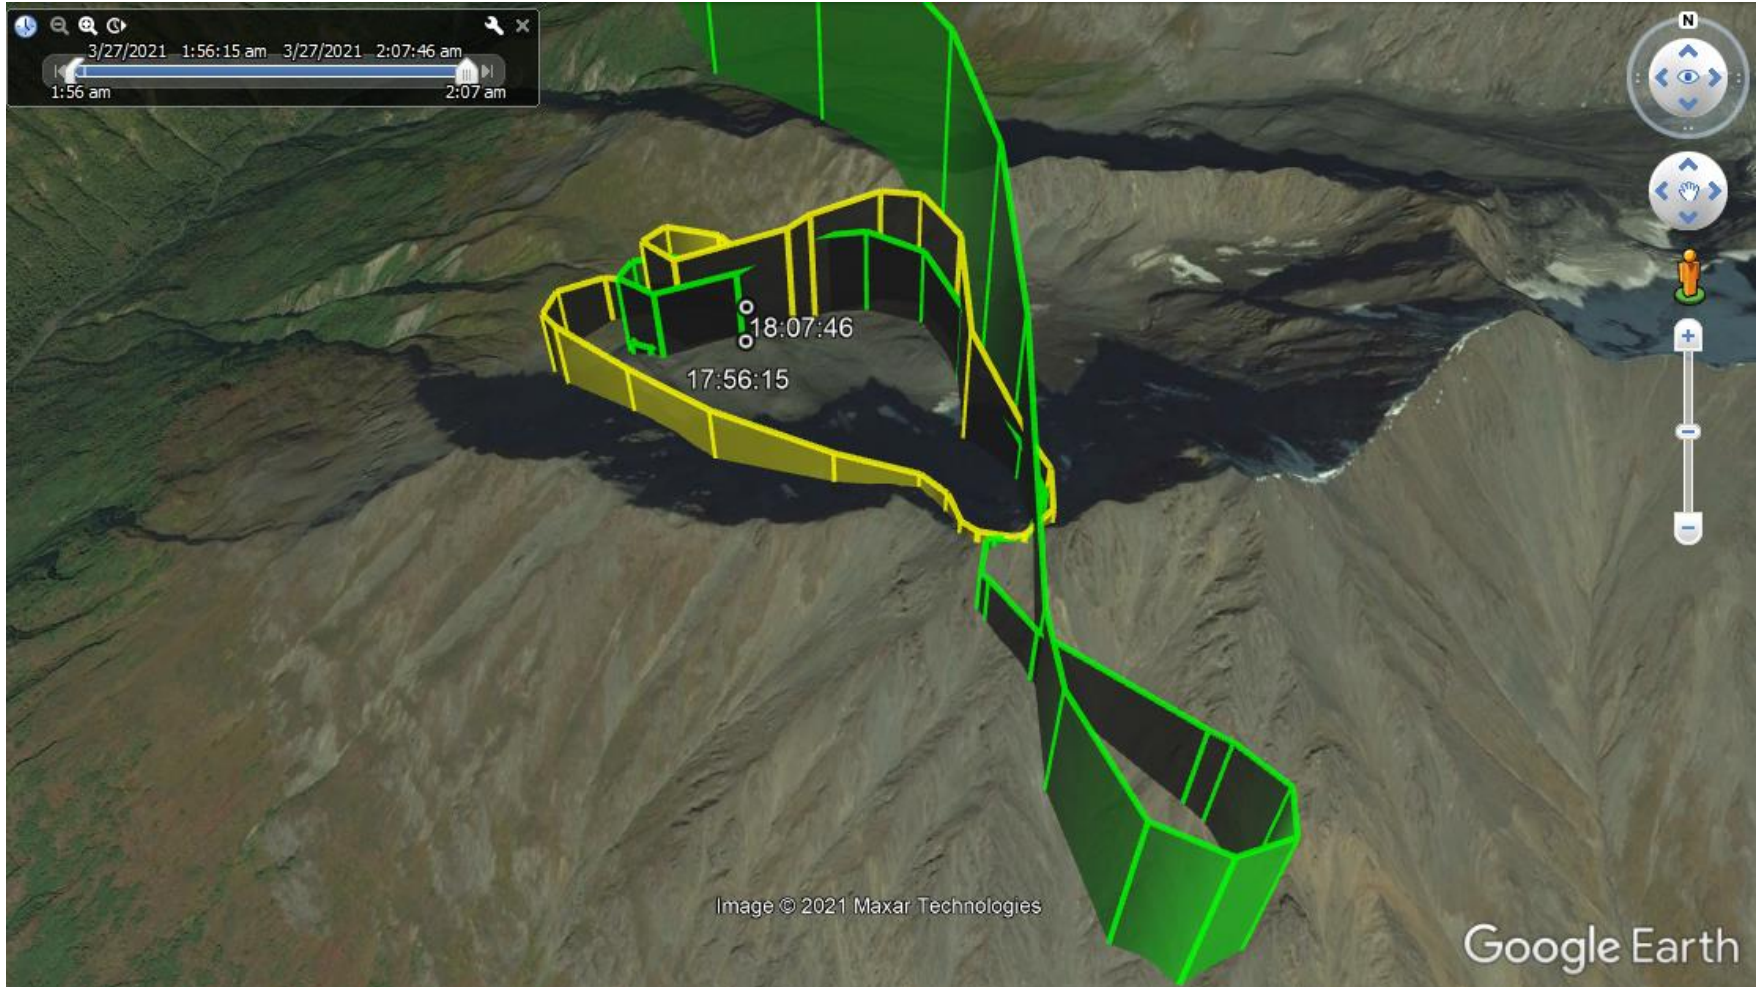
Figure 9 is a depiction of the GPS track showing the helicopter's tracks in the vicinity of the second mountainous area. A third leg is shown in yellow. Data for the third leg began at 17:56:15 and ended at 18:07:46. Subsequent tracks have been removed for clarity.

Figure 9. A depiction of the GPS tracks showing the helicopters tracks in the vicinity of the second mountainous area. A third leg is shown in yellow. Data began at 17:56:15 and ended at 18:07:46. Subsequent tracks have been removed for clarity.

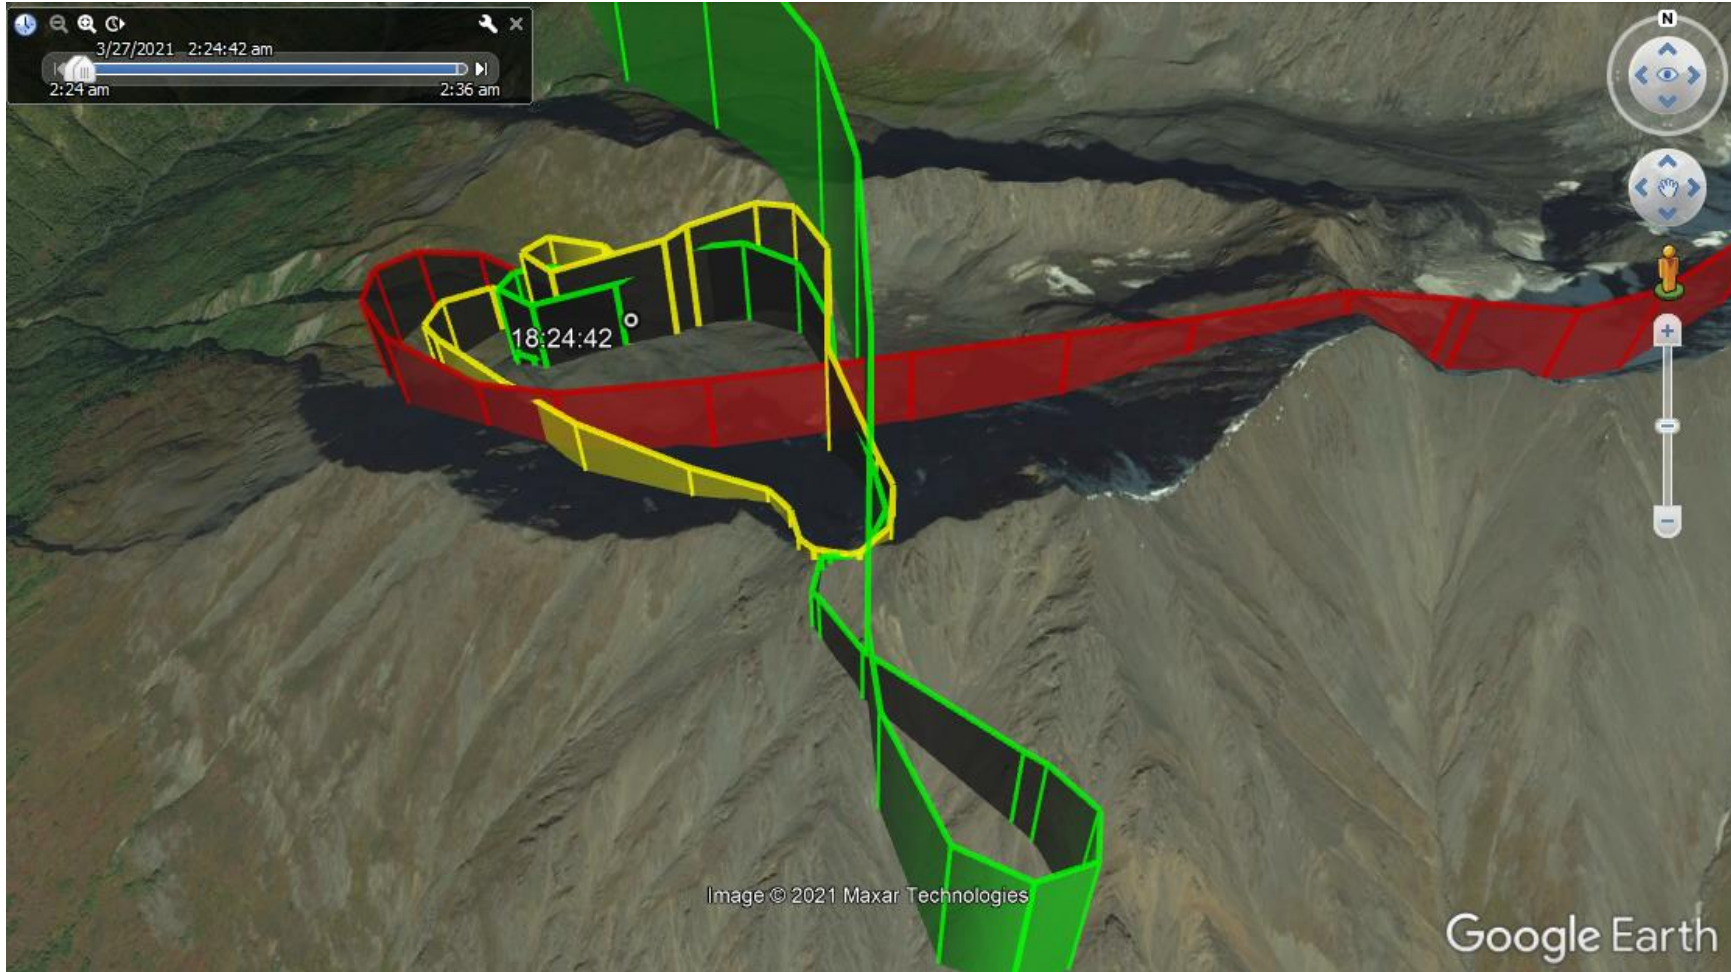
Figure 10 is a depiction of the GPS track for the helicopter's departure on the 4th and final (accident) leg. The accident leg is shown in red. Data recording for this leg began at 18:24:42.

Figure 10. A depiction of the GPS tracks for the helicopter's departure on the 4th and final (accident) leg. The accident leg is shown in red. Data recording for this leg began at 18:24:42.

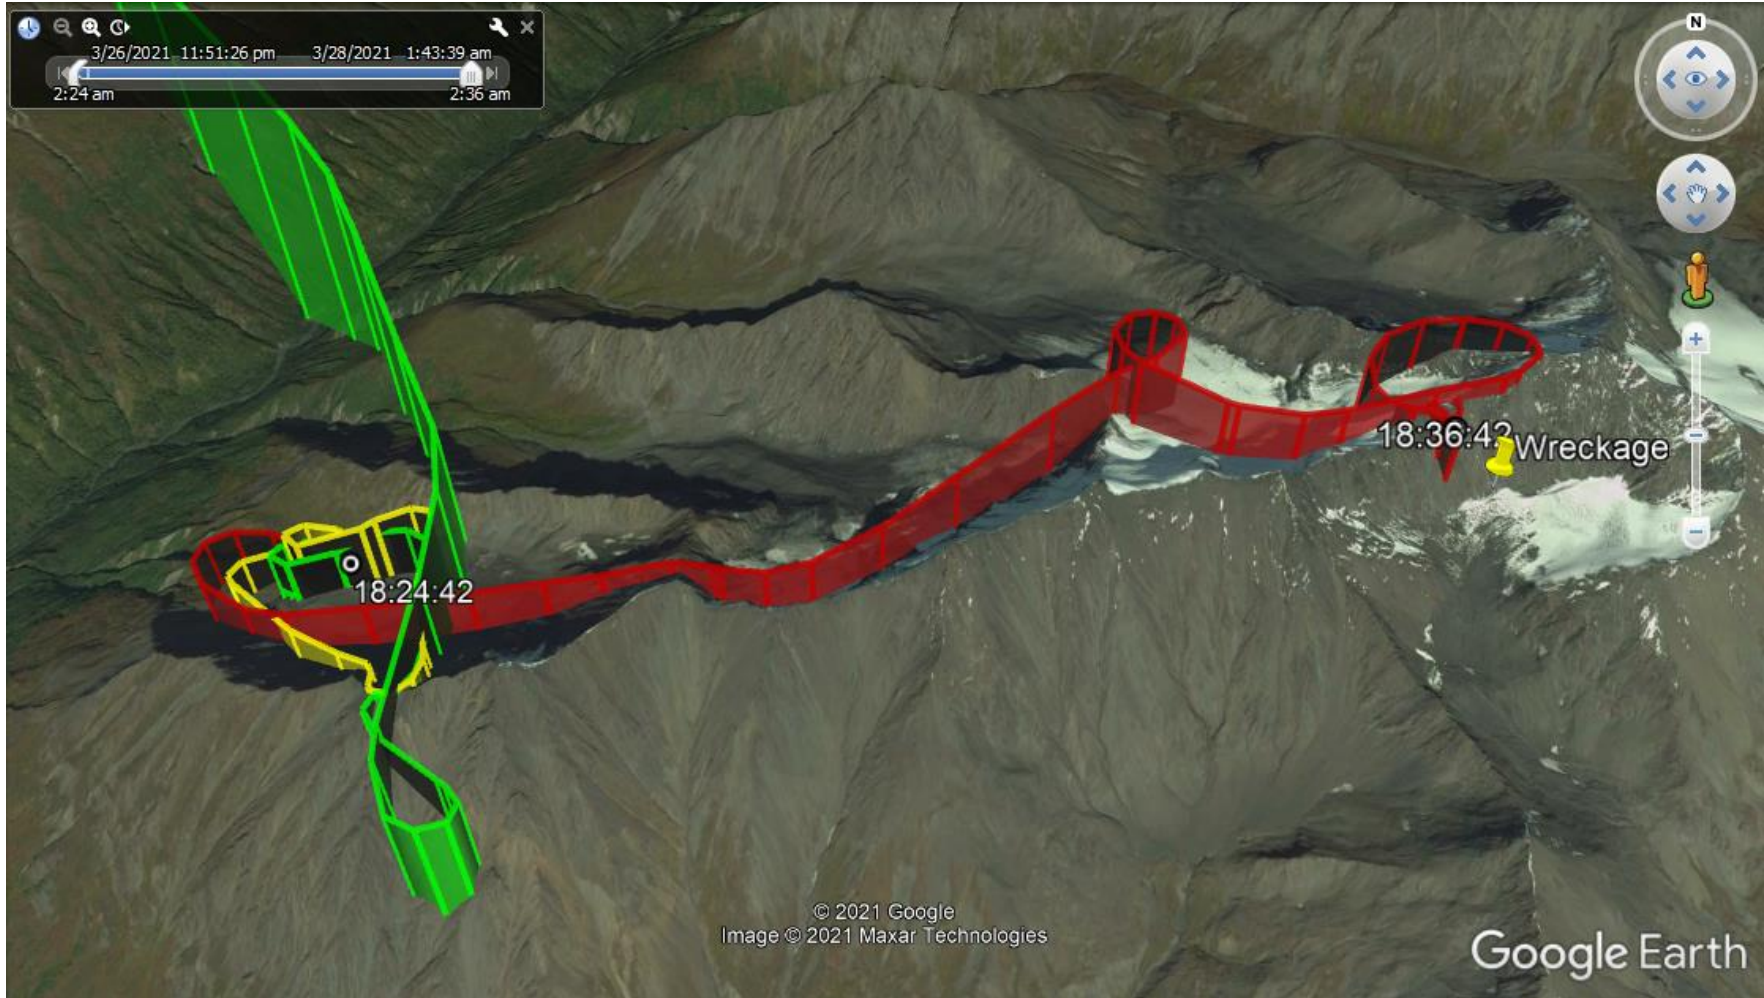
Figure 11 is an overview of the helicopter's GPS tracks for the accident leg (shown in red). The start and end time of the data is presented. The final resting place of the wreckage is depicted as a yellow pin.

Figure 11. A overview of the helicopter's GPS tracks for the accident leg (shown in red). The start and end time of the data is shown. The final resting place of the wreckage is depicted as a yellow pin.

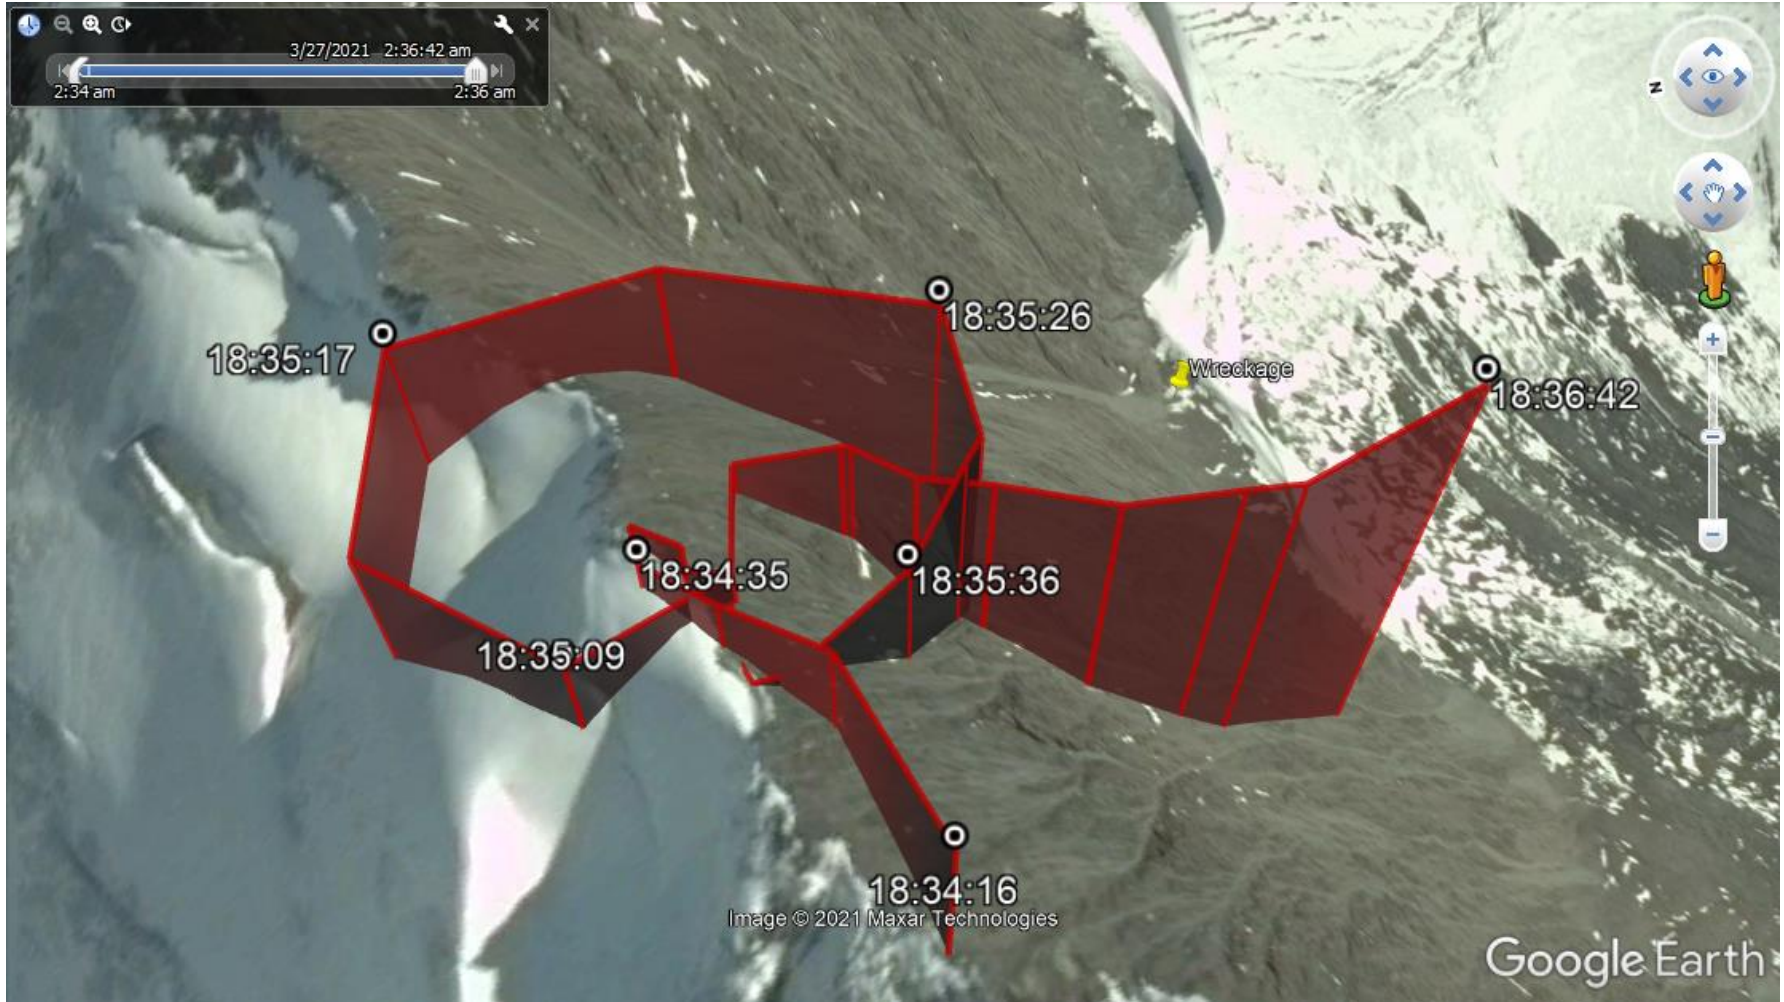
Figure 13 is a slanted view of the final tracklog points for the accident leg. Previous portions of the accident leg have been removed for clarity. The helicopter approached the ridgeline from the counterclockwise circle described in figure 11 at 18:34:16. Recorded GPS data then showed nearly stationary points between 18:34:35 and approximately 18:35:09. By 18:35:09, the helicopter had begun a clockwise circle from the stationary area of data. Data points between 18:35:26 and 18:35:36 show the helicopter approaching the top of the ridgeline. After 18:35:36, GPS data shows the helicopter in extremely close proximity to the ridgeline. The final points of data show the helicopter taking a southern track toward the final wreckage site. These final points potentially contain invalid GPS altitude and position data. The final resting place of the wreckage is depicted as a yellow pin.

Figure 13. An askew view of the final tracklog points for the accident leg. Previous portions of the accident leg have been removed for clarity. The final resting place of the wreckage is depicted as a yellow pin.

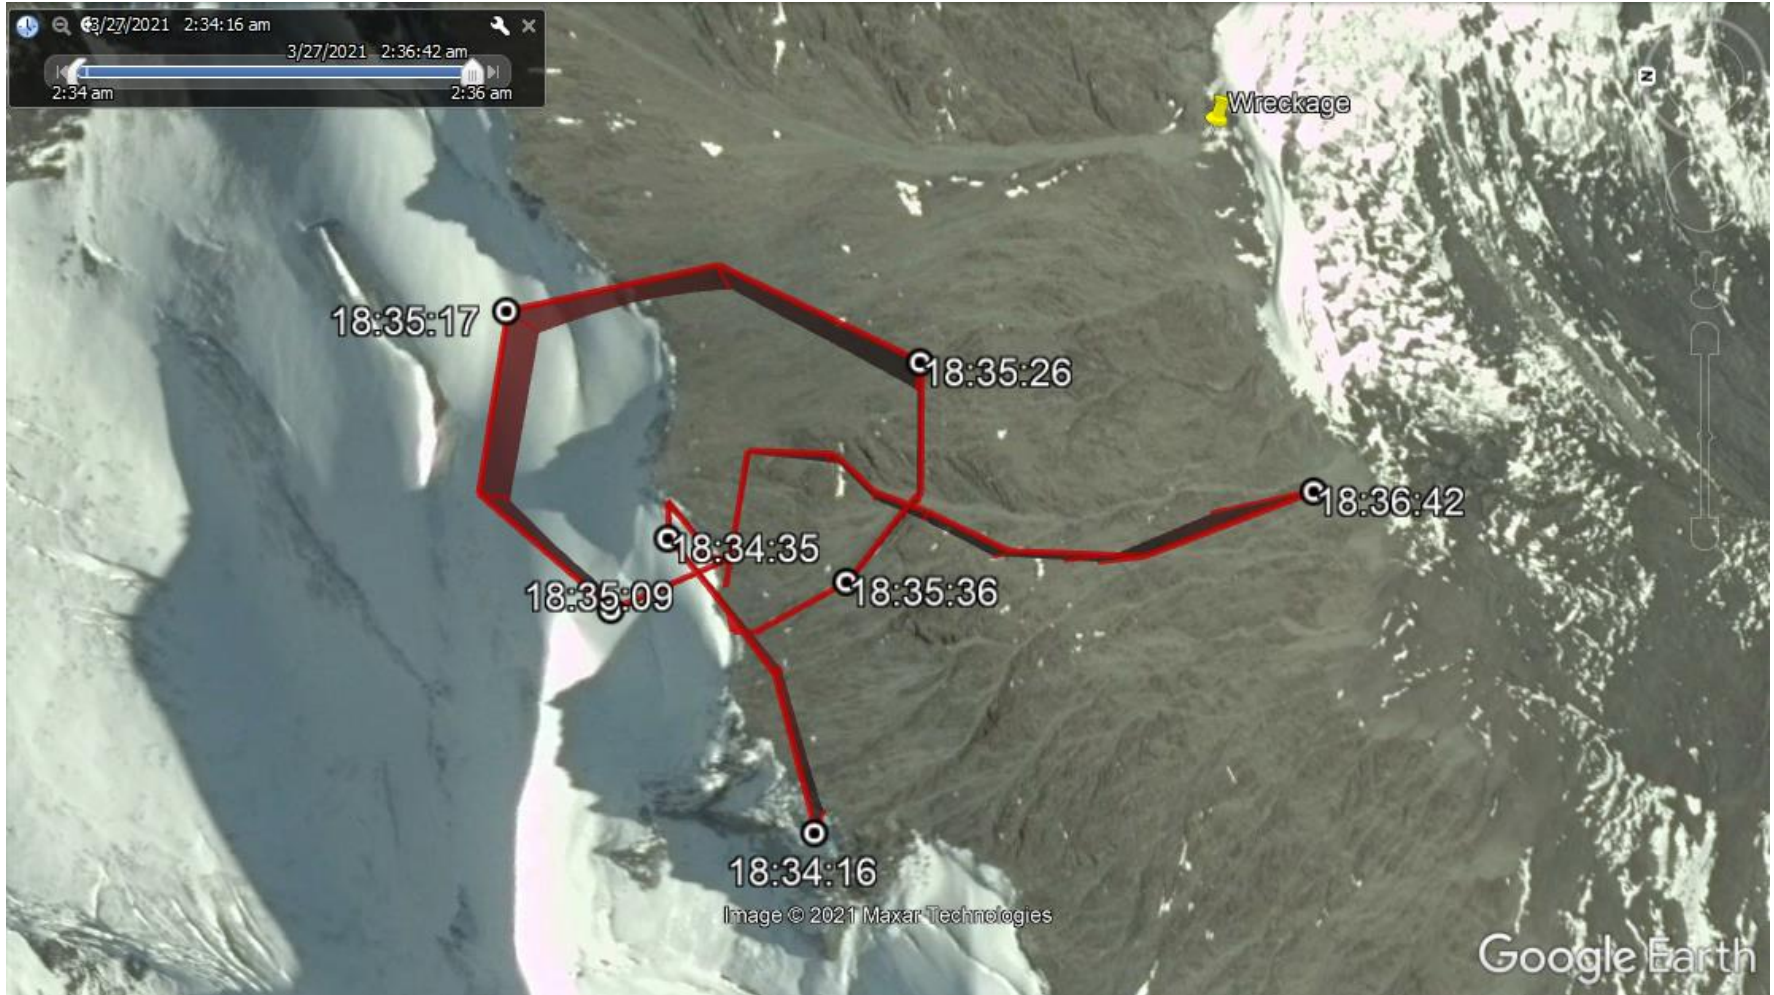
Figure 14 is a top-down view of the final tracklog points for the accident leg. Previous portions of the accident leg have been removed for clarity. The final resting place of the wreckage is depicted as a yellow pin.

Figure 14. A top down view of the final tracklog points for the accident leg. Previous portions of the accident leg have been removed for clarity. The final resting place of the wreckage is depicted as a yellow pin.
