NATIONAL TRANSPORTATION SAFETY BOARD

Electronic Devices

Specialist's Factual Report
by Gerald Kawamoto

Location: Soldotna, Alaska
Date: July 31, 2020
Aircraft: DeHavilland DHC-2 (N4982U) / Piper PA-12 (N2587M)
Operator: High Adventure Air Charter / Private
NTSB Number: ANC20LA074AB

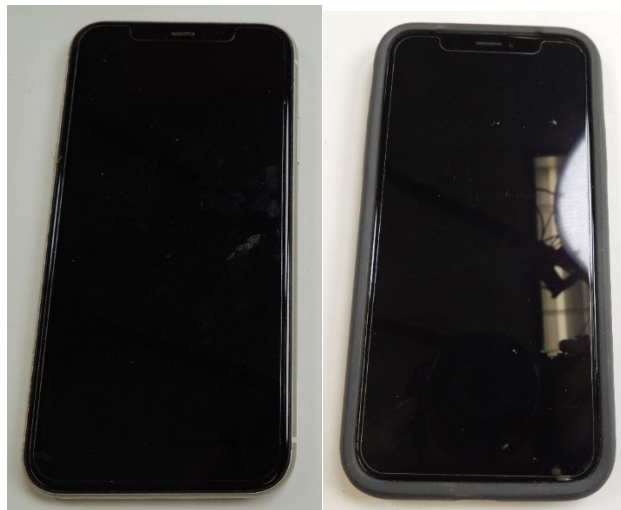
Figures 1 & 2. Undamaged iPhone 11 (left) and iPhone X (right) as received.

- The iPhone 11 and iPhone X were undamaged, as shown in Figures 1 and 2, and powered on normally.
- The iPhone 11 Pro, iPhone XR, iPhone 8, and iPad Mini 2 sustained impact damage, as shown in Figures 3 through 6, rendering the devices inoperable. The logic boards were removed and powered on normally in lab surrogates.
- The Samsung Galaxy S10 sustained impact damage, as shown in Figure 7, rendering the device inoperable. The logic board was removed and examined. The extent of the damage precluded normal recovery procedures and additional attempts at recovery usable data were unsuccessful, thus no data were recovered from the logic board. The device contained an undamaged micro SD card that downloaded normally using laboratory tools.

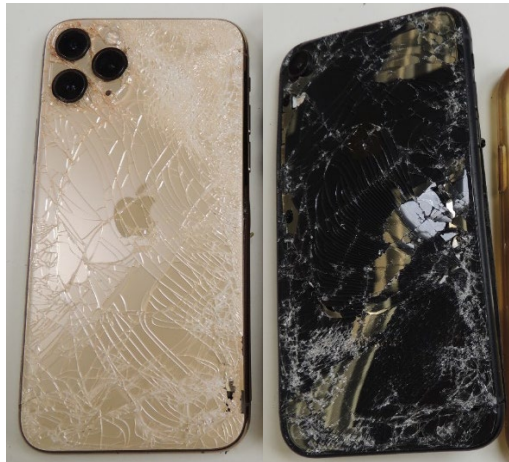
Figures 3 & 4. Damaged iPhone 11 Pro (left) and iPhone XR (right) as received.

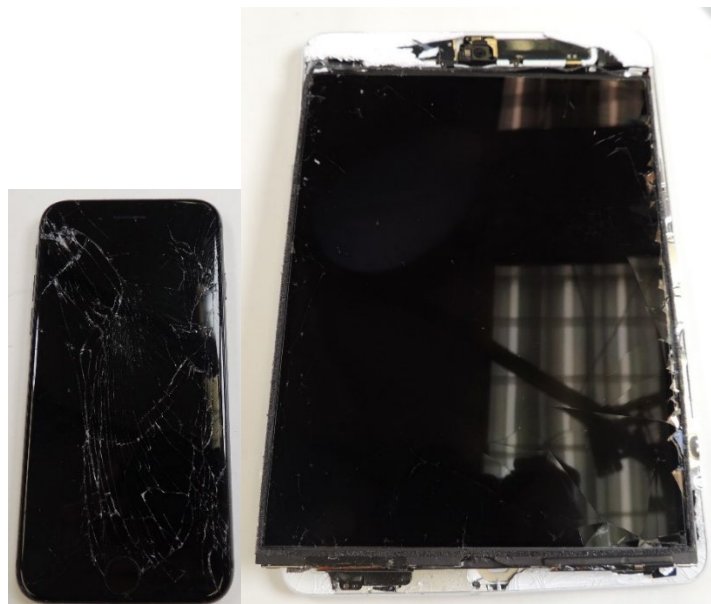
Figures 5 & 6. Damaged iPhone 8 (left) and iPad Mini 2 (right) as received.

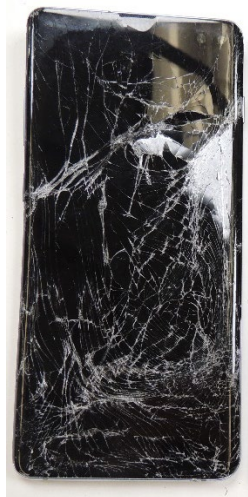
Figures 7. Damaged Samsung Galaxy S10 as received.

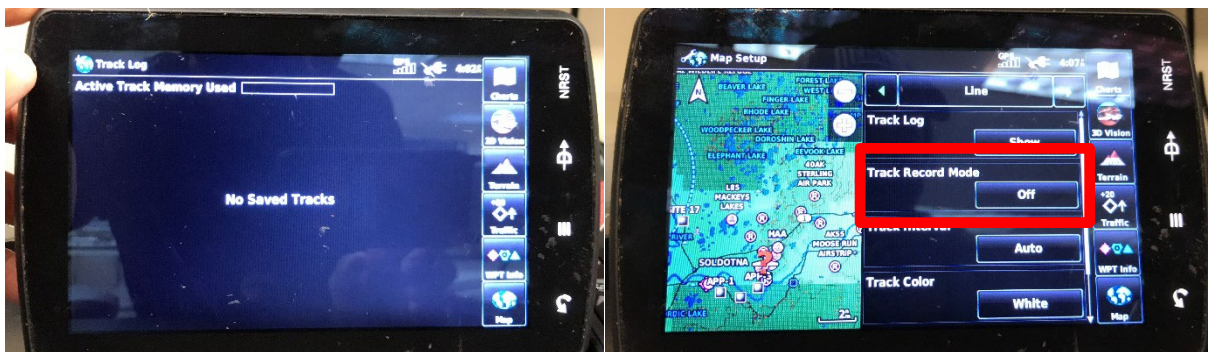
Upon arrival at the Vehicle Recorder Laboratory, an exterior examination revealed the unit had not sustained any damage and powered on normally. There were no track logs recorded to NVM as shown in Figure 7, and the “Track Record Mode” was set to “Off”, as shown in Figure 8, thus no data were recovered.

Figures 7 & 8. Track Log screen (left) and Track Record Mode (right).

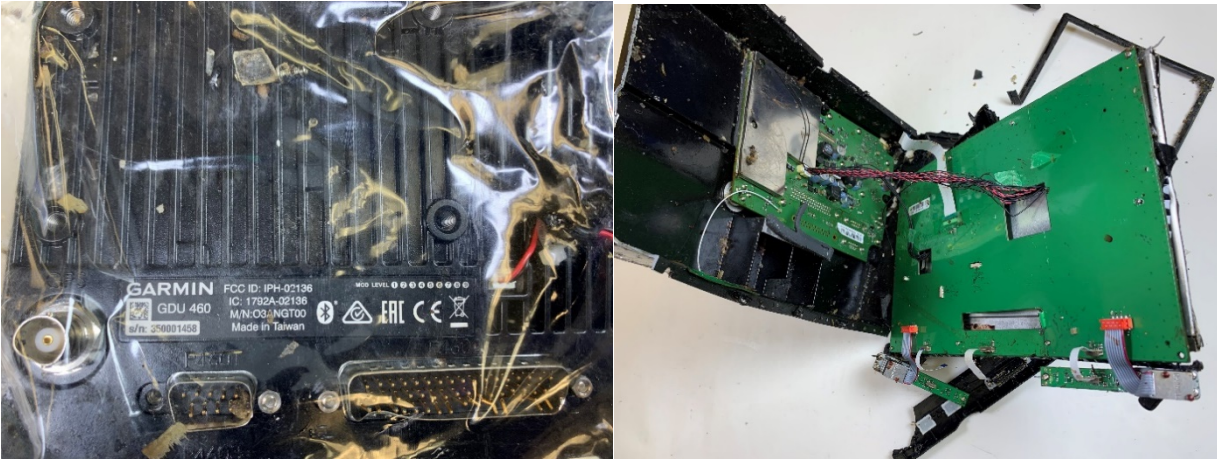
Upon arrival at the Vehicle Recorder Laboratory, an exterior examination revealed the unit had sustained impact damage, as shown in Figure 9, rendering it inoperable. No SD card was present in the front slot. A non-volatile memory chip was identified on one of the circuit boards and was removed, readout, and converted to engineering units using laboratory tools.

Figure 9. Garmin GDU 460 as received.

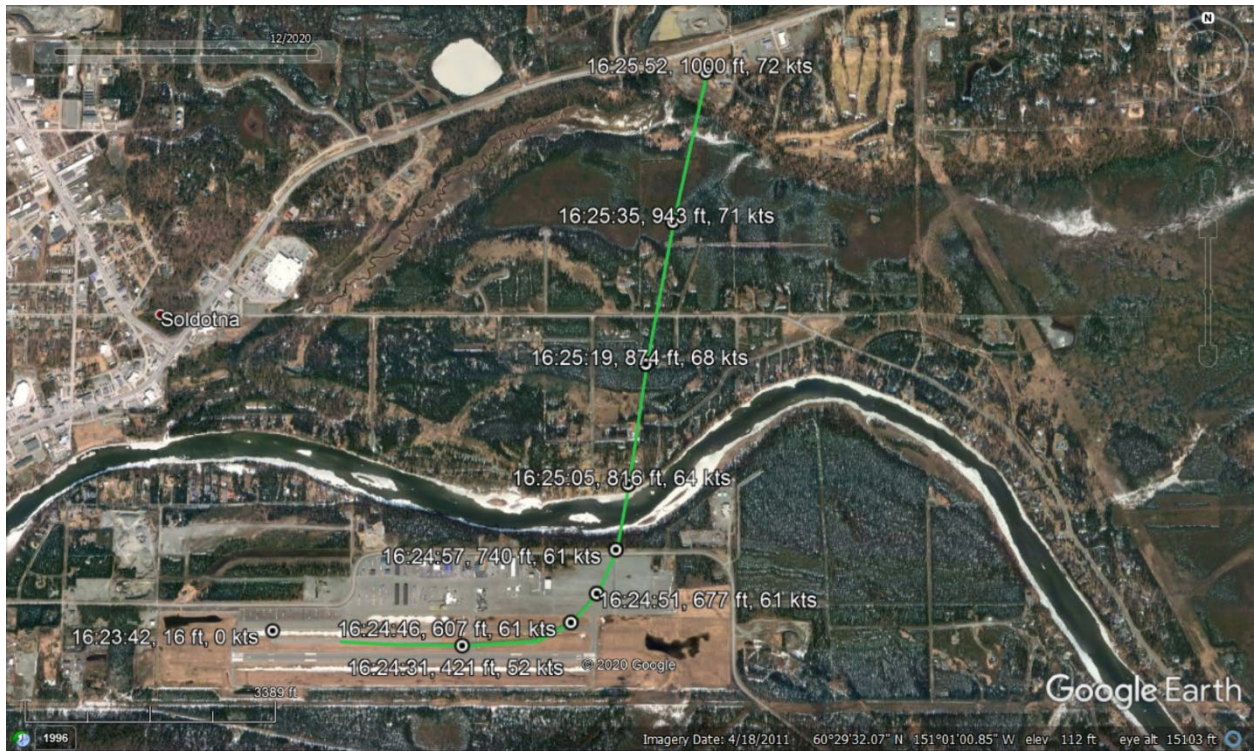
The converted data contained one track log from the date of the accident. The track log contained the first minute of the accident flight from the Piper PA-12 (N2587M) as shown in Figure 10. The corresponding tabular data used to create Figure 10 is provided in electronic comma separated value (.CSV) format as Attachment 1 to this report.

Figure 10. Data extracted from the Garmin GDU 460 memory chip.
