NATIONAL TRANSPORTATION SAFETY BOARD

Weather Factual

ANC20LA074AB

Location: Soldotna, Alaska
Date: July 31, 2020
Time: around 0827 Alaska daylight time
1627 Coordinated Universal Time (UTC)
Aircraft: Piper PA-12 and De Havilland DHC-2; Registration: N2587M and N4982U

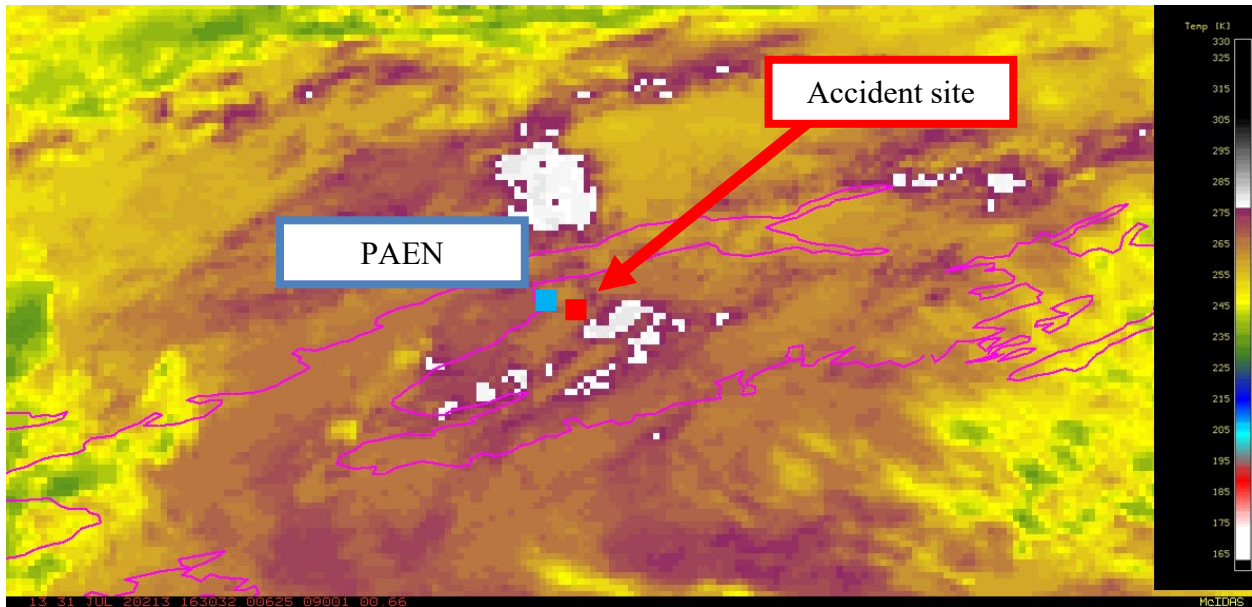
Figure 3 is the GOES-17 visible imagery at 0830 AKDT provided at 2X magnification with the accident site highlighted by a red square. Inspection of the visible imagery indicated broken cloud cover above the accident site at the accident time. Figure 4 is the GOES-17 infrared imagery at 0830 AKDT at 6X magnification with a temperature enhancement curve applied and the accident site highlighted by a red square. Inspection of the infrared imagery indicated cloud cover above the accident site at the accident time. It should be noted these figures have not been corrected for any parallax error. Based on the brightness temperatures above the accident site and the vertical temperature profile provided by the 0400 AKDT Anchorage, Alaska (PANC)⁸, sounding, the approximate cloud-top heights over the accident site were 11,000 ft msl at 0830 AKDT (temperature of about 267 Kelvin).

Figure 4 – GOES-17 infrared image at 0830 AKDT.

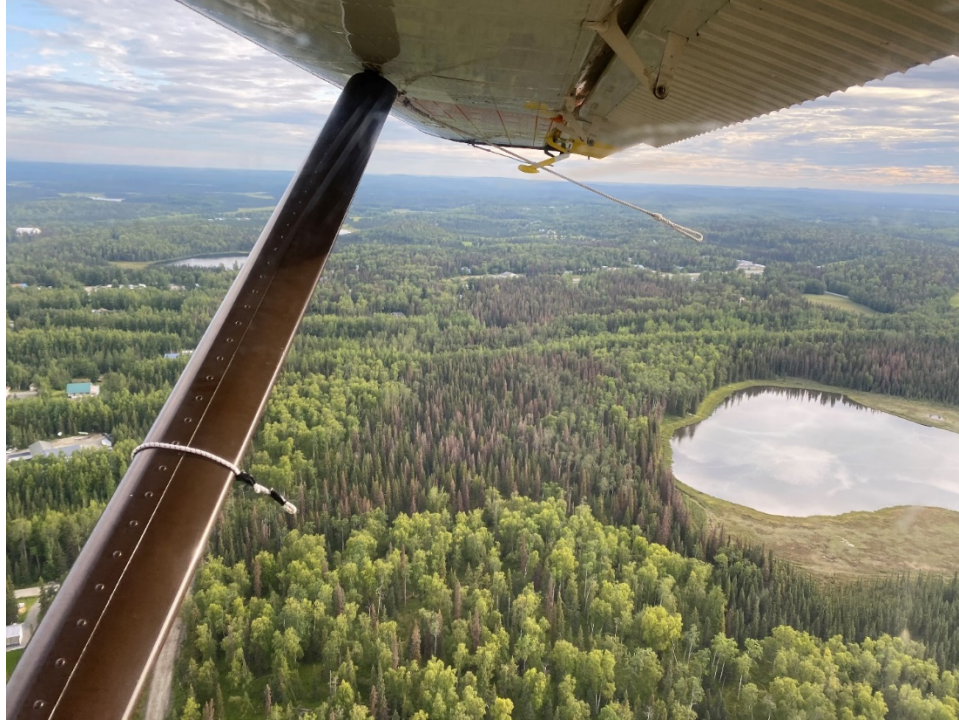
Figure 6 shows a view to the north-northeast from underneath the right wing.¹⁴ Primary features visible are a tree-covered area east of Walker Street (visible below the strut) and a small lake. Shadows are present behind buildings along walker street (to the left of the strut). The horizon is visible along with broken-scattered clouds above.

Figure 6 – View towards the north-northeast about 0825:39 showing ground features and sky cover.

Figure 9 shows a view to the east. Lake in figure 6 visible east of Huckabay Road and Sterling Highway is on the left side. Shadowing behind buildings and trees in foreground apparent. Horizon is visible along with broken-scattered clouds above.

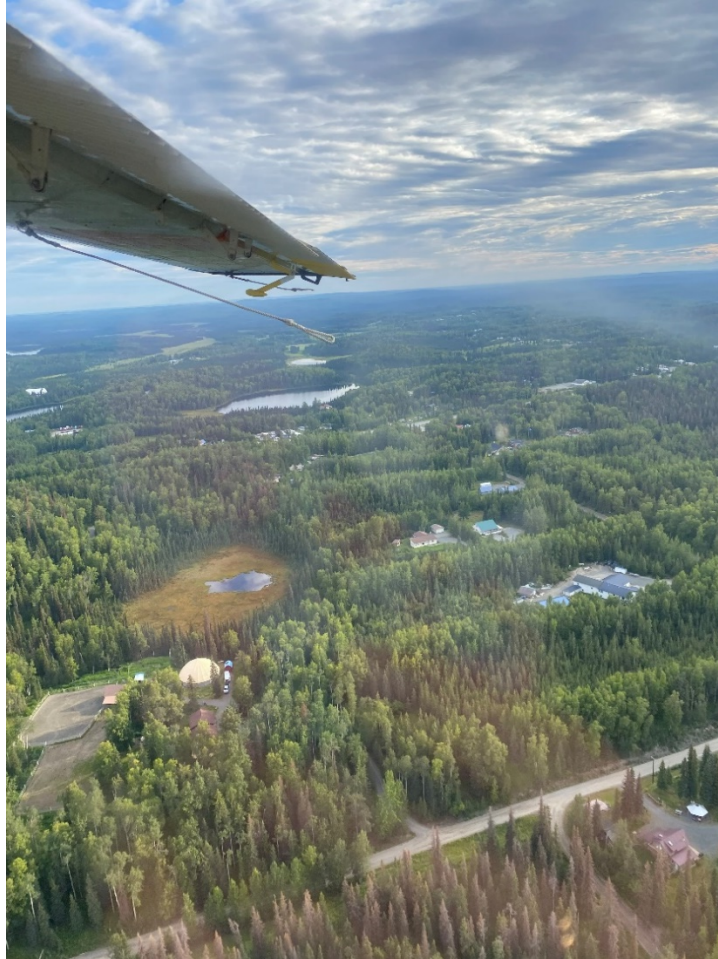
Figure 7 shows a view to the north-northeast from behind the right wing. Huckabay Road is visible at the bottom of the image. Lake below the wing tip is across Sterling Highway opposite Walker Road. Shadows are present behind buildings in foreground. Horizon is visible along with broken-scattered clouds above.

Figure 7 – View towards the north-northeast about 0825:46 showing ground features and sky cover.

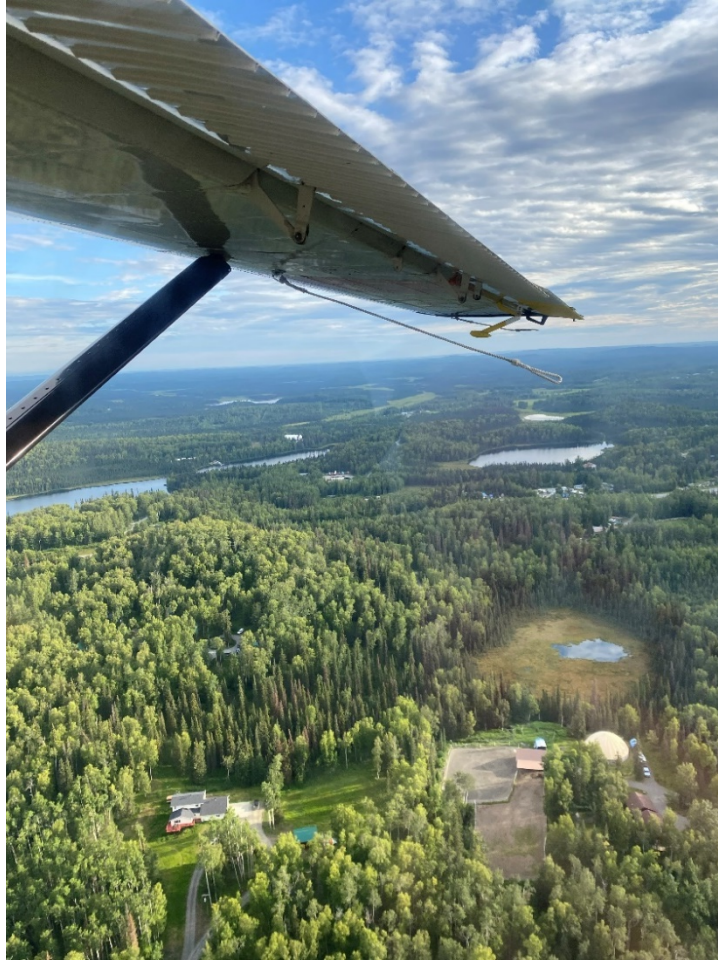
Figure 8 shows a view to the north from behind the right wing. Houses at west end of Huckabay Road are visible at the bottom of the image. Two lakes across Sterling Highway are also visible. Shadowing behind buildings and trees apparent from Huckabay Road towards Sterling Highway. Horizon is visible along with broken-scattered clouds above.

Figure 8 – View towards the north about 0825:49 showing ground features and sky cover.

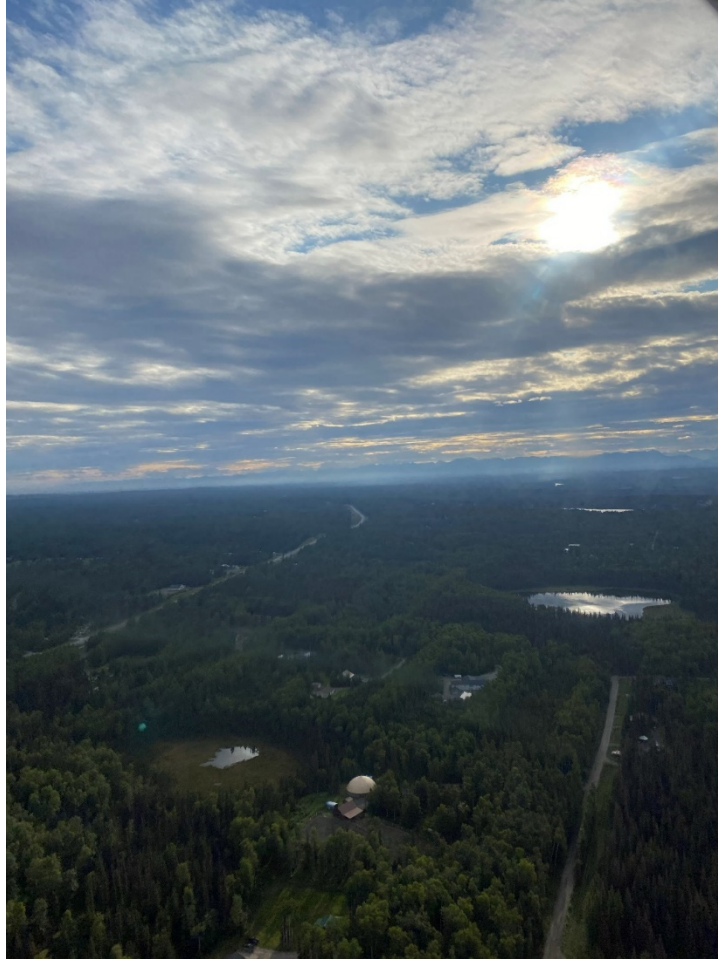
Figure 9 – View towards the east about 0825:56 showing ground features and sky cover.

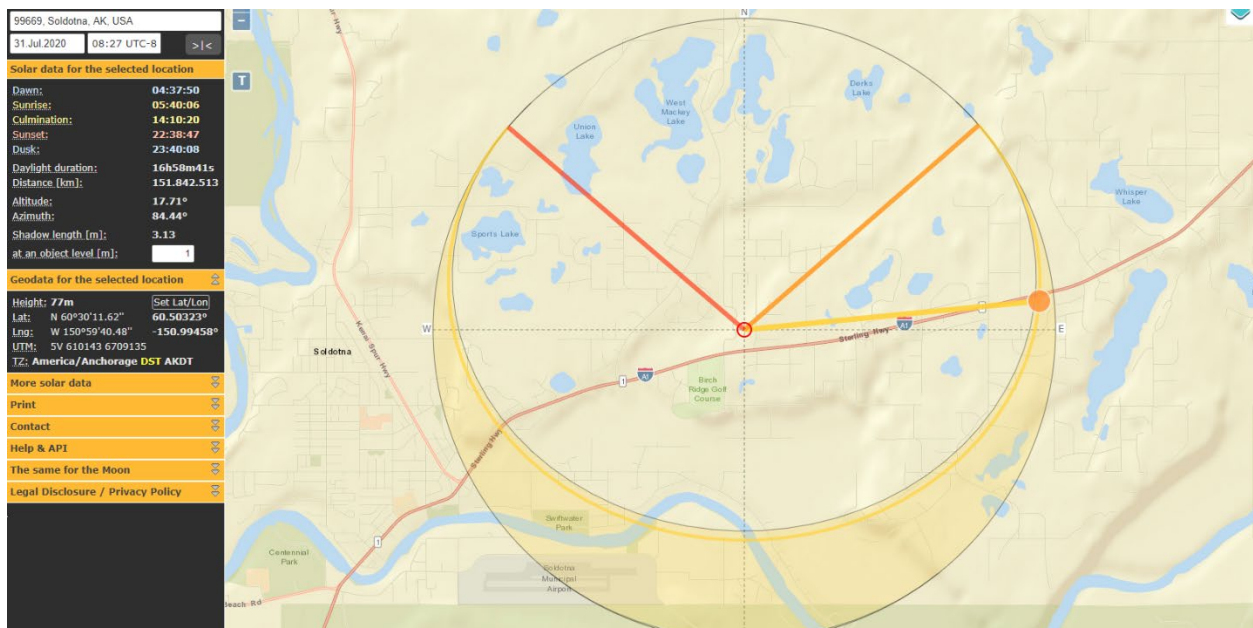
In addition, at 0827 AKDT the Sun azimuth was 84.44° or nearly due east with an altitude of 17.71° above the horizon (see figure 10).

Figure 10 – Sun angle calculations for accident site at 0827 AKDT.
