NATIONAL TRANSPORTATION SAFETY BOARD
Vehicle Recorder Division
Washington, DC 20594

Onboard Image Recorder

**Group Chairman's Factual Report
By Gerald Kawamoto**

Location:	Joplin, Montana
Date:	September 25, 2021
Vehicle:	Freight Train
Registration:	AMTK 74
Operator:	Amtrak
NTSB Number:	RRD21MR017

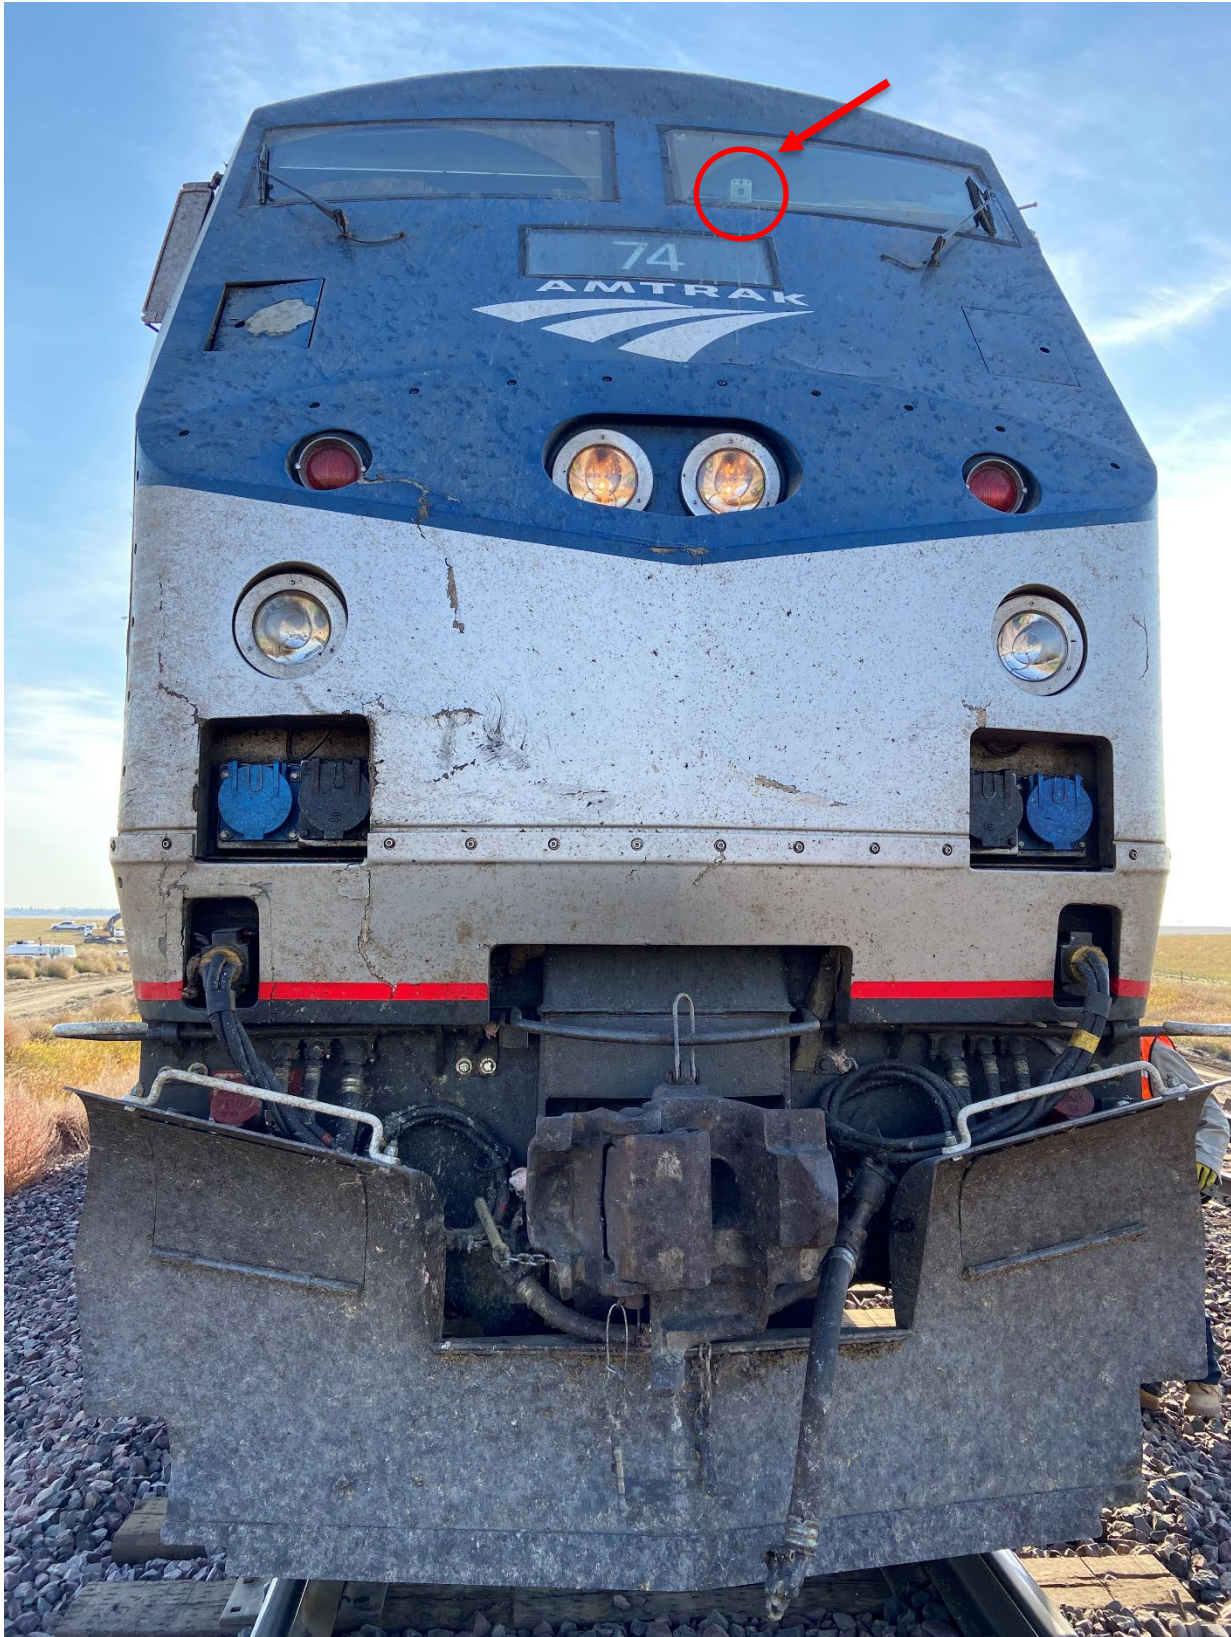
The video file received contained both video and audio data for 10 minutes of operation. The video started at 12:45:16 and ended at 12:55:17 embedded video time. The forward-facing video camera was mounted inside of the lead locomotive, as shown in the red circle in Figure 1. The video was sampled at 15 frames per second with a resolution of 704 x 480 pixels.

Figure 1. Location of forward-facing video camera as seen from the exterior. The camera is shown in a red circle.

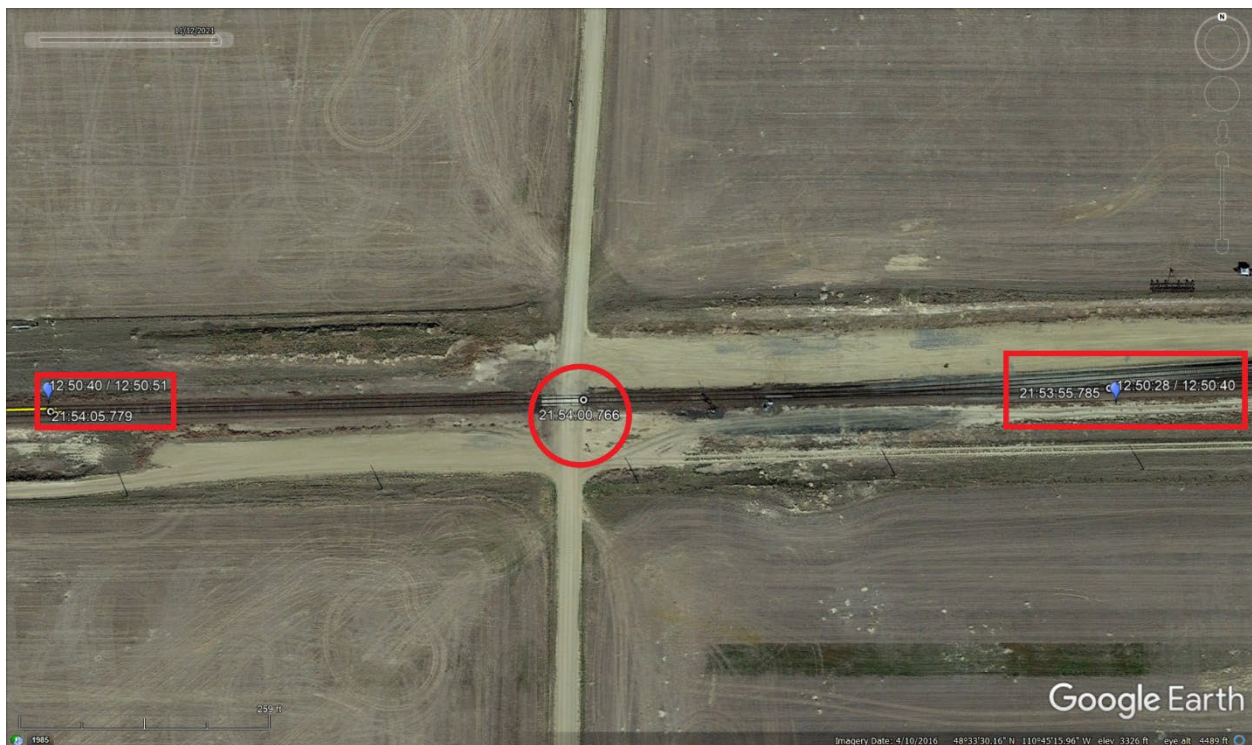
From 12:50:28 through 12:50:40 embedded video time, the GPS location recorded static values for latitude and longitude of 48.5582 degrees N and 110.7537 degrees W, respectively. This position corresponded to the position recorded on the PTC at 21:53:55.785 UTC, which had latitude and longitude values of 48.55824 degrees N and 110.75372 degrees W, respectively. These points are shown in the red rectangle on the right side of the image.

From 12:50:40 through 12:50:51 embedded video time, the GPS location recorded static values for latitude and longitude of 48.5582 degrees N and 110.7585 degrees W, respectively. This position corresponded to the position recorded on the PTC at 21:54:05.779 UTC, which had latitude and longitude values of 48.55817 degrees N and 110.75849 degrees W, respectively. These points are shown in the red rectangle on the left side of the image.

12:50:40 embedded video time is shown at both the data points in the red rectangles because the first 11 frames of this second correlated to the point on the right side of the image and the last four frames correlated to the point on the left side of the image. The locations indicate the locomotive was traveling from east to west.

The additional PTC data point seen in the image, which was slightly east of a North/South crossing, is shown in a red circle in Figure 2 and had a timestamp of 21:54:00.766 UTC. This point was correlated to the video by stepping through the video sequence frame-by-frame to observe when the crossing was in the camera's field-of-view (FOV) and subsequently when it was no longer in the camera's FOV. This sequence occurred during 12:50:35 embedded video time. The first frame of 12:50:35 shows the entire crossing in the center of the FOV, the fifth frame shows the crossing in the bottom half of the FOV, the ninth frame shows a portion of the crossing in the bottom of the FOV and is the last frame with the crossing in the FOV, and the tenth frame shows an image void of the crossing in the FOV. These four frames from 12:50:35 embedded video time are depicted in Figure 3. The FOV of the front-facing camera was westwardly facing.

Figure 2. Google Earth overlay showing aligned coordinates from video GPS and PTC GPS.

Table 1 summarizes GPS data embedded in the video and Table 2 summarizes GPS data from the PTC recorded data associated with Figure 2. There are two data points associated with each time in Table 2 because the locomotive was equipped with two Navigation Sensor Modules to provide cross-checking and redundancy for the system. It should be noted that due to the update rate of the GPS in the video, the embedded speed values do not necessarily represent the speed and location at their corresponding time stamp.

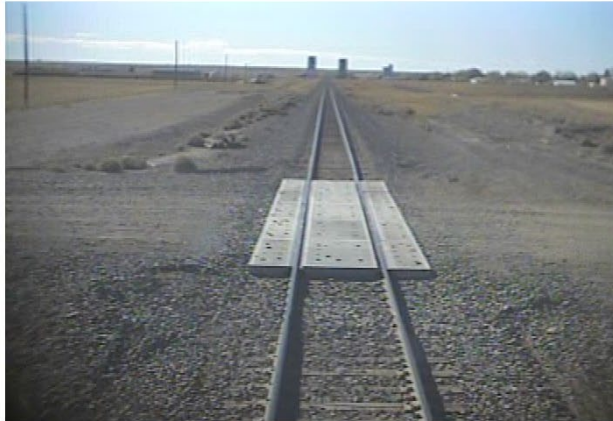
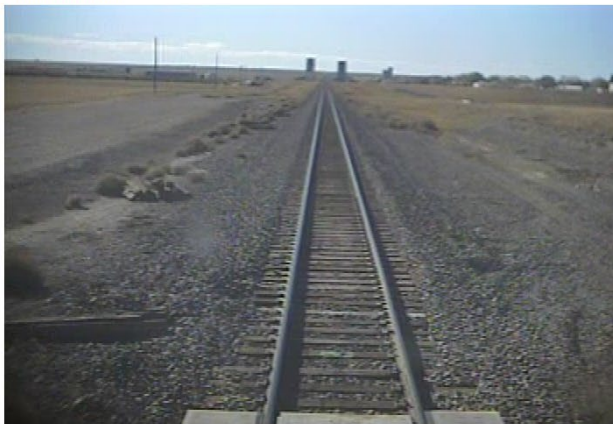
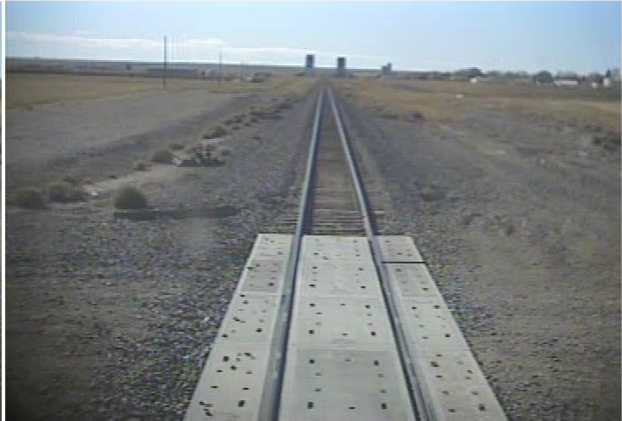
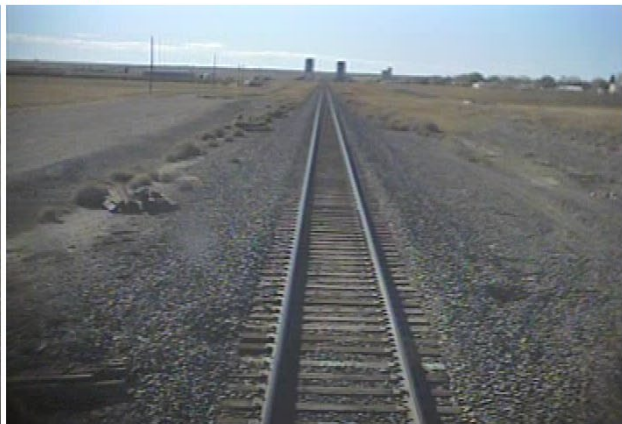
Figure 3. First (top left), fifth (top right), ninth (bottom left), and tenth (bottom right) frames of 15:54:01 MDT (12:50:35 embedded video time) showing the FOV of the camera as it traverses a crossing.

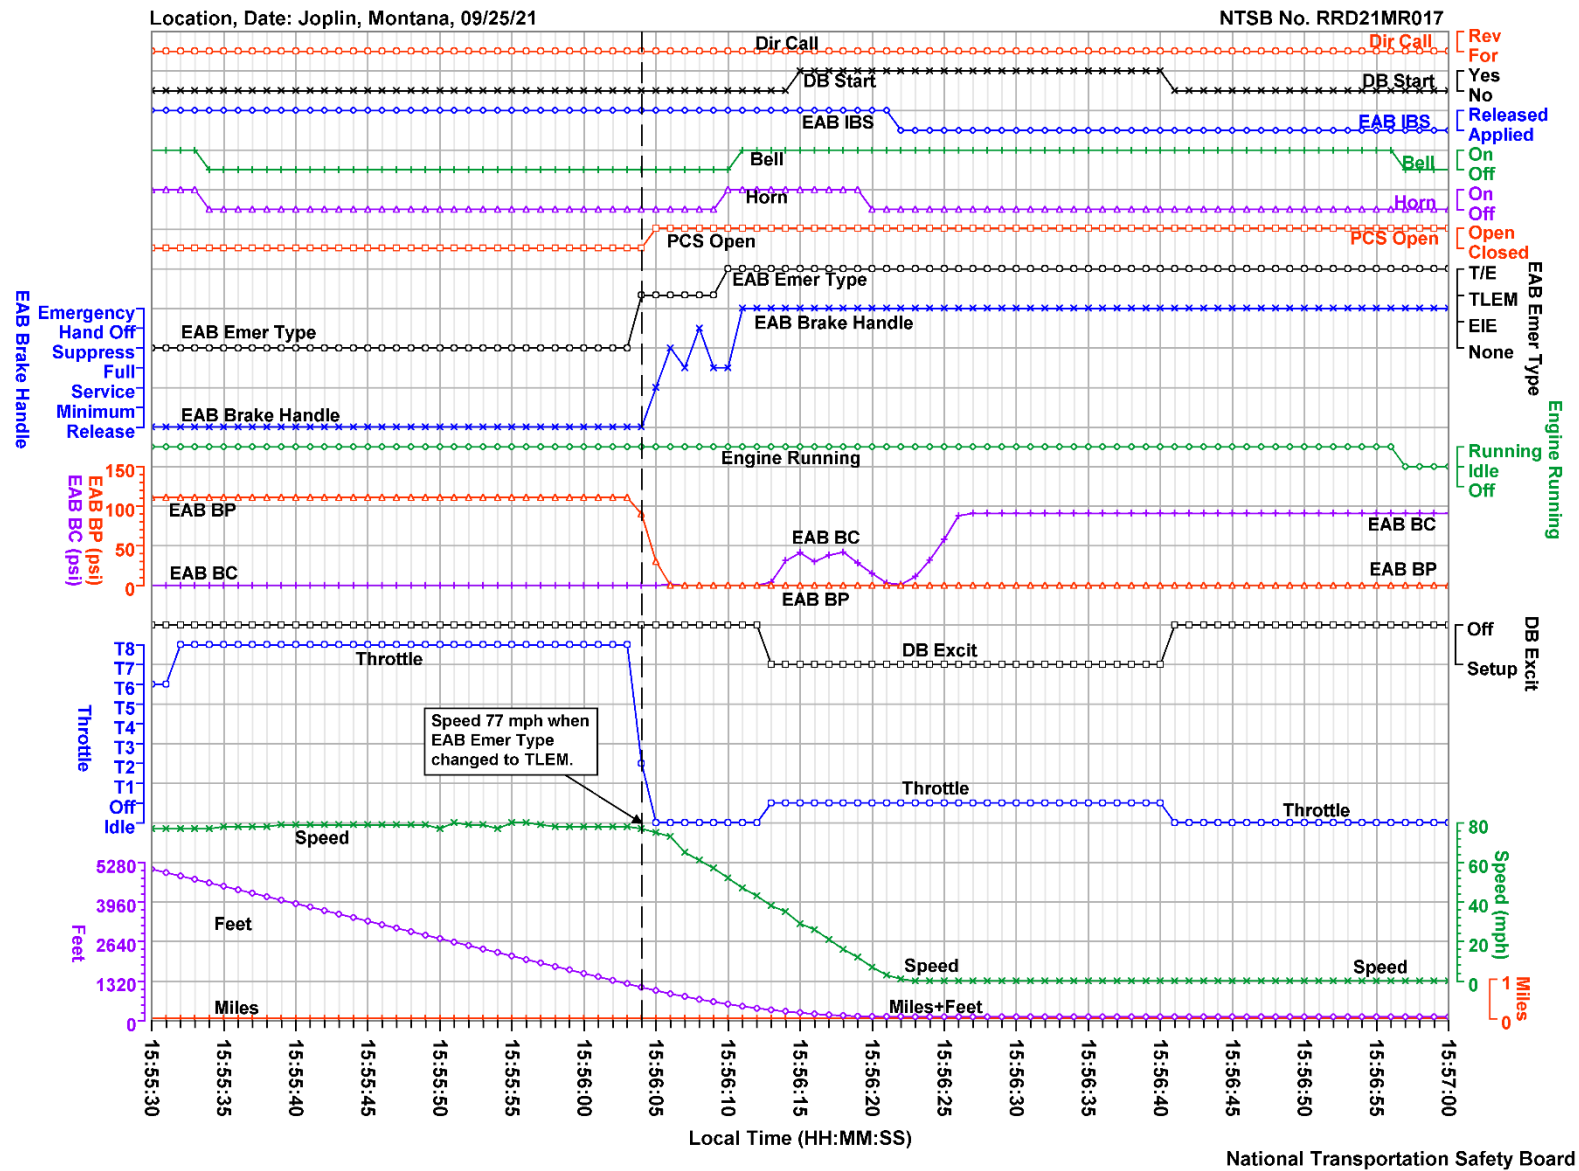
Figure 4. Plot of parameters from the event recorder.

The time correlation between embedded video time and the event recorder was determined by observing audible sounds of the horn recorded in the audio of the .avi file and aligning those times when the “Horn” parameter read “On” in the event recorder data. This yielded an offset of 4:04:57 or 14,697 seconds. Therefore, the event recorder is ahead of MDT by 3,691.234 seconds. From this point forward, times are referenced to MDT and are rounded to the nearest second. Figure 4 is a plot of parameters from the event recorder starting at 15:55:30 MDT and ending at 15:57:00 MDT. Detailed information on the parameters from the event recorder can be found in the Locomotive Event Recorder Specialist’s Factual Report in the public docket.

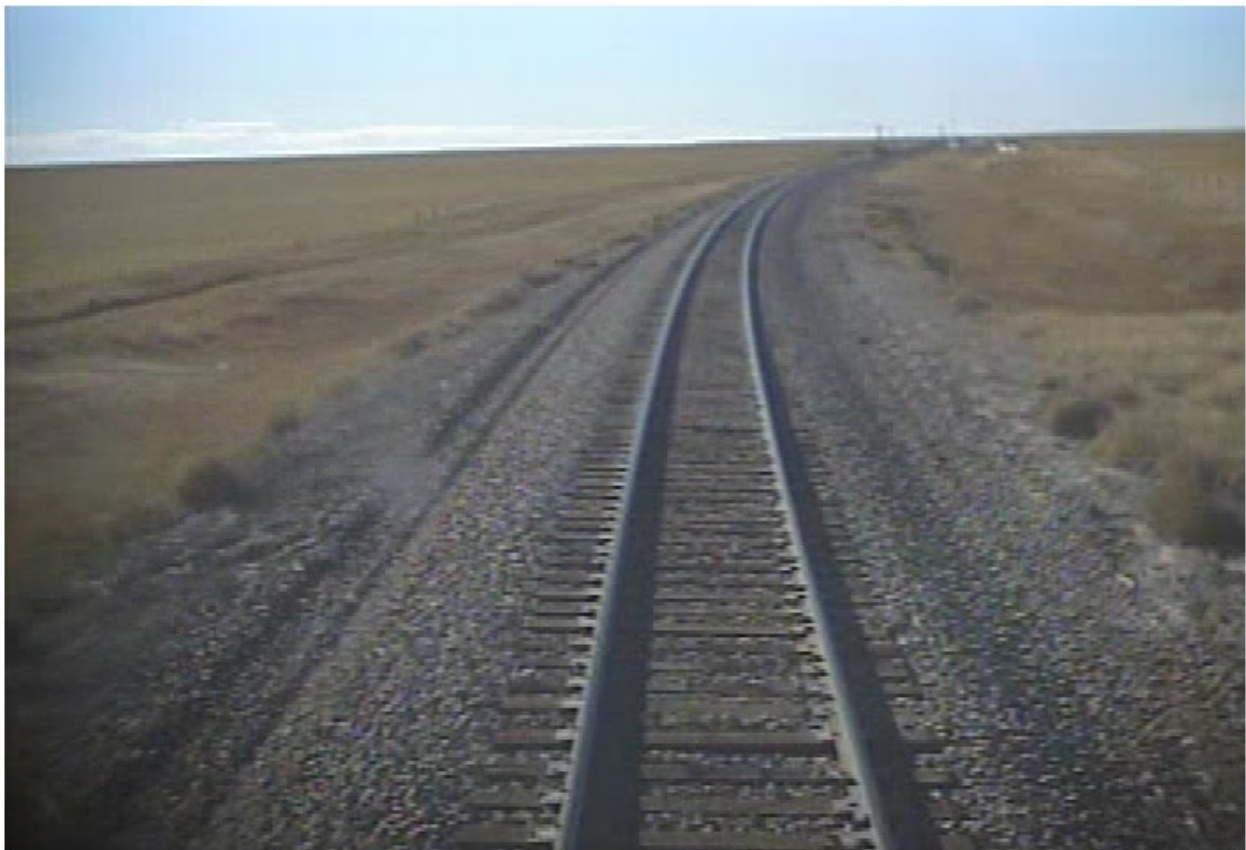
Figure 5 is a still image of the first frame recorded at 15:55:54 MDT (12:52:28 embedded video time). The image shows the locomotive heading west into a curved portion of the track.

Figure 5. The first frame of 15:55:54 MDT (12:52:28 embedded video time).

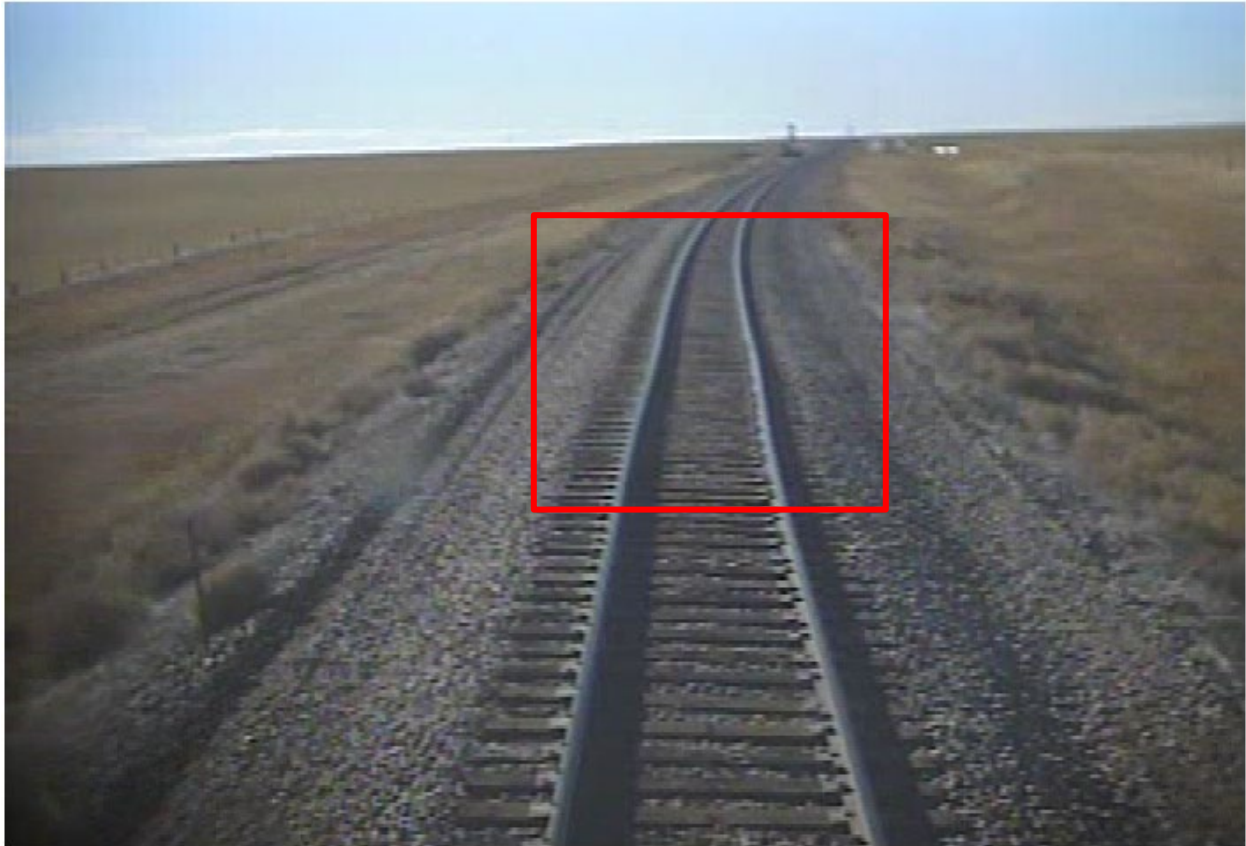
Figure 6 is a still image of the first frame recorded at 15:55:56 MDT (12:52:30 embedded video time). The image shows a rightward deflection in the track as shown in the red rectangle

Figure 6. The first frame of 15:55:56 MDT (12:52:30 embedded video time).

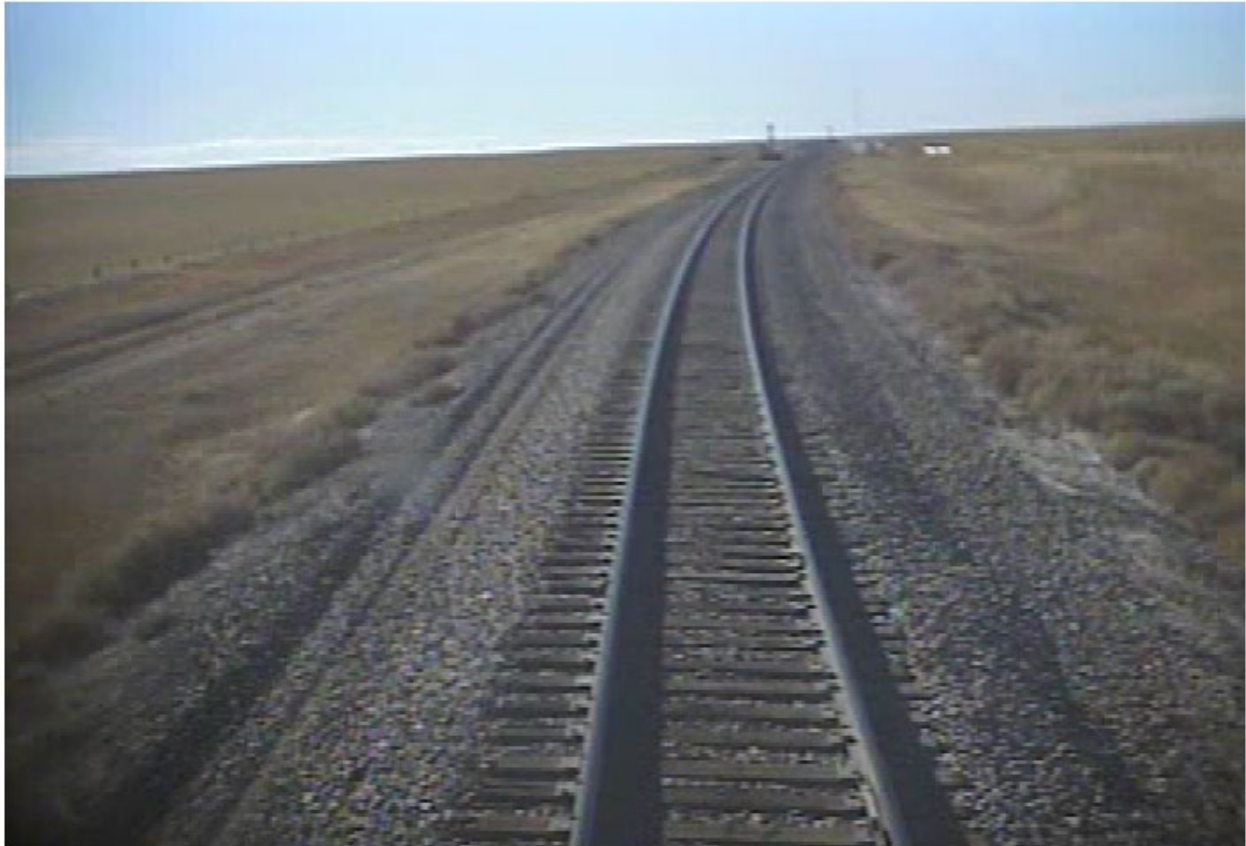
Figure 7 is a still image of the tenth frame recorded at 15:55:56 MDT (12:52:30 embedded video time). The deflection in the track was no longer visible and the locomotive was passing over the deflected portion of the track seen in Figure 6.

Figure 7. The tenth frame 15:55:56 MDT (12:52:30 embedded video time).

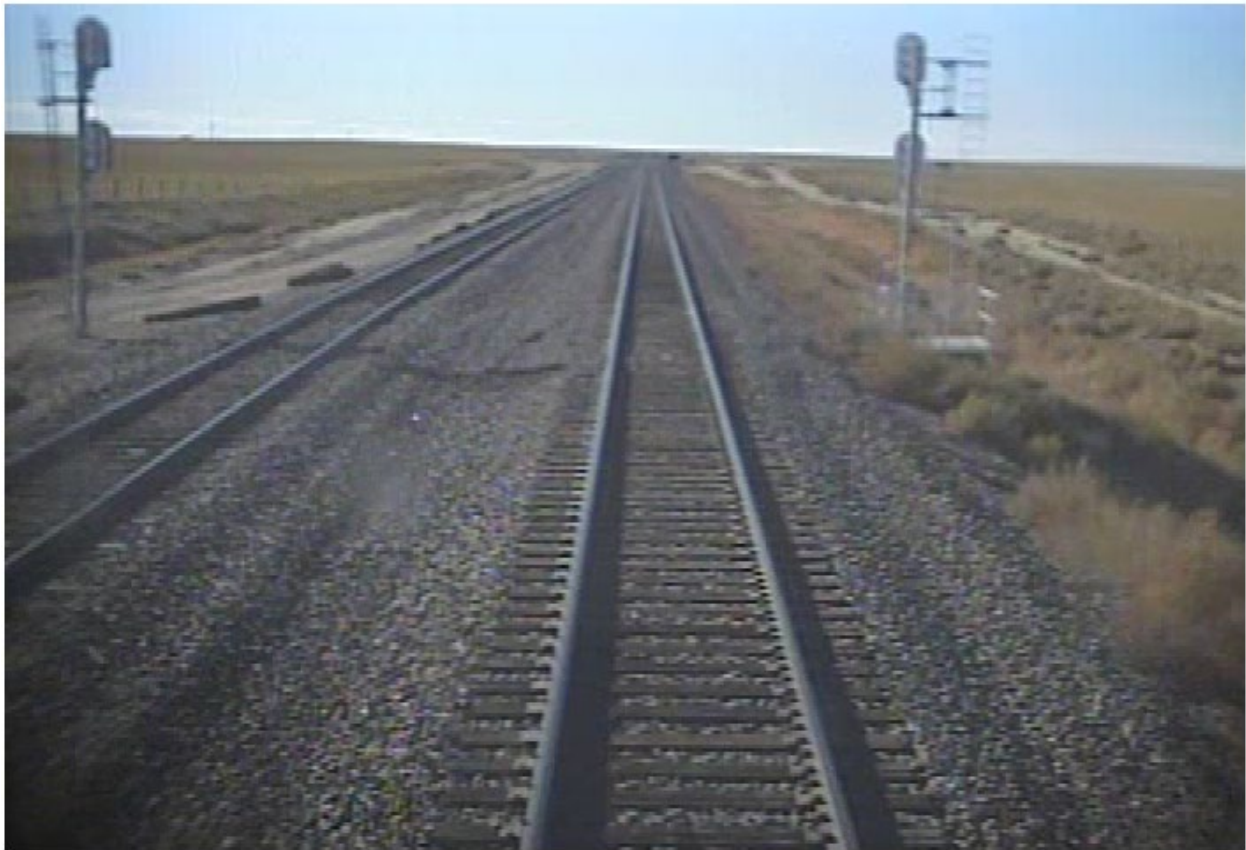
Figure 8 is a still image of the first frame recorded at 15:56:10 MDT (12:52:44 embedded video time). At this time, the horn became audible and remained audible for approximately 9 seconds. The “Horn” parameter in the event recorder data was “On” and simultaneously the “EAB Brake Handle” parameter indicated “Full.” One second later, at 15:56:11 MDT (12:52:45 embedded video time) the “EAB Brake Handle” parameter from the event recorder indicated “Emergency.”

Figure 8. The first frame of 15:56:10 MDT (12:52:44 embedded video time).

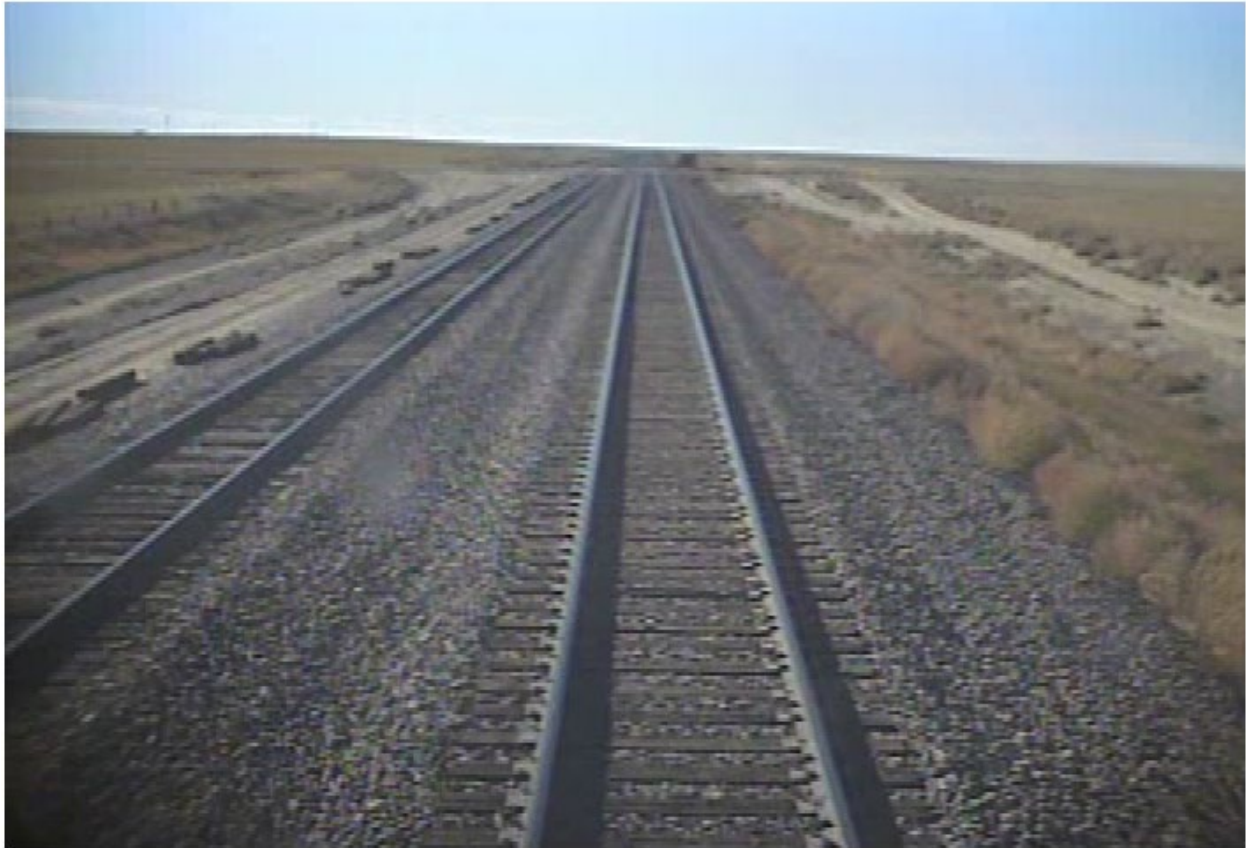
Figure 9 is a still image of the first frame recorded at 15:56:25 MDT (12:52:59 embedded video time). At this time, the locomotive had come to rest. The value of the speed parameter from the event recorder was 0 mph.

Figure 9. The first frame of 15:56:25 MDT (12:52:59 embedded video time).
