**Highway Factors Attachment – Vertical alignment performed by TDOT along stretch of
SR-58 immediately south and north of the crash site**

Decatur, TN

HWY21FH001

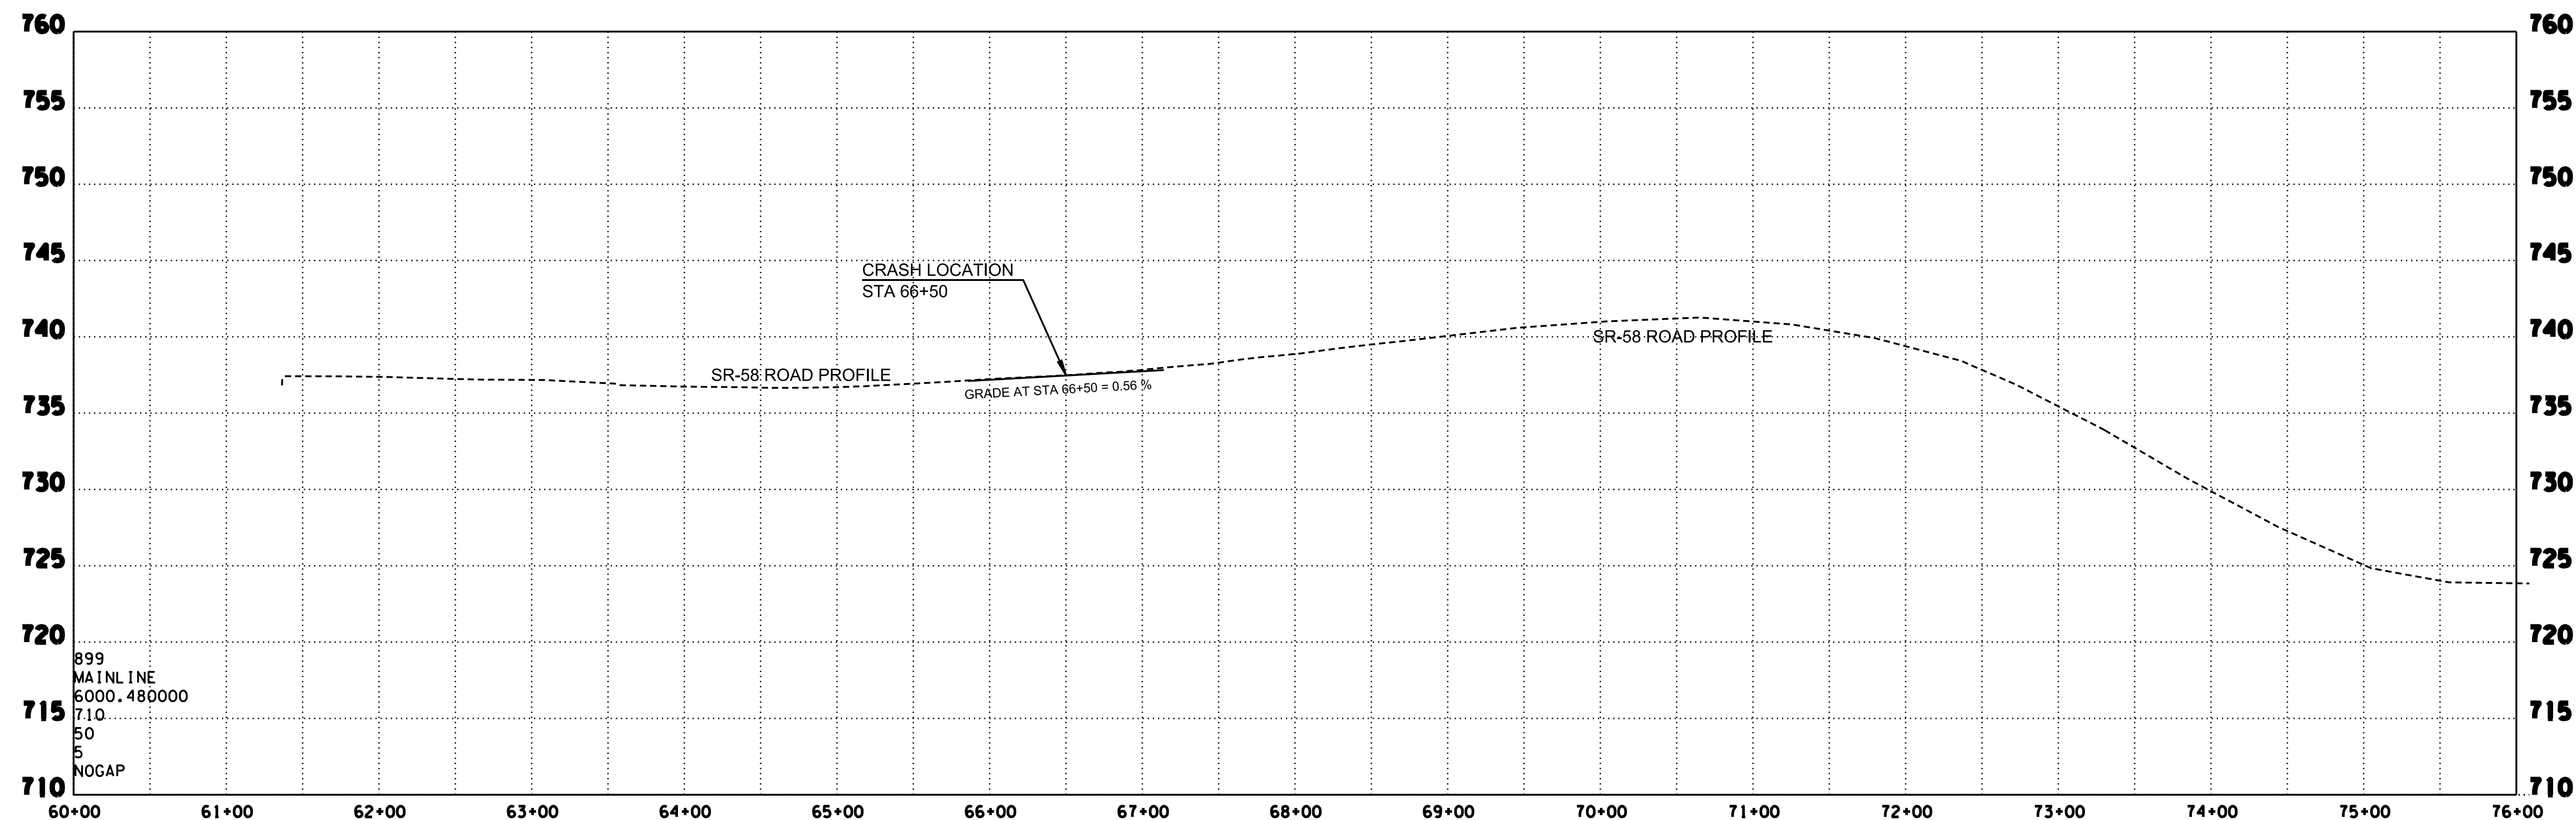
SR-58 CENTERLINE PROFILE
V.E. X 10
