National Transportation Safety Board
Office of Highway Safety
Washington, DC 20594

HWY23FH005

HUMAN PERFORMANCE

Group Chair's Factual Report

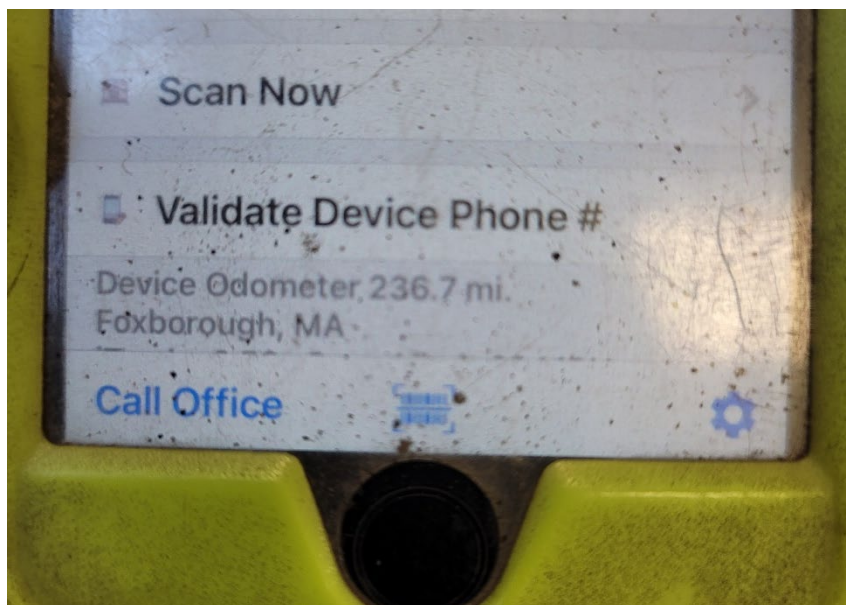
Figure 1. Exemplar AGL phone supplied to drivers, showing the “Call Office” link.

The truck driver's work phone was an iPhone 7, with cellular service provided by AT&T. According to the truck driver, his work phone stayed with the truck and was used primarily to log in and out of work, as well as to record deliveries. According to the records obtained from AT&T, in the 72-hours before the crash, only two outgoing calls were made - one at 10:57:18 a.m. on January 26 and the other at 6:01:19 a.m. on January 28.¹⁹

The latter call lasted 2 minutes and 57 seconds and was initiated about 1 minute before police dispatch received the first 9-1-1 call about the crash. The truck driver had called an AGL toll-free number. NTSB investigators were unable to arrange a subsequent interview with the truck driver to discuss this phone call; however, they did discuss the call with the AGL terminal manager. According to the terminal manager, the truck driver's work phone included a link at the bottom of the screen that a driver could use to quickly call the company (Figure 1). He stated that among the reasons a driver might use this number is to report that a delivery could not be made because a door was locked. He could not think of a reason the truck driver would use this phone number during transit unless it was to report an incident. The terminal manager stated that at the time the truck driver called the toll-free number, no one was at the terminal to answer the call, so the truck driver's call would have been routed to an automated answering system that presented the truck driver with options as to where he'd like his call directed. The terminal manager stated that the truck driver would not have had the option to leave a message. After terminating this call, the truck driver made a call directly to the terminal manager using his personal phone (Section 1.6.2).

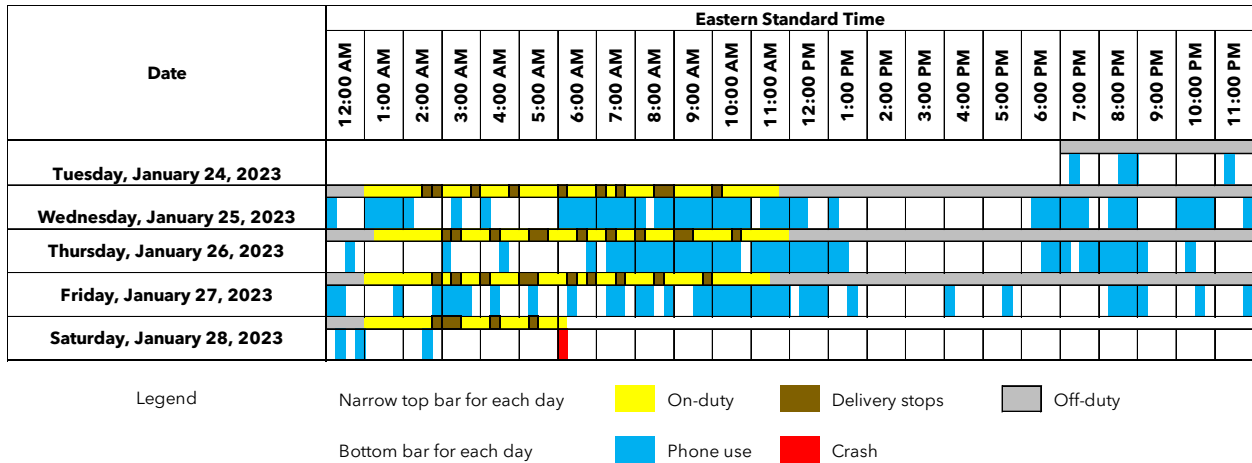
The truck driver’s personal cell phone was an iPhone 13 Pro Max, with cellular service provided by T-Mobile. Based on data extracted directly from his personal phone and records obtained from the driver’s phone carrier, the truck driver used his phone throughout the day, except for a few hours during the afternoons, around the time he told investigators that he slept.²⁰ Figure 2 provides an illustration of the truck driver’s active phone use (in blue). This includes calls and texts using the phone’s native applications, use of third-party applications, and browsing activities. The narrow yellow bars indicate when the truck driver was on-duty, based on AGL’s iTracker electronic trip sheets. The brown segments along the yellow bars indicate the times when the truck driver was at each of the nine stops he made during his shift. The red segment represents when the crash occurred.

Figure 2. Graphical representation on the truck driver’s on-duty and off-duty times, with each of his nine stops also indicated. Phone use is shown as a contiguous block if less than 15 minutes separated the time between outgoing texts or phone calls.

The graphic indicates that the driver frequently used his phone while driving. As shown in Figure 3, NTSB investigators found a Bluetooth right earphone in the driver’s floorboard area of the truck during its post-crash inspection, suggesting that the truck driver might have been using his personal phone in hands-free mode while driving. As mentioned previously, the driver denied using his phone while on-duty. According to 49 Code of Federal Regulations 392, Subpart H, no driver may use a hand-held mobile telephone or engage in texting while driving a CMV. The only occasion where either is permissible is when drivers are communicating with law enforcement officials or other emergency services.

The truck driver generally worked from about 1:00 a.m. until 11:30 a.m. five days per week. He lived with his partner and young child. Based on the information summarized in Figure 1, the truck driver had about five hours of uninterrupted sleep opportunity each day on January 25 and 26, with additional hours of sleep possible after phone use. He had more sleep opportunity on January 27; however, it was fragmented by several occasions of phone use.

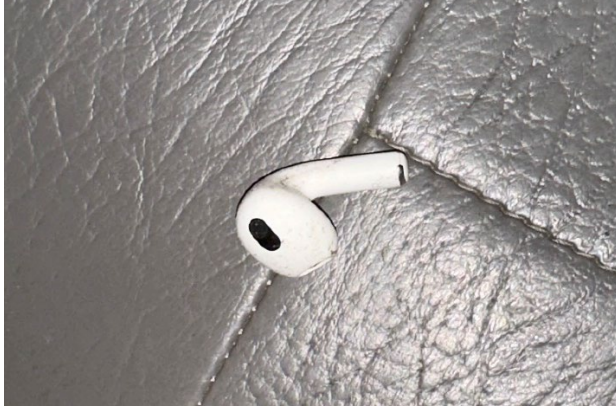
Figure 3. Bluetooth earphone that was found in the truck during the NTSB’s post-crash inspection.

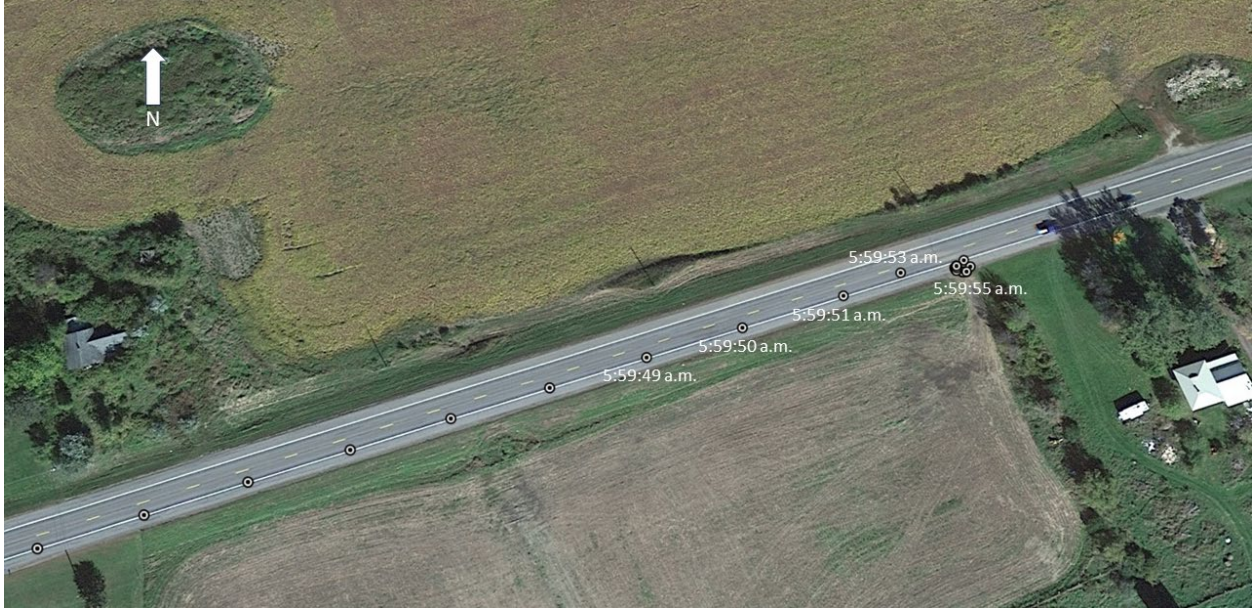
The Cellebrite extraction for the truck driver’s personal phone included location data. These location data were generally accurate to a radius of 4.7 meters (15.42 feet). Investigators created a *.csv file of the data for the day of the crash and imported it into Google Earth Pro. The phone generally recorded a latitude and longitude for each second it was in motion, creating a path that mirrored the truck driver’s route for the day of the crash. Between 5:59:51 a.m. and 5:59:53 a.m., the truck’s speed decreased abruptly. At 5:59:55 a.m., the GPS location of the phone was essentially stationary on the south shoulder of the roadway, near a small cluster of trees and on the opposite side of an electrical pole (Figure 4).²² This location was confirmed to be correct using drone images taken of the vehicles after the crash.

Figure 4. Google Earth Pro map with points indicating GPS locations of the truck before and after the crash.
