National Transportation Safety Board

HWY23MH015

Unmanned Aircraft System Aerial Imagery

Group Chair's Factual Report

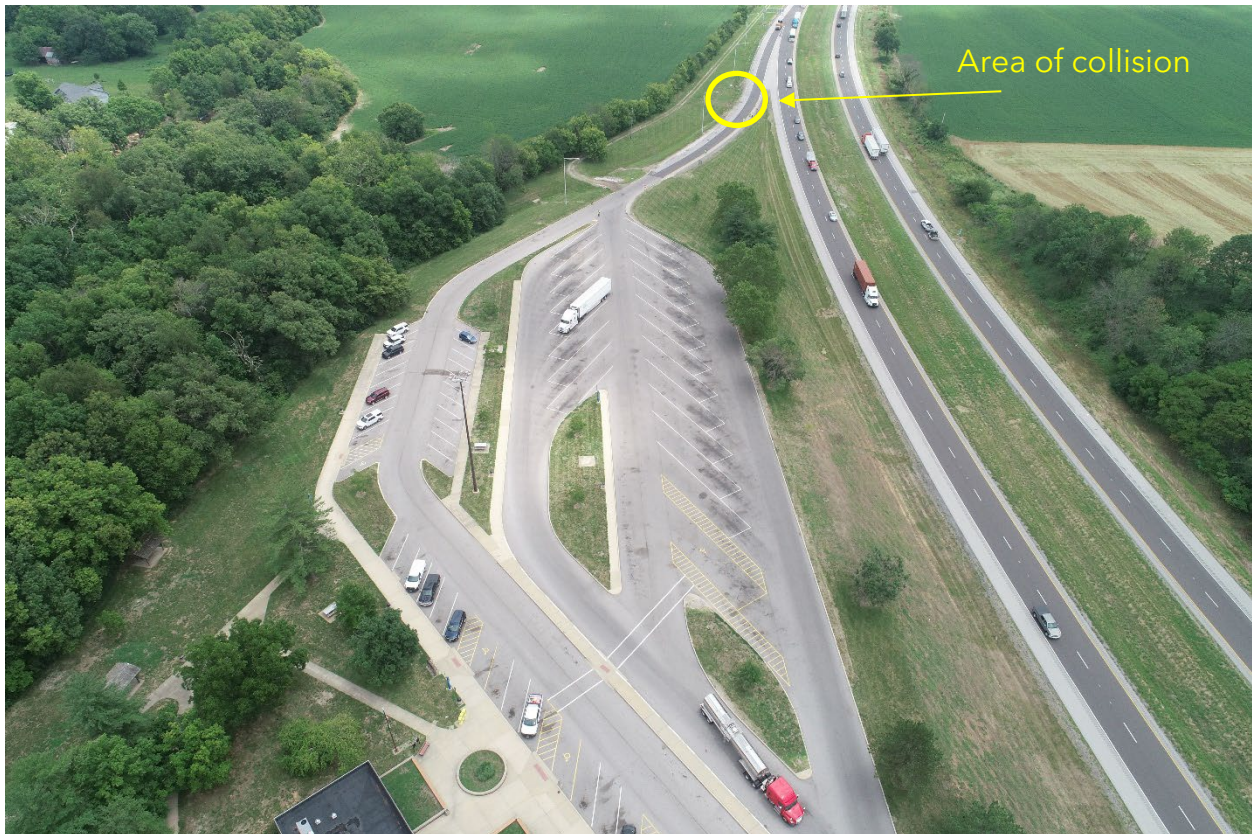
Figure 2. Aerial image of the westbound Interstate 70 rest area looking eastbound.

During the second mission, 167 aerial images were taken of the Greyhound motorcoach involved in the collision using the sUAS in an orbital flight path. The Greyhound bus was located at a tow and maintenance facility, 3801 N. 89th St., Caseyville, Illinois. At this location there were buildings located in the vicinity of the bus, but no significant terrain, environmental, or significant obstruction hazards. A visual observer was utilized for the entire flight. **Figure 2** is an aerial image of the westbound Interstate 70 rest area looking east towards the area of the collision is circled in yellow. **Figure 3** is an aerial image of the of the involved bus.

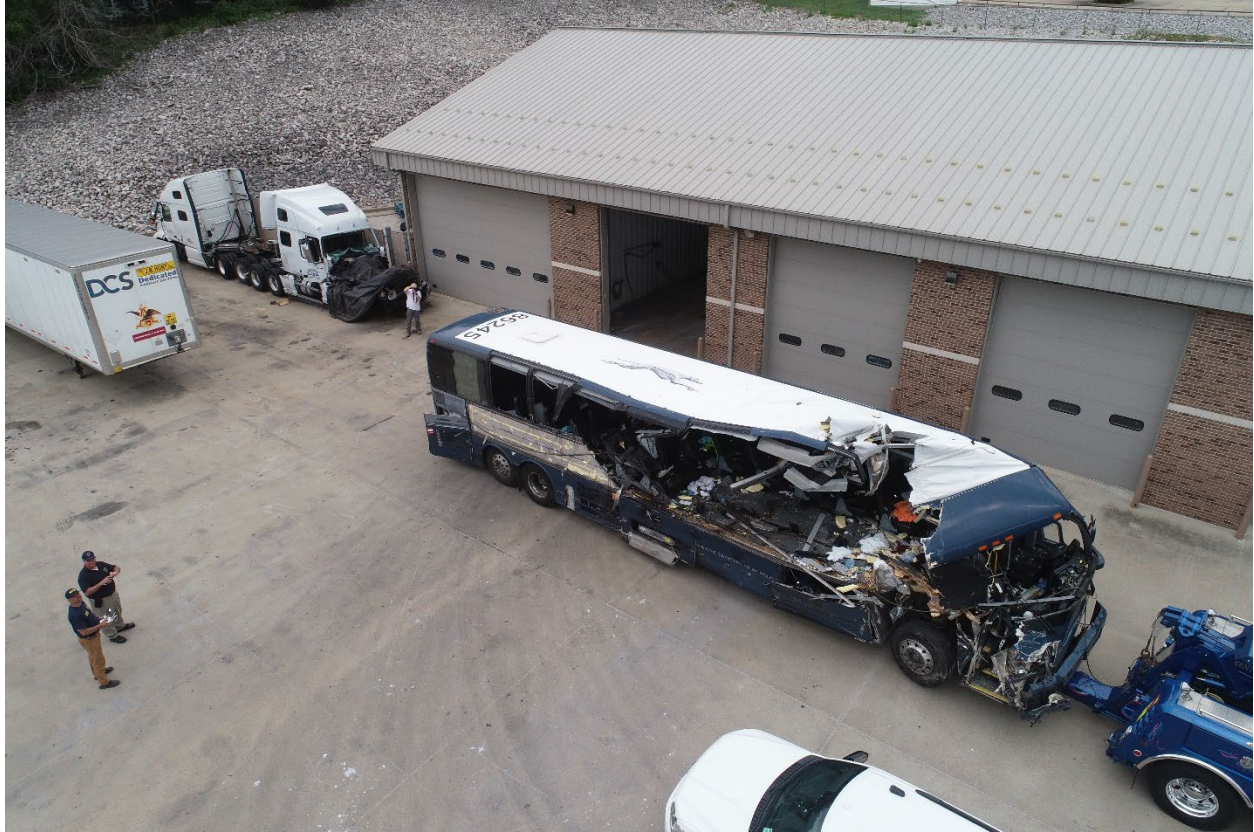
Figure 3. Aerial image of the involved Greyhound bus.

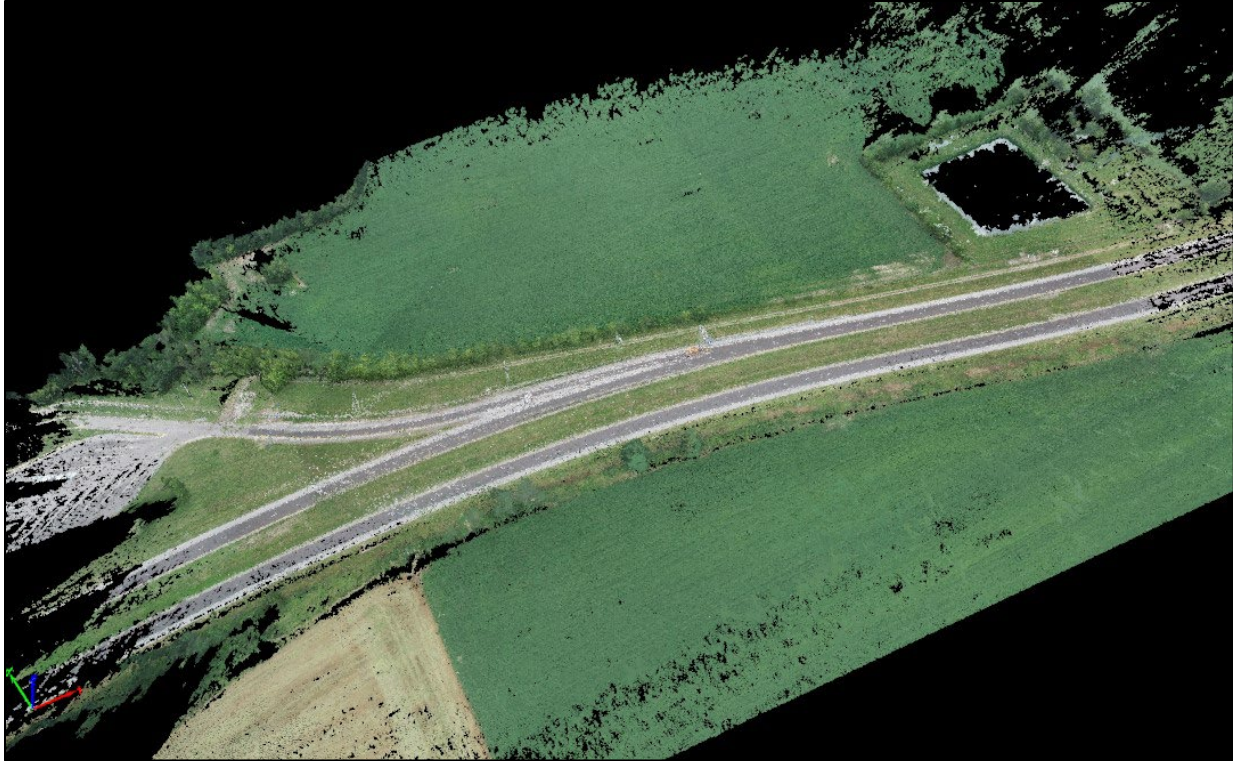
Figure 4. Generated point cloud of the crash location.

The photographs taken using the sUAS were processed using Pix4D to create a point cloud of the crash scene location. An oblique view of the 3D point cloud can be observed in **Figure 4**. From the point cloud, a high-resolution orthomosaic image was created of the crash location and can be observed in **Figure 5**.

The sUAS was used to capture 327 high resolution, georeferenced photographs of the crash scene suitable for processing in the Pix4D photogrammetry software⁴. An additional 27 perspective photographs were taken of an overview of the crash location and were not included in the photogrammetry processing.

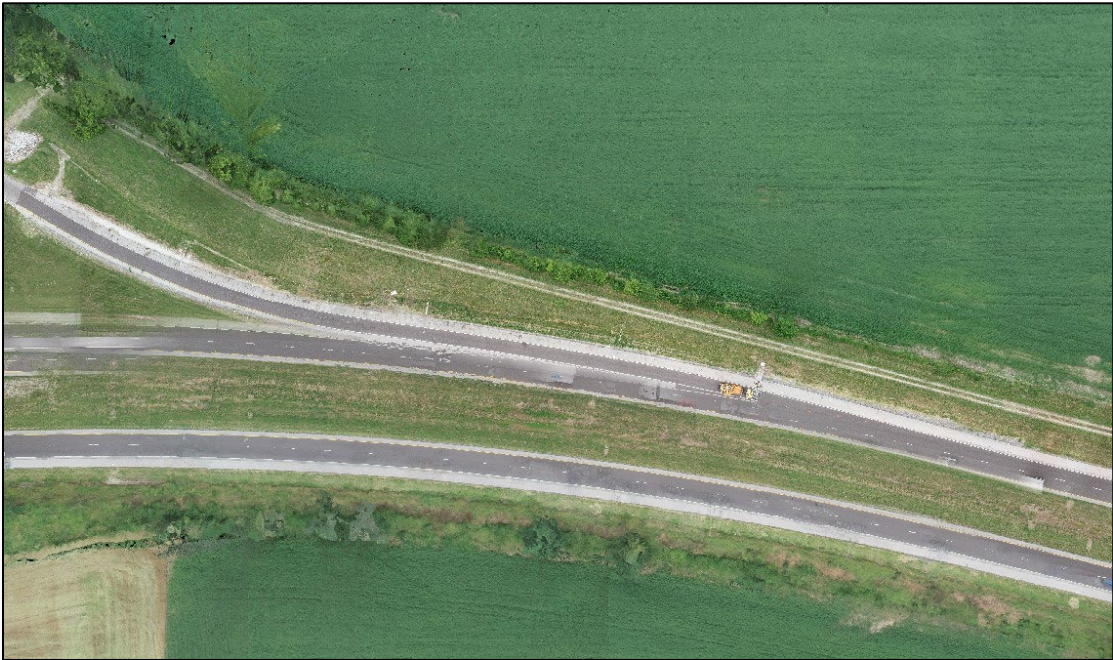
Figure 5. Generated orthomosaic image of the crash location.

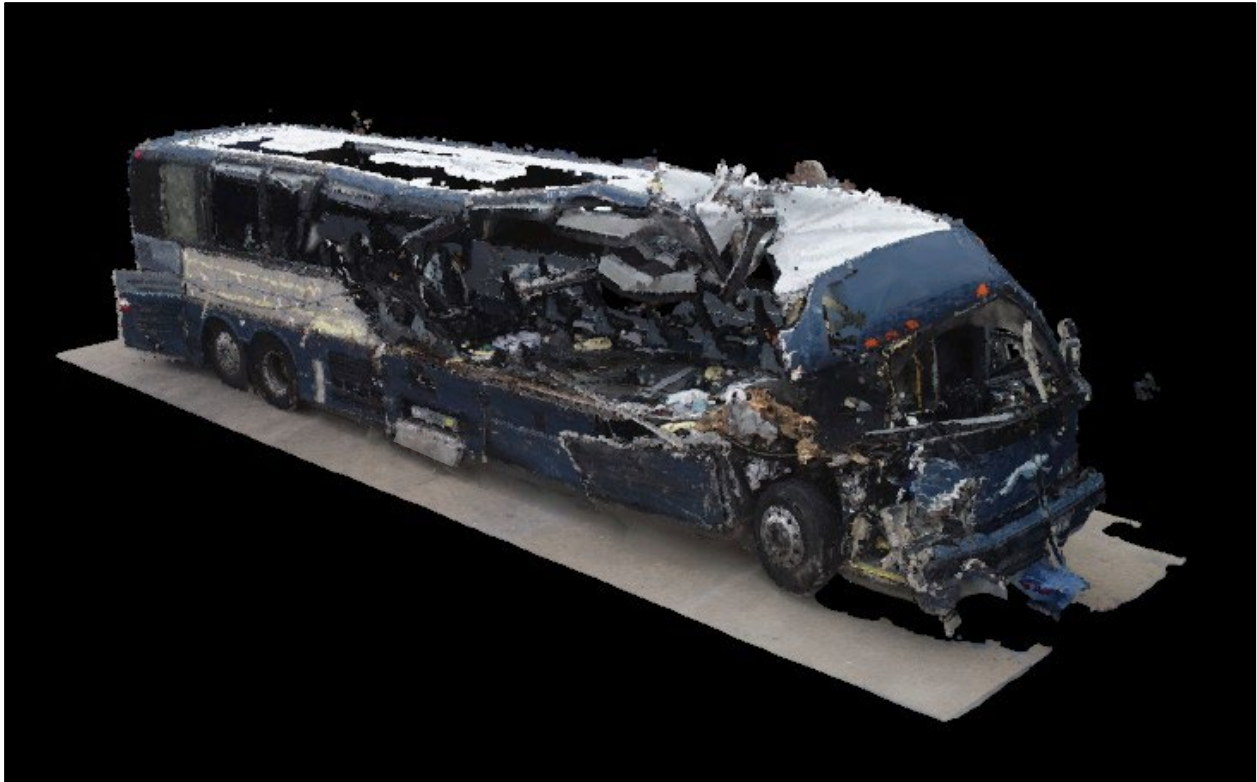
The sUAS was used to capture 167 high resolution, georeferenced photographs of involved Greyhound bus along with 111 photographs of an exemplar bus suitable for processing in the Pix4D photogrammetry software.⁵ The resulting point cloud of the involved Greyhound bus can be seen in **Figure 6**. **Figure 7** is the resulting point cloud of the exemplar bus.

Figure 6. Generated point cloud of the involved Greyhound bus.

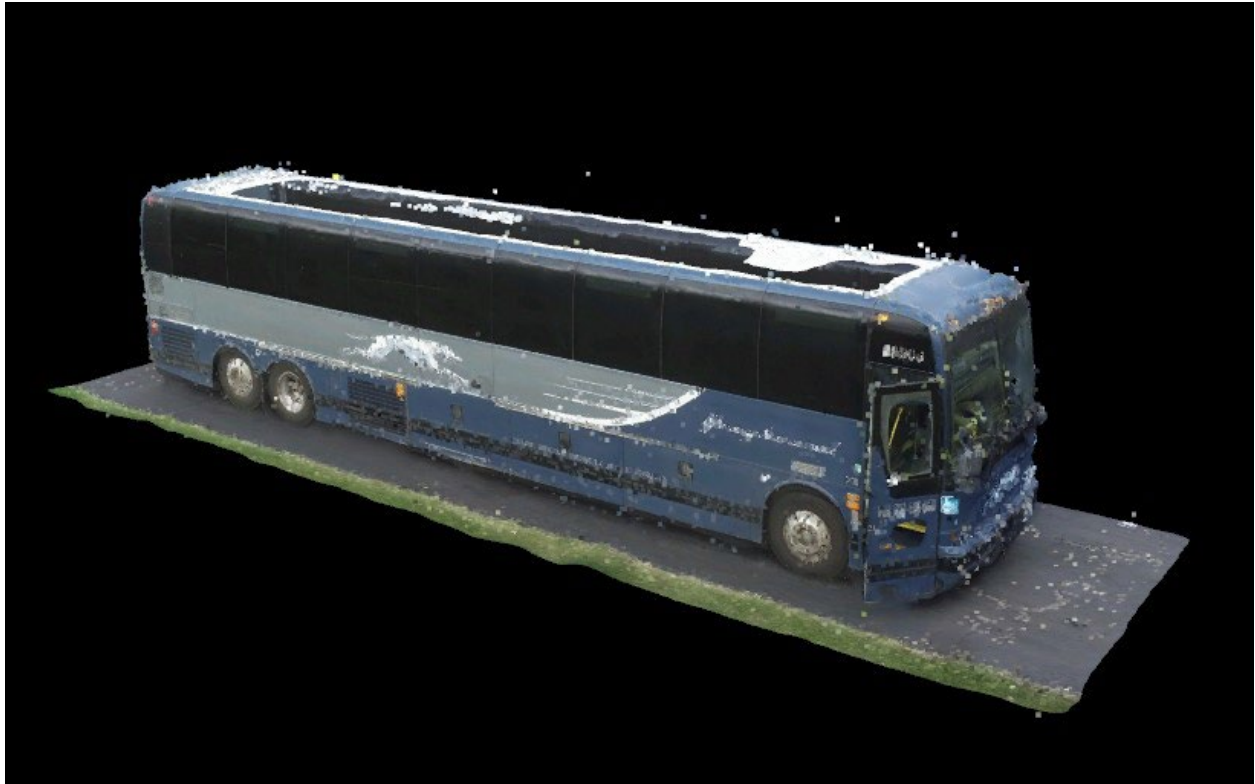
Figure 7. Generated point cloud of exemplar bus.
