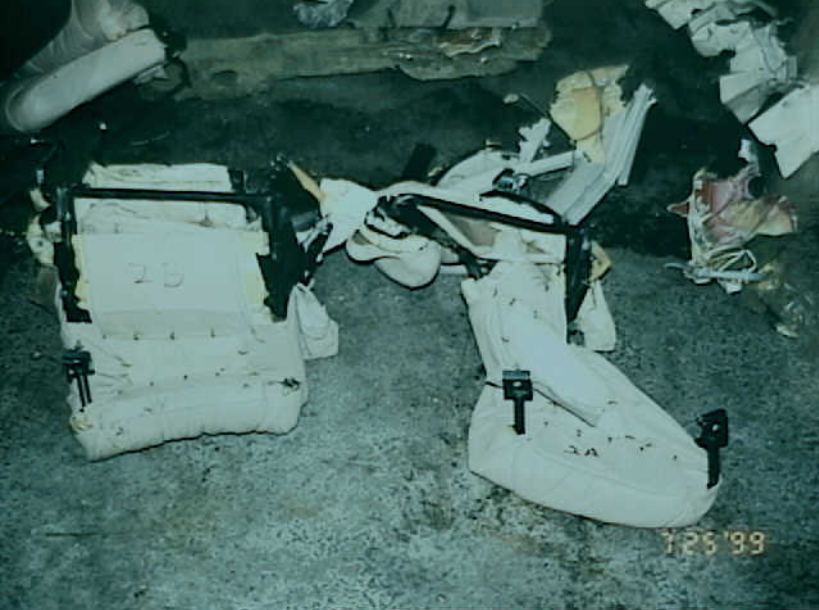
Airworthiness - Photo 16. View of the seat back structure of the aft-facing passenger seats in row 2. Note that the structure is bulged outward (forward relative to their normal installation in airplane). (NTSB-A2)
