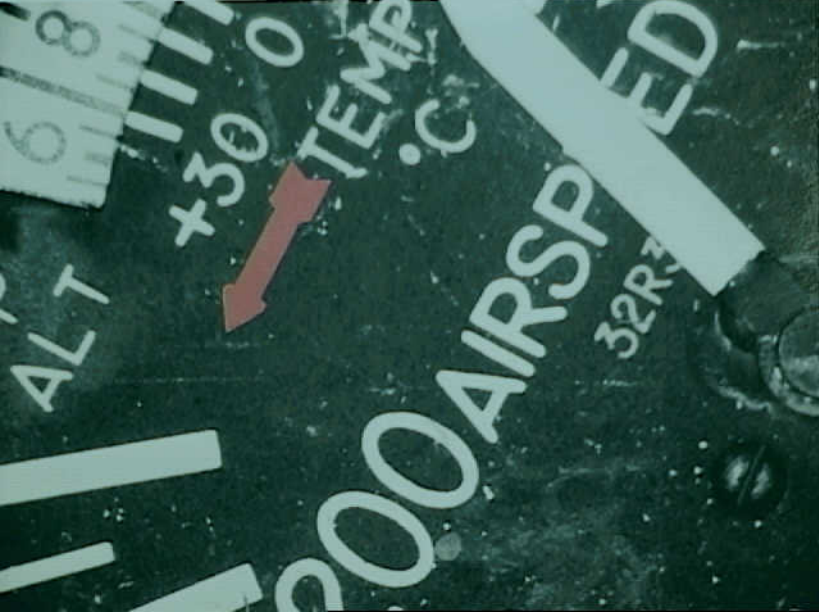
Airworthiness - Photo 20. Microscopic view of the vertical speed indicator face. Note needle slap mark is near the maximum indication of 2,000 feet per minute descent. (NTSB-Lab Polaroid)
